**Bundesstelle für Seeunfalluntersuchung**  
**Federal Bureau of Maritime Casualty Investigation**  
Federal Higher Authority subordinated to the Ministry of Transport  
and Digital Infrastructure

Investigation Report 265/13

**Very Serious Marine Casualty**

**Foundering of the Sailing Yacht  
FALADO VON RHODOS  
on 9 August 2013  
off Iceland**

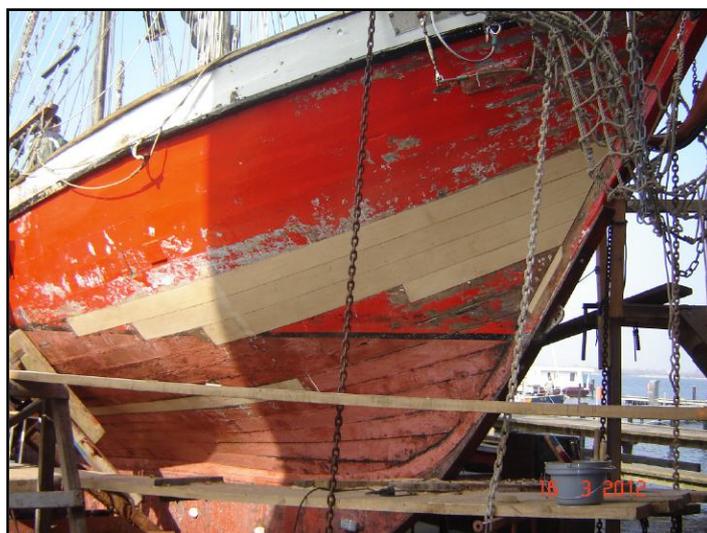
In March 2012, 17.3 running metres of planking were renewed forward on the starboard side in five strakes and 4.8 m on the port side in two strakes at the Modersitzki shipyard in Maasholm. This shipyard had already renewed 11 running metres of planking in two strakes and installed additional frames on the plank joints in 2008.

Figure 3: Renewed planking on the starboard side

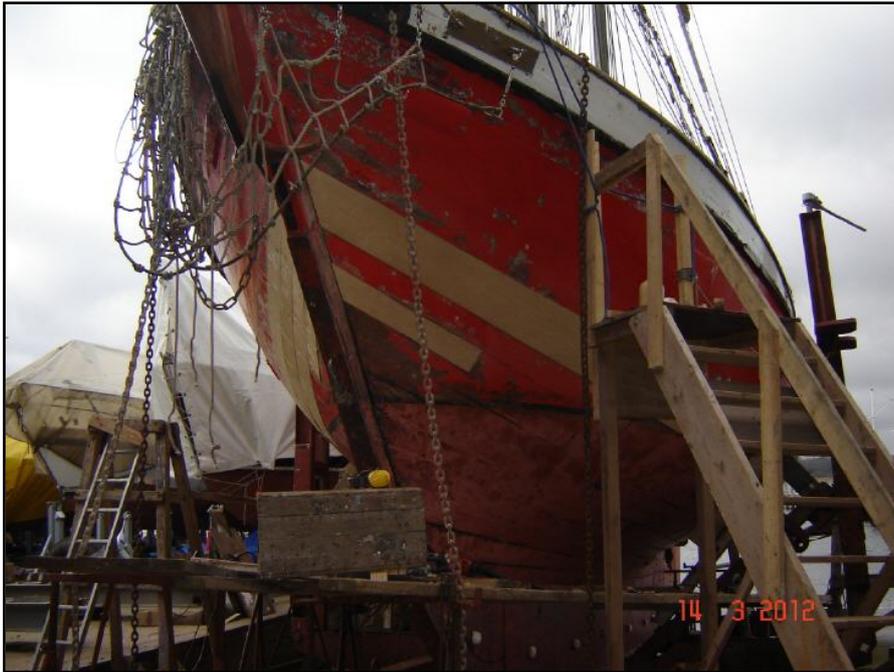
Figure 4: Renewed planking on the port side

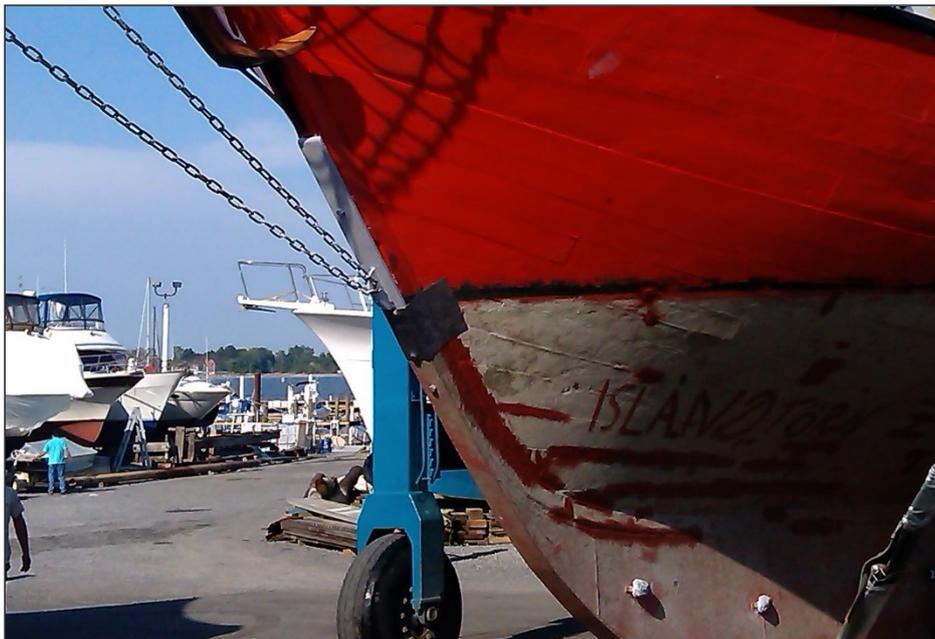
Dry-dock works were carried out on the hull in the Consolidated Yachts shipyard at City Island, New York, from 27-31 May 2013. Inter alia, several joints were re-caulked without outside assistance and the starboard shroud fittings relocated. On the stem, where the bobstay (the two chains in the following figure) is attached to the stem fitting, lead sheet was pinned/bonded beneath the stem fitting to prevent any leakage there. After she was launched, a leak was discovered on the port side in the lower berth, meaning the vessel had to be hauled out of the water again. This leak was sealed from the outside and also pinned with the application of lead; no further problems occurred after that.

Figure 6: Stem fitting pinned with application of lead

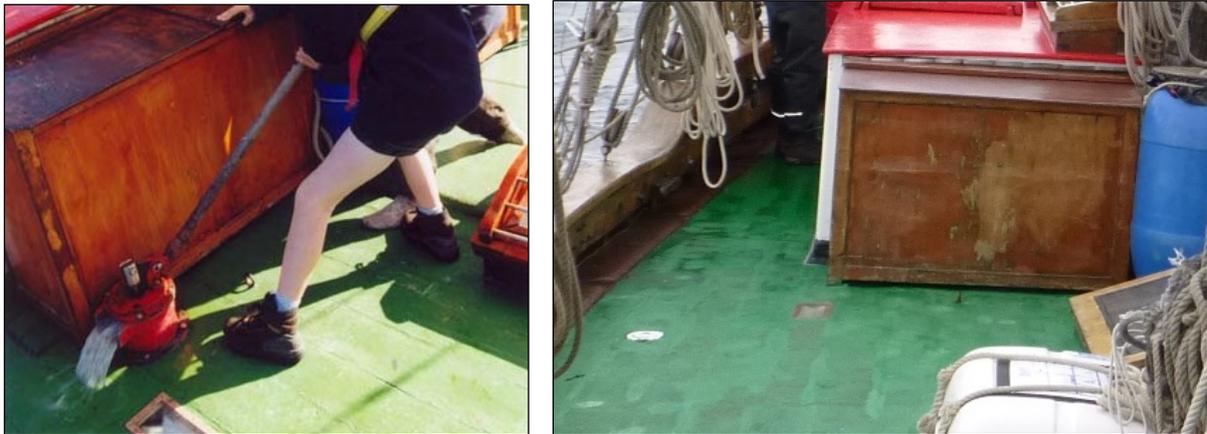
Photos taken in the years prior to 2010 also show a handle pump before the superstructure, which was installed when the vessel was built in Rhodes. Such handle pumps are the most effective because smaller particles in the bilge water do not affect the operation of the pump. This pump was removed because the rubber membrane was faulty and replacement parts were no longer available. In place of that, the Whale Gusher 30 pump below deck but operable from the deck indicated at 3.) was connected to the drainage system of the old handle pump. Pictured below in the photo to the left is the handle pump installed. The photo to the right was taken during the last sailing trip and shows the same place without the pump; the Whale Gusher pump (white circle, connecting point for hand lever) is installed below deck.

Figure 8: Handle pump

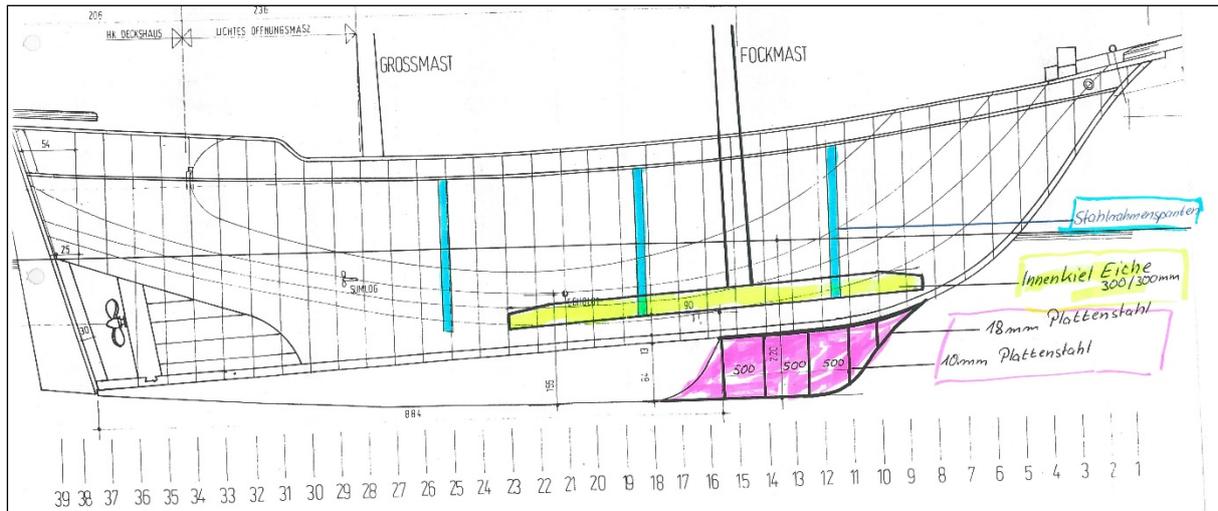
The following drawing was enclosed with the report. It illustrates the three required measures proposed by the expert – new steel web frames, additional internal keel (300/300 mm), and the extension of the keel – for improving the torsional and longitudinal strength in different colours.

Figure 12: Drawing with the proposed construction measures

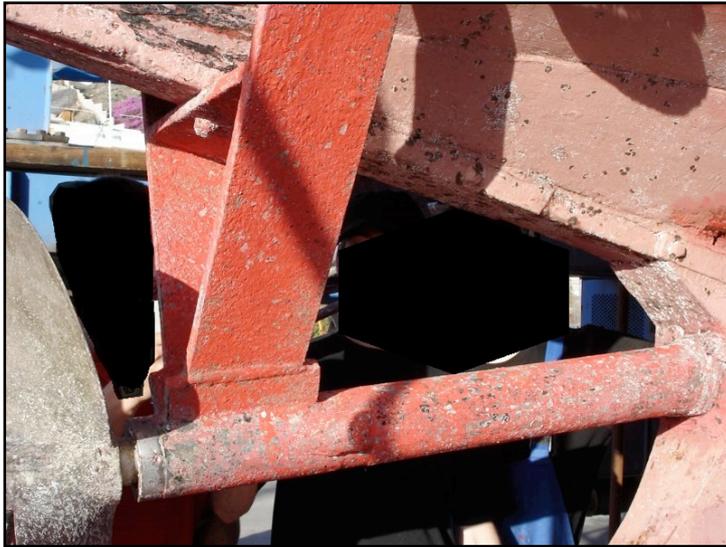
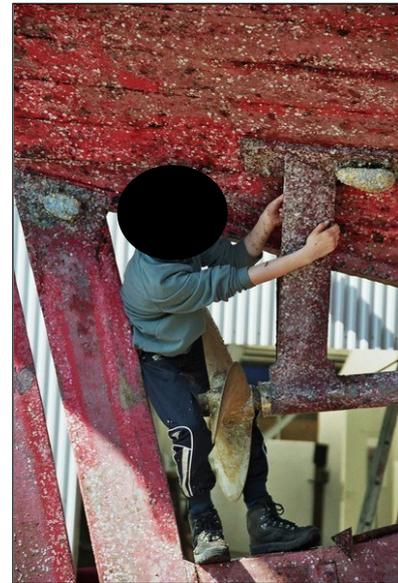
The change in the engine's output to 85 HP, then to 147 HP, and most recently to 140 HP bears no relation to the output originally configured and installed for the vessel. Documentation on what modifications were made to integrate this output with the vessel's structure was not available to the BSU. Information given by the skipper indicates that the engine's conversion from 85 HP to 147 HP, including complete conversion of the driving chain, was planned and executed by the Ebbe shipyard in Denmark. Such an increase in output usually requires a modification to the propeller, such as an increase in diameter. Here, the propeller was relocated aftward away from the deadwood in the screw aperture. To absorb the vibrations from the larger propeller, an additional shaft bracket was bolted outside to the keel, as shown in the following photo.

Figure 16: Shaft bracket

The shaft bracket is attached (not integrally) to the aft stem and hood ends of the planking. It looks as if the entire load from the vibration of the propeller on two bolts, which were inserted into the keel, should be introduced into the vessel's structure. There is no lateral integral connection with the keel and planking. The shaft bracket's lateral bar is evidently bolted to a plank above (photo to the right). Nothing is known about the how this shaft bracket is otherwise attached to the vessel's structure. However, at a frame spacing of 390 mm it is reasonable to assume that bolting is made with two frames, which is not enough for the introduction of a load. The above left photo also suggests that the thickness of the wood on the keel at the stern tube penetration is relatively weak. It was not possible to establish whether the deadwood behind it has now been executed in solid wood.

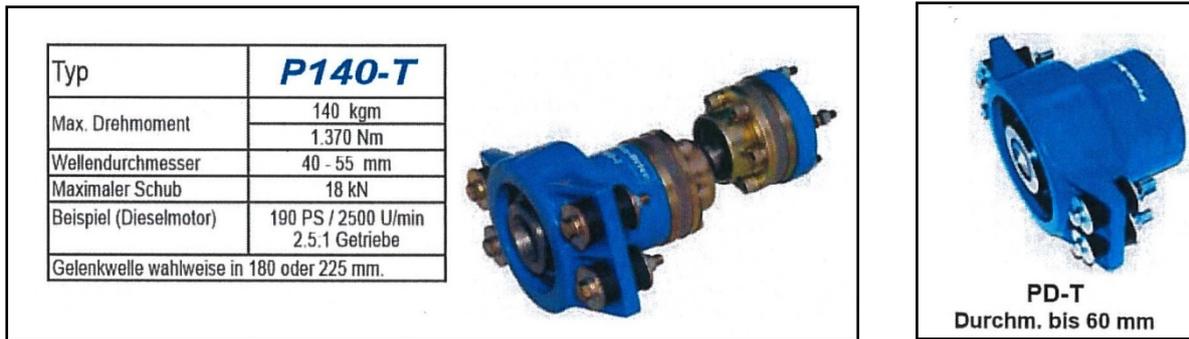
In May 2012, damage was discovered on the newly installed shafting after the most recent modifications to the machinery. A new PD-T thrust bearing for a 55 mm shaft was delivered and installed and the shaft seal repaired.

Figure 17: Thrust bearing

There were no design or manufacturing faults according to information given by the manufacturer of the thrust bearing. The damage was caused when the thrust bearing and the stern tube seal must have been exposed to water inside the vessel. It was not possible to determine precisely whether this water ingress was the result of shaft misalignment, incorrect interpretation or poor production of the design for the introduction of the compressive load into the vessel's structure, or other causes. The BSU was only informed that the FALADO VON RHODOS often had to be put on a slipway after calling at a shipyard due to water ingress in the aft section, in particular. Problems with the tightness of planking below the engine seating were experienced on several occasions, which involved planking separating from the frames and not being properly attached to the stern rabbet, floor or frames.

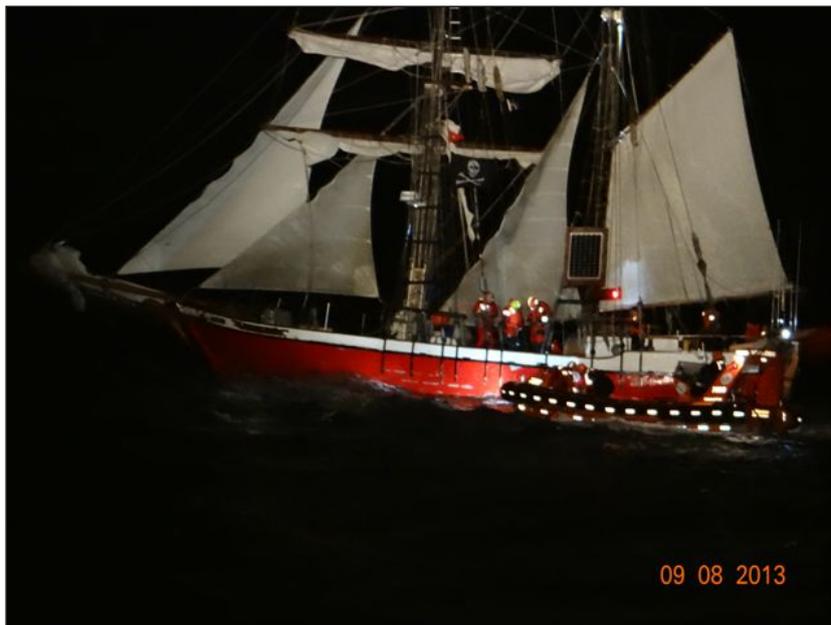
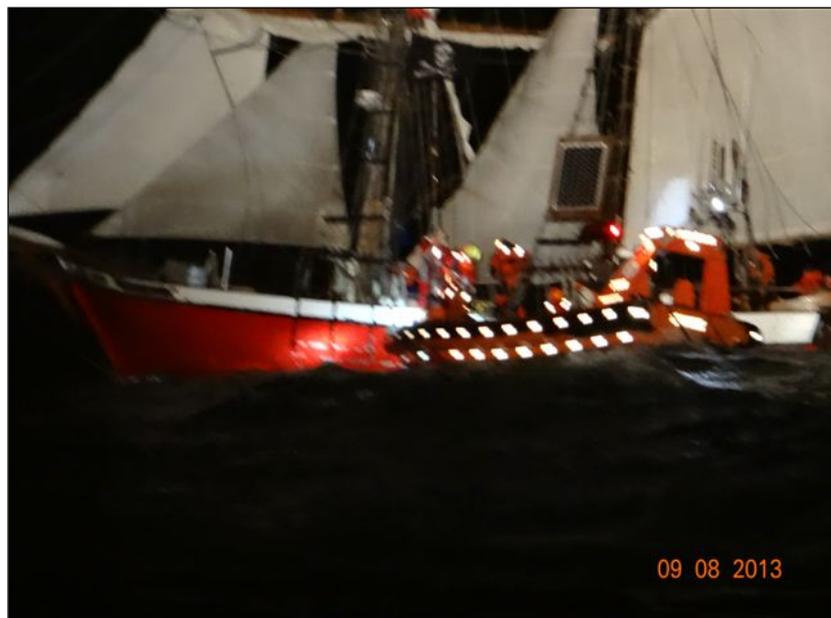
On the following photos, which were taken during the rescue operation, it looks as if there is a significant amount of paint peeling in the area of the chainplate attachments (white vertical stripe). This suggests that the longitudinal joints in that area have cracked due to the load of the mast, which may have led to leakage. Indeed, a systematic search for the cause of the water ingress was carried out. However, the crew did not isolate any damage that viewed alone could be regarded as the cause of the water ingress.

Figure 18: Final photos of the FALADO VON RHODOS
