Tension Technology International Ltd

‘MV NORTHERN FAITH’

**VISUAL EXAMINATION AND TENSILE TESTING OF
A FAILED MOORING LINE TO ESTABLISH THE
CAUSE OF FAILURE**

**Federal Bureau of Investigation of Maritime Casualty
Investigation**

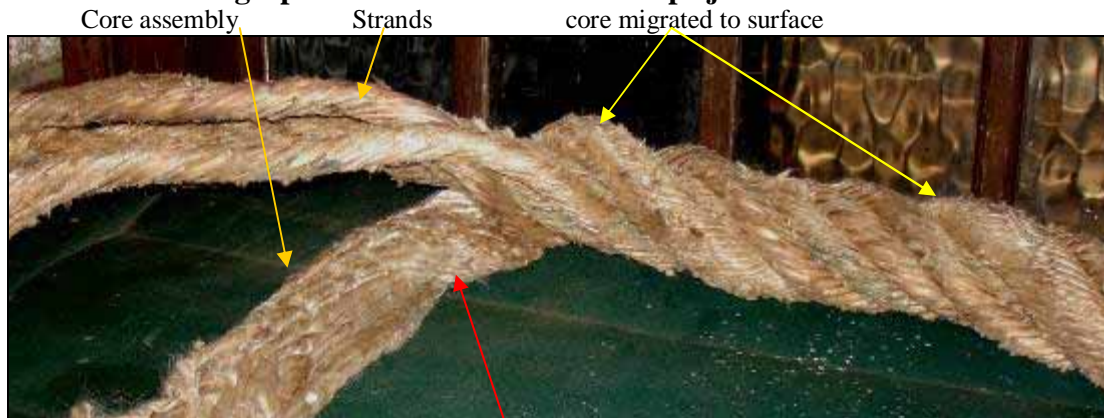
Photograph 1 General view of the rope just behind the fail zone

The core assembly was found to be arranged in a helical fashion around the rope axis and this must have happened as a result of the failure when the rope recoiled following the release of strain energy. This is shown in photograph 1

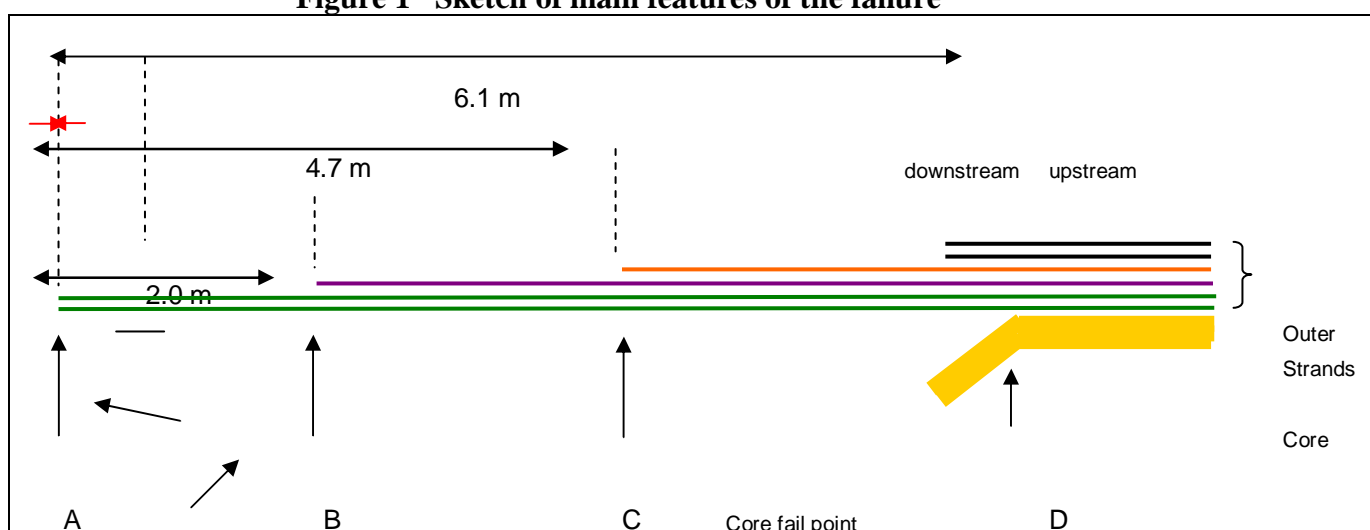
Figure 1 Sketch of main features of the failure

4. The two black coloured strands of figure 1 failed initially. During the course of their failure, the strands exerted extreme pressure on the core structure of the rope. This resulted in the damage seen to the rope yarns of the core, photograph 8.

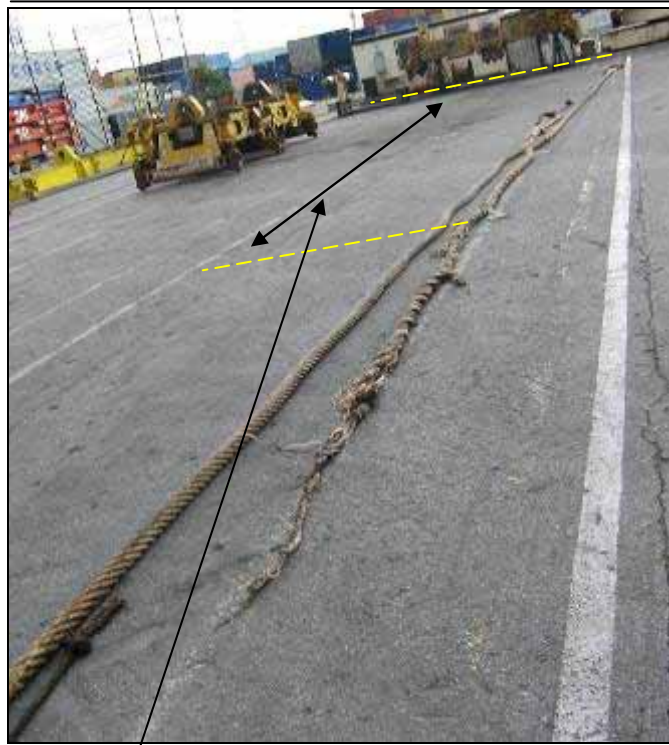
Photograph 2 General view of failure, looking towards pier bollard eye

The failure is located about 20 metres from the pier bollard eye and thus would probably have been located within the 'free length' of the line, between the pier bollard and deck winch/ fairlead at the time of the accident.

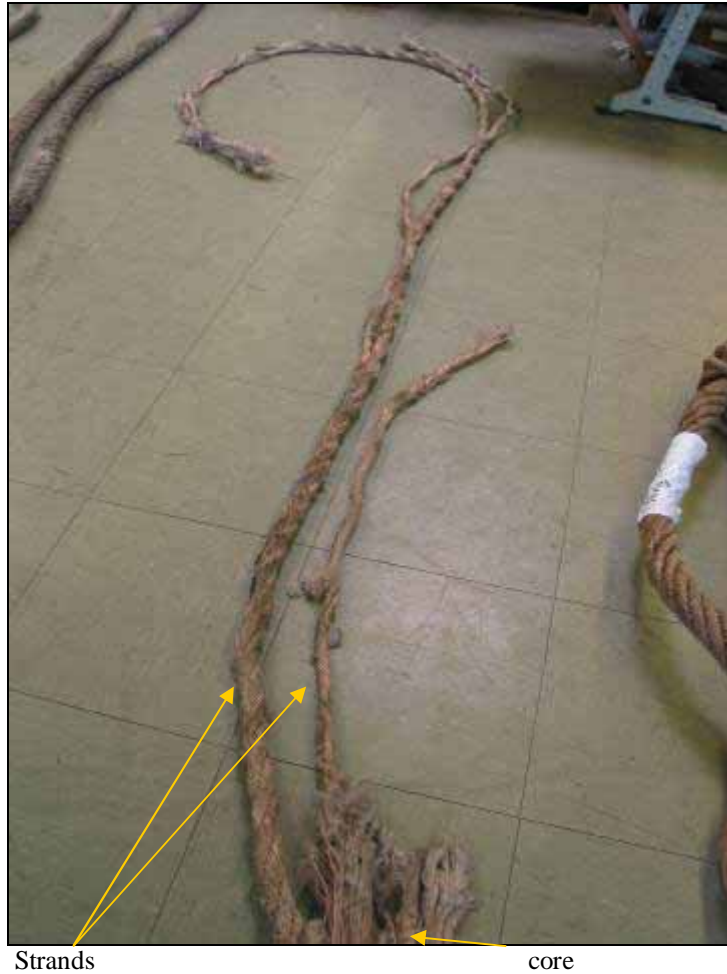
Photograph 3 General view of one half of the fail zone

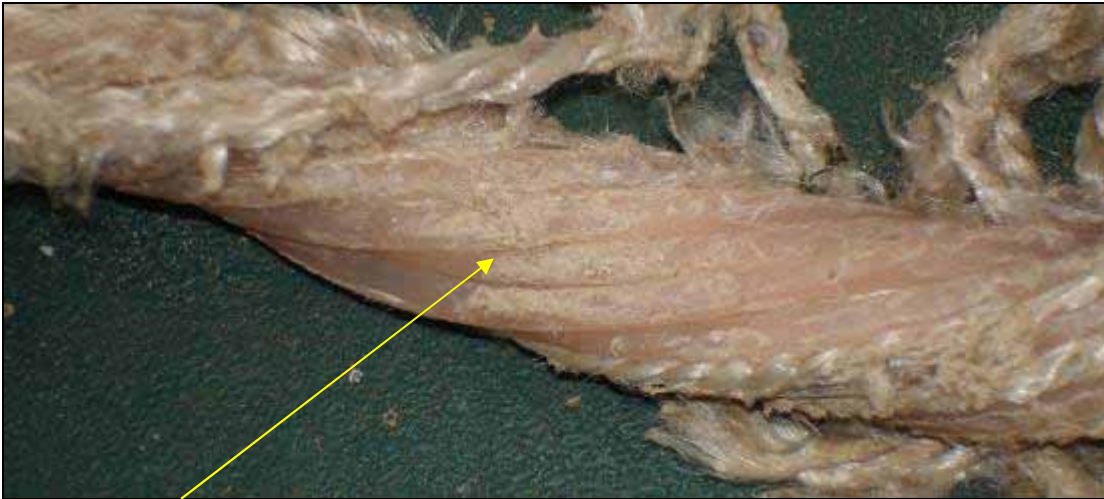
Photograph 4

Condition of a strand in fail zone, 1 metre behind position A of figure 1

External abrasion

Both images reveal that the rope yarns of the strands had been subjected to severe external abrasion, resulting in either complete removal [photo 4] or fused material [photo 5]. Inspection of all the strands revealed that a general melding of the textile and monofilament components had occurred, indicating a failure under elevated temperature and/or pressure conditions.

In photograph 4, abrasion to the monofilament material is also clearly seen.

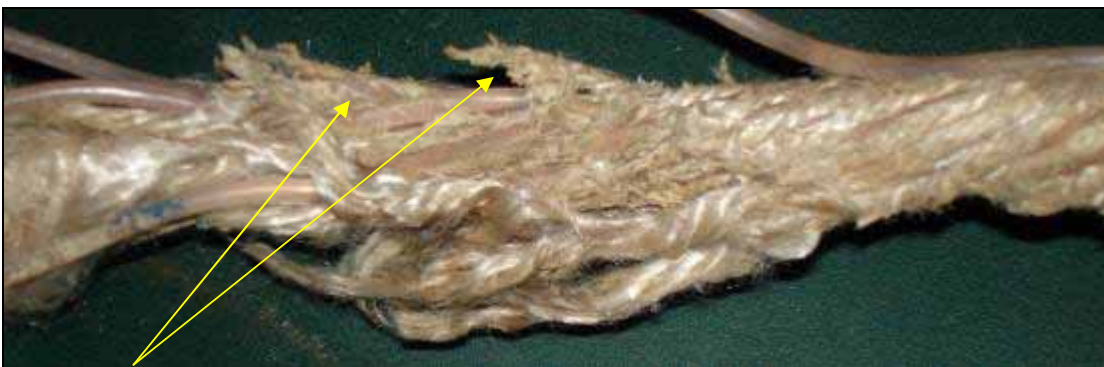
Photograph 5

Condition of a strand 1 metre downstream of position D of figure 1

Fused rope yarn material

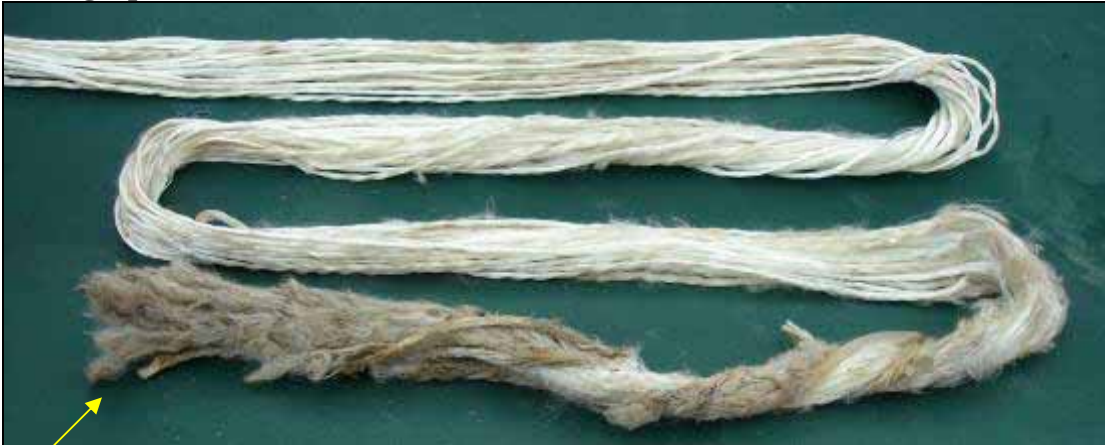
Photograph 6 shows about 1.2 metres of an outer strand core assembly of rope yarns, behind its fail point.

Fail point

The rope yarns are relatively clean and in reasonable condition up to about 400 mm from the actual fail point. As the fail point is approached, contamination increases and the overall condition declines rapidly. These are indications of external abrasion having occurred.

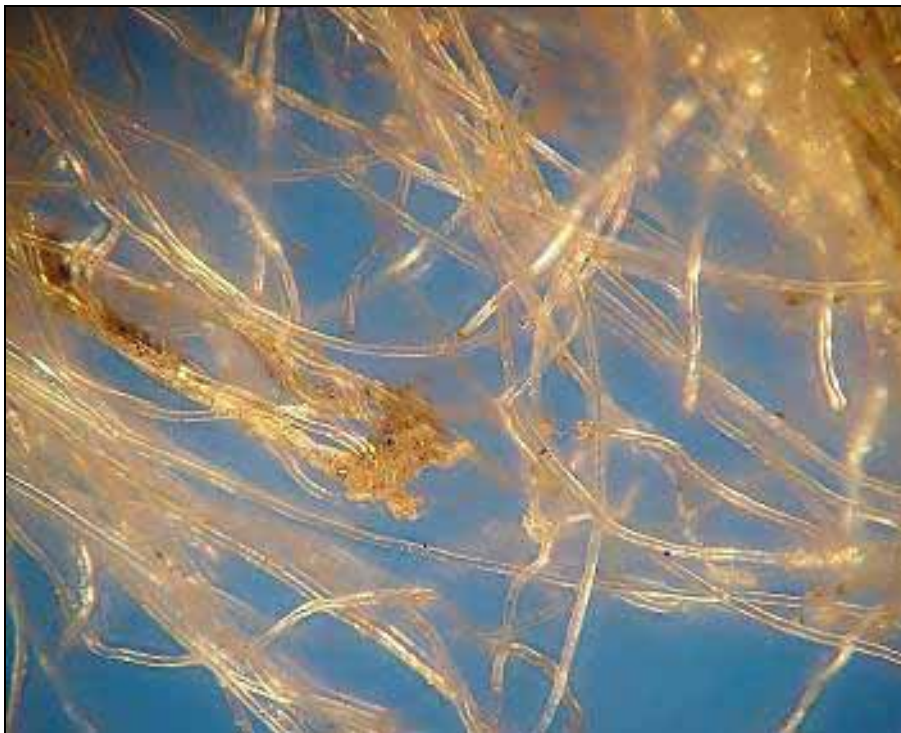
Photograph 7 Fused filaments from core fail point of figure 1

A cluster of fused filaments is seen in the centre of the image. Darker spots are also seen which could be charred material or contamination. The image is evidence of excessive heat being present at the time of failure.

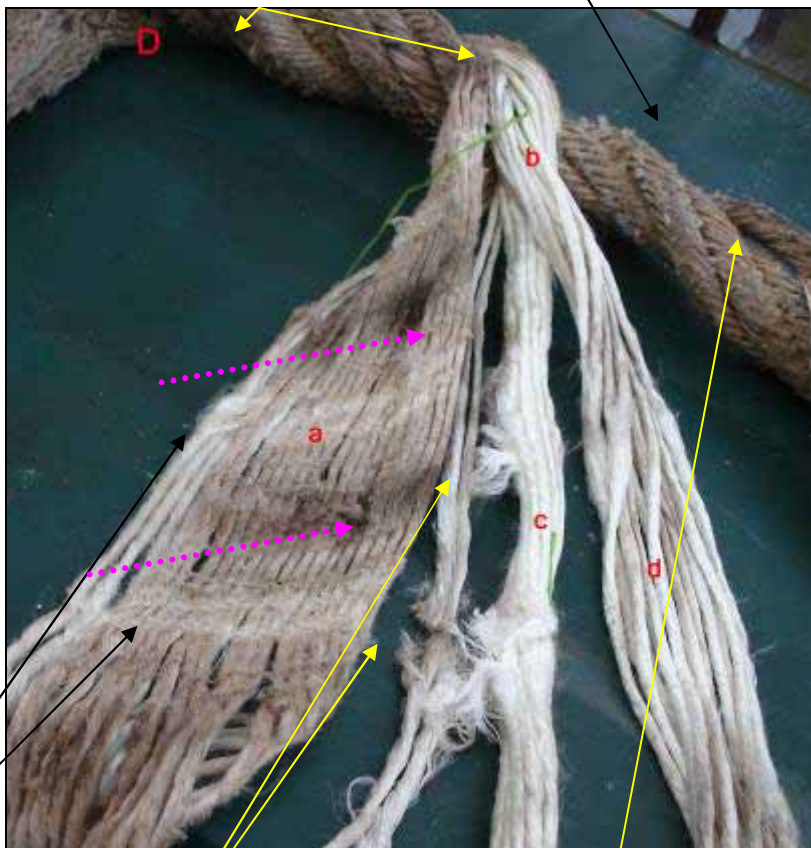
General melding of the rope components was found. Photograph 8 shows the rope core assembly, opened up to reveal the condition of the elements. At 'a', the outer rope yarns are seen. The view is of their inner faces. The yarns have been 'melded' together but could be separated by pulling them apart. The outer faces of these yarns show evidence of damage that is consistent with the effects of heat and pressure.

Above and below 'a', two zones of excessive damage are seen running in the line of the purple arrows across the image. These have been caused by pressure from the two strands, coloured black in figure 1, repeated below for convenience. During the investigation, these two strands were found to be severely melded to the outer rope yarns of the core and could only be separated by exerting considerable force

Photograph 8 Unraveled core, upstream of position D

melded cluster of 4 strands

Localised compression

localised failure

one of two strands not melded with 4-strand c

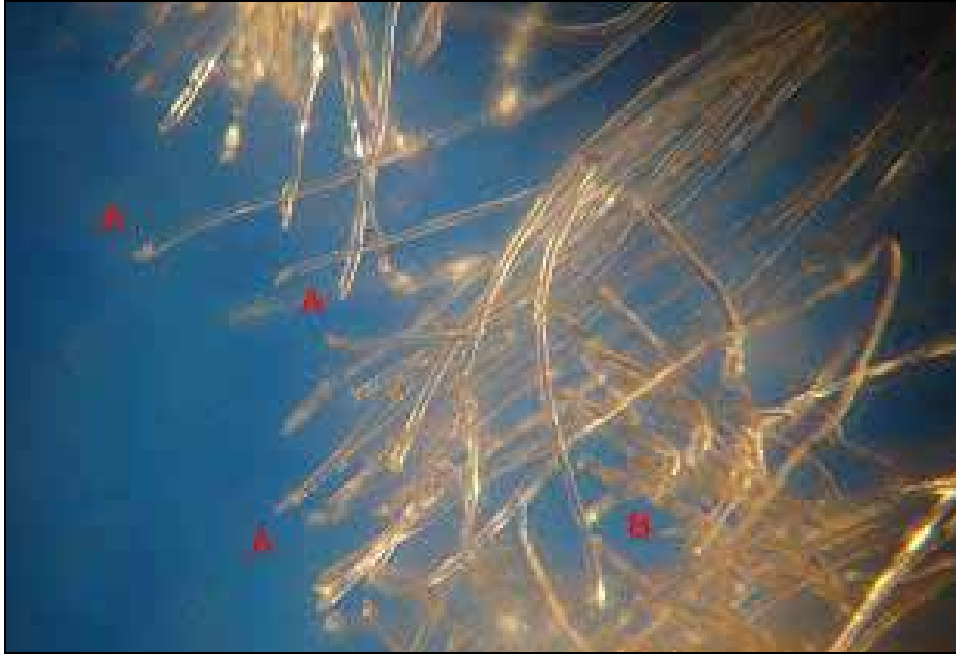
Photo 9 Failed filaments from inner rope yarns of core assembly

At 'A', the failed ends have a shape that is typical of ductile tensile failure. At B, folding and flattening of filaments is seen [the image is slightly out of focus]. This indicates that pressure has been a factor in these failures of the internal rope yarns

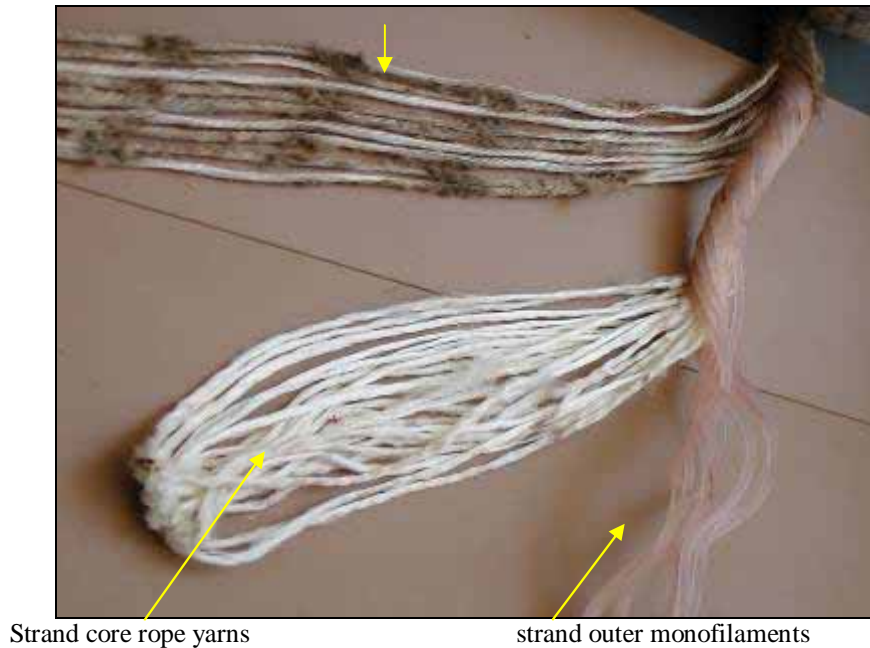
Photograph 10 shows one of the strands upstream of D, unraveled. The outer rope yarns are abraded, but retain some structure. Also, the yarns had a soft 'feel' to the hand, in contrast to the harder 'feel' found on surviving rope yarn material downstream of D. In addition, examination of the monofilaments failed to reveal the same degree of external abrasion as that found on monofilaments downstream of D.

Photograph 10 Unraveled strand, upstream of D
Strand outer rope yarns

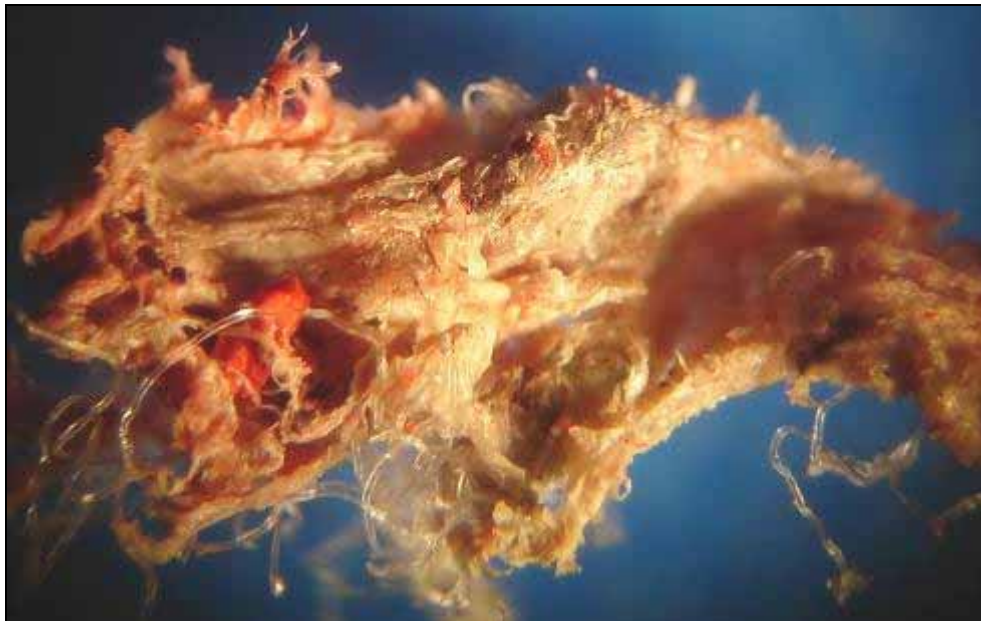
Photograph 11 Red particle embedded in fused matrix of rope filaments

It was concluded that these areas of contamination were most likely to be paint that had contaminated the rope when the rope had made high energy contact with the vessel during the recoil after the failure.

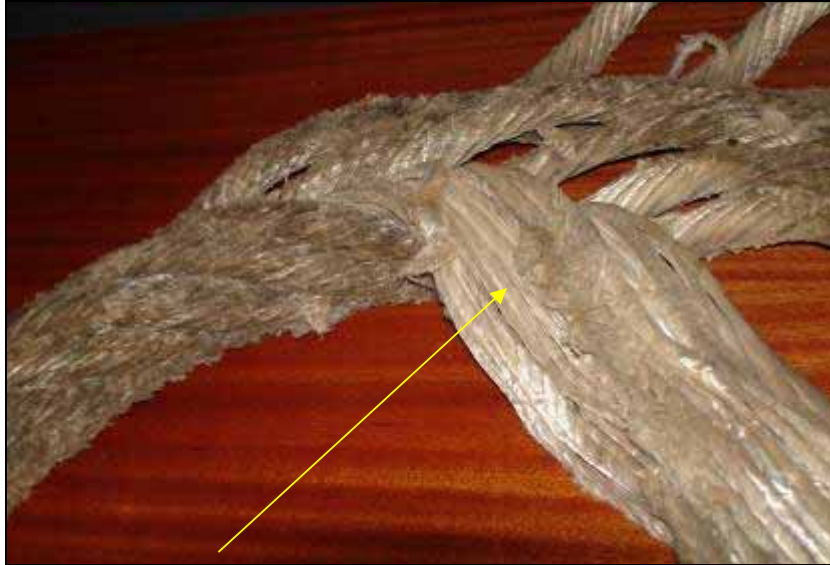
Photo 12 Unraveled 'adjacent' sample showing core rope yarns

Severe damage to cluster of core rope yarns

Severe damage was found to some of the rope yarns in the core assembly, photograph 12, but with little evidence of similar damage to the outer strands in the that region. This is similar to damage found in the 'failure' sample, upstream of D, where damage to the core was not matched by comparable damage to the outer strands. However, in this case, the cause may have been a previous compression incident, not related to the rope failure. The outer strands, with the tough monofilaments, were able to withstand the compression, whilst the softer core rope yarns could not.

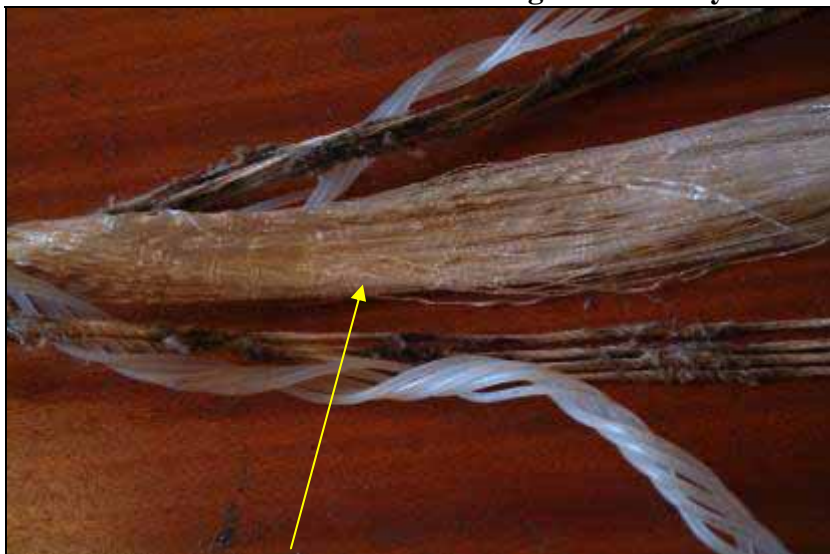
Photo 13 Unraveled strand showing core textile yarns

Textile yarns of core assembly

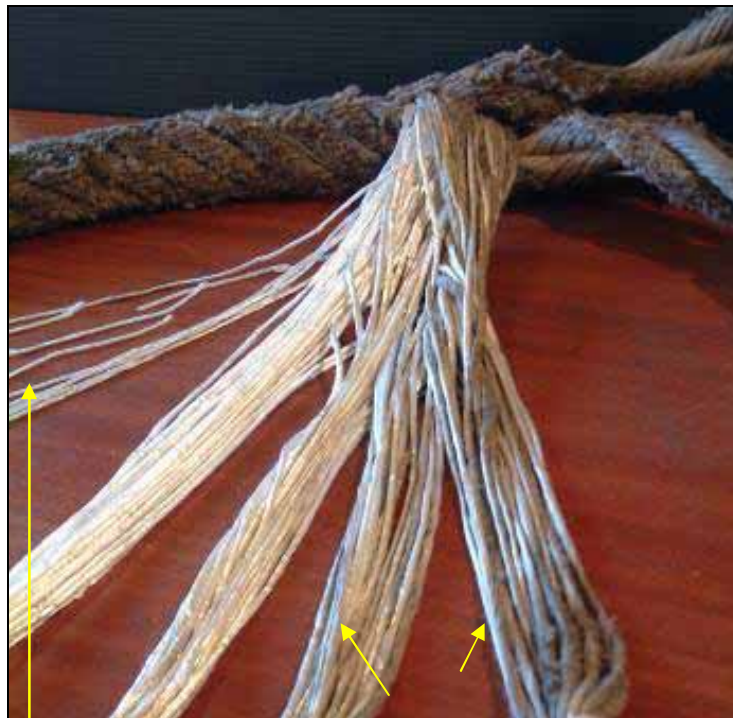
Photograph 14 'Clear of fail zone' sample unraveled to expose core rope yarns

Broken small diameter rope yarns

contaminated and damaged large diameter rope yarns

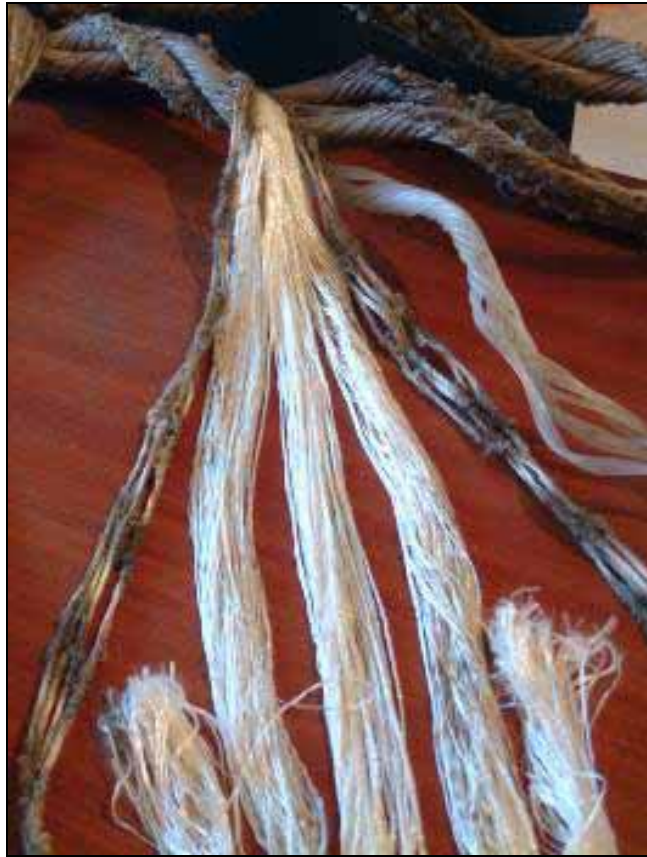
Photograph 15
Strand from 'clear' sample, unraveled to core reveal textile yarns

Damage to the rope yarns and textile yarns were seen, but it was thought not to be of much use for the present investigation to perform further tensile testing.
