Investigation Report
Release Mechanism
of Port Life- and Rescue Boat
MT „OLIVER JACOB“
Very Serious Casualty
Dated 21.01.2006

Report-No.: 2006-05/e

Prepared For: Federal Bureau of Maritime Casualty Investigation (BSU)
Bernhard-Nocht-Straße 78
D-20359 Hamburg

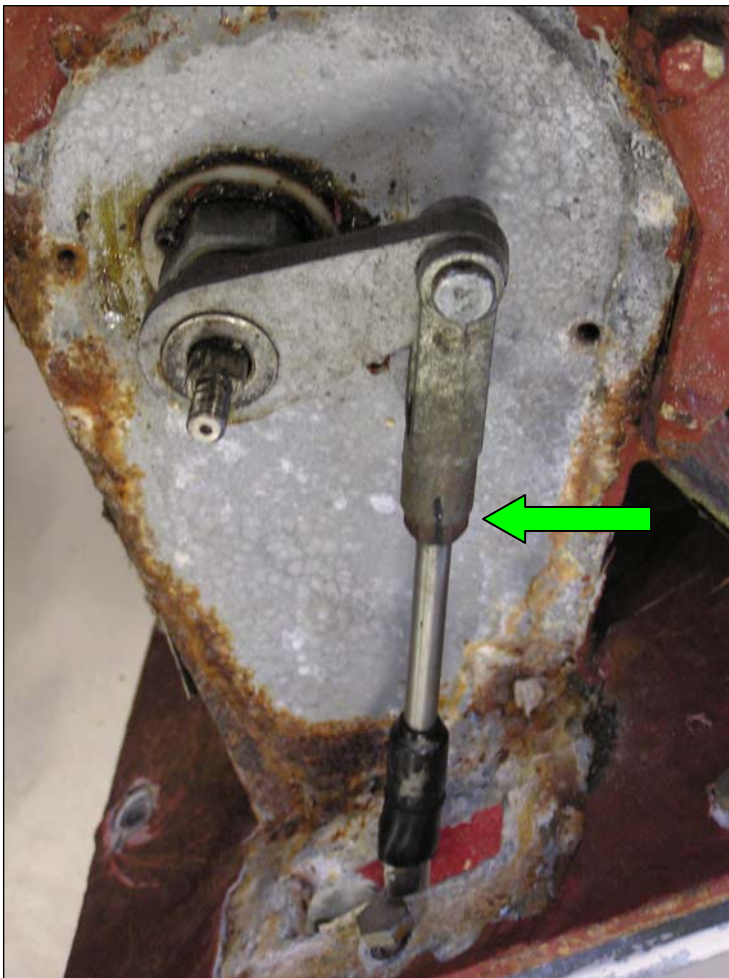
Figure 7:
Forward hoisting hook:
Assembly of release cable to
release lever arm of forward
hoisting hook.
Marking of release cable length:
This has been marked prior
dismantling.

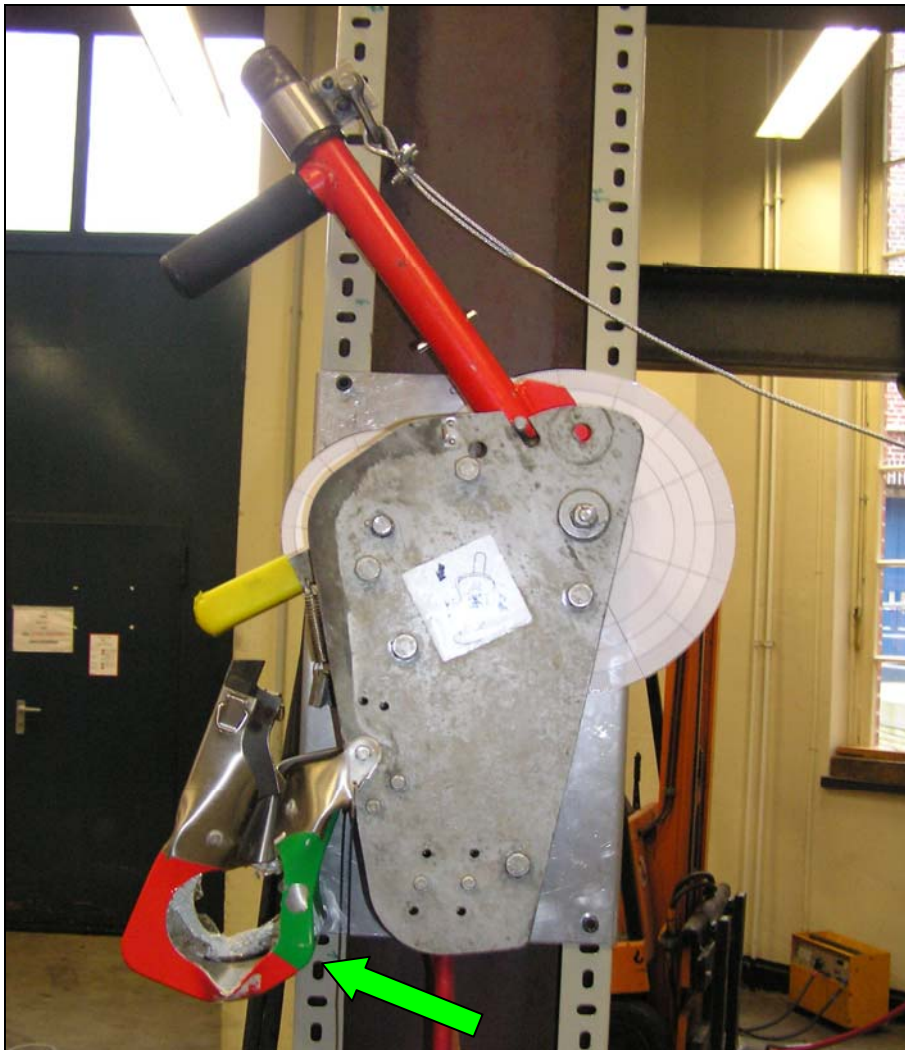
Figure 10:
Central release unit:
Mounted to test foundation structure. Damaged safety cover of hydrostatic securing flap has been turned down during these tests. The safety cover has been damaged by interior parts of the boat during accident.

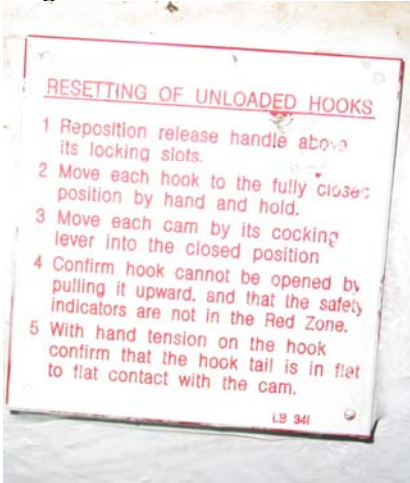
Figure 11
1.3.1.	Is it possible to fully secure release handle at central release unit?	A fully securing at central release unit is not possible. It is not possible to turn the aft operating quadrant (right washer in Figure 12) in the fully aft position for fully securing by safety pin. Right leading pin of release handle Has contact to aft operating quadrant causing friction to it. Release handle is in more or less secured and arrested position but a fully securing with safety pin can not be done. Safety pin can only be stick in partly.

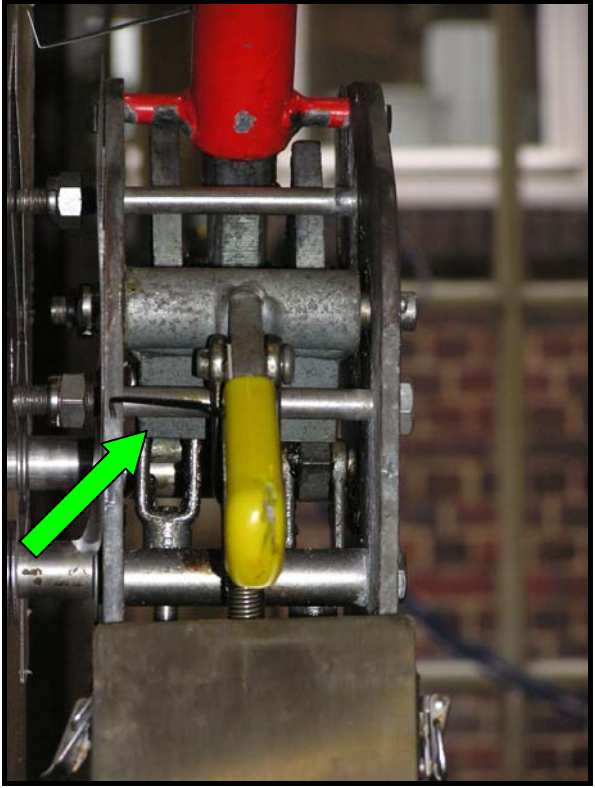
<p>1.4.</p> <p>1.4.1.</p> <p>1.4.1.1</p> <p>1.4.1.2</p>	<p>Investigation of hydrostatic lock system</p> <p>Water level 100 mm above hydrostatic pressure cell Draught of boat abt. 523 mm</p> <p>Angel of opening of hydrostatic securing flap?</p> <p>Is it possible to release the hoisting hooks by central release unit?</p>	<p>Movement causing from hydrostatic pressure cell at the release lever can not be recognised.</p> <p>1,5° The hydrostatic securing flap partially has contact with the not fully returned aft operating quadrant (acc. to test no. 1.3.1) and to the fork-head of aft release cable. (Figure 13)</p> <p>Yes, because hydrostatic securing flap could not be fully secured prior launching into water.</p>

<p>Figure 13</p>
<p>1.4.2.</p> <p>1.4.2.1</p> <p>1.4.2.2</p>	<p>Water level 200 mm above hydrostatic pressure cell Draught of boat: abt. 623 mm</p> <p>Angel of opening of hydrostatic release lever?</p> <p>Is it possible to release the hoisting hooks by central release unit?</p>	<p>Movement of hydrostatic securing flap can not be identified</p> <p>7°</p> <p>see 1.4.1.2</p>

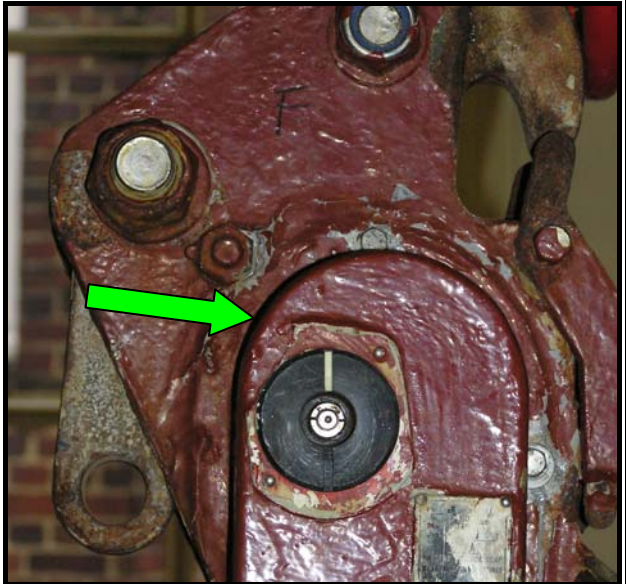
Figure 14

1.4.3.	Water level 300 mm above hydrostatic pressure cell Draught of boat: abt. 723 mm	The hydrostatic securing flap has opened fully
1.4.3.1	Angel of opening of hydrostatic release lever?	12,5°
1.4.3.2	Is it possible to release the hoisting hooks by central release unit?	Yes
1.5.	General Investigation:	
1.5.1.	Function of safety pin	
1.5.1.1	Unintentional push out of safety pin from fully inserted position possible?	The safety pin is fully functioning. Pushing out could not be recognised.
1.5.2.	Marking of cam release pin: Forward hoisting hook port	
1.5.2.1	Clear to be identified?	No, painted
1.5.2.2	Position?	Can not be identified
1.5.2.3	In correspondence with operation instruction plate no. 34i (Figure 11)?	Red zone can not be identified

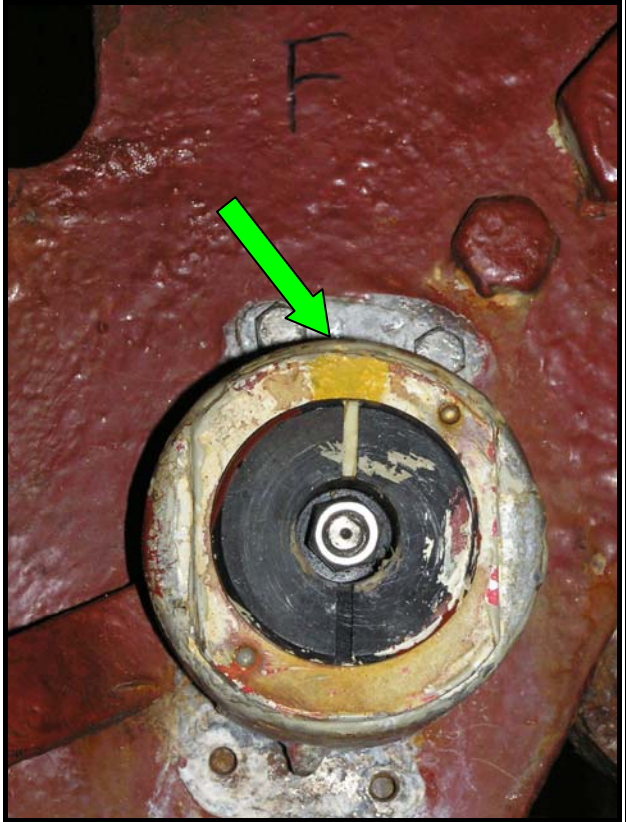
<p>Figure 15</p>
---	--	--

<p>1.5.3. Marking of cam release pin: Forward hoisting hook starboard side</p> <p>1.5.3.1 Clear to be identified?</p> <p>1.5.3.2 Position?</p> <p>1.5.3.3 In correspondence with operation instruction plate no. 34i (Figure 11)?</p>		<p>No, yellow zone</p> <p>Secured, but in yellow zone</p> <p>No</p>

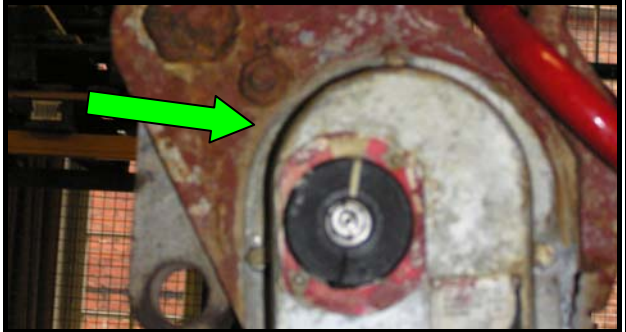
<p>1.5.4. Marking of cam release pin: Aft hoisting hook starboard side</p> <p>1.5.4.1 Clear to be identified?</p> <p>1.5.4.2 Position?</p> <p>1.5.4.3 In correspondence with operation instruction plate no. 34i (Figure 11)?</p>		<p>Yes</p> <p>Secured</p> <p>Yes</p>

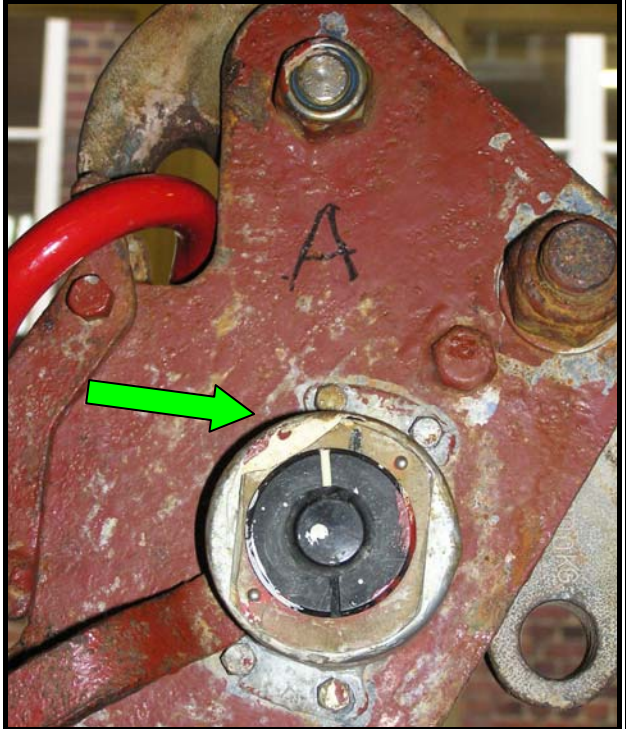
<p>Figure 17</p>

<p>Figure 16</p>
<p>1.5.5. Marking of cam release pin: Aft hoisting hook port</p> <p>1.5.5.1 Clear to be identified?</p> <p>1.5.5.2 Position?</p> <p>1.5.5.3 In correspondence with operation instruction plate no. 34i (Figure 11)?</p>		<p>No, partly damaged</p> <p>Not clear</p> <p>No</p>

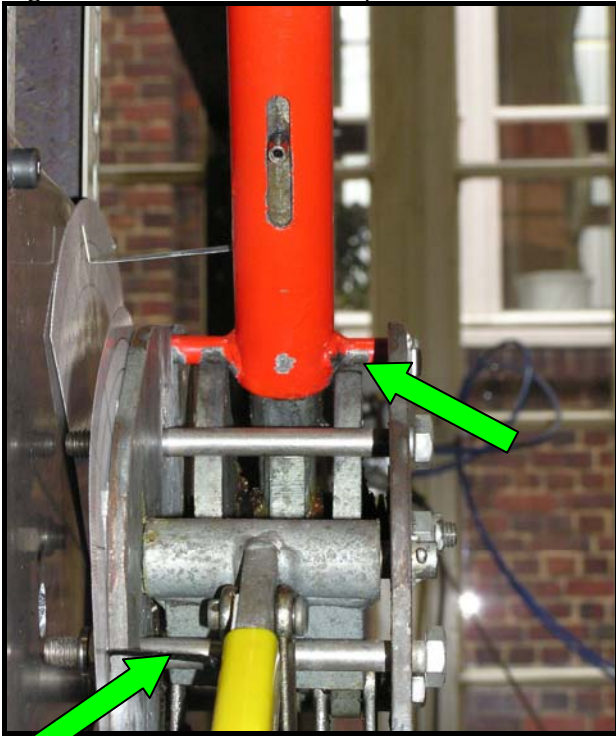
<p>1.6.1.</p>	<p>Functioning test with vertical tensile force of 16,51 KN per hook (boat loaded with 3 pers. of 75 kg). Simulation of release point</p>	<p>Hydrostatic securing flap is open up to a tensile load of 2,21 to per hook (because boat is still afloat!) Release handle is in more or less secured and arrested position (as described in 1.3.1)</p>
<p>1.6.1.1</p>	<p>Simultaneous release of both hoisting hooks?</p>	<p>No. Forward operating quadrant is turning against welding seam of release handle at higher loads than 2,21 KN per hook</p>

<p>Figure 18</p> <p>In this new position of forward operating quadrant the hydrostatic securing flap is not able to secure this forward operating quadrant, because the hydrostatic securing flap has contact with fork-head of aft release cable and can not turn further on. (see 1.4.1.1) Forward hoisting hook is releasing during lift up procedure of release handle in this secured angle position. Only forward hoisting hook is releasing self automatic.</p>

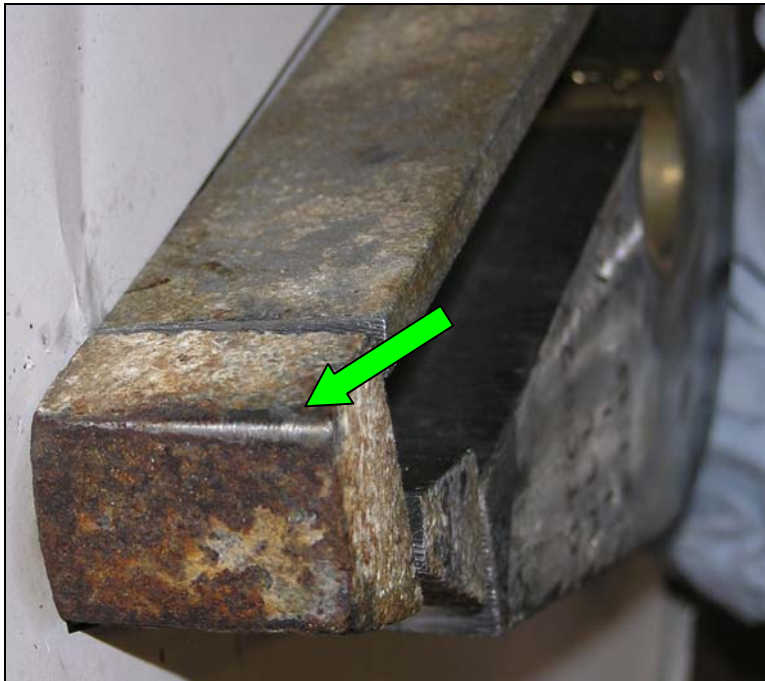
Figure 20:

Forward hook:

- Asymmetric
- Sign of wear.

Bottom part of hook is strong corroded.

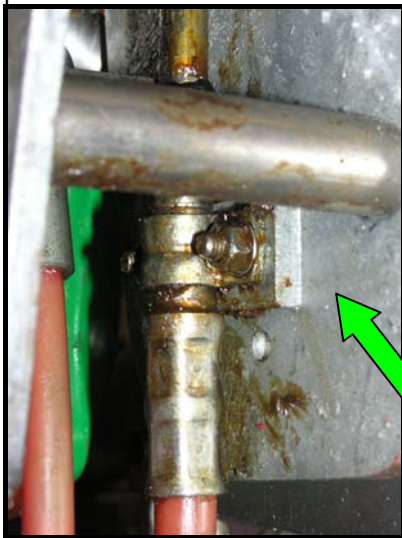
Figure 22: Original assembly point of the release cable on the release unit.

The port lifeboat and rescue boat was hauled up and swung into the stowage position after the running trials. Since the boat could be swung in without damage up to the stowage position, both the forward and the aft hoisting hooks were able, at times, to carry a total load of at least 33.02 kN (16.51 kN per hook). Because of the secured release mechanism the safety pin cannot have been fully pushed in before the hoisting since this was not technically possible. The release handle was indeed in the secured angular position but could not be completely locked, since the aft release cable could not turn the aft operating quadrant into a position which would have made it possible to secure the release handle with the safety pin. The aft release cable was both wrongly adjusted for length and incorrectly fitted onto the operating unit. As part of the test carried out (A.3-1.9) the release cable length on the aft hoisting hook was increased by 4.73 mm and the aft release cable on the release unit fixed to a new base position (Figures 22, 23). Only then was it possible to turn the aft operating quadrant into a position which enabled it to secure the release handle with the safety pin.

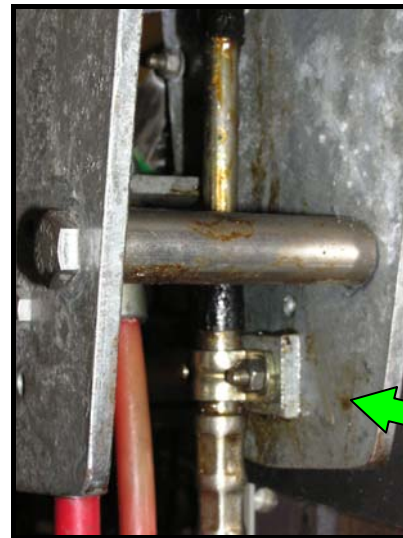
Figure 23: Modified assembly point of the release cable on the release unit.

B. By shifting the mounting point for the cable hose fixing on the aft foundation plate of the operating unit as specified in Figure 22 and 23.

The measure under B was carried out in Test No. A.3-1.9. At the same time the aft release cable on the fork head of the aft hook fixing was extended by 4.73 mm, in order that the release distance was sufficiently long.

It should be noted that the new assembly position of the cable fixing on the release unit as shown in Figure 22 was already available predrilled. Consequently there was an adjustment possibility available to equalise a cable tolerance.

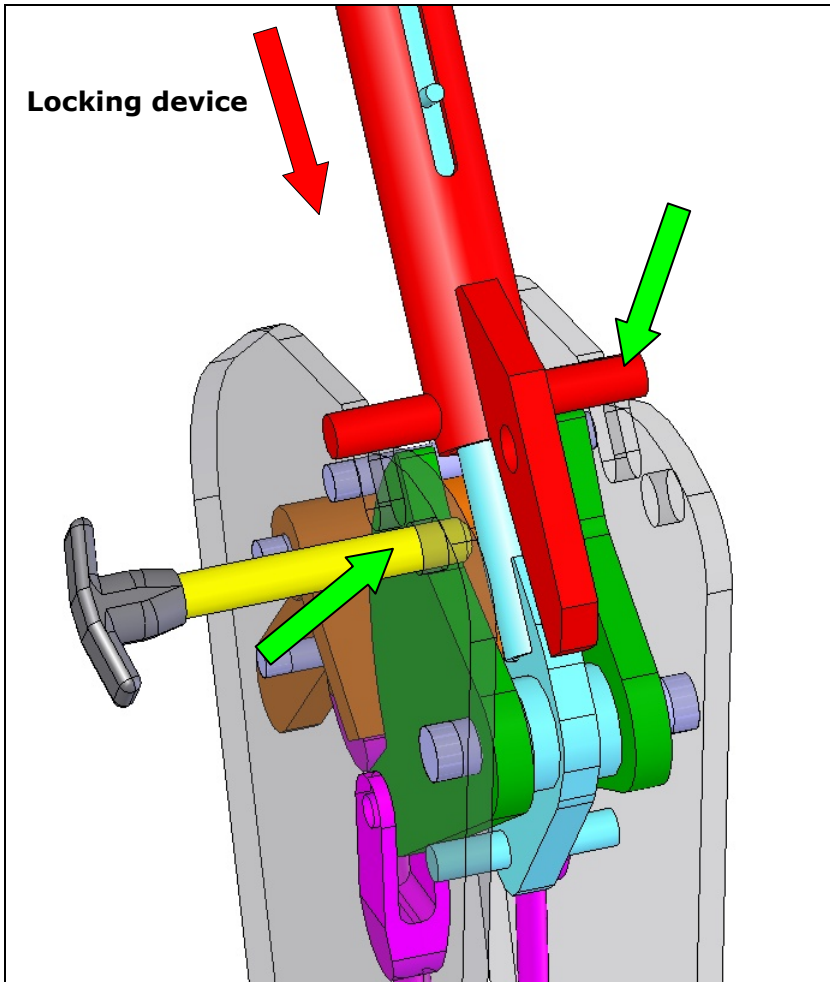
Consequently it can be concluded that the safety pin was only pushed into the side base plate but not up to the area of the forward operating quadrant.

Figure 24:
Release unit:
The right side leading pin (see arrow marking) lies on the aft operating quadrant. Therefore the release handle cannot be lowered. The side leading pins thus do not reach the position to protect the operating quadrants.

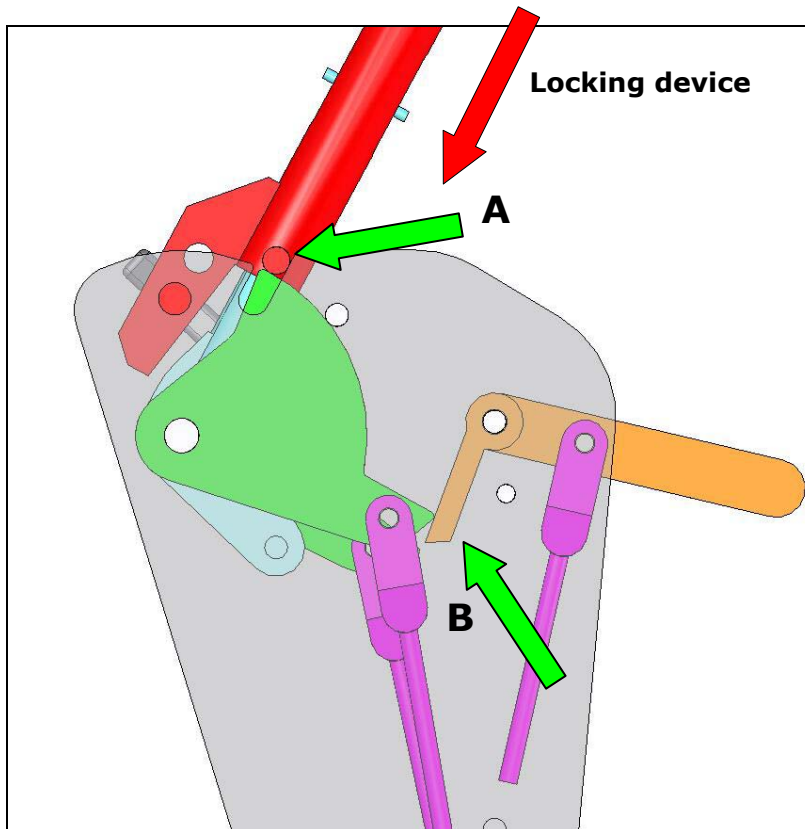
Figure 25:

Release unit:

B: The hydrostatic securing flap cannot secure both operating quadrants, since they lie against the aft operating quadrant or against the aft release cable.

The hydrostatic protection flap could not exercise its function of protecting the two operating quadrants since even when lifted out of the water it was not able to turn into its safety position.

In Test No. A.3-1.4.1. – A.3-1.4.3. the water pressure cell worked when hoisting out of the water. As a result of the description given in B.1. the water pressure cell could not turn the hydrostatic securing flap into the securing position, since it fitted closely on the aft operating quadrant (Figure 25, Arrow B).

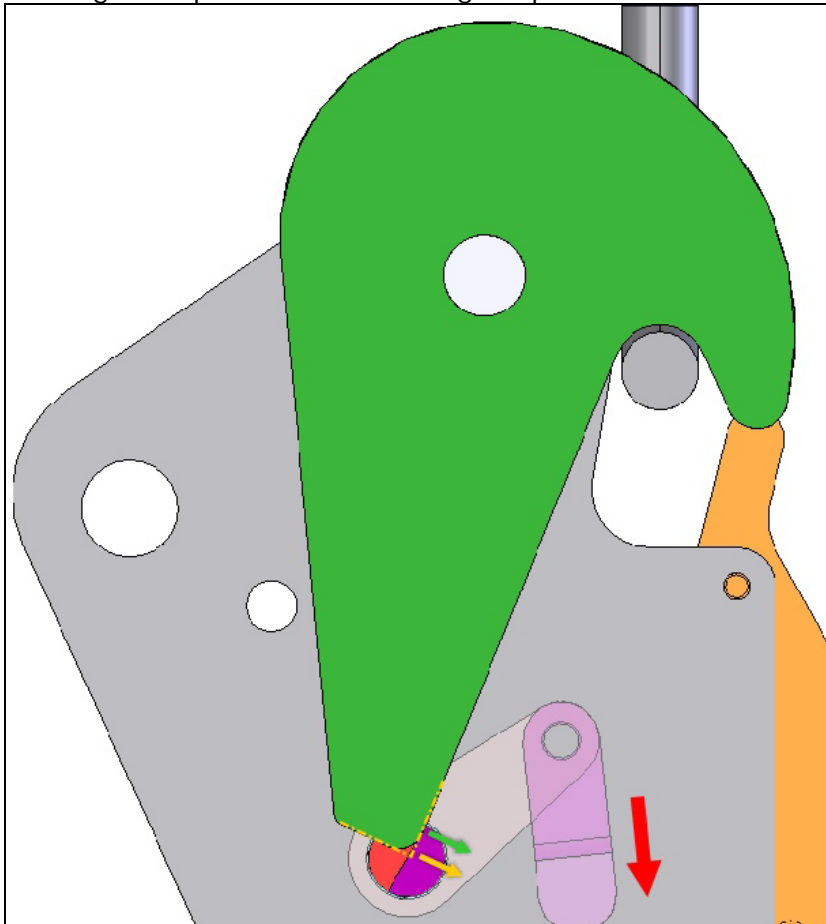
In this connection the following questions must now be asked: Why did a cam release pin on the hoisting hook release independently? In the description of the accident sequence of events an independent release took place, because as shown in Figure 27 the geometry of the hoisting hook due to a reduction of material by wear on the hoisting hook produced a releasing torque on the cam release pin.

Figure 27:
Display of the releasing torque on the cam release pin: The theoretical pressure point of the hook on the cam release pin is shown by the yellow arrow. The actual pressure point of the hook on the cam release pin is shown by the green arrow. This produces the torque that led to the independent release of the aft and forward hoisting hooks.

No material reduction or abrasion could be seen on the cam release pins. The releasing torque due to the hook on the cam release pin was so great that it retrospectively affected the release cable which had turned the unprotected operating quadrant.

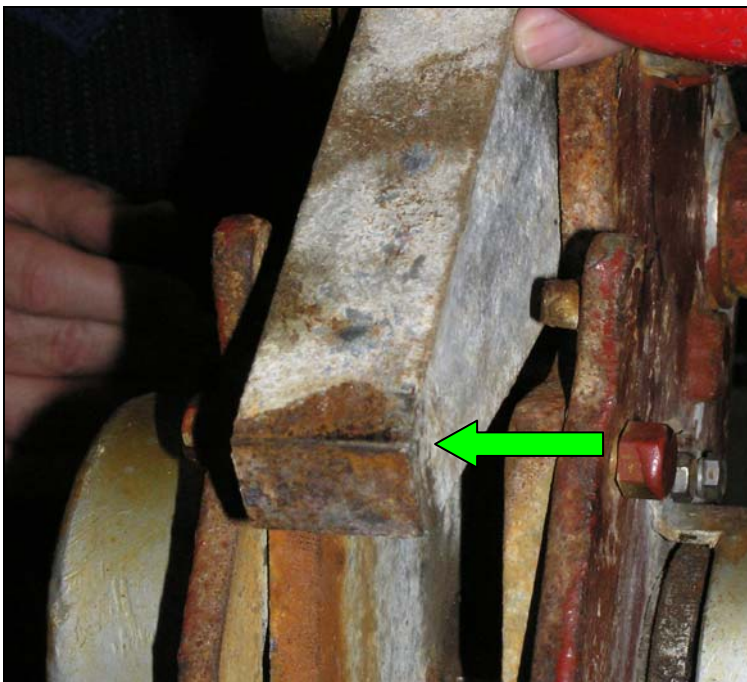
According to drawing TG 94 (Appendix No. 7) the hook should have a galvanising coat. This galvanising was no longer present in the area of the equipment surfaces for the release on both hooks as shown in Figures 20 and 28. It should be noted that galvanising is not a sensible way of preventing corrosion in the area of the hook. According to drawing TG 94 (Appendix No. 7) the manufacturing accuracy is given as 151.33 (+ 0.08/-0.00) mm for the part of the hook relevant for release. Galvanising and the wear in the operation of this material contradict the functional accuracy of this dimension. To reduce the material wear the hook material should be changed to a material with a greater wear resistant. Moreover it should be sea water resistant. As a result the maintenance requirements on this important part would be reduced. Furthermore the complete geometry of the force transmission from hook to cam release pin should be so changed that in future automatic release due to wear or corrosion can be excluded.

Figure 28:
Surface of the hook of the
aft hoisting hook:
The galvanising was worn
away.
The galvanising had already
corroded in other areas of
the hoisting hook.

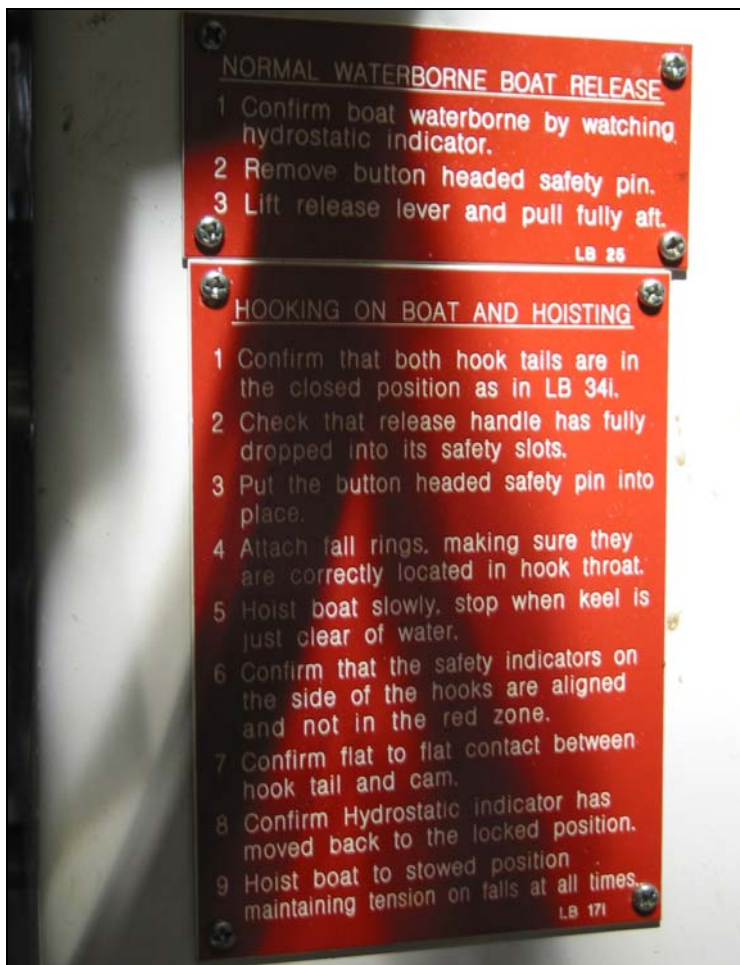
Figure 29:
Operating plate LB 25 and
operating plate LB 171.

Item 8: What is the locked position? The hydrostatic locking flap was according to Appendix No. 10 marked before the destruction with a green plate "Closed" in the green area and a red plate "Open" in the red area. This description is misleading. In order to properly describe the safe position of the hydrostatic locking system the same terminology should have been used: closed position and not locked position. An illustrated description would be very helpful to show the two positions of the handle:

Conclusion: The plate and description for the central release mechanism found in the boat was to some extent misleading and incomplete.
