Federal Bureau of Maritime Casualty Investigation

Press Release 13/12

HANLA LEVEL CO., LTD. HFO-Flow-Sensors: Danger of Earth Fault

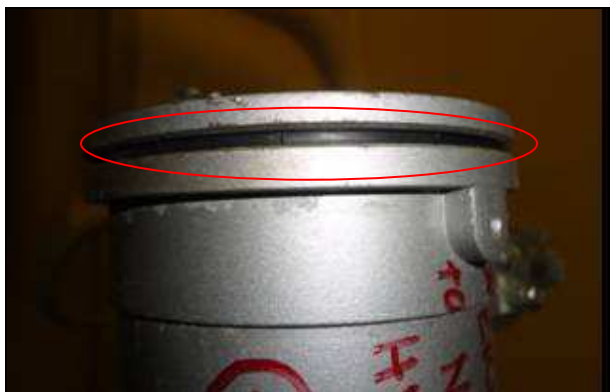
Picture 1

The failure occurs when the O-ring for sealing the sensor between the housing and the cover is not installed (picture 1). In this case the cover (picture 2) can touch a jumper on the board of the sensor (picture 3) which leads to an earth fault (-24 V DC).

The thread of the affected sensor covers should be shortened by at least 10 mm. When this counter-measure is done the cover can not touch the jumper even if the O-ring is not installed. Please note that the O-ring should be installed anyway! If you find a sensor box without O-ring and with slight touching marks on the jumper, please also check if the earth fault detection module of the 24 V system is working correct (picture 4) before fixing the problem at the cover. Therefore connect the earth-port of the module to the ground of the cabinet by using a short line. If then the red LED of the detection module starts to shine, then the original earth line of the detection module is interrupted.

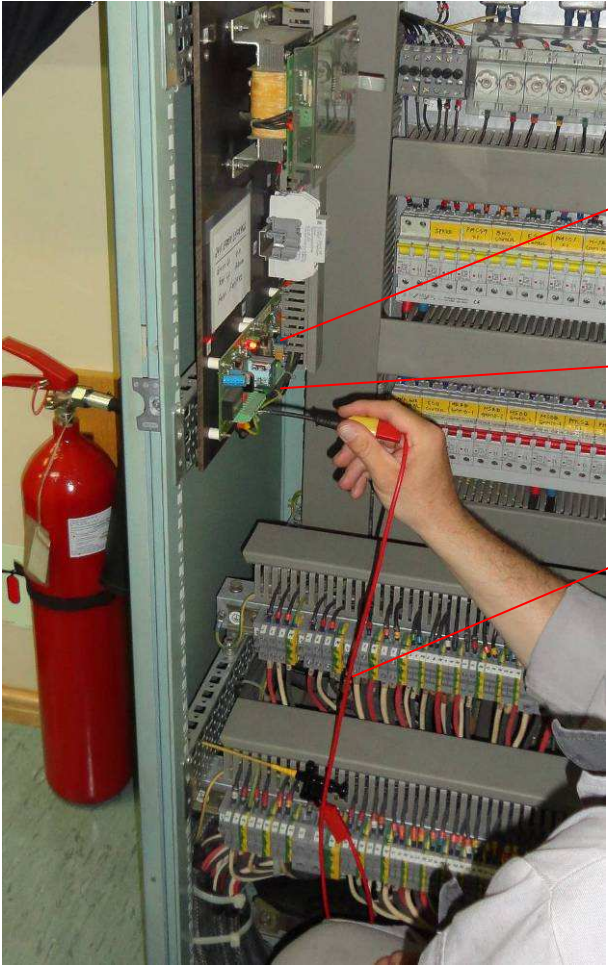
Picture 4

Cabinet: DC 24 V UPS FOR AMS & BMS

Board for earth fault detection

Ground wire (yellow/green, connected to the board)

Manual bridge between ground connection of board and ground of cabinet
