National Transportation Safety Board

Marine Accident Brief

Sinking of Tall Ship *Bounty*

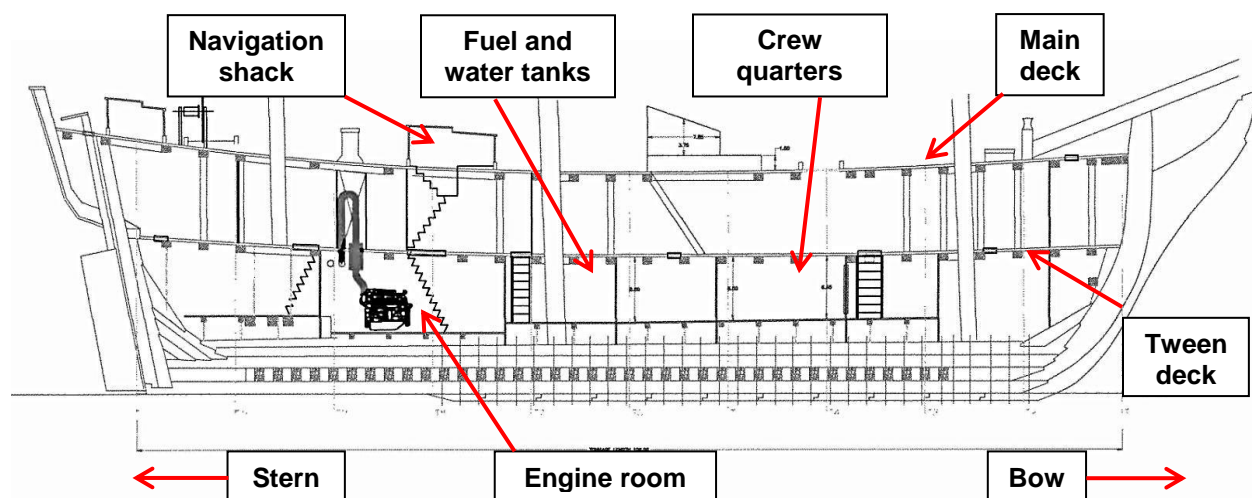
Inboard profile of the *Bounty*. (Drawing provided by the HMS *Bounty* Organization)

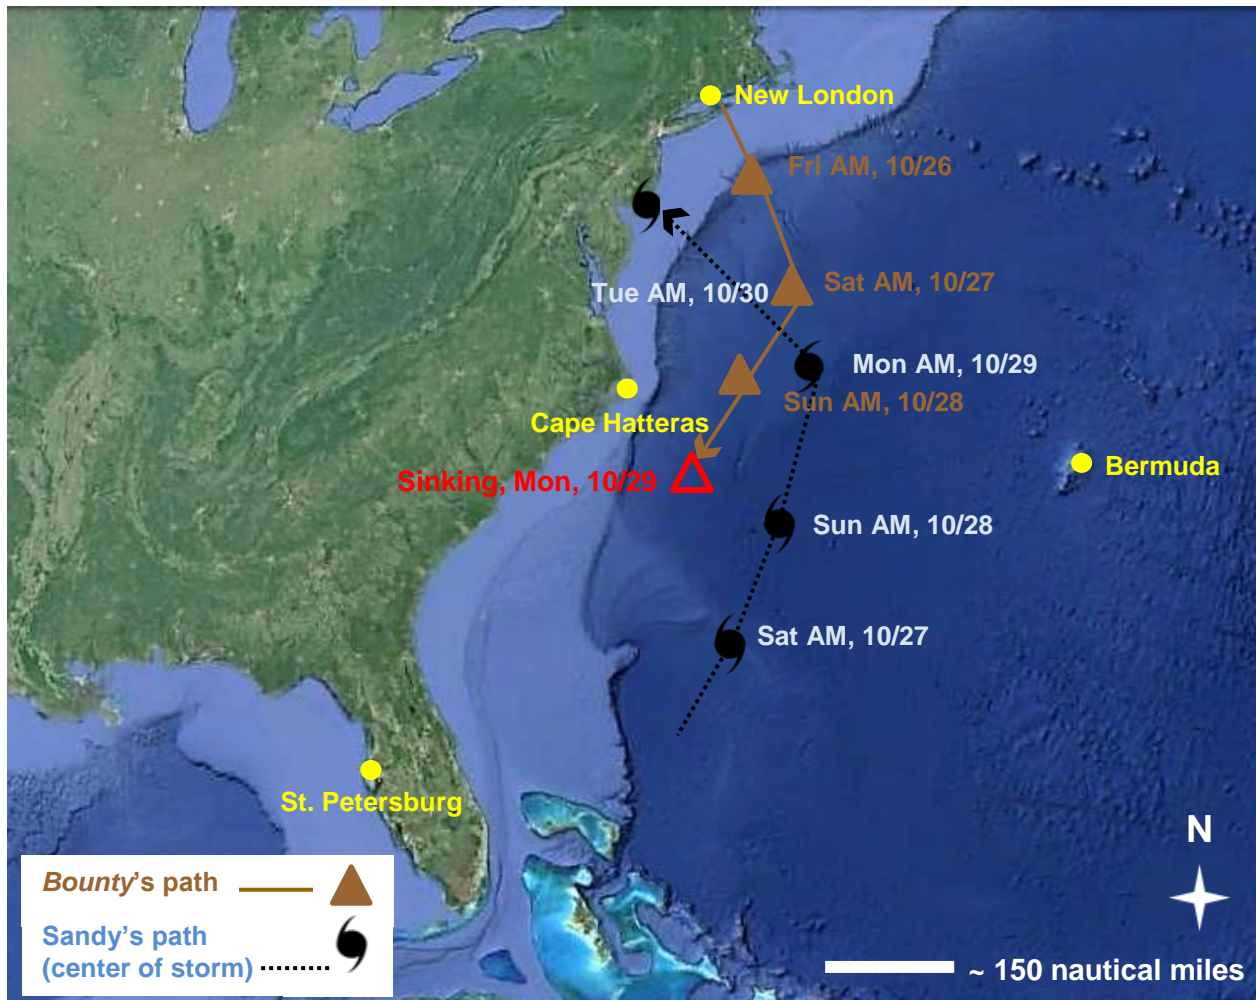
Satellite image showing the approximate southbound path of the *Bounty* and the approximate northbound path of Hurricane Sandy. (Background by Google Earth)

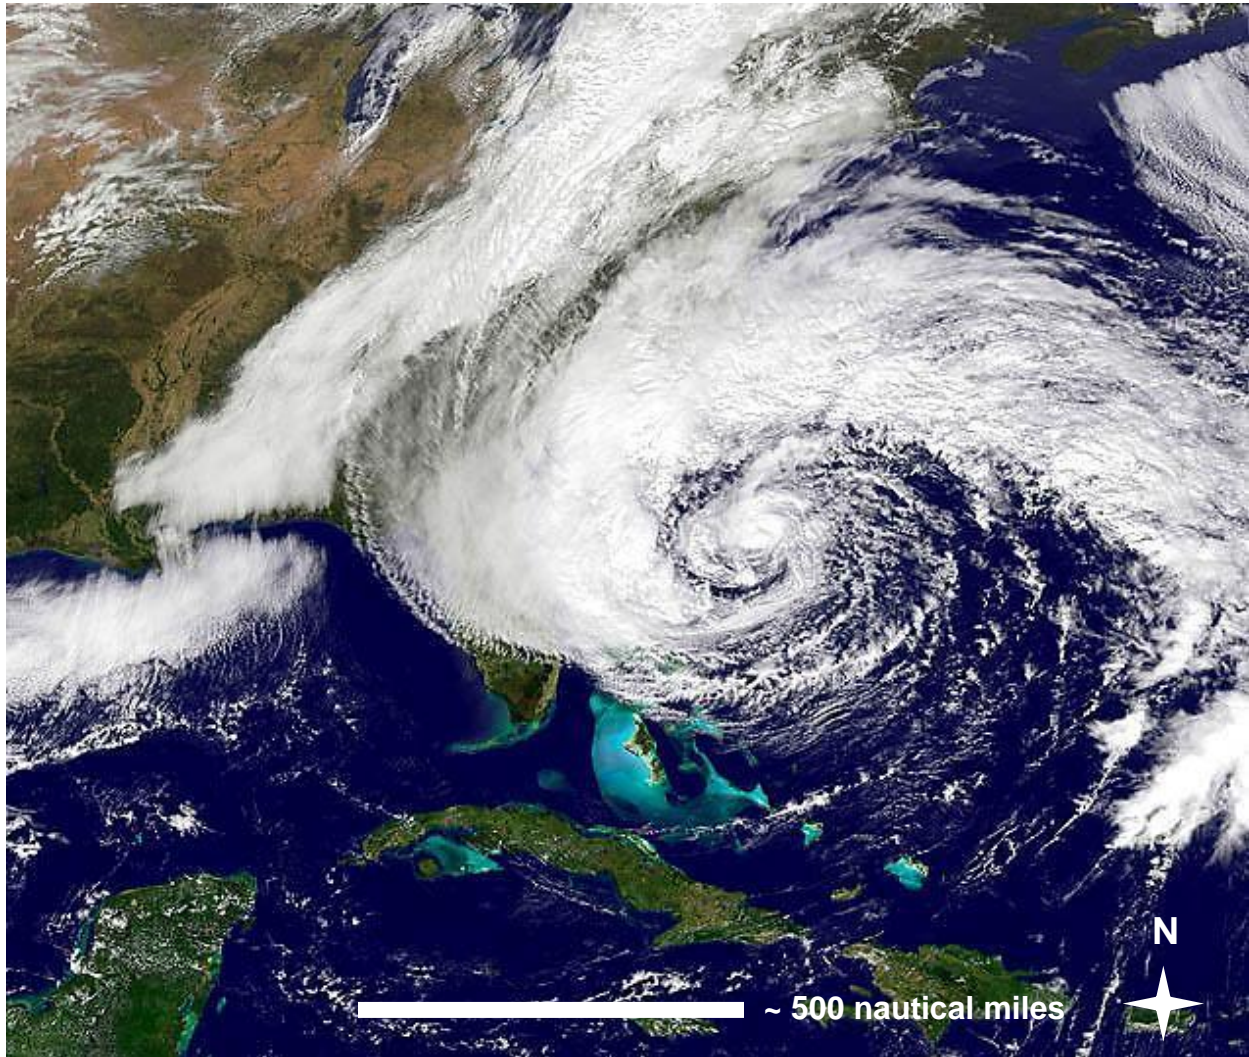
Satellite image of Hurricane Sandy on October 27, showing the large expanse of the storm. A National Weather Service advisory, issued at 1100 that day and sent in an email to the captain, stated that tropical storm-force winds extended up to 450 miles from the center of the storm and were already near the North Carolina coast.

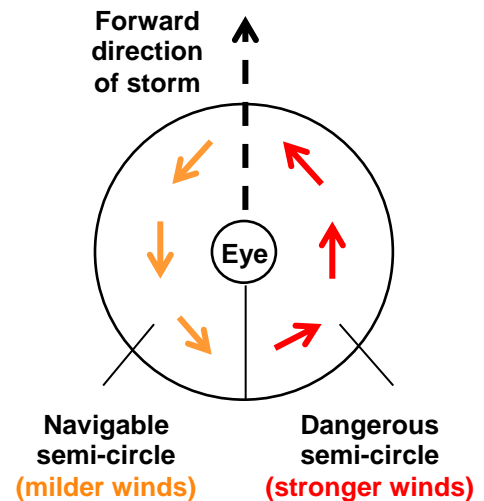
By sailing the *Bounty* down the hurricane's west side (the "navigable semi-circle"; see next image), the captain hoped to take advantage of a following wind pushing the vessel southwest toward its Florida destination. What everyone, especially the captain and senior crew, seemingly failed to anticipate was the damaging effect that prolonged exposure to the storm would have on the wooden vessel.

In the northern hemisphere, hurricanes rotate in a counter-clockwise direction, and the winds on the right side of the storm's travel direction are typically stronger. This is because the right side is subjected both to the circulation winds and the hurricane's travel speed. So, for example, if the winds are circulating at 100 knots and the hurricane is traveling north at 10 knots, the total wind force on the right/east side is 110 knots. On the hurricane's left/west side, the travel speed of 10 knots is subtracted from the circulating wind speed, and so the overall wind force there is 90 knots. Therefore, mariners sometimes refer to the left side of a hurricane's travel direction as the "navigable semi-circle." However, being near a hurricane on any side is dangerous as the winds are strong on all sides. In addition, hurricanes can be unpredictable, including spawning tornadoes.

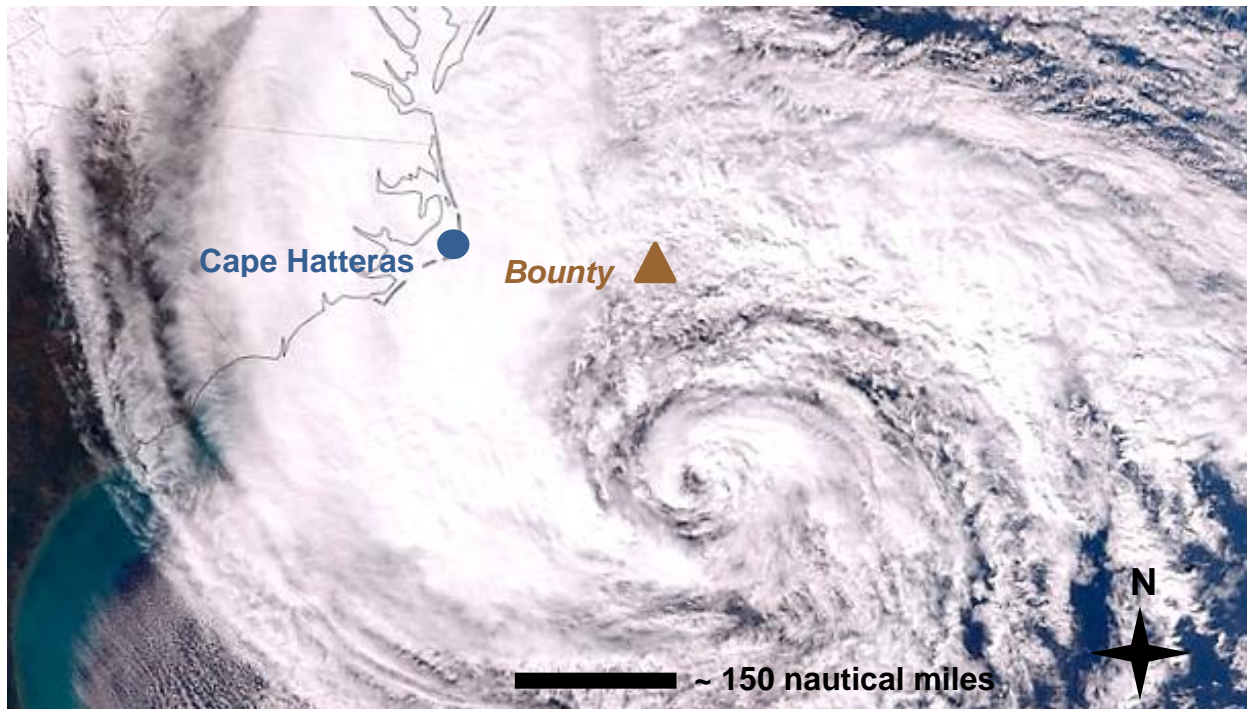
Satellite image of Hurricane Sandy, midday on Sunday, October 28. Overlaid on the image is the approximate position of the *Bounty* at that time.

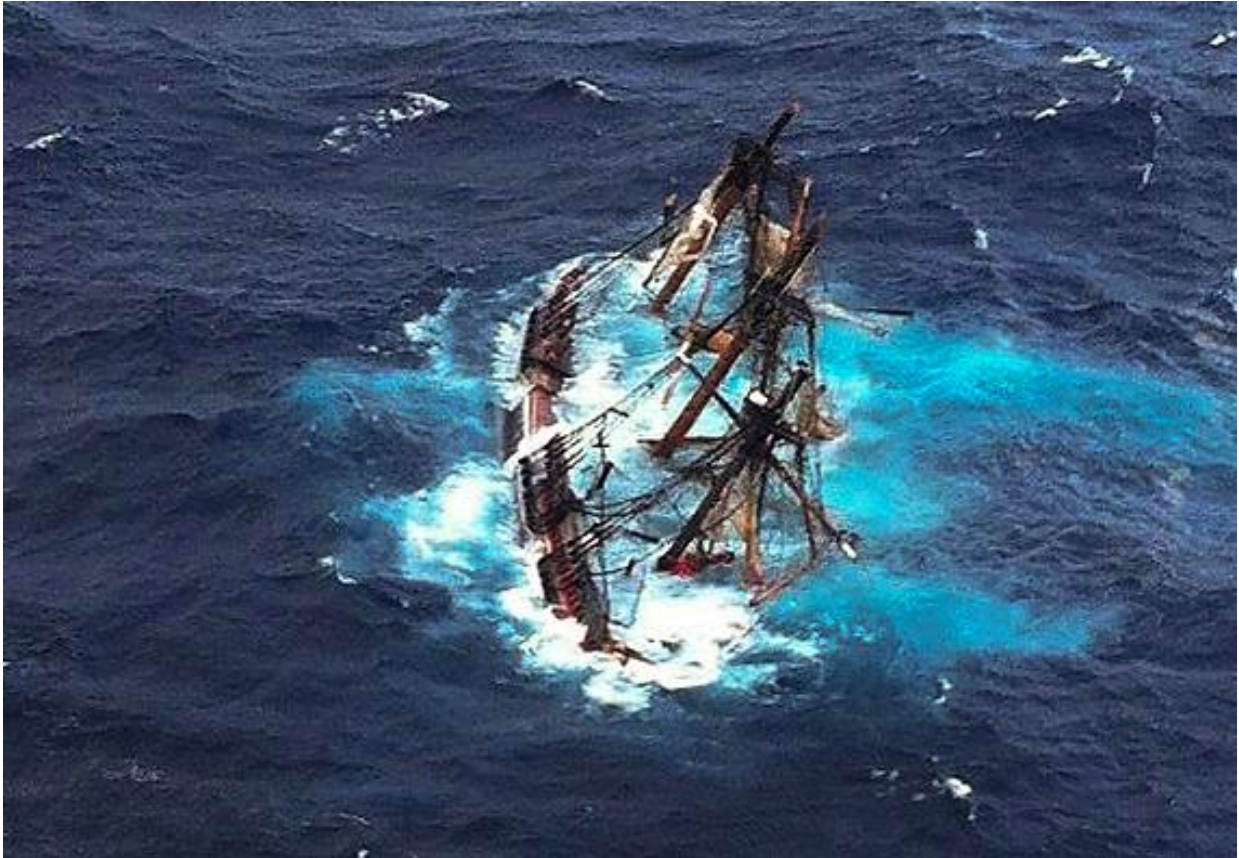
The *Bounty*, photographed from a Coast Guard aircraft above, before the vessel sank.

The last confirmed sighting of the *Bounty* was at 1920 on October 29, 2012, when the crew of a Coast Guard cutter saw the vessel lying on its side, awash in the sea, about 13 nautical miles southeast of where the crew had abandoned ship more than 15 hours earlier. It was an end to a voyage that should not have been attempted. To set sail into an approaching hurricane introduced needless risk. Further, most of the crewmembers were inexperienced and their complement was smaller than usual. In addition, despite the fact that the *Bounty* took on water
