**Bundesstelle für Seeunfalluntersuchung**  
**Federal Bureau of Maritime Casualty Investigation**  
Bundesoberbehörde im Geschäftsbereich des Bundesministeriums  
für Verkehr und digitale Infrastruktur

**Untersuchungsbericht 34/15**

**Sehr schwerer Seeunfall**

**Tödlicher Personenunfall  
an Bord des MS HANJIN DALLAS  
am 1. Februar 2015 vor der Ostküste USA**

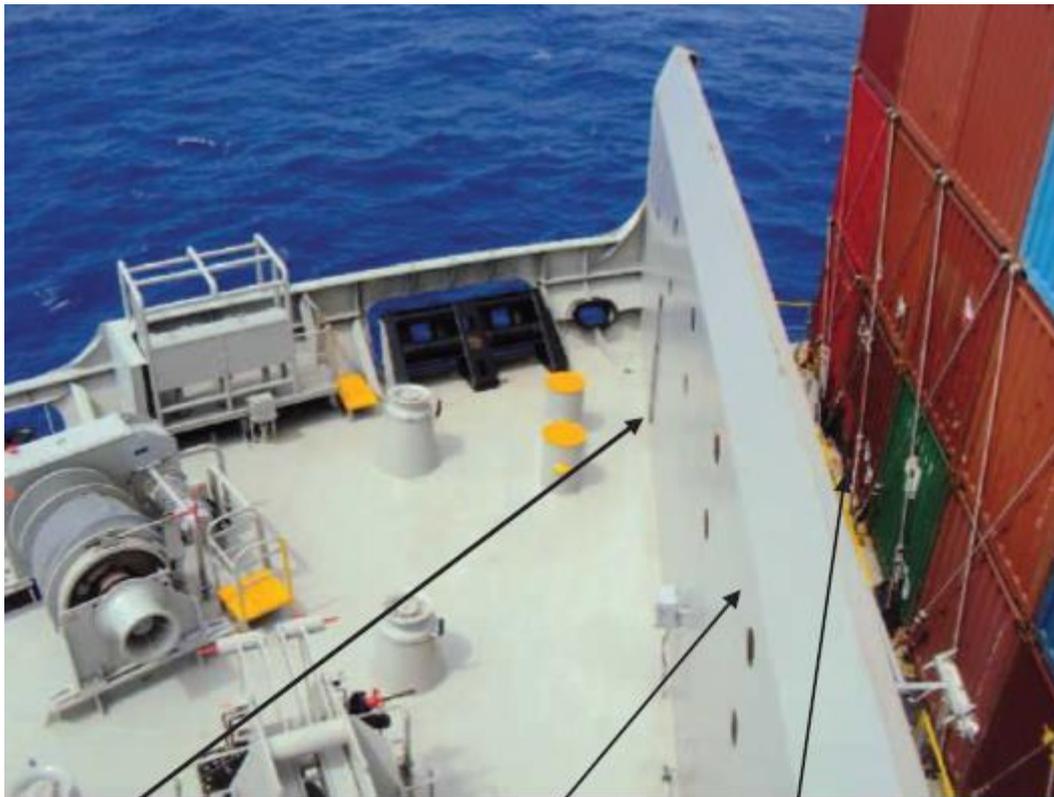
Abbildung 5: Unfallort, Ansicht von oben

Der Unfallort ist auf dem Vorschiff auf der Steuerbordseite. Vor der ersten Containerlage ist ein Wellenbrecher aufgebaut, der an beiden Seiten einen Durchgang zum Vorschiff hat.

Durchgang

Wellenbrecher

Auffindeposition Verunfallter

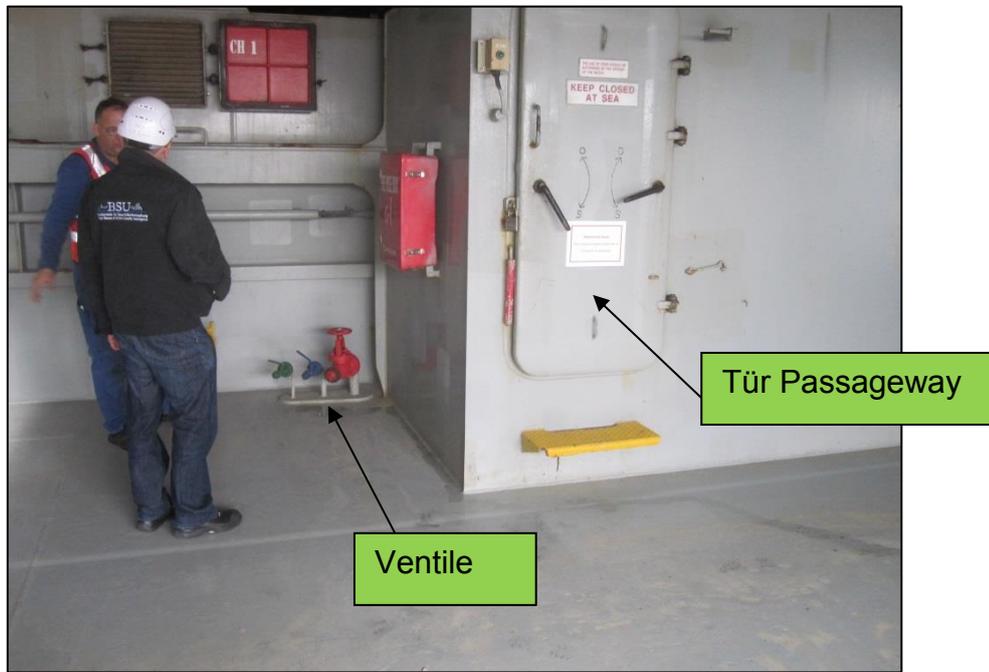
Abbildung 7: Ventile und Tür Passageway

Bei der Besichtigung der Unfallstelle im Hafen von New York wurde die Position des Verunfallten nachgestellt. Die Tür des Passageways war verschlossen, als der SM nach vorne kam. Es ist daher zu vermuten, dass der Bootsmann über die Backbordseite des Hauptdecks nach vorne gekommen sein musste.

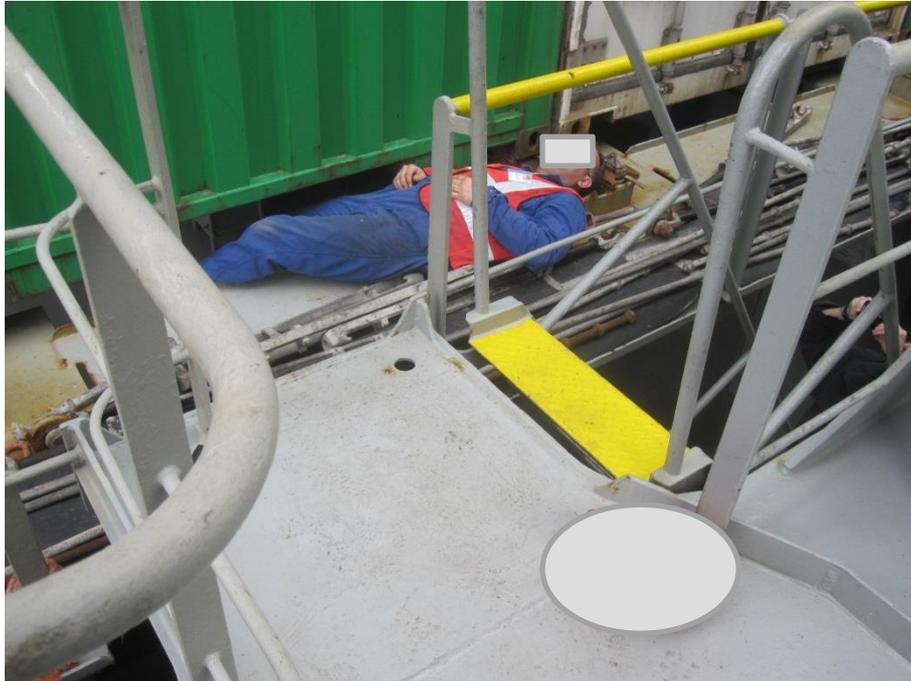
Abbildung 9: Blick von vorne durch den Wellenbrecher

Der Weg auf dem Hauptdeck auf Backbordseite führt zunächst auf der Wind- und Wellen abgewandten Seite in den geschützten Bereich Achterkante Back, hinter dem Wellenbrecher. Eine Treppe führt nach oben (letzte Stufe gelb gemalt) und endet hinter dem Wellenbrecher, dort wo sich der Durchgang vom Vorschiff befindet.

Der Bootsmann wurde hinter den Zurrstangen gefunden, die auf obigem Bild noch nicht gesetzt sind. Genau im Bereich der Auffindeposition befindet sich die Öffnung im Wellenbrecher zum Vordeck.

Der Bootsmann ist wahrscheinlich durch Wellenschlag am Durchgang des Wellenbrechers von den Wellen sehr unglücklich getroffen und gegen die Container gespült worden. Dabei hat er sich so schwere Verletzungen zugezogen, dass er später daran verstarb.
