| FLEET CIRCULAR | | | |
| FMS 02/2020 | Additional safety measures for cargo holds | | ALL |
| ISSUE DATE: | 22.01.2020 | VALIDITY: | unlimited |

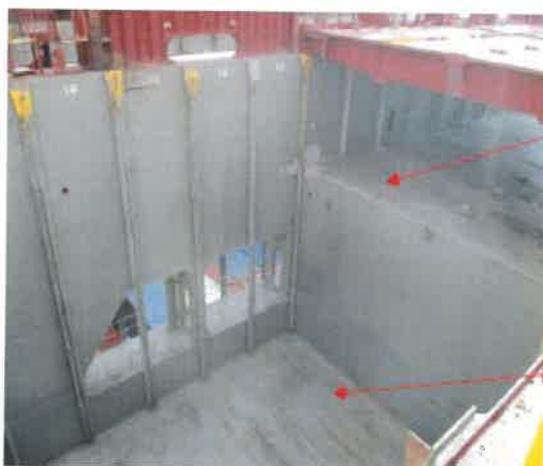
As you are most probably aware, we sadly had to experience a fatal accident on board of our vessel CMS "SAJIR". The accident occurred during an inspection of the cargo hold No. 9 where one crew member fell approximately 8m from an upper part of the hold onto the tank top, suffering fatal injuries.

assumed place of falling
view from port side aft of Bay 70

Position of person

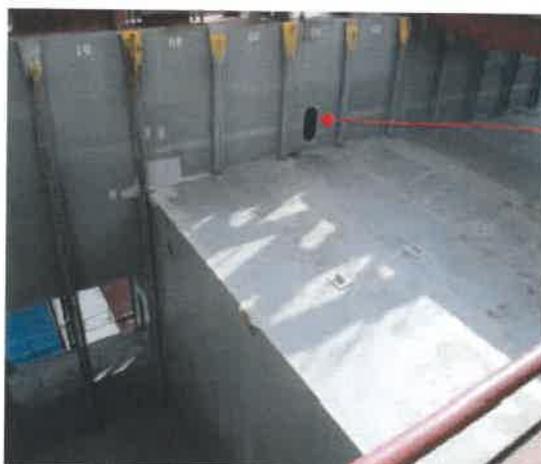
the only opening in bulkhead from where the top part of hold nbr 9 (Bay 70) can be accessed

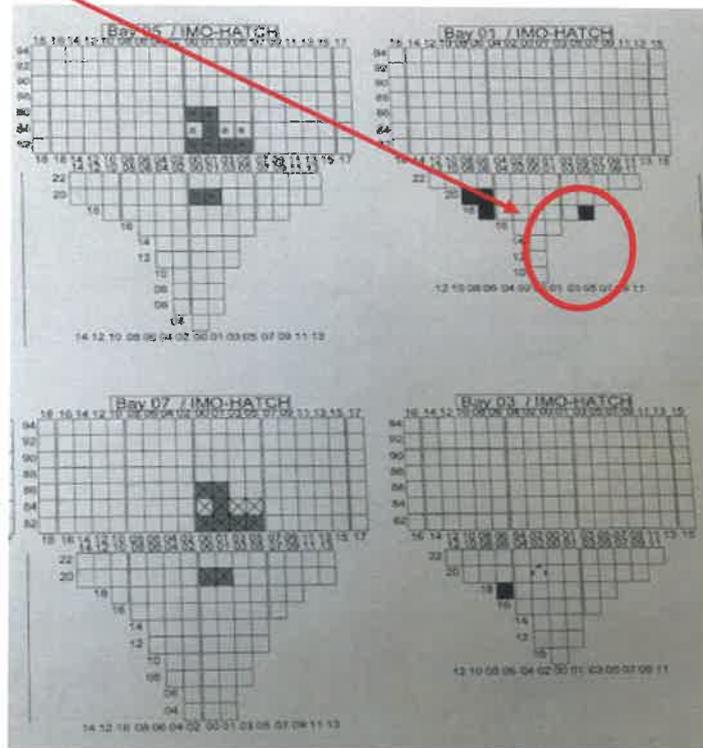
General Remark: We are aware, that all vessels have similar single container storing positions in the forward, e.g. here:

These areas are normally only “single stowage positions”, which are neither used for breakbulk, nor can be entered accidentally, due to their open construction. Therefore, we do not deem it necessary to install a “tiger” marking as mentioned above. However, all other measures are also applicable for the forward locations.

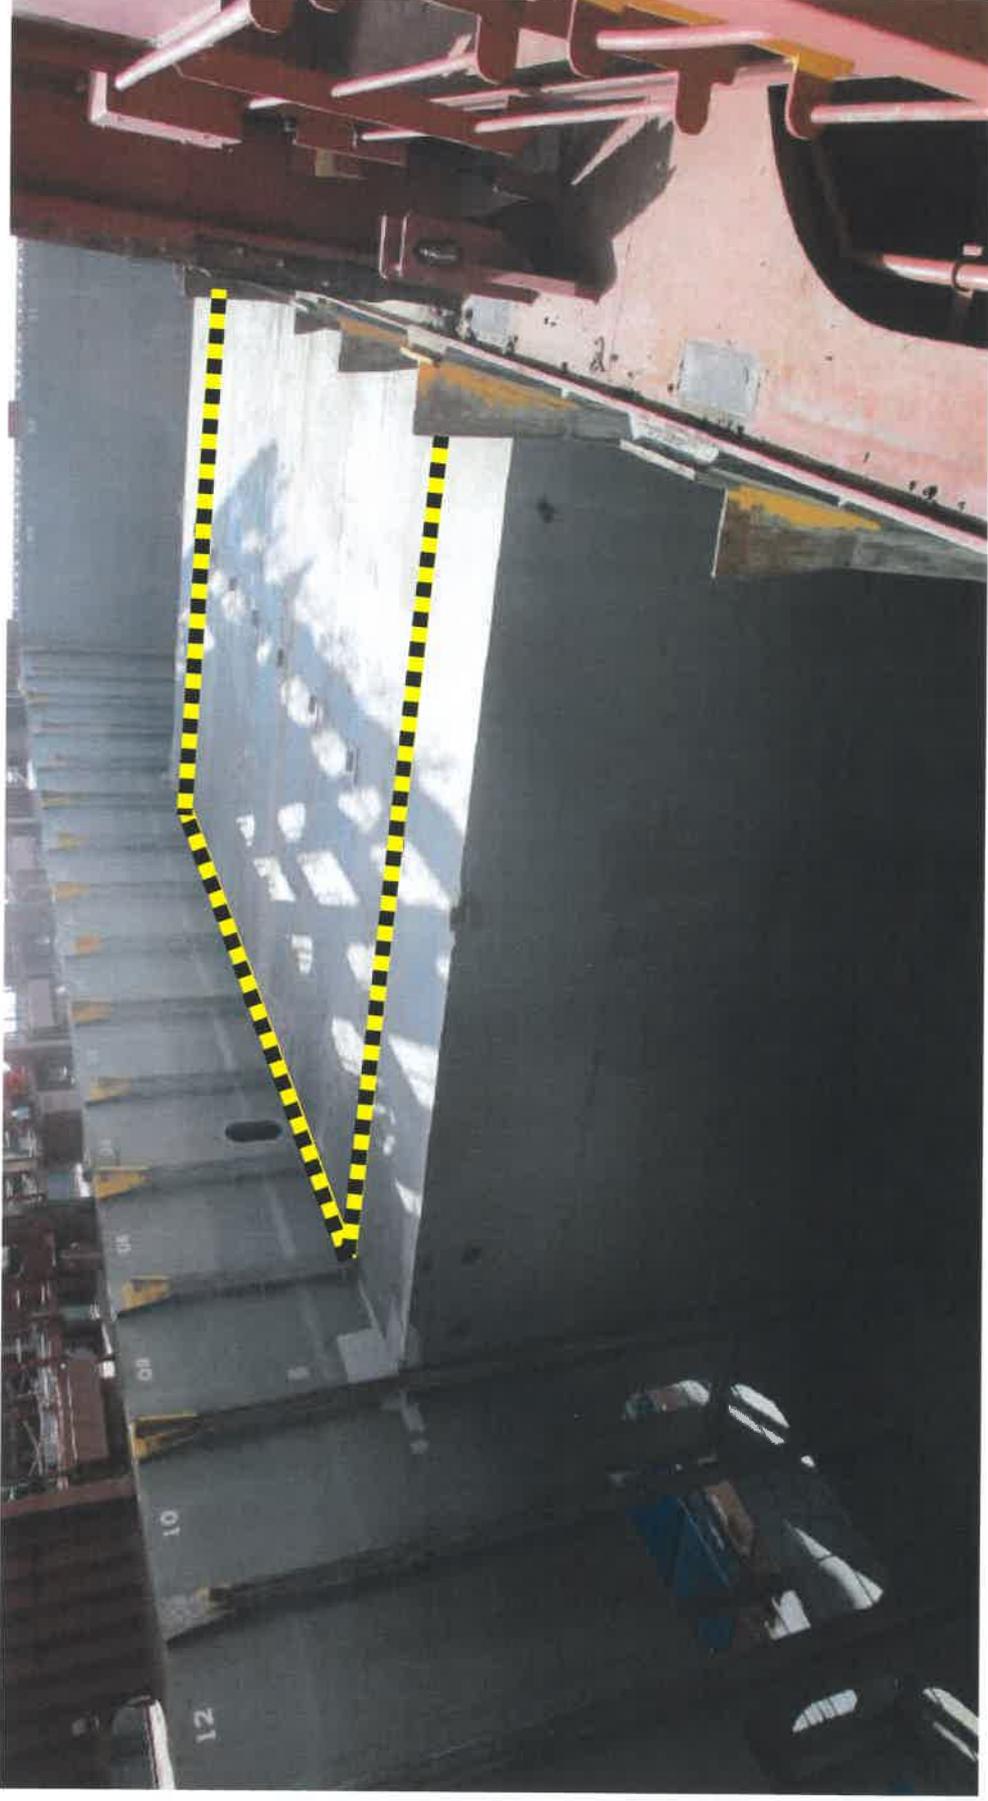
BE AWARE OF CONSTRUCTIONAL DESIGN OF CARGO HOLD
DANGER OF FALLING
