Findings of the Inspection of the Relay of the Rudder Controller M/T Northsea Rational

Order by Prof. Dr.-Ing. Friedrich Wirz (TUHH) on behalf of Bundesstelle für Seeunfalluntersuchung (BSU), Hamburg

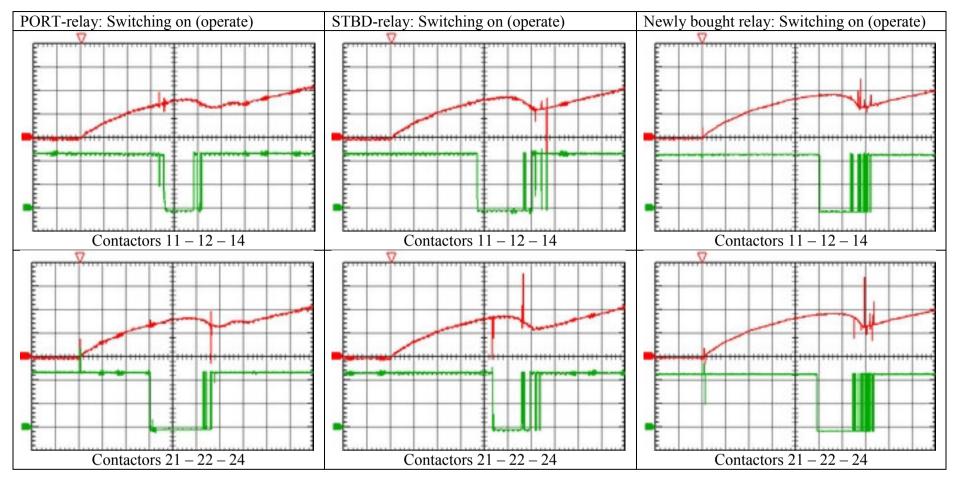
Picture 6: Operate times and bounce times: Horizontal: 2 ms/div; upper curve (red): Current in coil 20 mA/div; lower curve (green): Center contact connected to 24 V, low means, contactor is flying or bouncing. Specification [2]: Operate time 11 ms, bounce time 1 ms; (continue Picture 7)

The measurement results shown in Picture 6, Picture 7 and Picture 8 show that there are no significant differences between the three relays. Operate time, release time and bouncing times are reasonable with respect to the specification. It is reasonable to assume that the specified [2] times are maximum values. The times when closing and opening are lower than the specified values, some bouncing times are slightly higher.

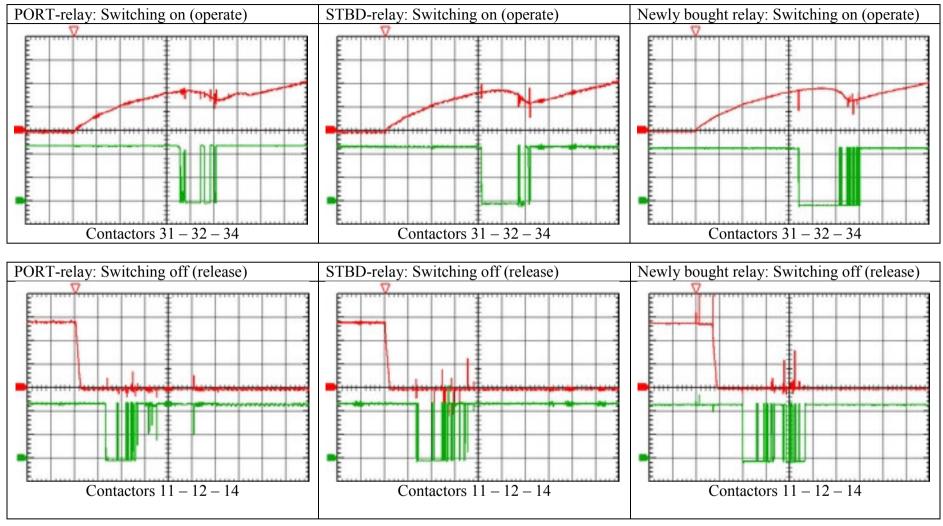
Picture 7: (Continuation of Picture 6) Operate times, release times and bounce times: Horizontal: 2 ms/div; upper curve (red): Current in coil 20 mA/div; lower curve (green): Center contact connected to 24 V, low means, contactor is flying or bouncing. Specification [2]: Operate time 11 ms, bounce time 1 ms; Release time 4 ms, bounce time 4 ms; (continue Picture 8)

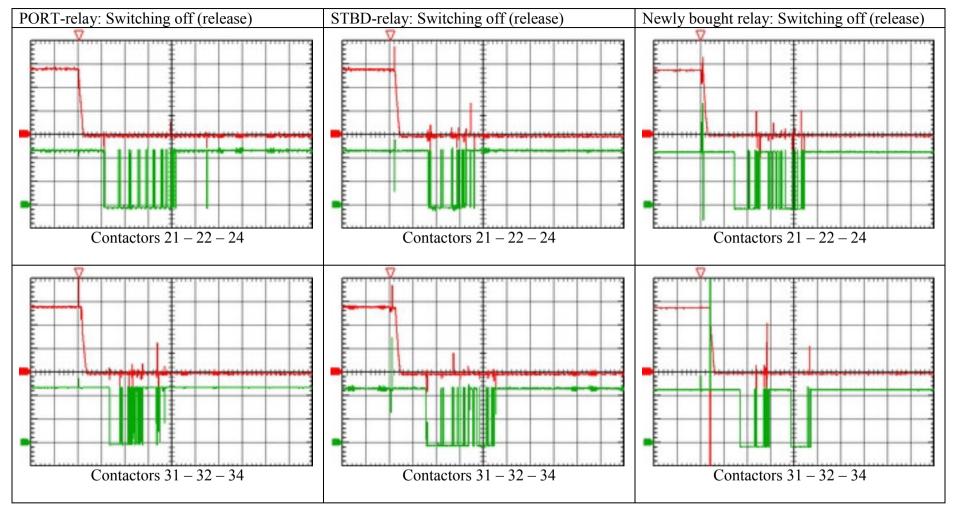
Picture 8: (Continuation of Picture 7) Relase times and bounce times: Horizontal: 2 ms/div; upper curve (red): Current in coil 20 mA/div; lower curve (green): Center contact connected to 24 V, low means, contactor is flying or bouncing. Specification [2]: Release time 4 ms, bounce time 4 ms

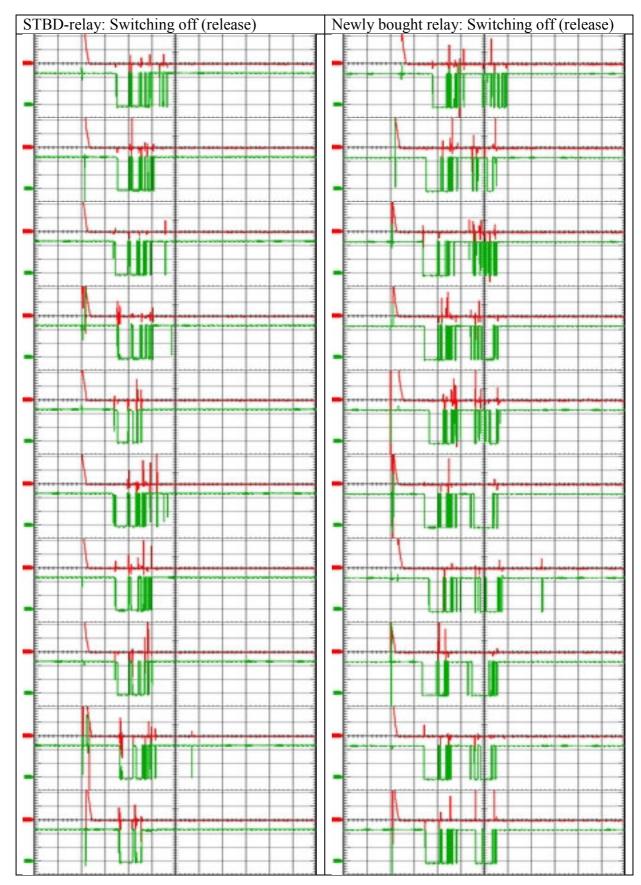
Picture 9: Reproducibility of release times and bounce times: Horizontal: 2 ms/div; upper curve (red): Current in coil 20 mA/div; lower curve (green): Center contact connected to 24 V, low means, contactor is flying or bouncing. Contactors 31-32-34

Picture 9 shows the result of 10 measurements for the STBD-relay and the newly bought relay. It shows that there a clear differences between the bouncing in the 10 trials, but this is the case for both relays. There is no significant difference in the reproducibility between both relays.
