Bundesstelle für Seeunfalluntersuchung
Federal Bureau of Maritime Casualty Investigation
Bundesoberbehörde im Geschäftsbereich des Bundesministeriums
für Verkehr, Bau- und Wohnungswesen

Investigation Report
118/02

15 May 2003

Very Serious Marine Casualty:
Sinking of
MV “Stadt Arnis”
on 10 October 2002
near Dahmeshöved

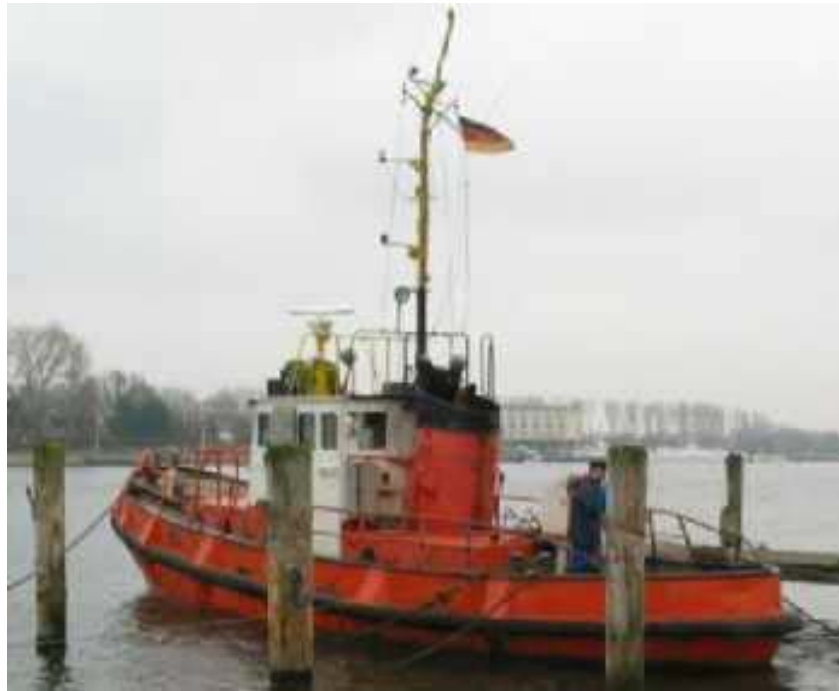
Photo 1, Stadt Arnis

The surveys of MV "STADT ARNIS", which has been lifted in the meantime (see Photo 1), revealed that the vessel was in a poor general condition. The deck and the bulkheads as well as the air pipes and ventilators had rusted. In the port side alley main deck on a level with the front engine bulkhead there was an opening with a diameter of approx. 250 mm that was closed with a brass lid (see Photo 3). The hatch to the after peak (see Photo 2) could not be closed weather-tight.

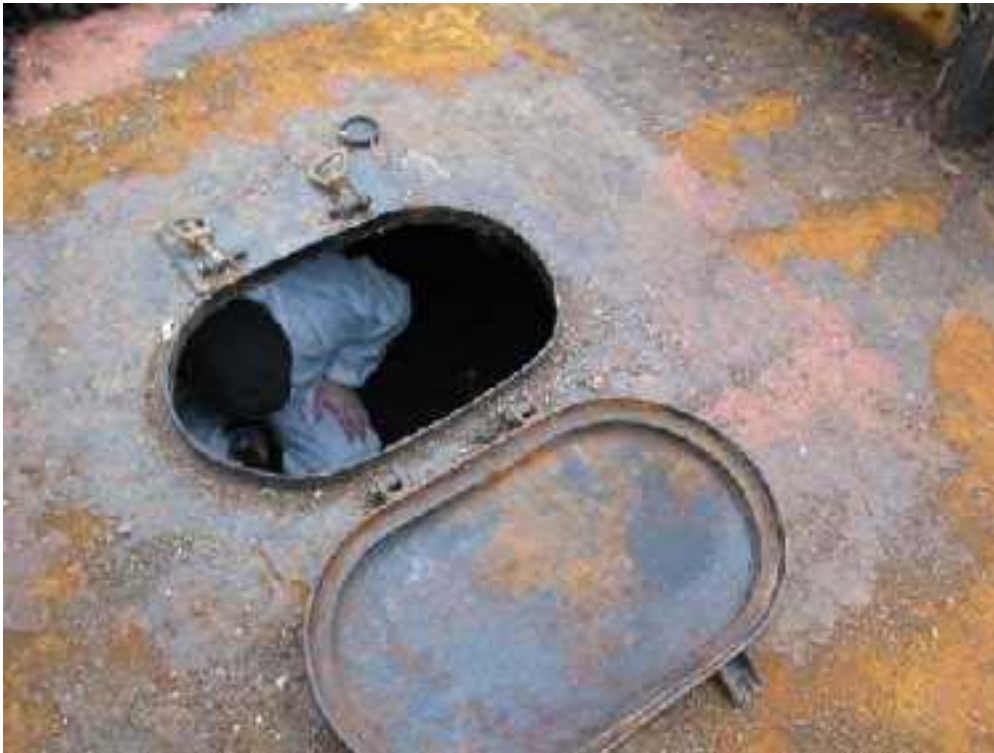
Photo 2, Manhole after peak

Under the given weather conditions and with the towed pontoon, MV "STADT ARNIS" took water in the aft part of the vessel that could not flow off completely. The water made its way via the leaky hatch into the after peak.

The hatch to the after peak could not be closed water-tight. Strips welded on were found before and after the hatch, onto which the hinges were welded forward and the brackets of the locking bolts with case nuts in the aft direction. The left side of the pressure fork struck against the left bracket of the starboard closure. This prevented uniform pressure on the rubber seal. Viewed from the after peak, a considerable air gap was discovered in the closed condition. It was not possible to ascertain when and by whom the work on the hatch had been carried out.

The cause of the accident was the incorrect repair of the hatch to the after peak, the incorrect – not complying with the standards – execution and sealing of the lubricating oil line between the after peak and the storage compartment, and the heavy rusting of the two aft bulkheads. Flooding couldn't be prevented by this means.

During the periodic survey by the supervisory institution more attention should be paid to defects such as hatch fastenings, that open outwards, and surveys of bulkheads that can conceal rusty places, as well as the lines on rescue facilities. The water intake could have been noticed earlier by the crew if the vessel had been equipped with a bilge alarm.

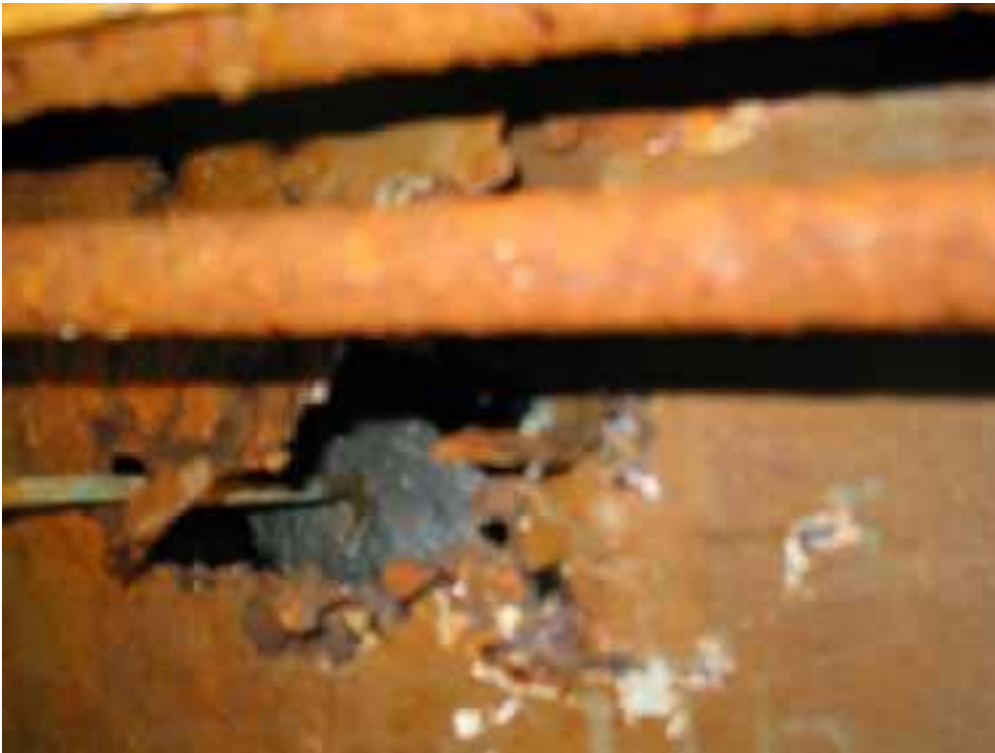
Photo 4, After peak ahead

A loosely installed lubricating oil line was driven through the bulkhead between the aft peak and stowage compartment in the aft peak at frame No. 4 above the water line (see Photo 4). The passage was sealed with polyurethane (see Photo 5). Directly next to the passage was a round iron bar in the bulkhead with a diameter of approx. 8 mm, and approx. 20 cm long, that additionally damaged the GRP-coating of the bulkhead. The polyurethane sealing enabled the intake of water. The GRP-coating was used as protection against corrosion.

It is to be assumed that the after peak ran full via the hatch and the water made its way along the lubricating oil line into the storage compartment and caused the hole to the engine room, so that the after peak, storage compartment and engine room ran full. After this MV "STADT ARNIS" sank. The polyurethane seal of the lubricating oil line promoted the intake of water. The attempt to use a portable drainage pump and a hand pump failed.

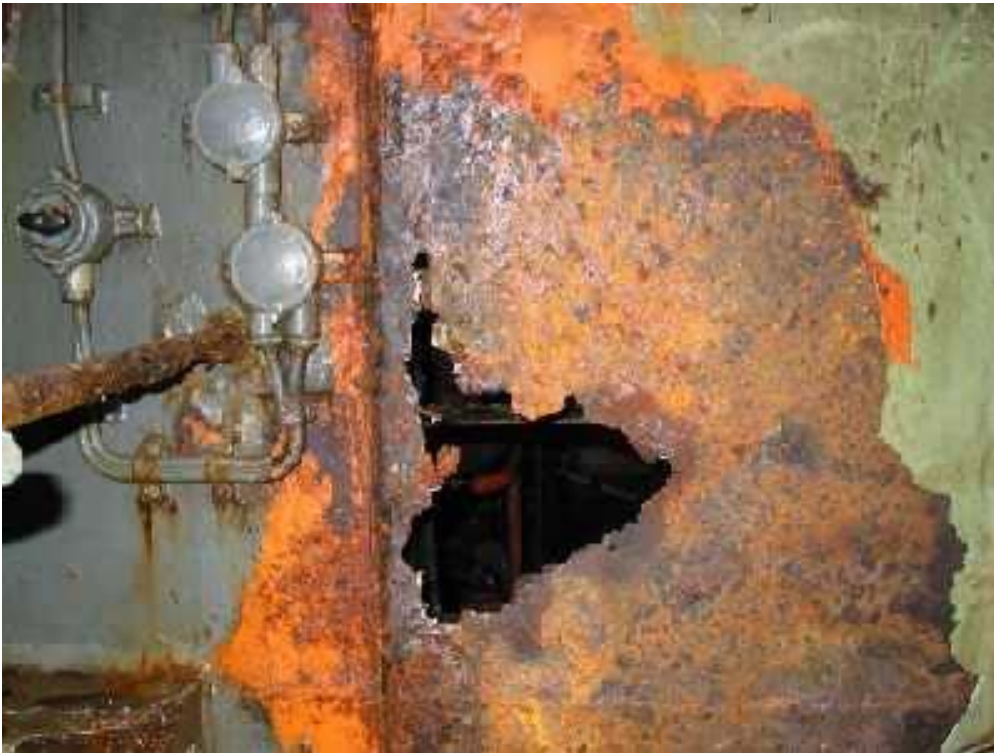
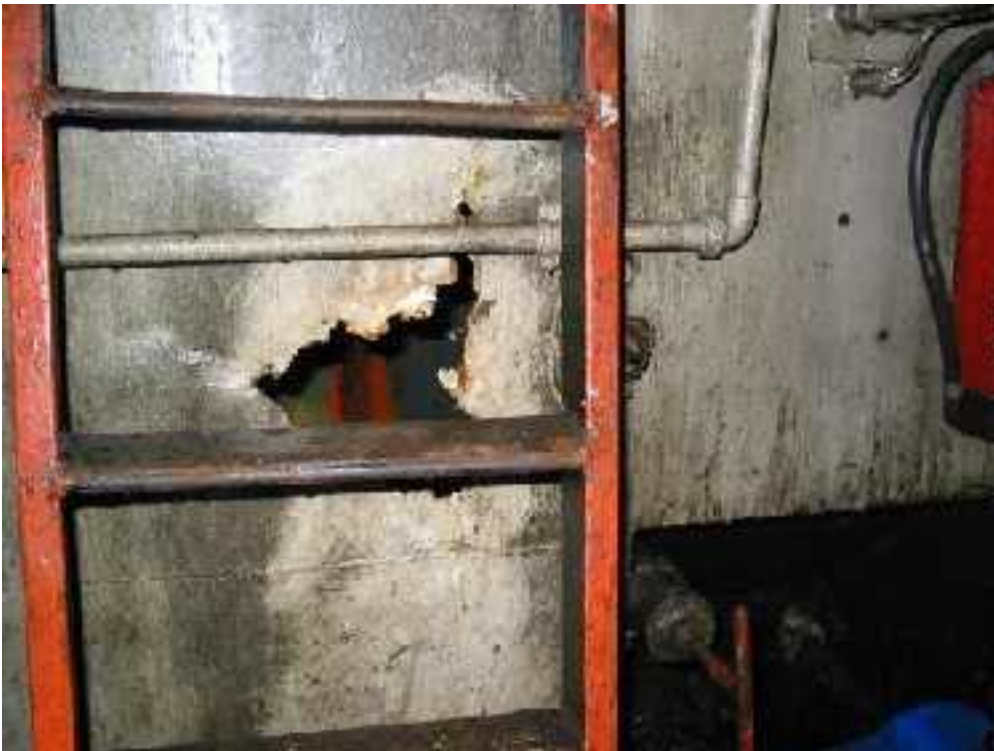
There was an approx. 15 cm x 20 cm hole in the bulkhead at frame No. 20 beneath the water line between the stowage compartment and the engine room, that showed traces of anti-rust paint and GRP coating at the edges (see Photos 6, 7). The steel had rusted away so far that the bulkhead was in all probability destroyed by the water pressure in the store.

The owner must comply with his obligations under the Marine Safety Law and report repairs that bring about changes in the structural condition to the supervisory institution, and maintain his vessel in an operationally safe condition at all times. If major rusting does not satisfy the specified rusting and wear tolerances, the relevant structural parts are to be renewed.

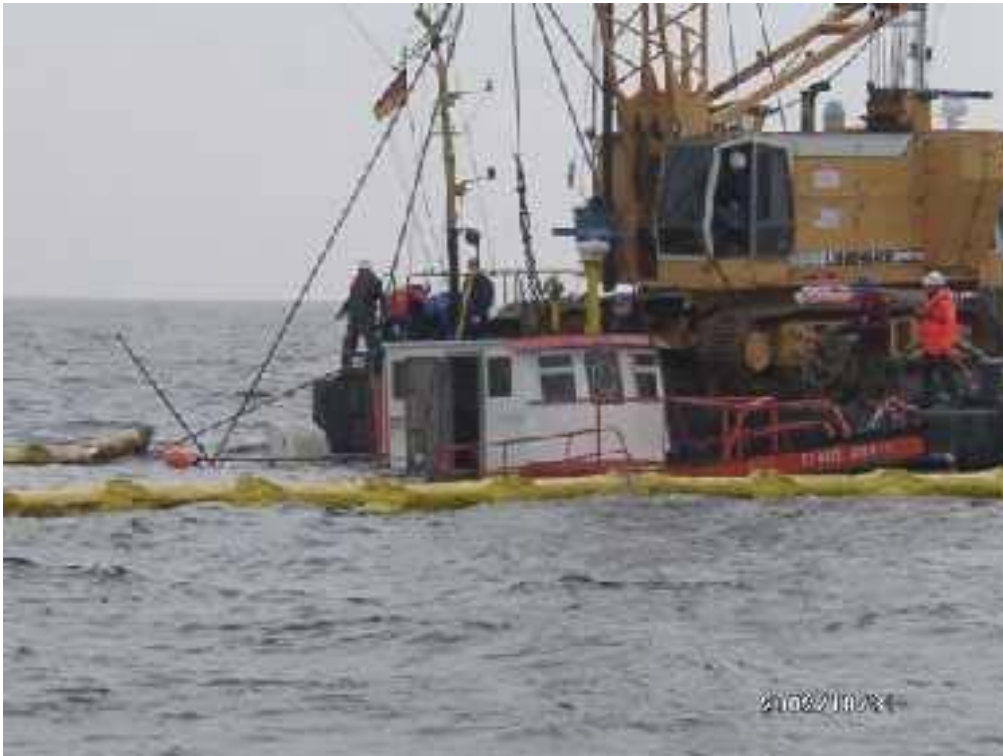
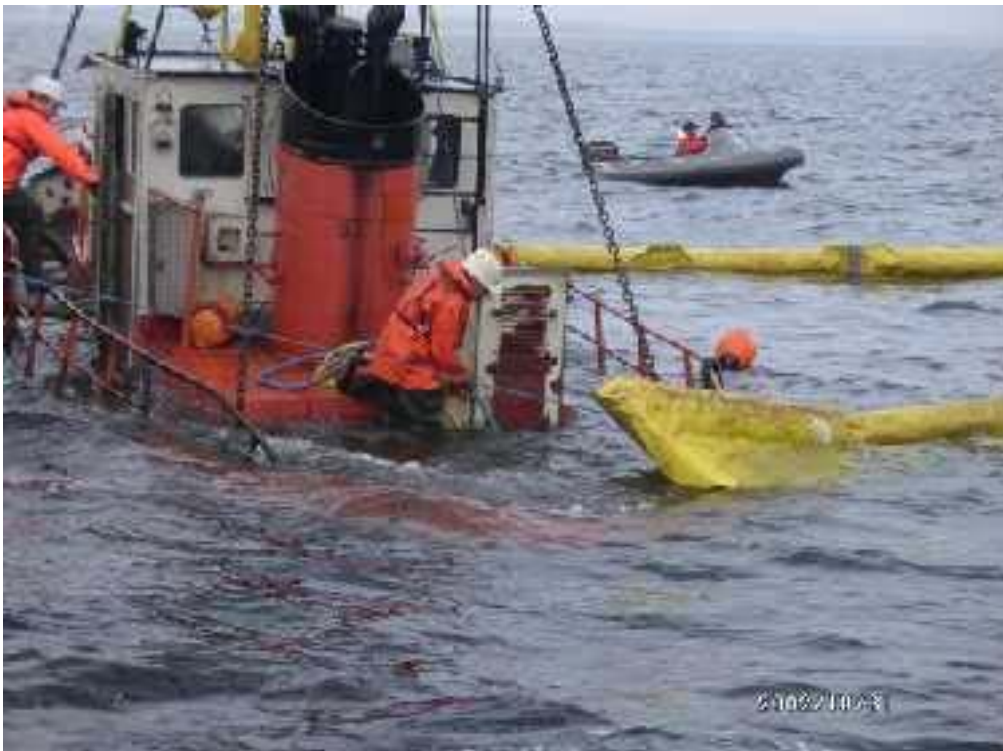
On the after deck a hole with a diameter of approx. 5 cm was discovered between the after peak and the store room during the survey on 05.12.2002. The hole presumably occurred after salvage (see Photos 8, 9).

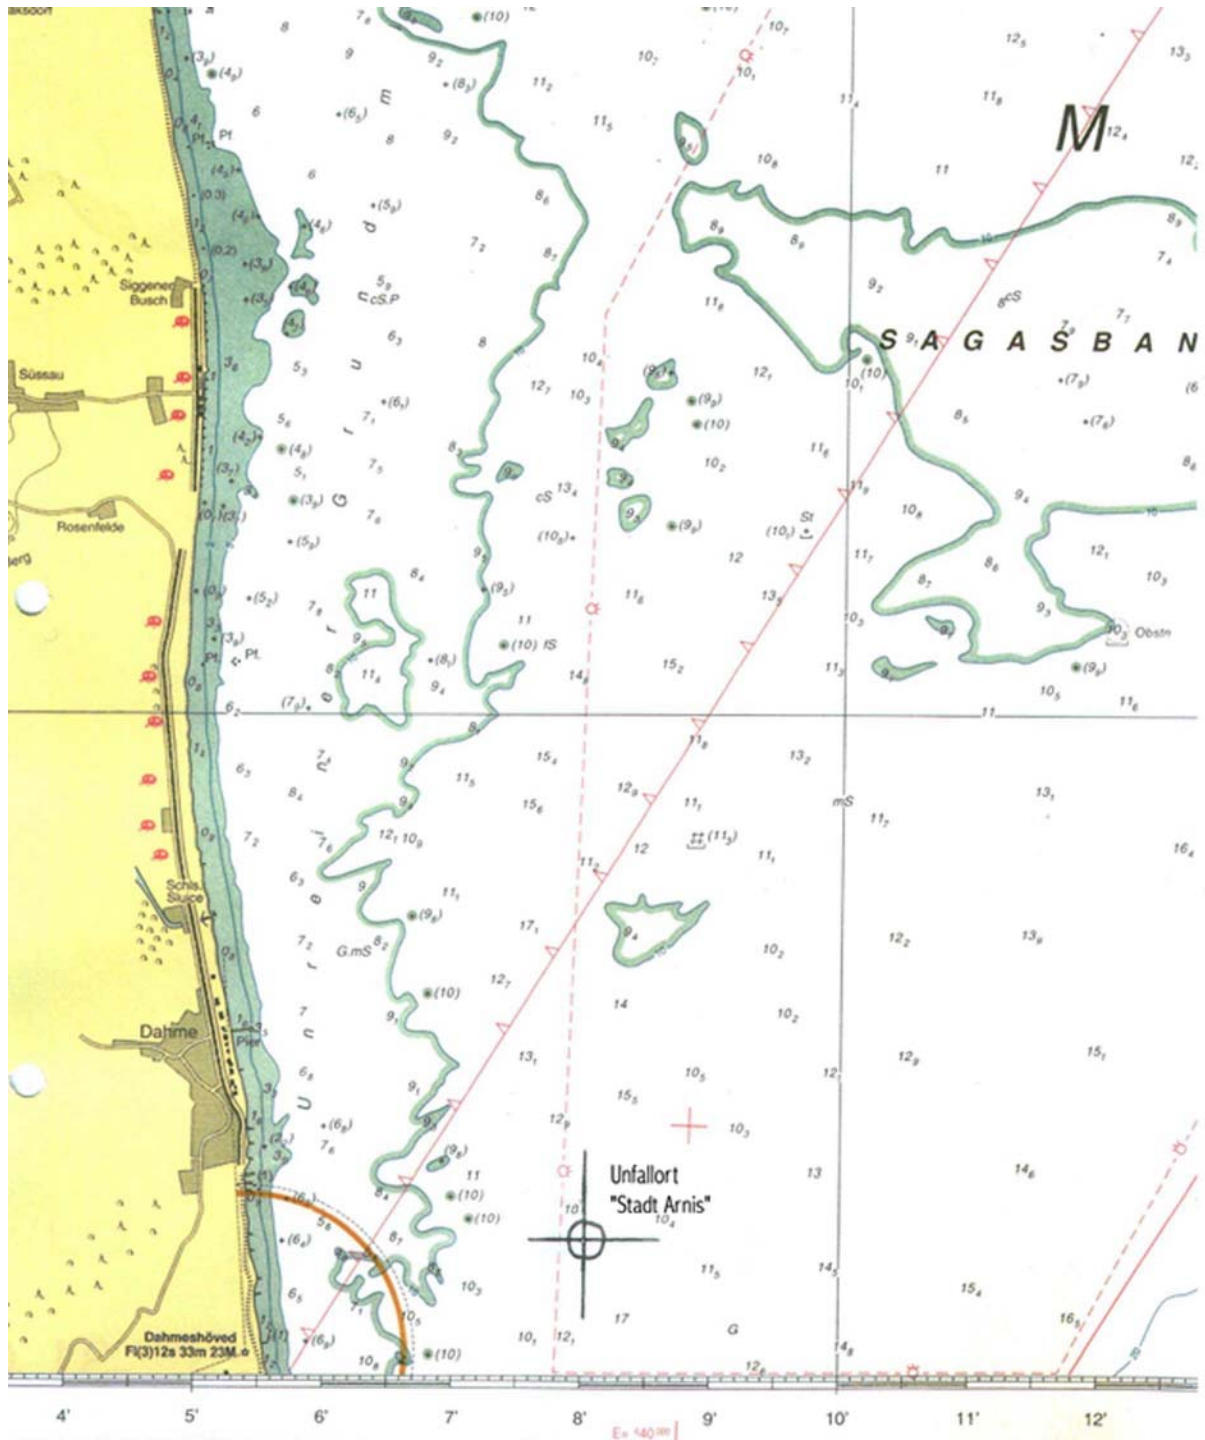
Photo 11, Scene of accident

On 10 October 2002 between 05.25h and 06.00h MV "STADT ARNIS" sank approx. 1.5 sea miles on the beam of Dahmeshöved (see Photo 11). The vessel was towing the pontoon "OSTSEEDIENST 8". Prior to sinking an emergency call was issued. The crew, consisting of the Master and a (female) ship's mechanic, were rescued by the rescue cruiser "BREMEN".
