Bundesstelle für Seeunfalluntersuchung
Federal Bureau of Maritime Casualty Investigation
Bundesoberbehörde im Geschäftsbereich des Bundesministeriums
für Verkehr, Bau- und Wohnungswesen

Investigation Report 166/03

Serious marine casualty:

**Collision of MV FINNRUNNER
with pier**

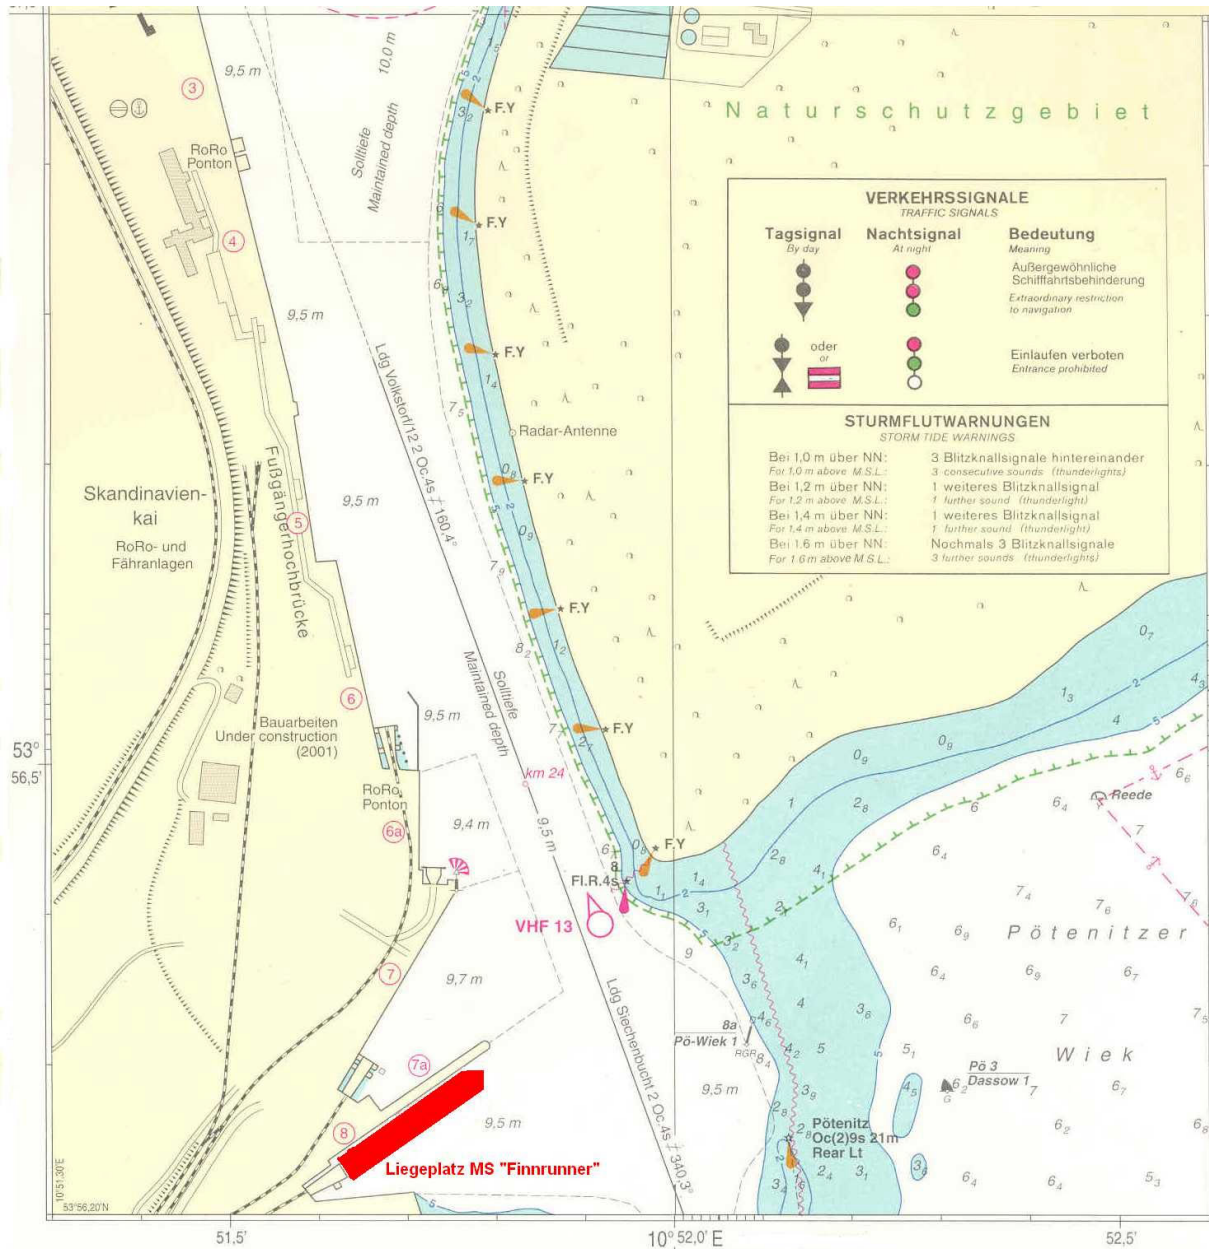
Figure 1, Scene of the accident with FINNRUNNER

Location: Travemünde, Skandinavienskai, pier 8

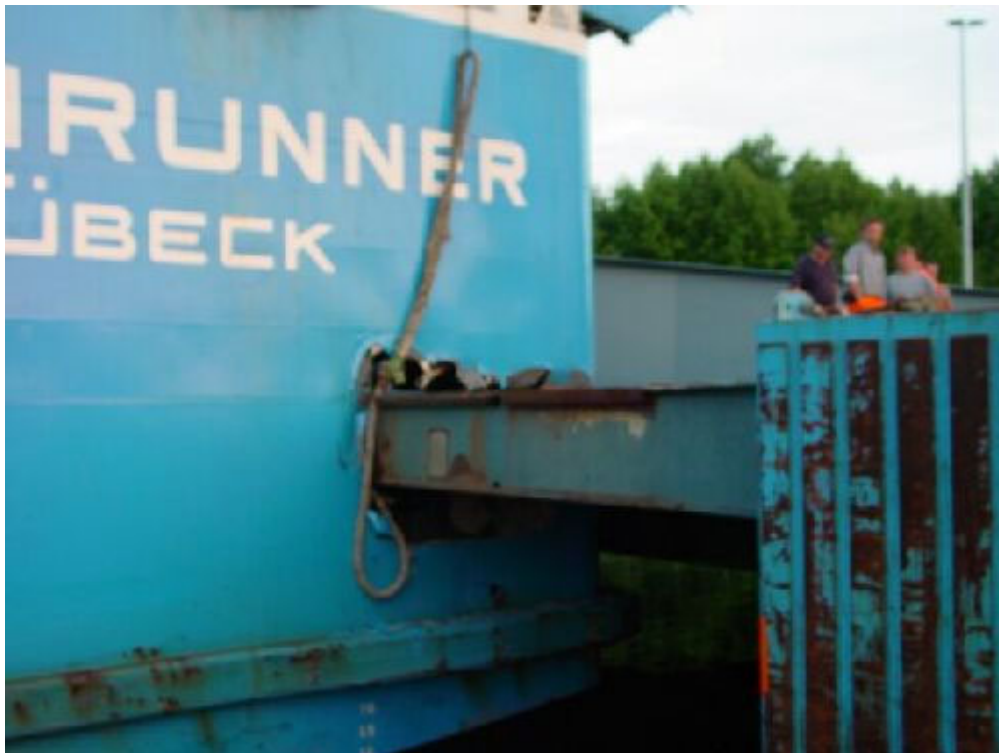
Figure 3, Ramp port aft

Name of vessel:	FINNRUNNER ex RAILSHIP III
Port of registry:	Lübeck
Nationality/Flag:	Federal Republic of Germany
IMO – Number:	8807416
Ship's call sign:	DMGD
Type of vessel:	Railway ferry
Trade range:	Coastal trading
Crew:	17
Classification:	Germanischer Lloyd 100 A5 E4
Year built:	1990
Construction yard:	Schichau Seebeckwerft AG
Construction:	Steel
Length over all:	189.70 m
Moulded beam:	21.60 m
Draft:	5.40 m middle
Gross tonnage	20,729
Engine rating:	2* 8145kW
Engine type:	Diesel
Speed:	18.5 kn
Property damage:	Port aft 3*2 m hole over main deck and 2*0.5 m hole on main deck, stern flap and ramp damaged

FINNRUNNER is used in regular liner service between Travemünde and Turku-Pansio in Finland. At 20.00 h on 11 June 2003 the vessel passed Buoy 1 on the Lübeck-Gedser path in the Lübeck bay; at 20.18 h it passed the Trave Buoy of Travemünde and was in the Priwall leading light line steering a chart course of 215°. The sea voyage ended at 19.54 h and the two main engines were being run at a rating of 70 %. At 20.50 h the FINNRUNNER was off the pier 8 (see figure 2) at the Skandinavienkai wharf and was turning so that she could make fast backwards at the ramp of pier 8. At 21.00 h the vessel collided with the shore ramp. A hole about 3 m long and 2 m high above the main deck was ripped open on the port side, aft and a 2 m * 0.5 m large hole on the main deck (see figure 3 and 4). Functional parts were damaged at the stern flap.

The vessel was inspected by Germanischer Lloyd on behalf of the See-BG (Seamen's Accident Prevention and Insurance Association) and transferred to Rostock for repairs subject to the condition that it should not carry any cargo with it, should only proceed in calm weather conditions, should have the leak sealed provisionally, and must keep the stern flap closed and secured.

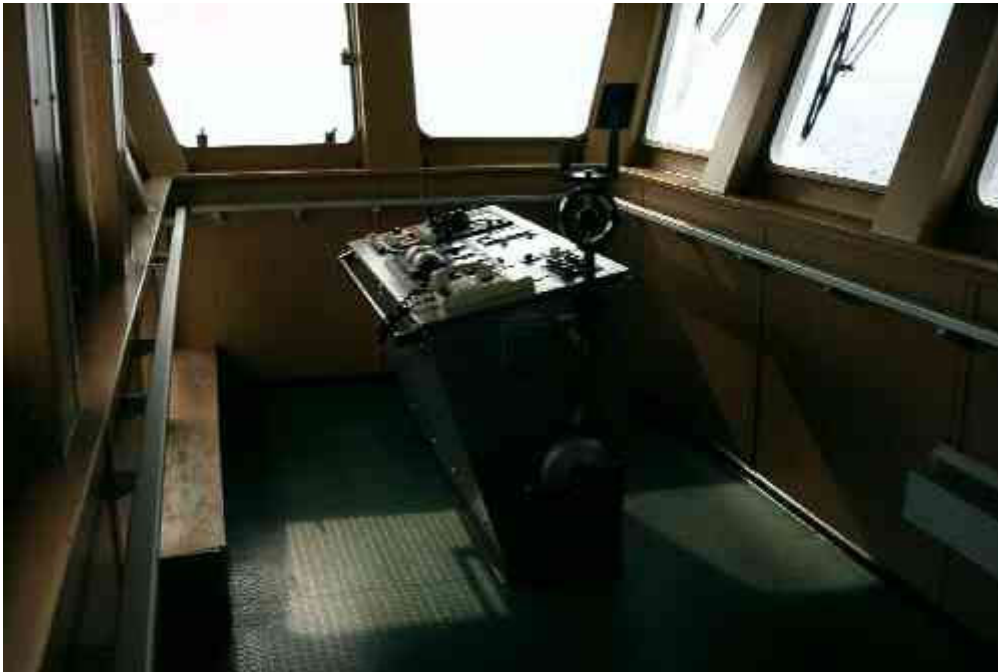
Figure 5, Port conning position

The berthing manoeuvre was carried out from the port conning position (see figure 5). At the conning position there are speed levers for the bow thruster and variable pitch propellers and a display for the vessel log.

1.07% at VH during the trial run on 2 March 1990. This value corresponds to an error of -0.17 kn of the speed reading, which is to be taken into account as a correction. The speed display in the outer conning position was not used prior to the collision.

The risk of an accident when berthing without tug assistance can be reduced if more information about the speed and rate of turn of the vessel is available at an appropriate position and if vessels operate with official electronic chart data as an ECDIS-System. An ECDIS-System with precise chart data in the DGPS area, a rate of turn display and display of the transverse speed can additionally support berthing. The rate of turn forward or stern speed and the transverse speed of MV FINNRUNNER could then be displayed in the outer control positions.

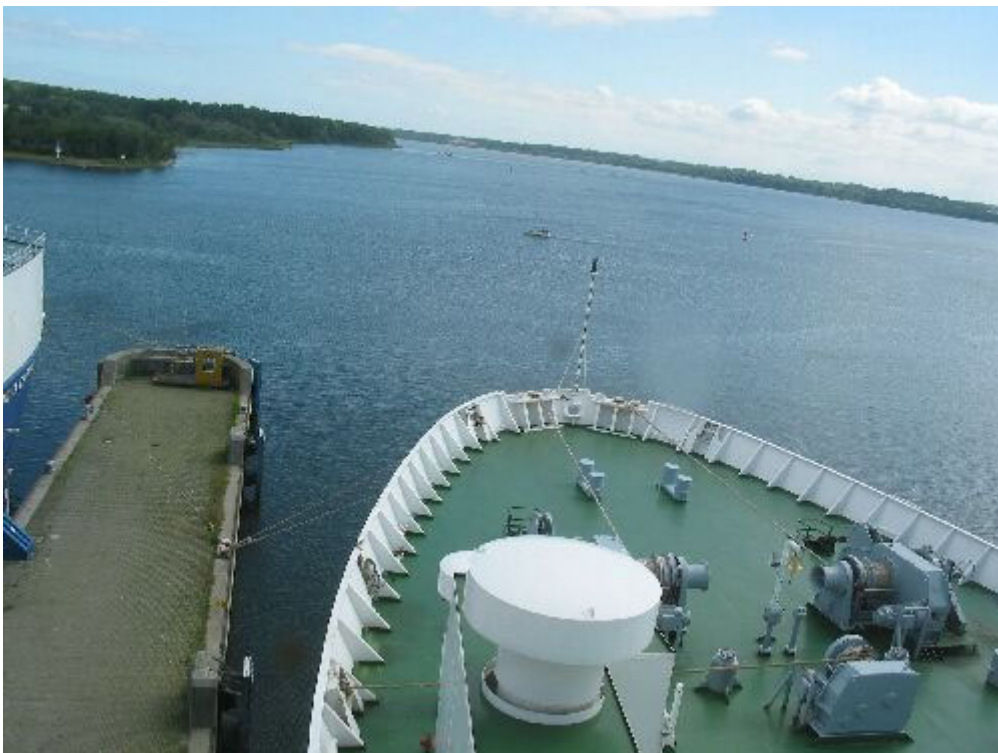
Figure 6, Pier 8 forward, Finn rider

The forecastle manoeuvring station was manned by two ships mechanics. The chief mate was supervising the forecastle from the bridge (see figure 6). The stern was manned by one officer and two ships mechanics. Distances from the pier were reported to the bridge via walky-talky. The engine was staffed by the Chief Engineer and one engine man.

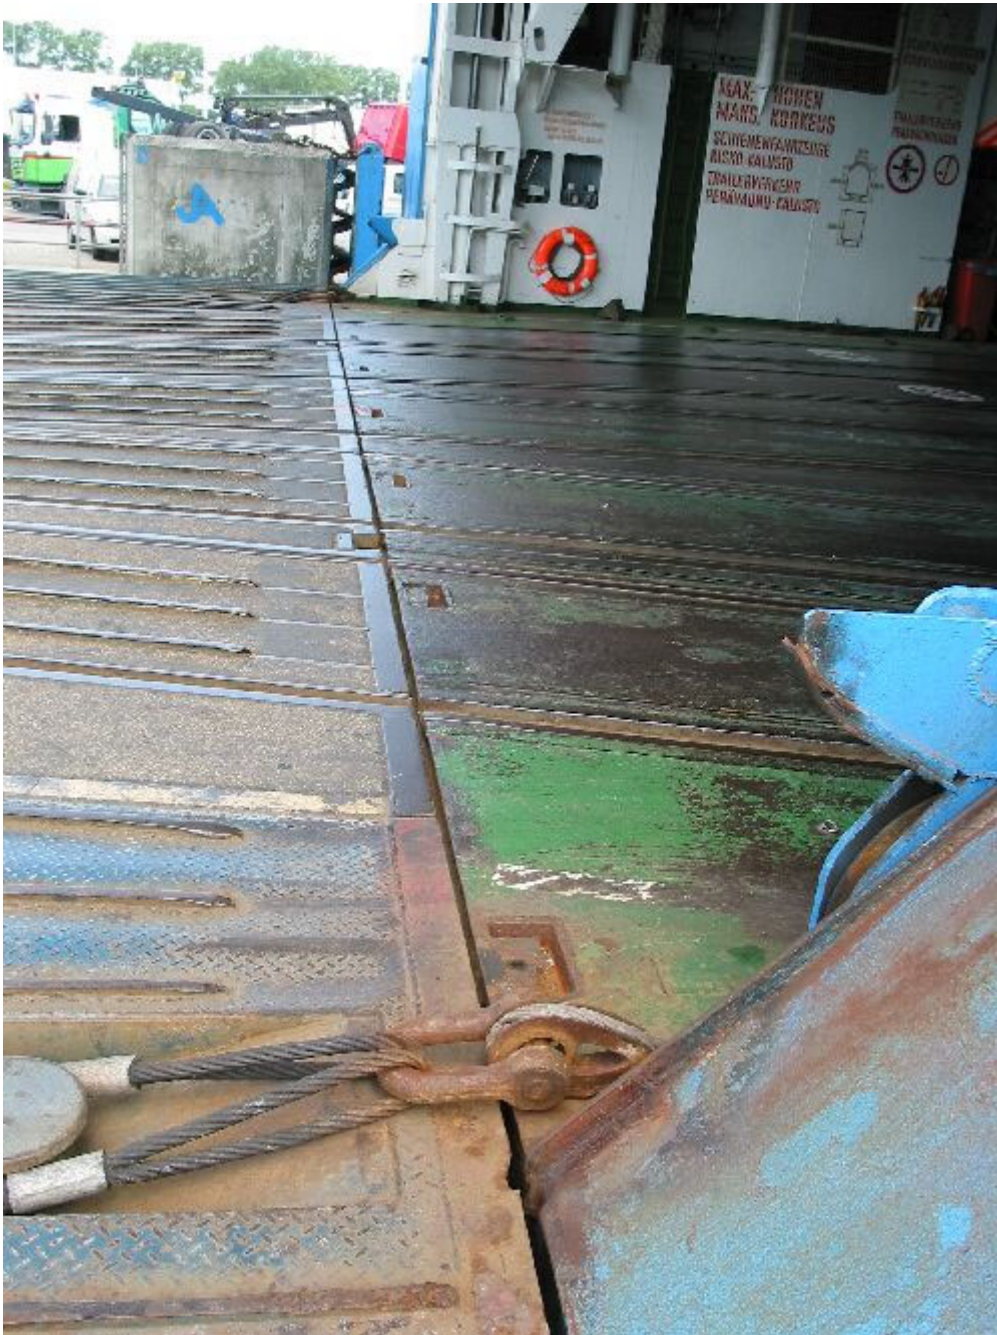
Figure 7, Loading ramp, Finnriider

On 11 June 2003 at 21.00 h MV FINNRUNNER collided with the ramp of pier 8 while berthing at the Skandinavienkai in Travemünde. Visibility was good with slight westerly winds. Property damage was sustained on the aft port side of the vessel resulting in repair at a yard. The Master is considered to be experienced and has been working on the route since 1984. The engines and navigation equipment of MV FINNRUNNER were operable. When berthing the railway ferry it is necessary to establish a direct connection between the shore ramp and the stern of the vessel that only allows a tolerance of a few cm (see figure 7).

During the inspection on the ramp it could be seen that MV FINNRUNNER has to manoeuvre precisely down to the last cm so that the rails on shore and on the vessel coincide in order to unload the rail wagons. The vessel can only work with fore lines, fore springs, cross lines and stern lines when berthing. It is not possible to hand over a stern spring ashore. Only the anchors could be used additionally for berthing. It is not customary to berth with anchor assistance in Travemünde.

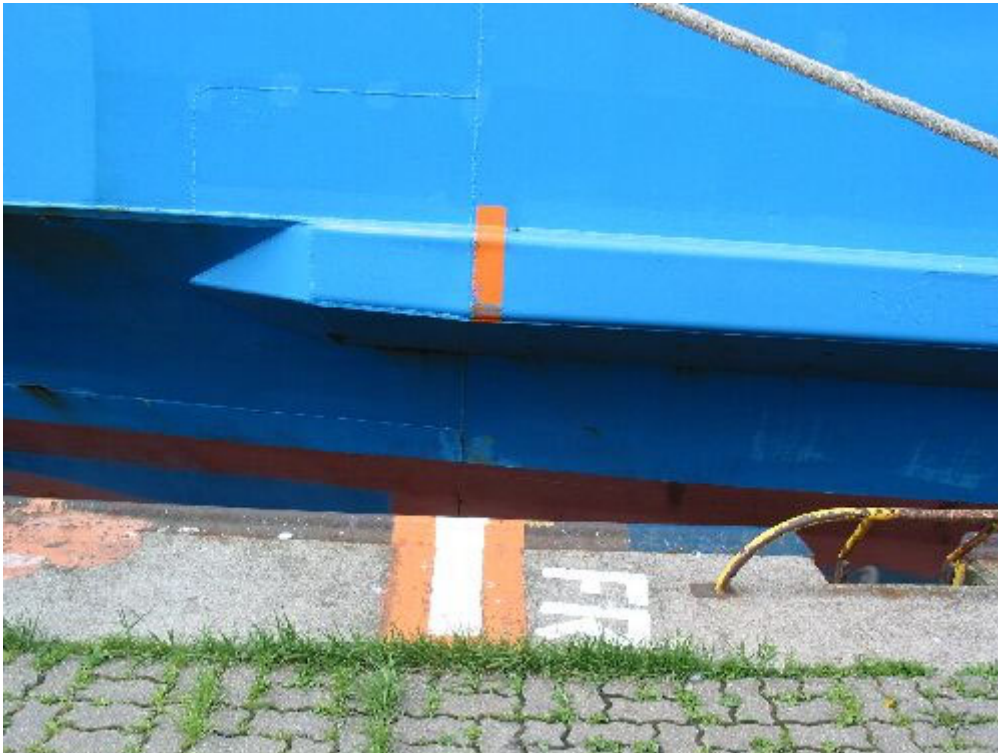
Figure 8, Land marks for berthing, Finn rider

The Master is very experienced and performs approx. 70 berthing manoeuvres a year in Travemünde with MV FINNRUNNER or FINNRIDER, a sister vessel of the same type. He generally carries out the berthing manoeuvres estimating them with his eye and the landmarks. There is a Dolog on board MV FINNRUNNER as navigation aid for speed measuring, which had a measuring error after calibration of
