Bundesstelle für Seeunfalluntersuchung
Federal Bureau of Maritime Casualty Investigation
Bundesoberbehörde im Geschäftsbereich des Bundesministeriums
für Verkehr, Bau- und Wohnungswesen

Investigation Report 179/02

**Collision MV "HENNY"
and
MV "OOCL CANADA"**

on 25.11.2002 in the River Elbe at buoy 116

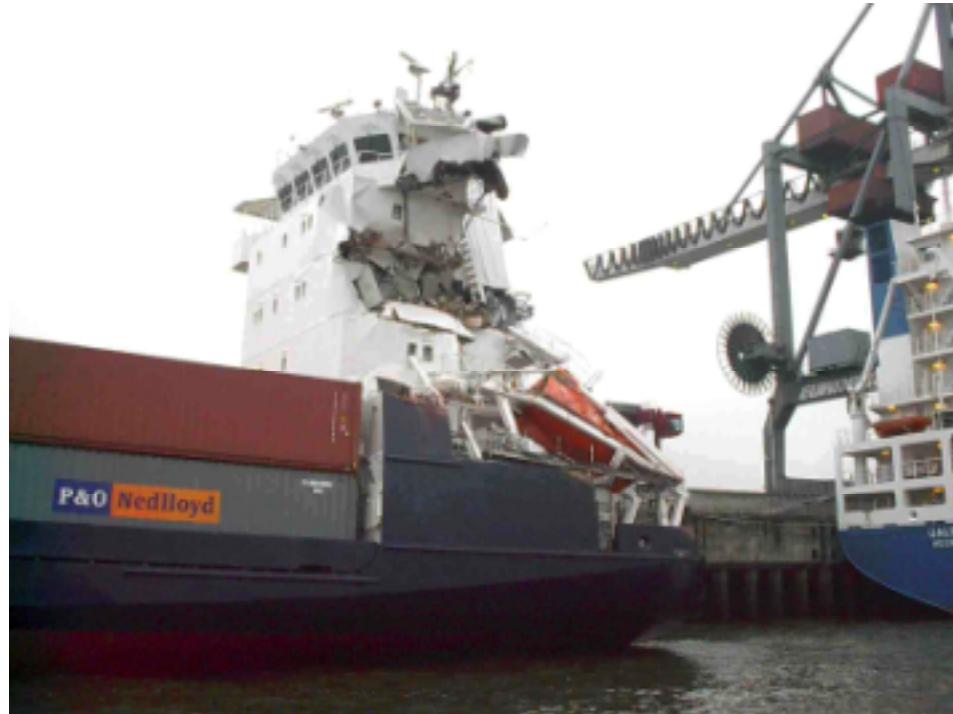
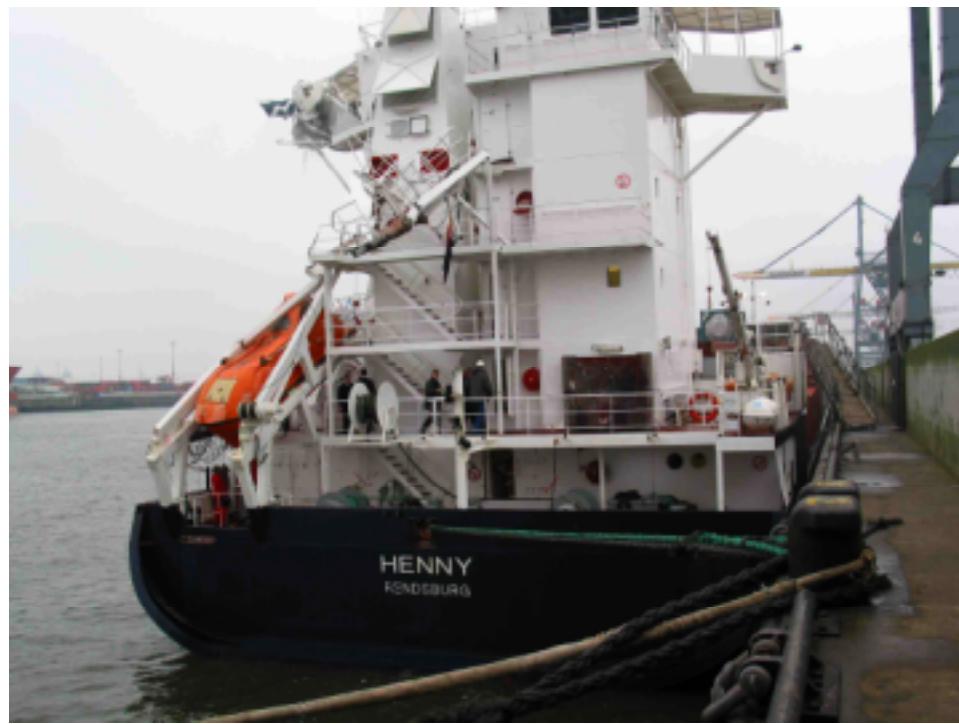
The damage on board MV "HENNY" is evident from the attached photos. The port bridge wing and the mechanic's cabin below were largely destroyed. One person was jammed in

this cabin and injured. The free-fall lifeboat with associated ramp was heavily damaged. Deformation over all decks. A period in the yard was necessary.

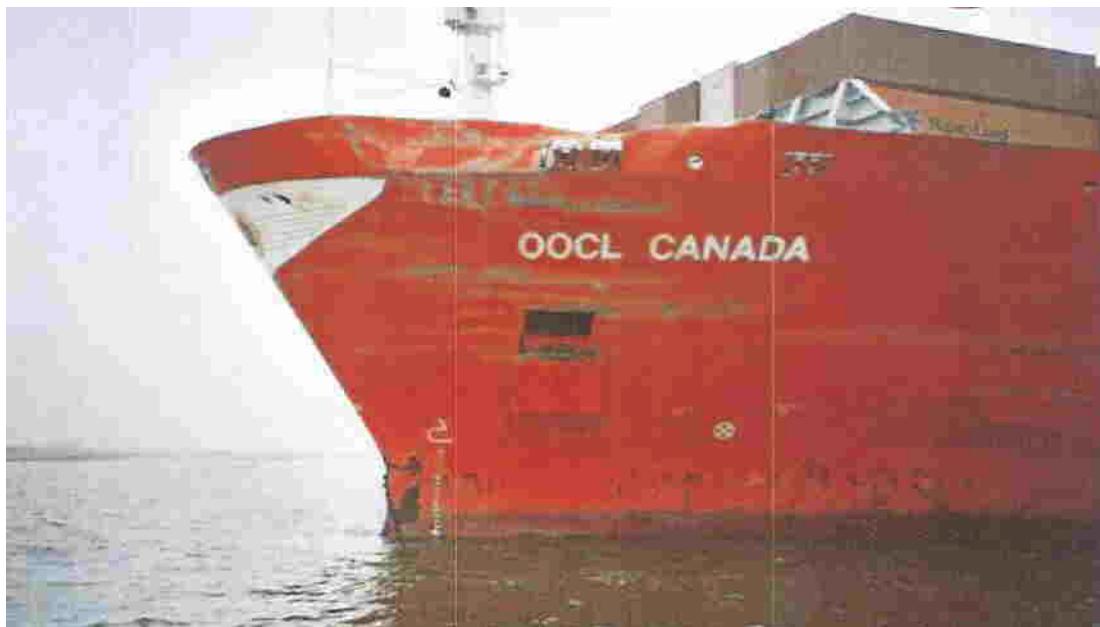
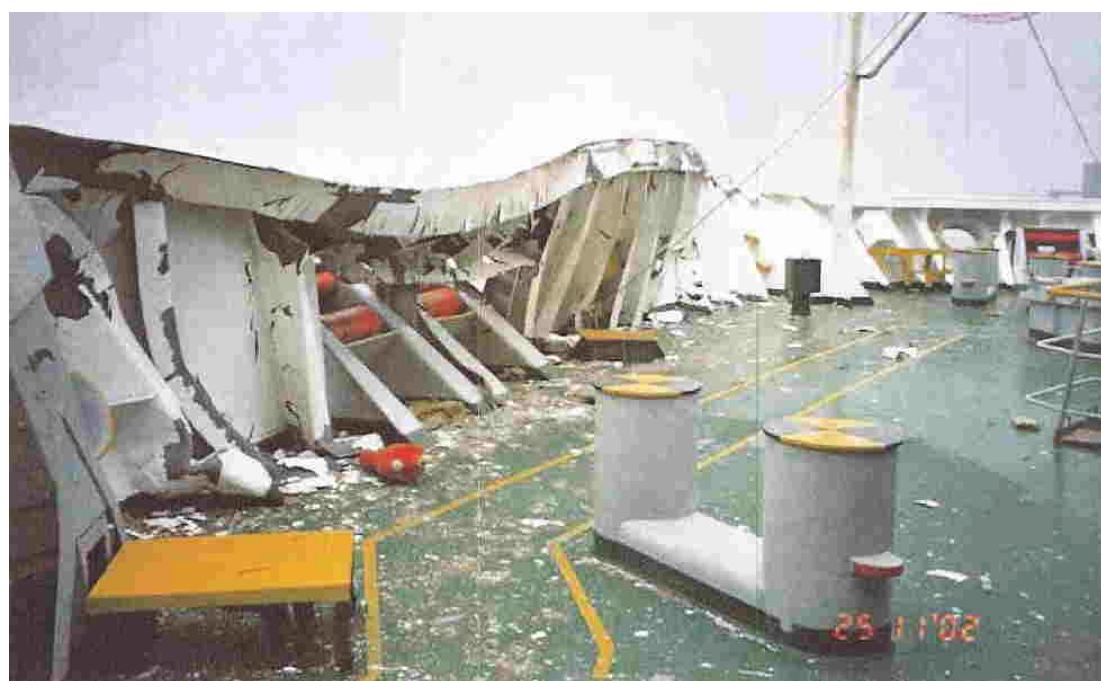
The damage to the forecastle at the front of MV "OOCL CANADA" is evident from the photos. The forecastle bulwark was set in approx. 20 m on port. There is a hole in the shell

plating of approx. 40 x 80 cm at a height of about 8 – 10 m above the water line. The forward port wavebreaker is damaged.
