Bundesstelle für Seeunfalluntersuchung
Federal Bureau of Maritime Casualty Investigation
Bundesoberbehörde im Geschäftsbereich des Bundesministeriums
für Verkehr, Bau- und Wohnungswesen

Investigation Report 183/02

Sinking of the Fishing Vessel “IRKA” – Ort 6

on 28 November 2002 nearby Fehmarn

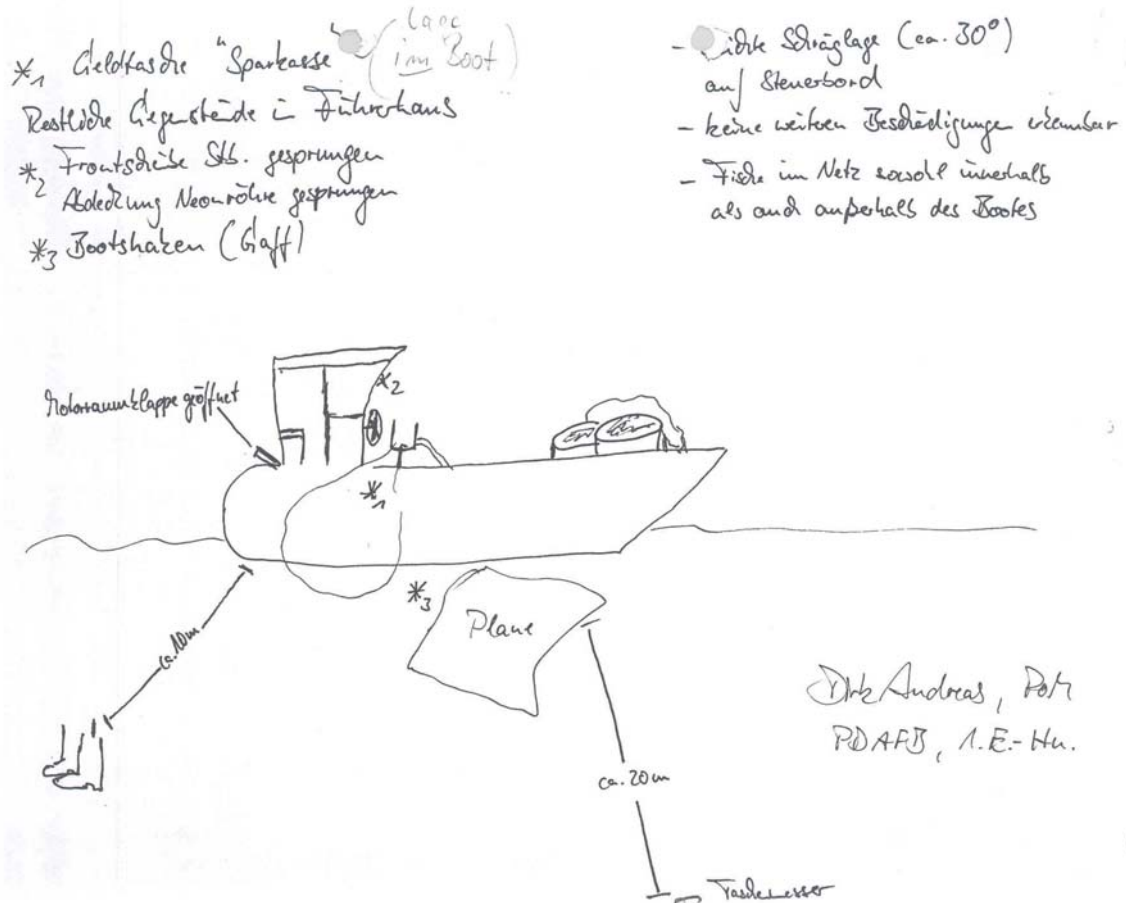
Diver's sketch :

At 12.28 h a police diver inspected the wreck and identified it as the missed Fishing Vessel "IRKA". The missing fisherman was not found. The vessel was lying on the bottom with its stem facing Heiligenhafen (SSE) in a position slanting slightly to starboard. A fishing net with fish in the net was hanging partly on deck and partly outboard on the starboard side. No damage to the wreck could be found. The only wheelhouse door on the starboard side was missing. The engine compartment flap at the aft edge of the wheelhouse was open. A pair of rubber boots and a fishing knife were found near the wreck.

- * Wallet marked "Sparkasse" (= savings bank) was lying in the boat
- Other items in the wheelhouse
- * windscreen starboard cracked
- Cover of neon tube cracked
- * Boat hook (gaff)

Slightly sloping position (approx. 30°) to starboard
No further damage evident
Fish in net both inside and outside the boat

Engine compartment flap open

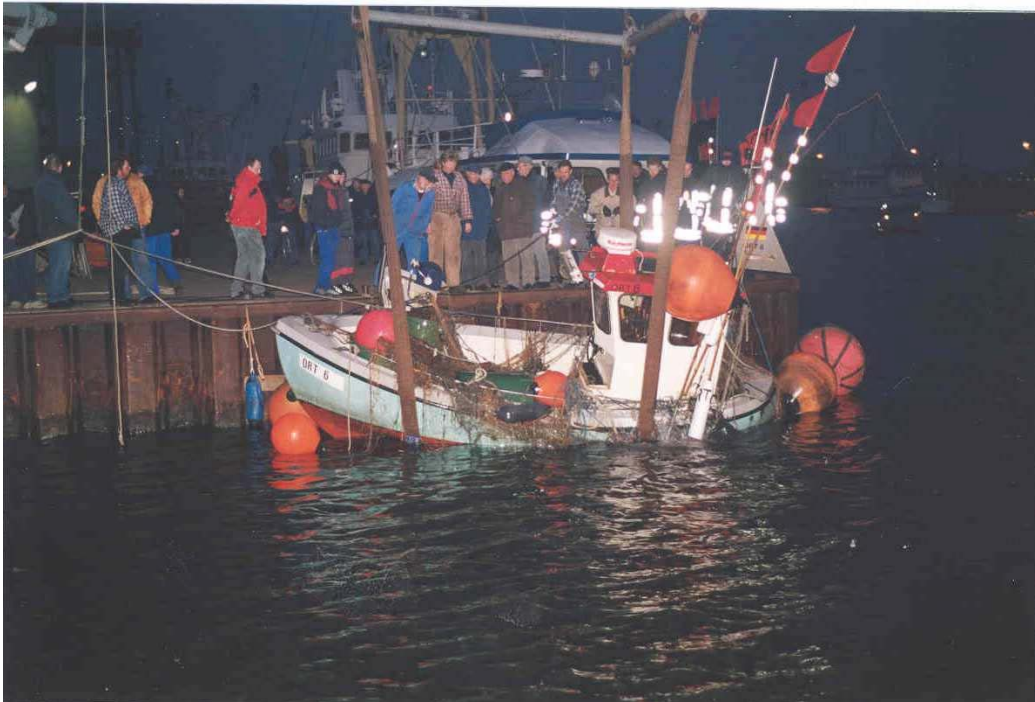
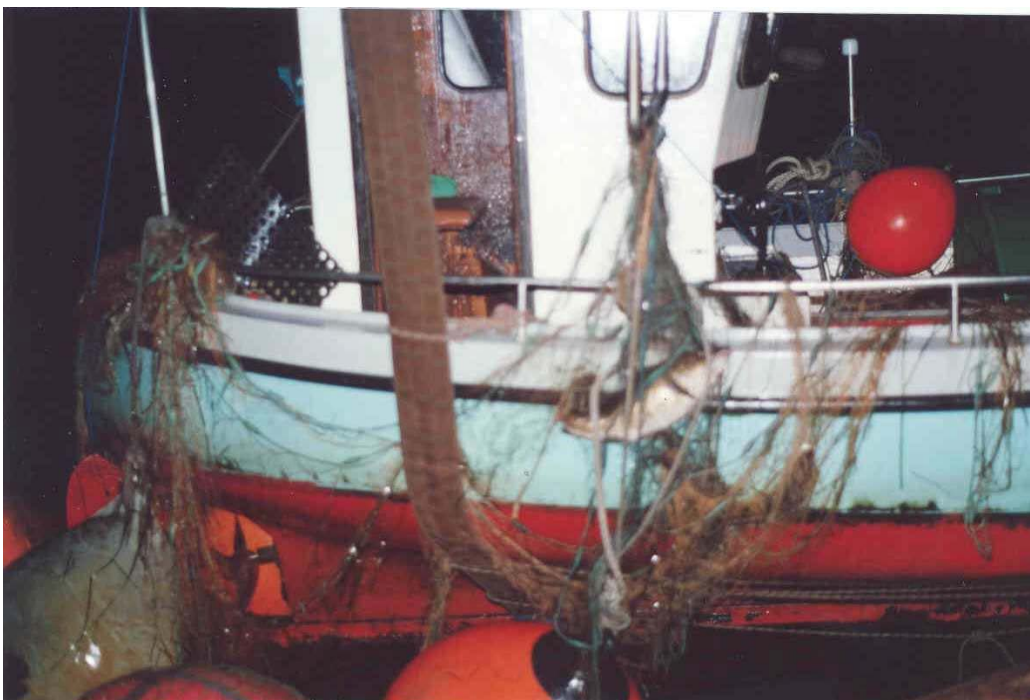
The vessel was salvaged by the sons on 3 December 2002 with the assistance of fishing colleagues and friends under the supervision of the Water Police Heiligenhafen, towed to Heiligenhafen, and taken on land there.
