**Bundesstelle für Seeunfalluntersuchung**  
**Federal Bureau of Maritime Casualty Investigation**  
Bundesoberbehörde im Geschäftsbereich des Bundesministeriums  
für Verkehr, Bau- und Wohnungswesen

**Investigation Report**  
**198/02**

**Serious Marine Casualty:**

**Collision**  
**CMV HONGKONG EXPRESS**  
**and**  
**TMV SARAH GLORY**

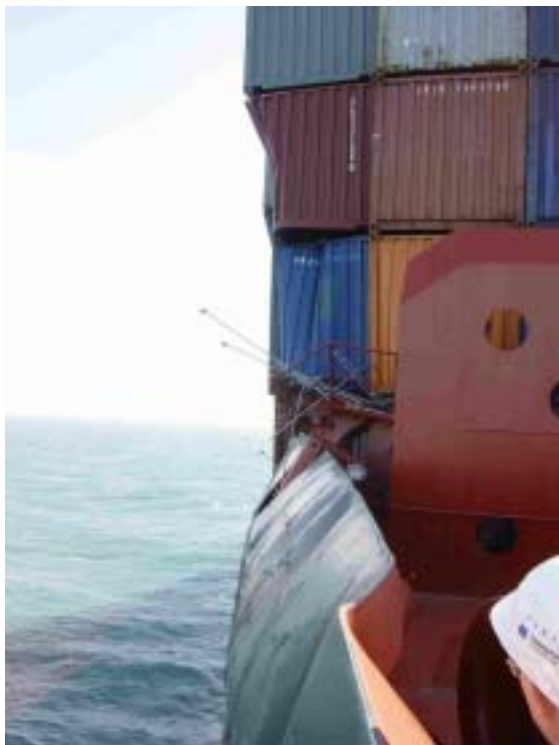
Picture 5: damage photo 1

Both vessels sustained damages at the shell plating. Numerous containers were damaged, 13 fell over the side, nine of which sank and four fell onto the deck of TMV SARAH GLORY. There were no personal injuries nor any oil pollution or underwater damages.

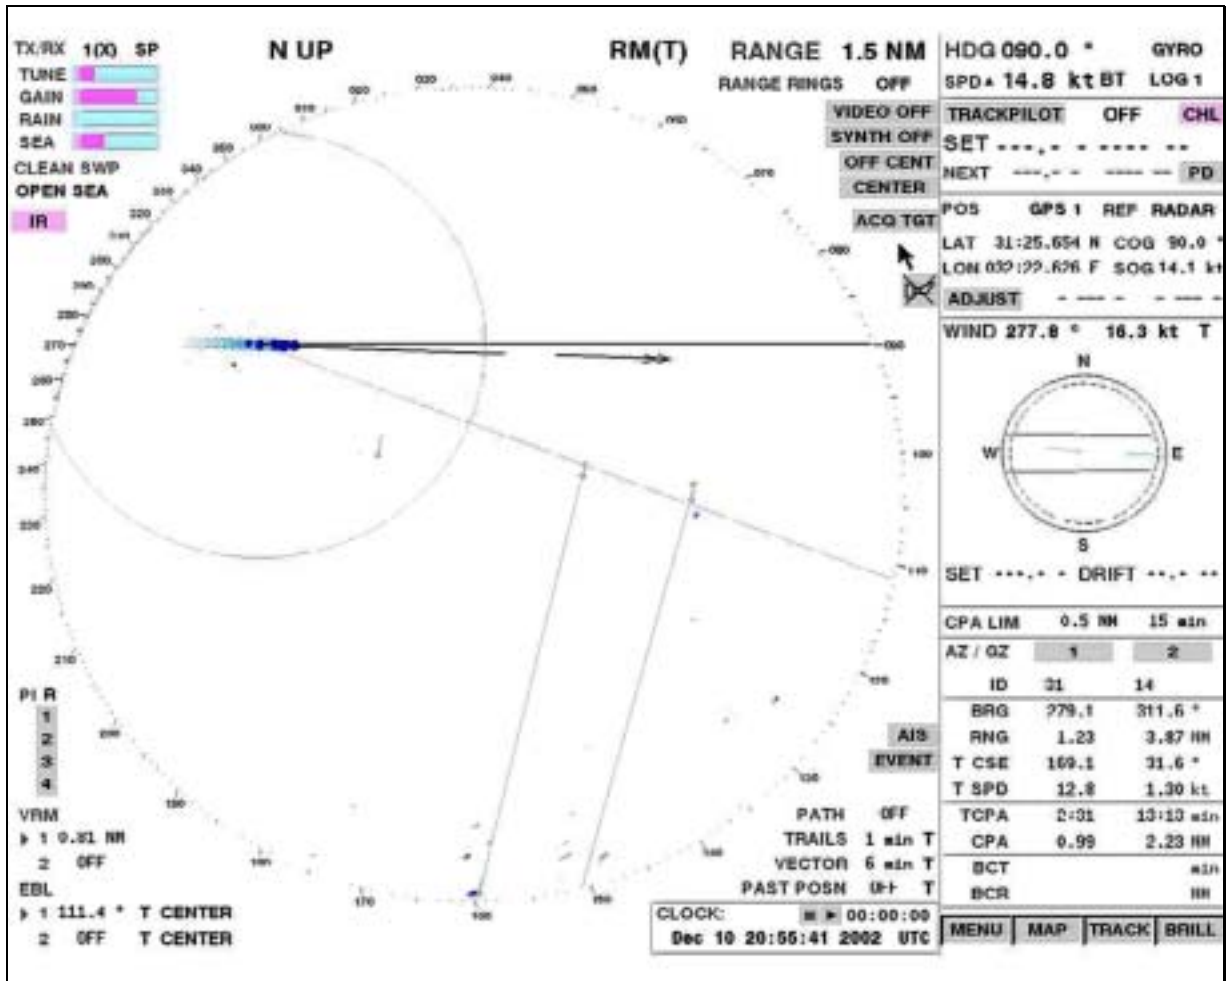
**Picture 16: Radarplot 1**

The radar display of the CMV HONGKONG EXPRESS at 22.55 Uhr LT:

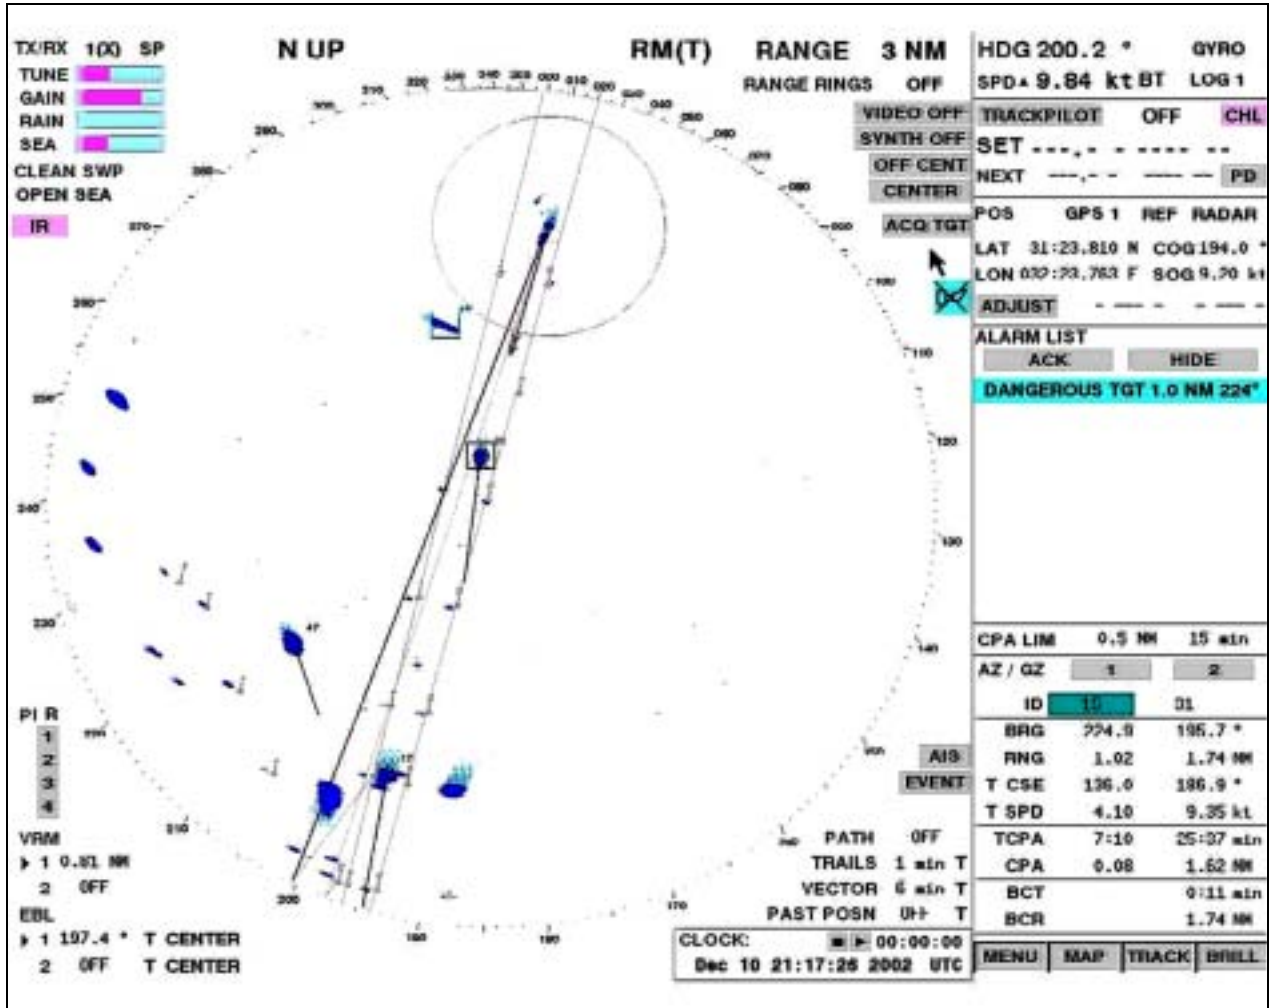
Picture 17: Radarplot 2

The Radar display of the CMV HONGKONG EXPRESS at 23.17 Lt.:

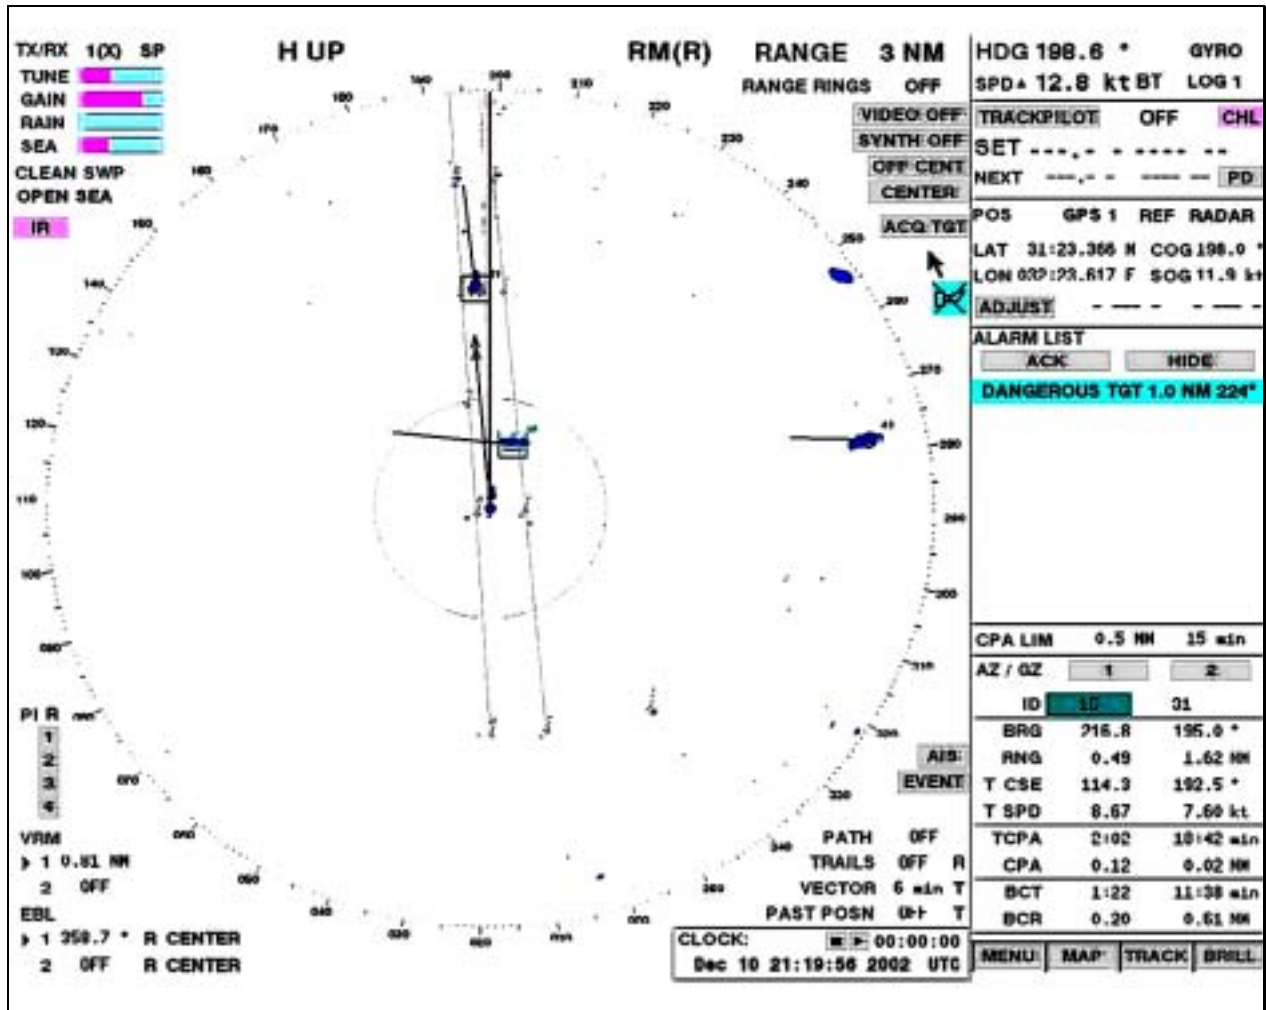
Picture 18: Radarplot 3

The Radar display of the CMV HONGKONG EXPRESS at 23.20 Uhr LT:

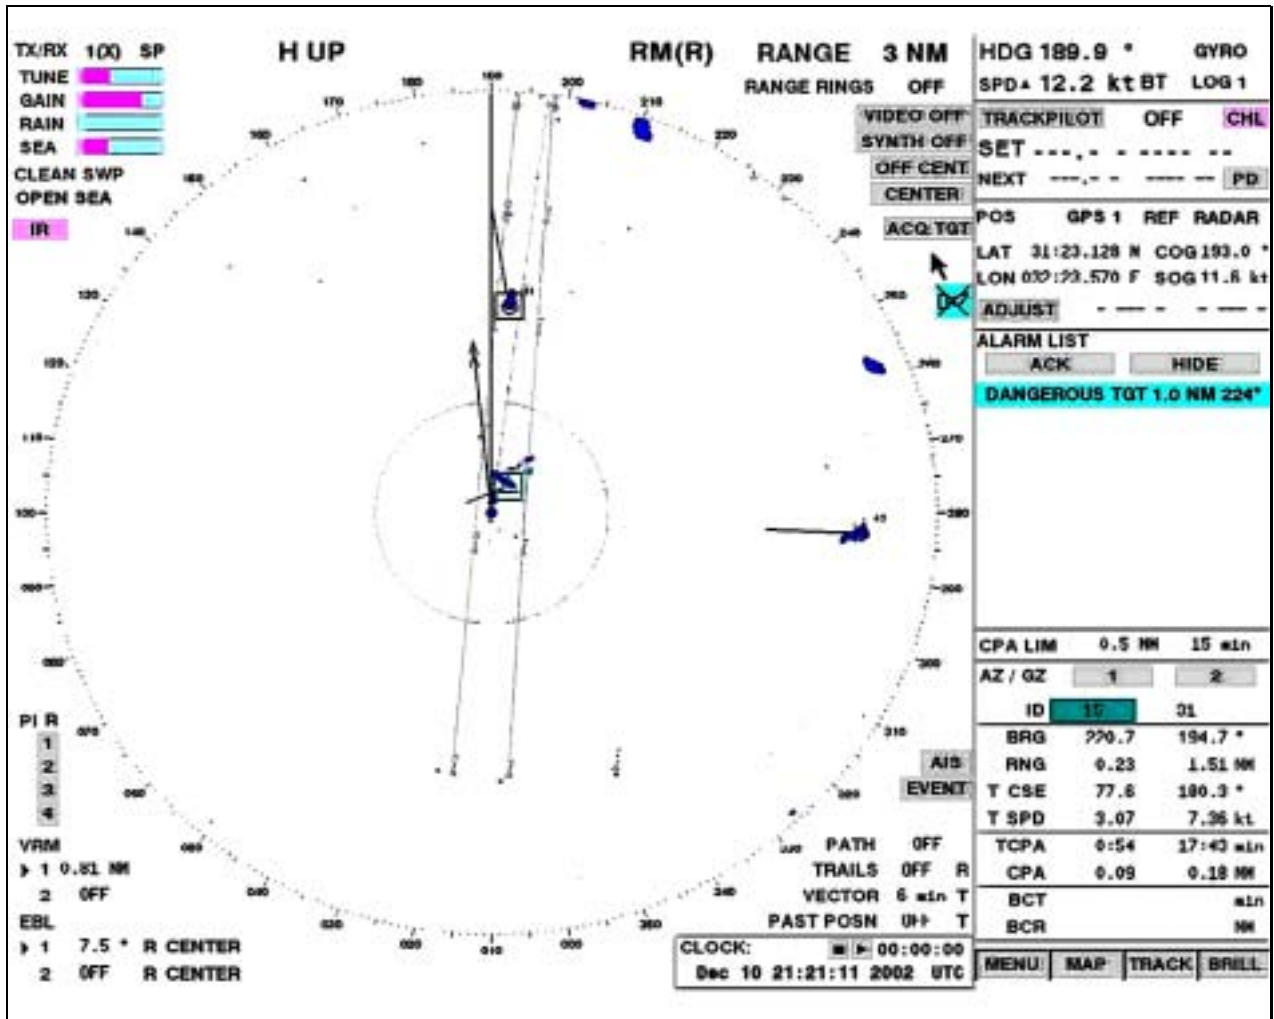
Picture 19: Radarplot 4

The Radar display of the CMV HONGKONG EXPRESS at 23.21 Uhr LT:

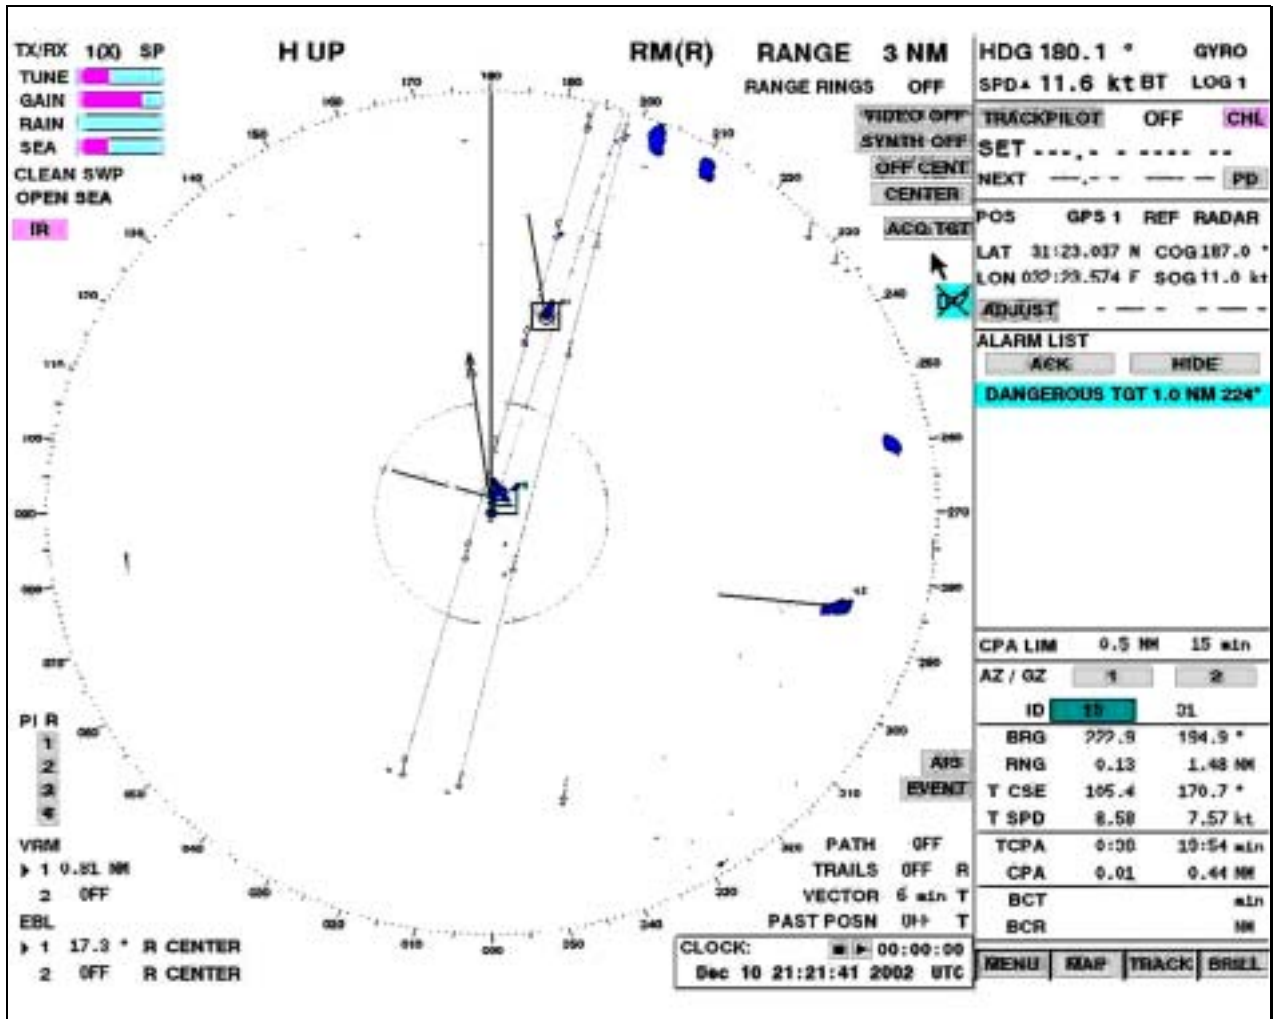
Picture 20: Radarplot 5

The Radar display of the CMV HONGKONG EXPRESS at 23.22 Uhr LT:

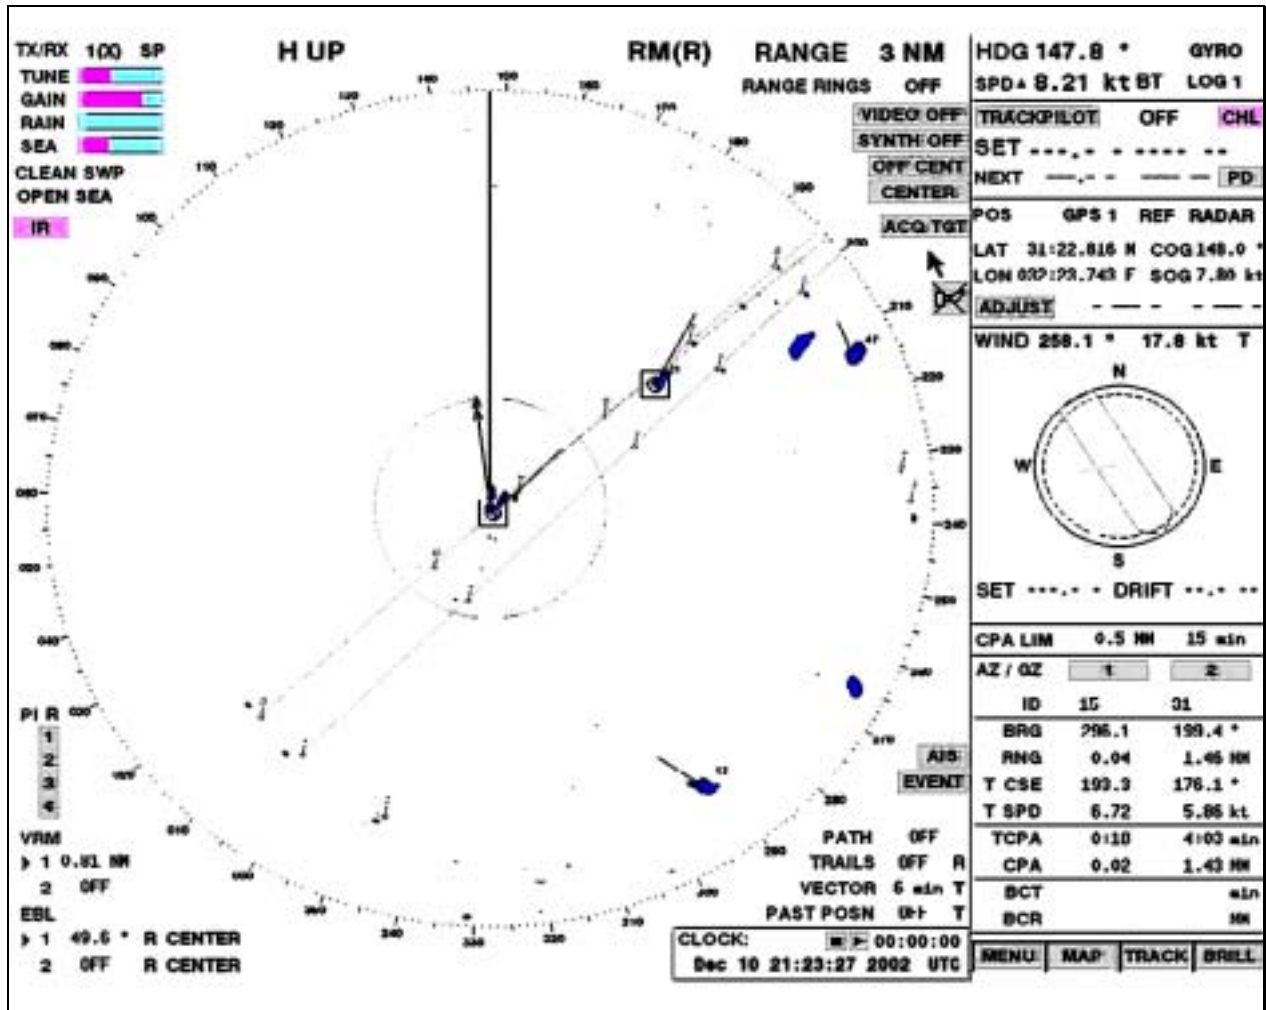
Picture 21: Radarplot 6

The Radar display of the CMV HONGKONG EXPRESS at 23.23 Uhr LT:
