Bundesstelle für Seeunfalluntersuchung
Federal Bureau of Maritime Casualty Investigation
Bundesoberbehörde im Geschäftsbereich des Bundesministeriums
für Verkehr, Bau- und Wohnungswesen

Summary
Investigation Report No. 19/03

Collision

Container M/V "VILLE D'ORION"
and
M/V "TOP GLORY"

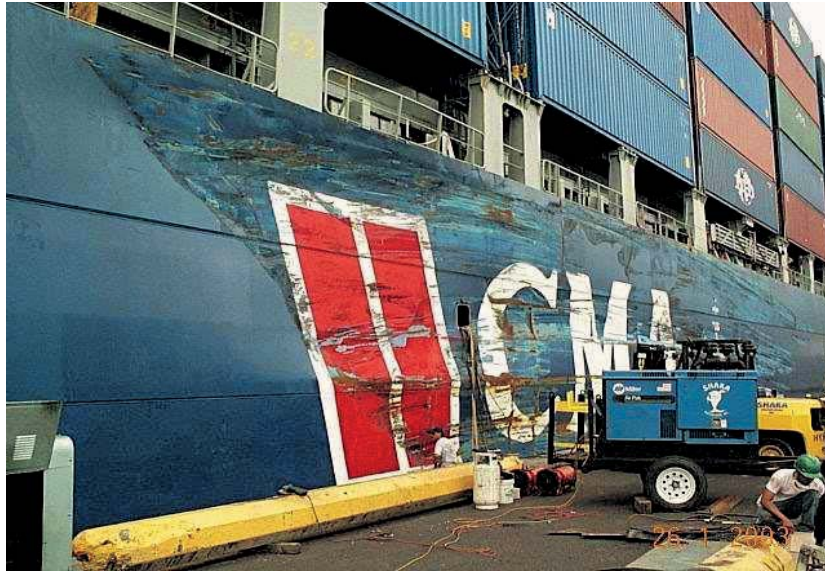
Figure 3, Emergency repair to the Container M/V "VILLE D'ORION" at the Pier in Honolulu

On 26 January 2003 at 08:00 h the Container M/V "VILLE D'ORION" entered the port of Honolulu and went alongside at Pier 1 in order to have the emergency repairs carried out to the port shell plating.

The emergency repairs were completed on 27 January 2003. The Container M/V "VILLE D'ORION" left Honolulu in the direction of Los Angeles, California, USA. The USCG Test Report on the repairs carried out is recorded in the document MISLE Vessel Inspection Activity – No.: 1739972.

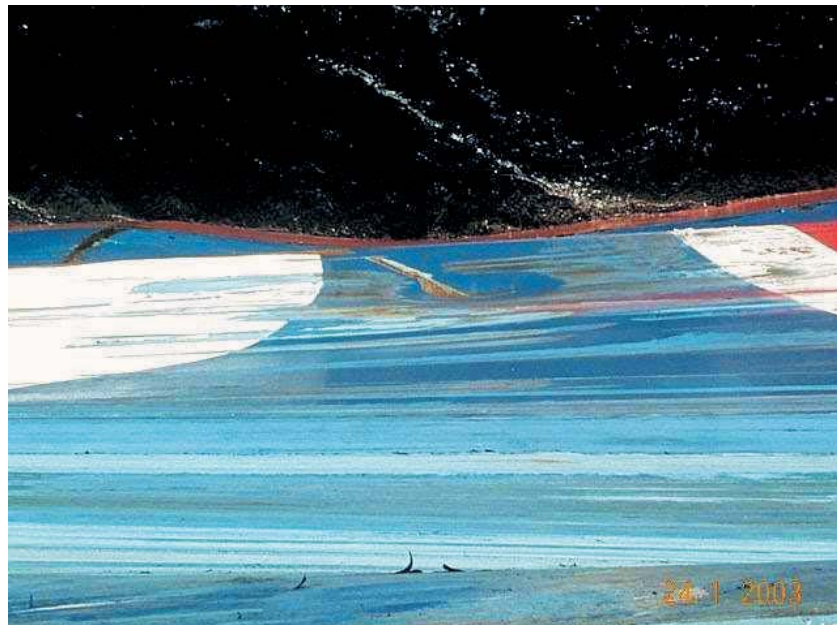
The container M/V "VILLE D'ORION" sustained damage to the port side between frames 71 and 85 (Bay 21-35) in the collision. After Germanischer Lloyd, the insurer and the authorities were informed, the vessel was redirected to Honolulu, Hawaii as port of distress to have the damage ascertained and the necessary scope of repair fixed. The vessel's expert estimated the costs of repair at \$ 1.5 million.

Later at 07:00 h the ship's mechanic of Container M/V "VILLE D'ORION" discovered the damage to the port side of the vessel.

Figure 4, Damage to the port side of Container M/V "VILLE D'ORION"

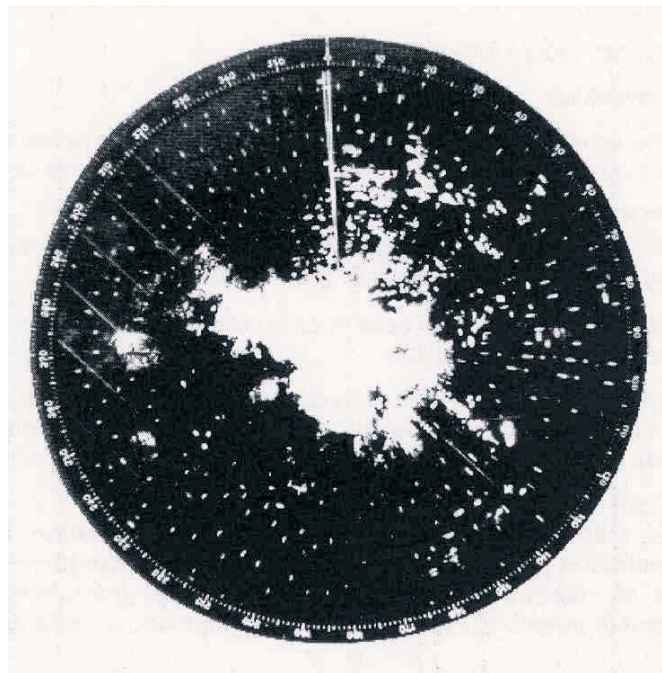
Figure 9, Radar display 1

Dense raindrops, snow and hail showers can impair the radar radiation emitted so heavily, especial in 3 cm long X-Band radar waves, that the range is drastically reduced and even major radar echoes are not visible in this zone. By bringing in the FTC reflecting edges are emphasized. With this function the outer edge of the precipitation field, as well as targets in the precipitation field, are emphasized. Despite this, this technology does not make it possible to increase the reduced range due to range attenuation existing under normal propagation conditions. In particular in the case of very heavy tropical rain showers it is quite possible that no useful radar targets can be distinguished from the rain.

(Example of disturbances on the radar screen caused by heavy rain)

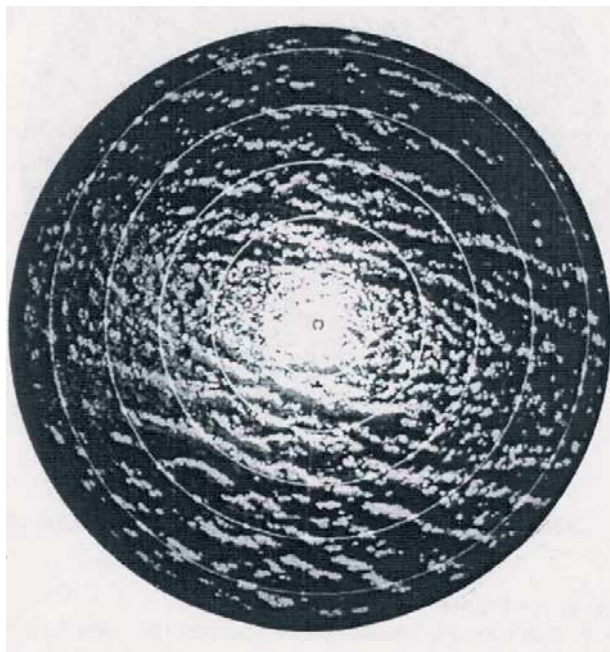
Figure 10, Radar display 2

This interference depends on the height of the antenna of the radar set, the sea height and the wave period. This problem can be processed with the switch "sea decluttering".

(Presentation of a radar display without the sea decluttering switched on. The course of the waves against the vessel can be seen well. Dark to light centre point. Radar target difficult to recognise in the wave echoes.)

When the sea decluttering (STC) is used the necessary reception energy level is raised. This can suppress weak radar targets or only display them on the radar screen after two to three radar antenna revolutions. This means that the radar operator must concentrate fully on the radar screen.
