CASUALTY REPORT

May 26, 2003
Case 199926108/9
File 01.40.01

Collision between Danish m/v UNO and German pushbarge DETTMER TANK 116 on 11 July 2002

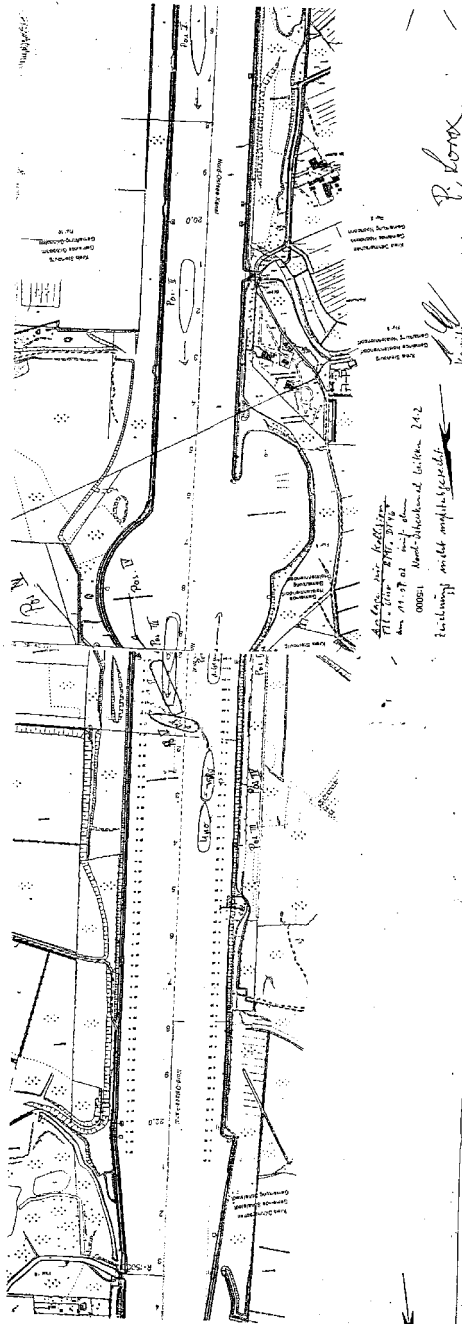
ENCLOSURE 1

At this moment, when the mate was operating the engine telegraph, the number two vessel, UNO, then at a distance of about 40 – 60 m, was suddenly seen turning more than 45° to port crossing ahead of the push unit. The engine was stopped and then set to full astern. A collision was however unavoidable and the starboard bow of DT 116 hit the starboard side of UNO. The collision was quite violent and caused one of the connections between the push boat and the barge to break. The push unit and UNO came free of each other shortly after the collision.

Enclosure 1: A sketch of the movements of the vessels drawn up by the mate of DETTMER TANK 46.
