Investigation Report 49/02

Very Serious Marine Casualty:

**Sinking of the
GOTLAND**

on 15 June 2002 near Damp

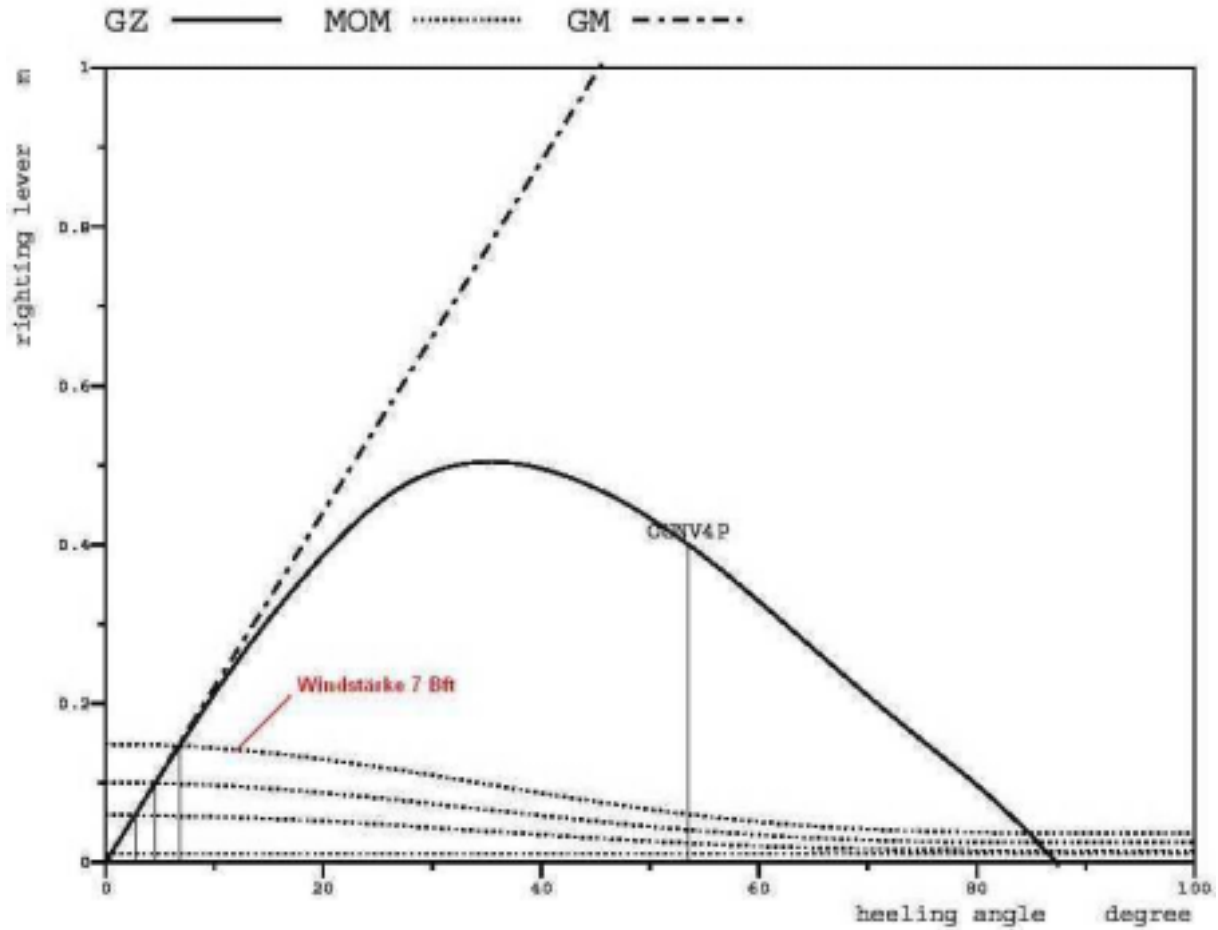
Curve of statical stability for the fishing cutter before the reconstruction, with sails set

The dotted lines refer to the wind forces of 4-7 Bft. "OUNV4P" (see Photo 13) designates the ventilation shaft of the engine room after the reconstruction.

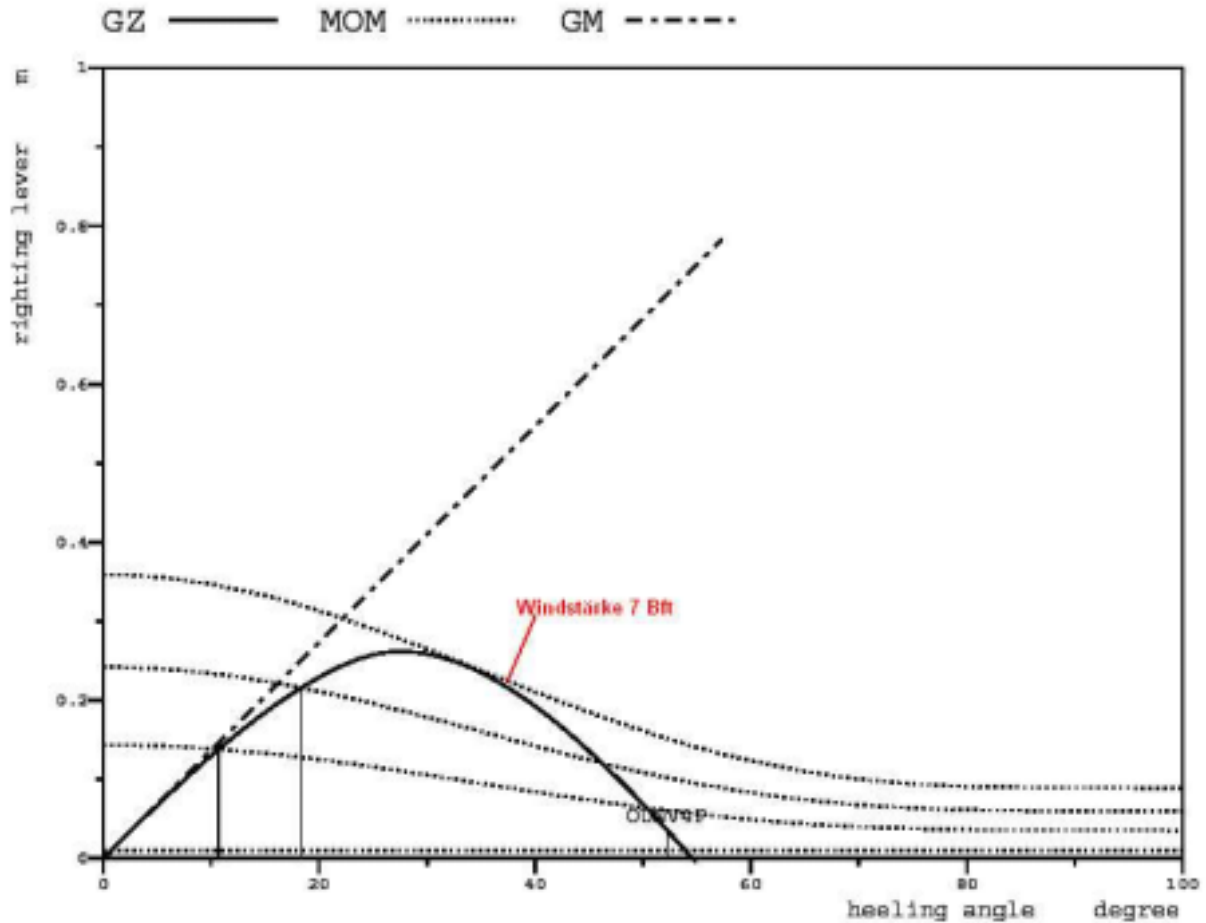
Curve of statical stability for the sailing-vessel with sails set at the moment of the accident

The dotted lines refer to the wind forces of 4-7 Bft. "OUNV4P" designates the ventilation shaft of the engine room, which was the first to make water.

In her original condition, the vessel has a sufficient stability and partially met the requirements for modern sailing yachts. The height of the centre of gravity raised by the reconstruction and at the same time the strongly augmented sail surface with a lateral centre of gravity increased in its turn, each of these two facts had a negative effect on the stability of the vessel. The righting moment of the vessel has decreased by the alterations, and the heeling moment by the wind has increased by the augmentation of the sail surface and the increased centre of gravity of the sails.

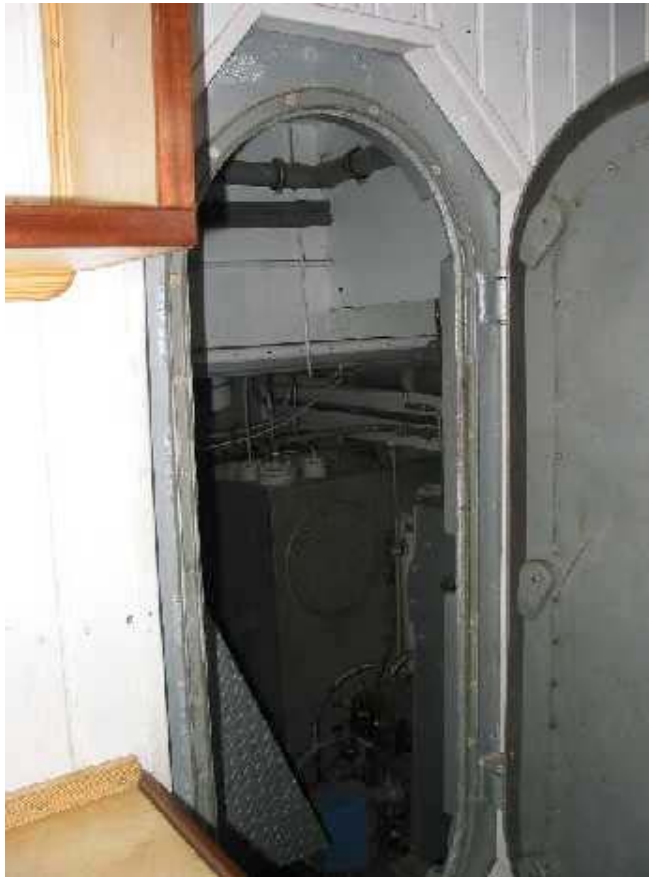
Photo 10, Aft bulkhead door

The bulkheads have been shifted, with the exception of the aftpeak bulkhead and the aft engine room bulkhead – both bulkheads are not watertight (see Photos 10, 11). The fore collision bulkhead is the only bulkhead to be watertight .

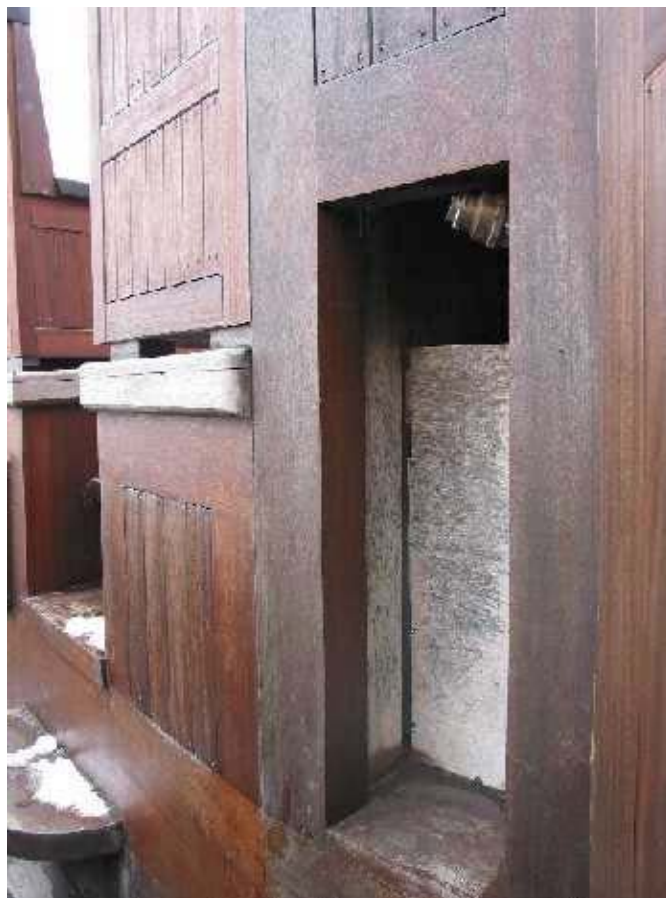
Photo 13, Starboard ventilation shaft (OUNV4P)

The water entered the ship via the starboard ventilation shaft of the engine (see Photo 13), the starboard window of the aft cabin, the starboard bathroom window and via the skylights (see Photos 18, 19, 20).

The vessel first filled with water via the open ventilation shaft of the engine on the starboard side. The skylights, the open window of the fore edge of the bridge, and an open bathroom window as well as the open ventilation shaft of the engine on port side accelerated the sinking. The three hatches of the bulkheads were closed. However, in the aft portion, no watertight conditions towards the engine could be achieved, as the area of the tail wave was permeable. By the pressure of the water streaming in, the hatch in front of the collision bulkhead broke, which resulted in that the forecabin filled with water. An eye-catching feature of the design is the collision bulkhead, which, after the initial construction, was shifted far towards the bow, for which, apart from the sketch prepared by the BSU (see Photo 5), no drawings could be submitted to the BSU.

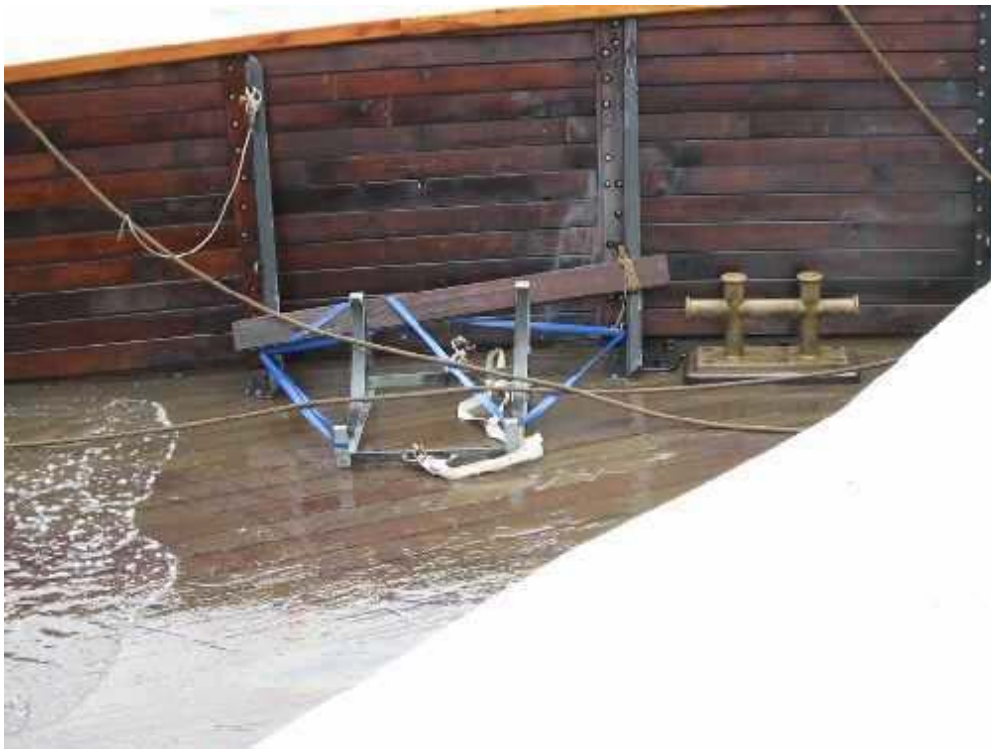
Photo 16, Liferaft support

The liferaft was hired by the owner completely with cradle for the season and fixed temporarily with its cradle on the port side of the main deck by means of lashing straps. The pelican hook intended for the release of the raft was on the rear side and only hard to access (see Photo 16).

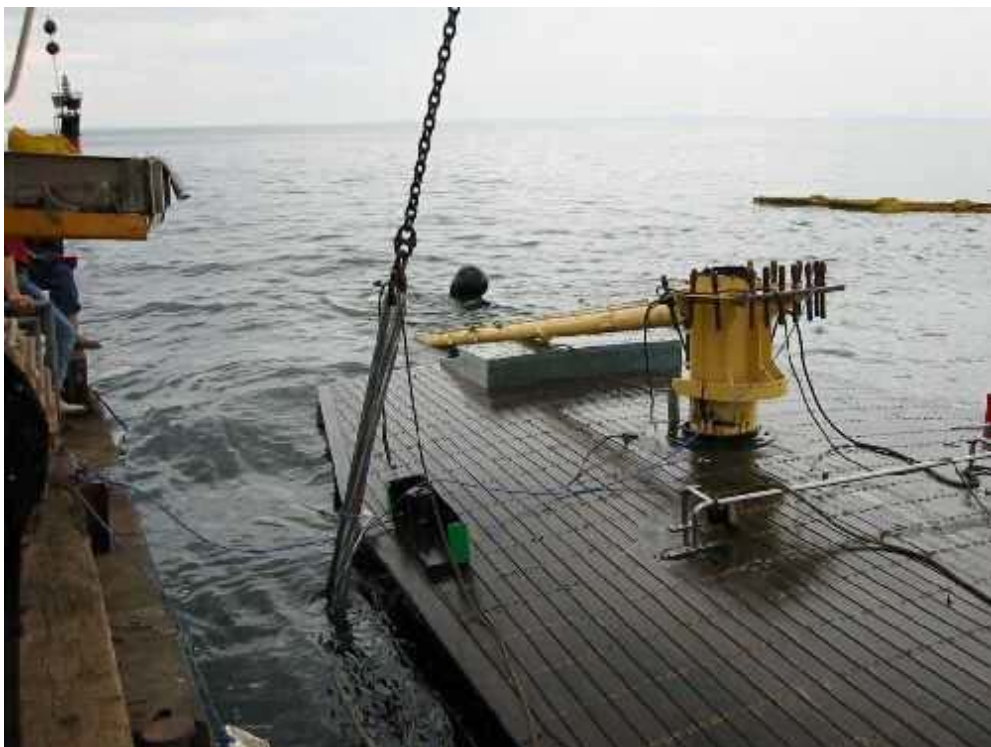
Photo 17, Salvage

Before raising the GOTLAND, main mast and schooner mast were welded off under water. (see Photo 17). Both masts were disposed of. At the survey by the BSU on 4 March 2003, only the mast stump of the main mast, present in the superstructure, and parts of the schooner mast could be found.
