**Summary  
Investigation Report**

**63/03**

**Collision**

**Passenger Vessel SPIEKEROOG II  
with  
the Gandersum Flood Barrage**

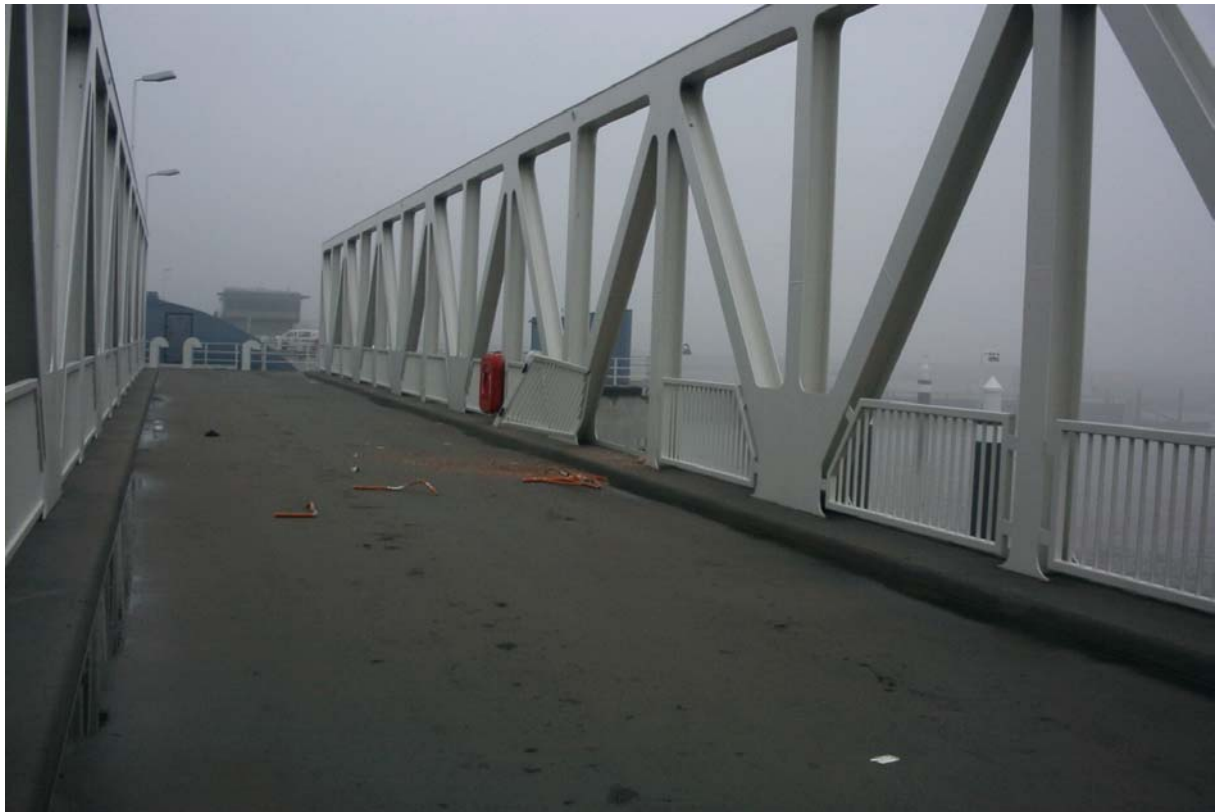
Among other things the railing of the flood barrage, the lower part of its bridge over the inland navigation opening and the movable element of the channel were damaged.

**Figure 6: Damage at the flood barrage**

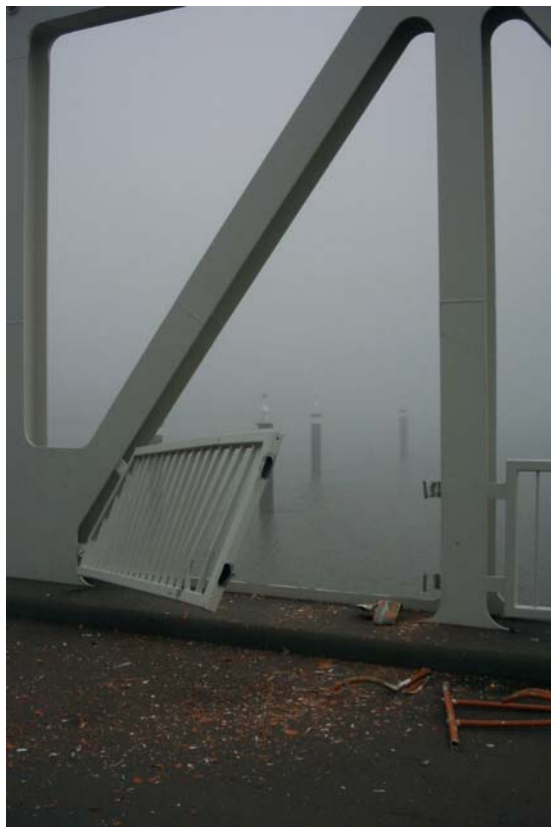
**Figure 7: Detailed damage at the flood barrage**

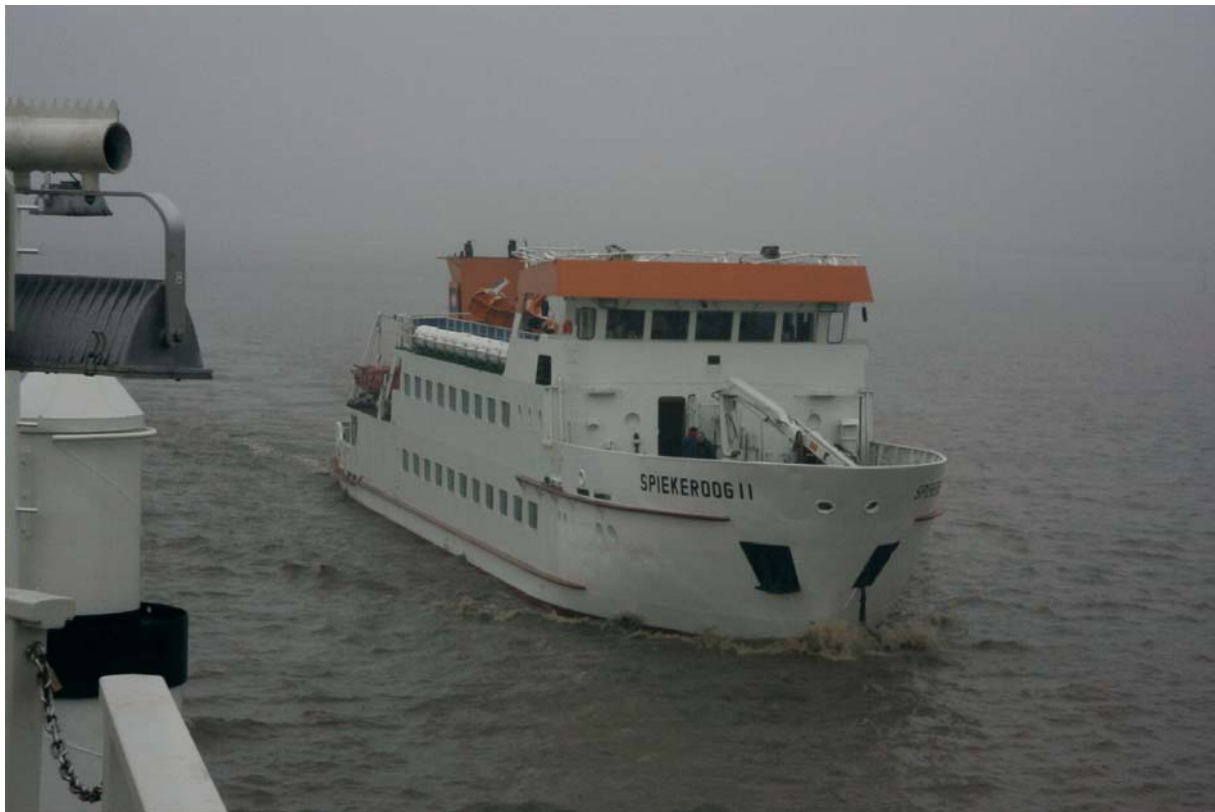
The Passenger Vessel SPIEKEROOG II sustained considerable damages due to the breakdown of the radar mast off the wheelhouse top and its downfall on the upper deck. Thus among other things 6 liferafts, the navigation instruments, benches as well as navigation- and lighting installations were damaged. On the wheelhouse top ruptures and holes arose. Furthermore at the chimney some pipes were bended.

**Figure 8: Damage at the Vessel - front view**

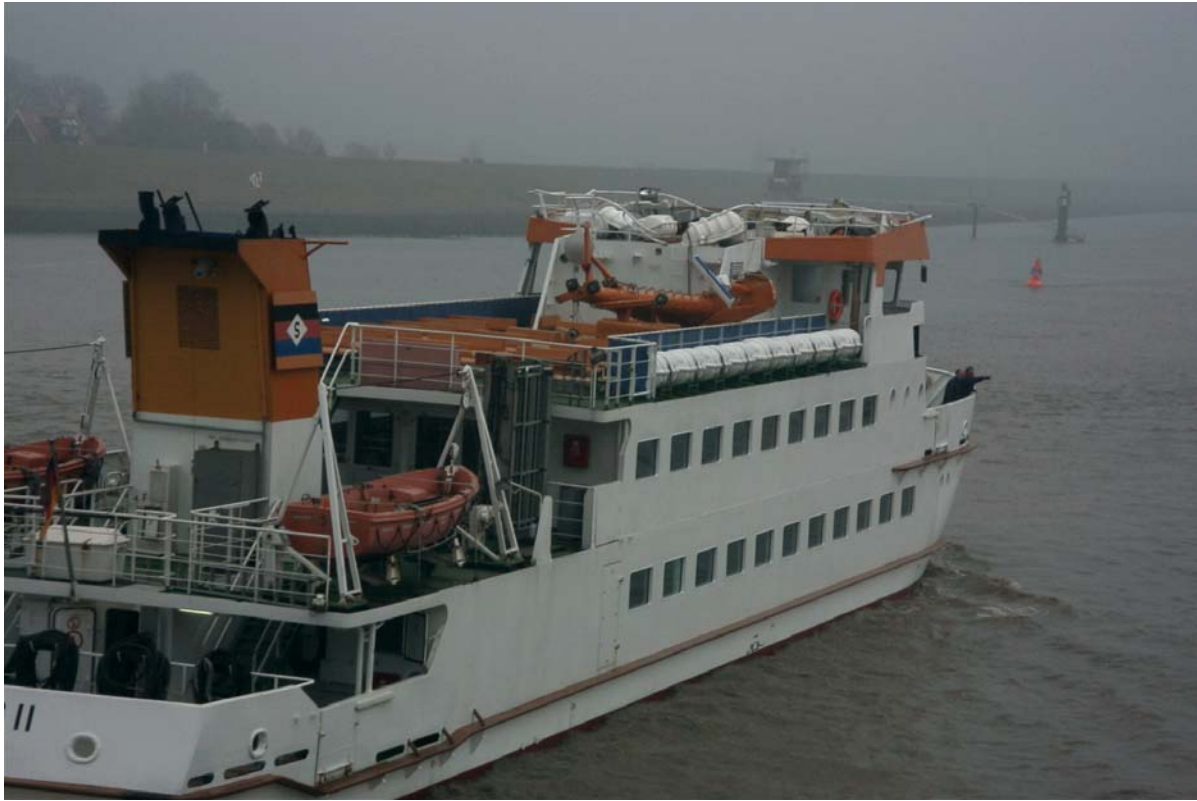
**Figure 9: Damage of the vessel - aft view**

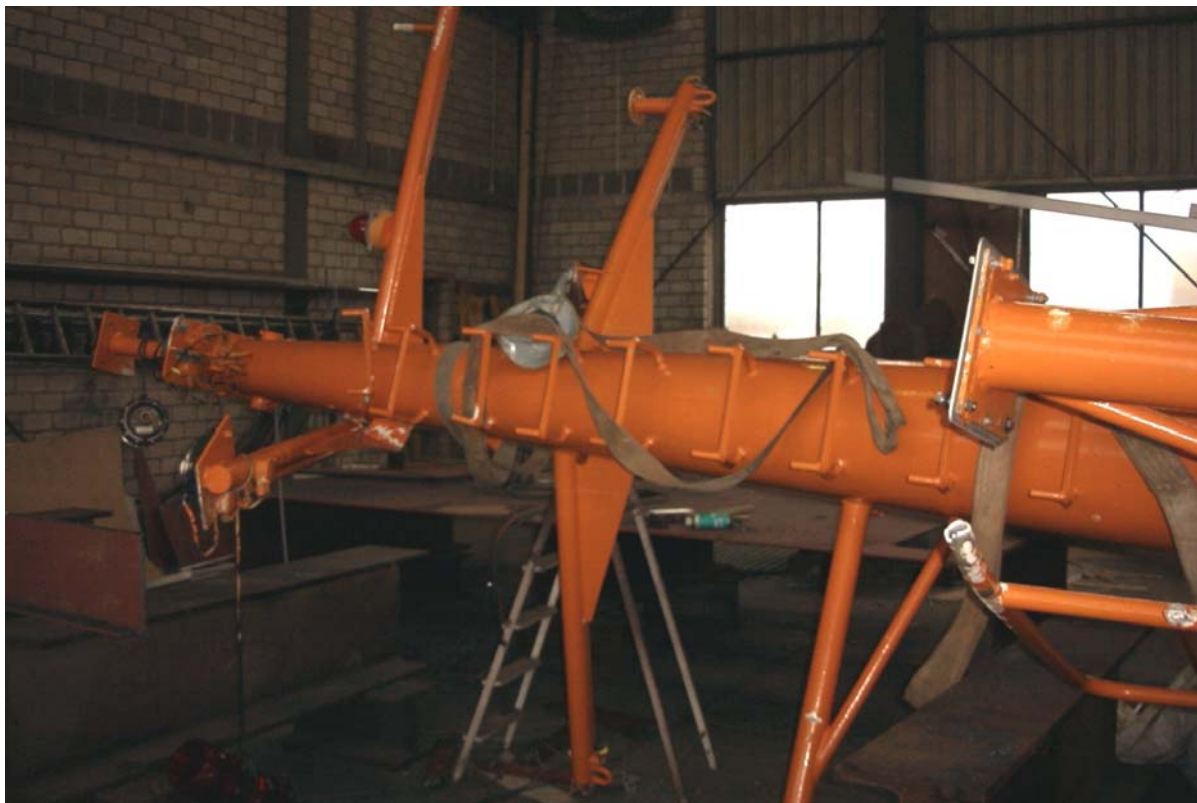
**Figure 10: Damage to the radar mast**
