Investigation Report
75/02

Very serious marine casualty

Sinking of MY TAUCHER

on 7 September 2002
in the Bay of Mecklenburg

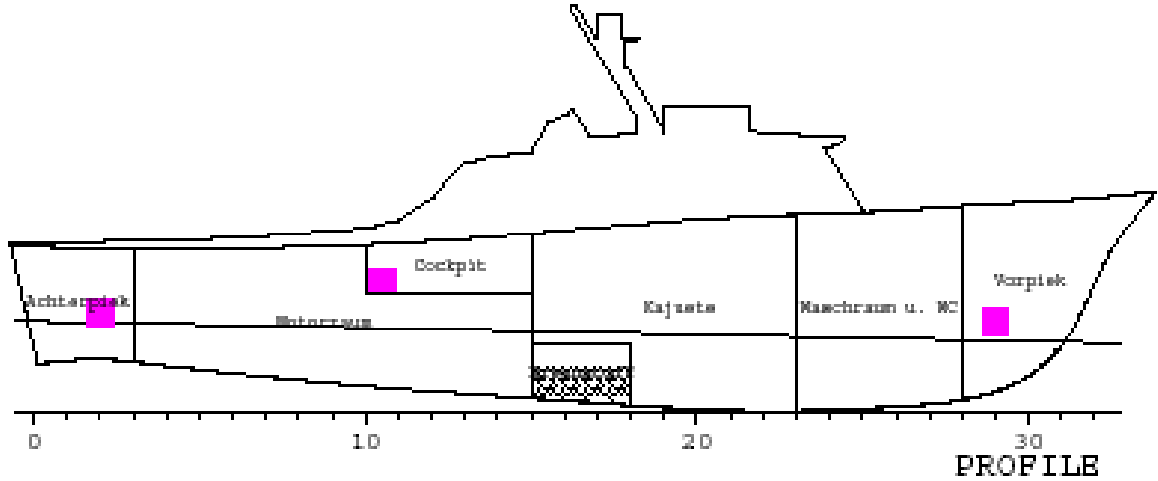
1.2 Cond. C20, Leeres Schiff n. Archiv-Photo

It was assumed that the fuel tank was 50% full. This results in a vessel weight with standard equipment without fuel of 8.5 t (Annex Load Case C20).

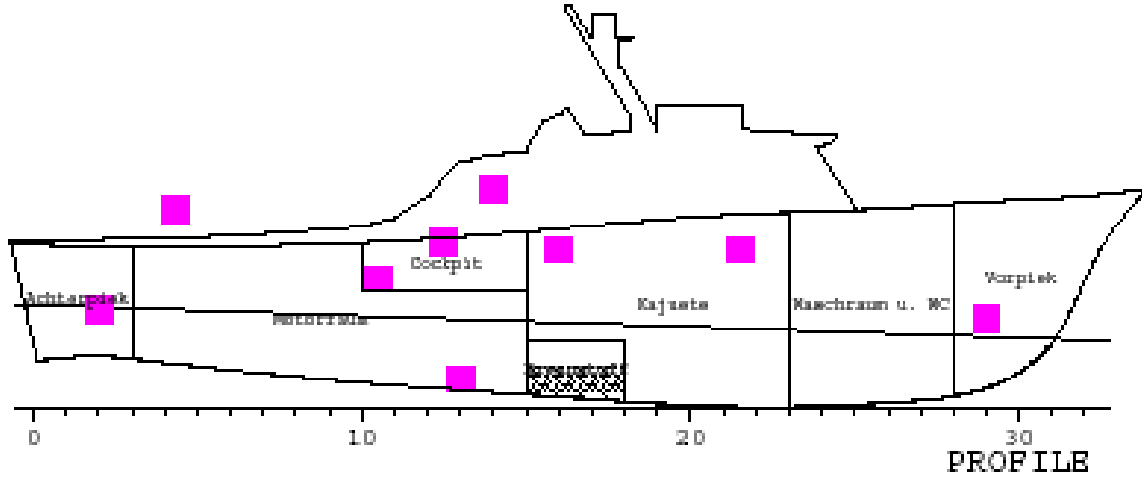
1.4 Cond. C22, 12 Pers. an Bord, LSW n. Photo, Ankerkraft 0.25t

25 m comes to 800 kg. Assuming slow speed at 30% power, this results in a vertical force of 250 kg that leads to a heeling angle of 5.2°. (Annex Load Case C22).

The engine room exhaust air apertures are then still 230 mm over a smooth water surface. The freeboard to the cockpit is then approx. 560 mm.
