Bundesstelle für Seeunfalluntersuchung
Federal Bureau of Maritime Casualty Investigation
Bundesoberbehörde im Geschäftsbereich des Bundesministeriums
für Verkehr, Bau- und Wohnungswesen

Investigation Report 5/04

Marine Casualty

**Carbon monoxide exposure
of two crew members
on MT SEATURBOT
on 3 January 2004
in Milford Haven (UK)**

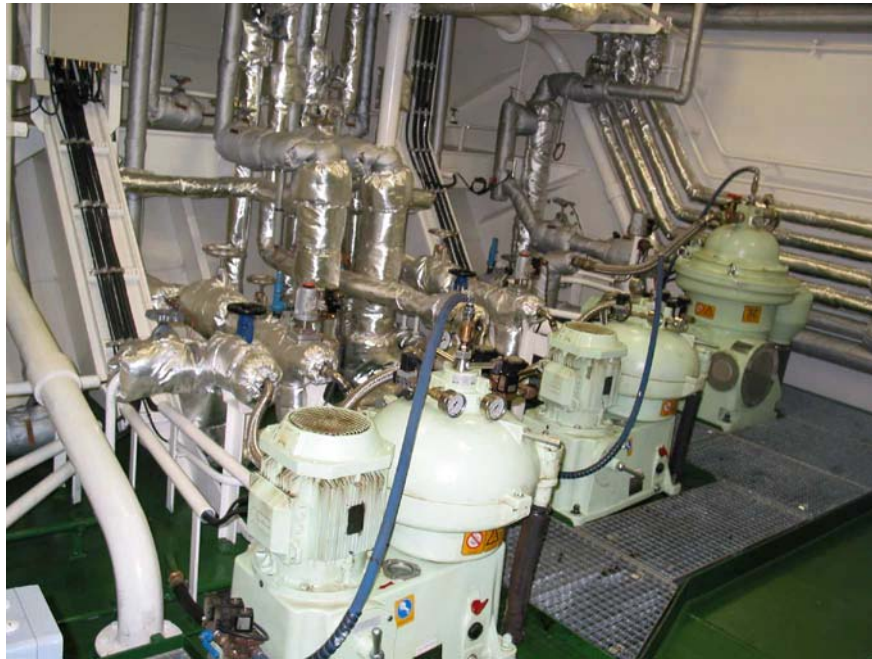
Figure 5: Separator room

At the time of the accident the lubricating oil separator was being serviced. The lubricating oil separator is close to a lockable waste air duct. Instead of closing the supply air duct so as not to work in the supply air current, the engine room ventilator was switched off. Thus the engine room and separator room could no longer be ventilated sufficiently. The performance of the engine room ventilator might possibly have sufficed to reduce the air contaminated with CO to a contamination level that is not dangerous for humans.

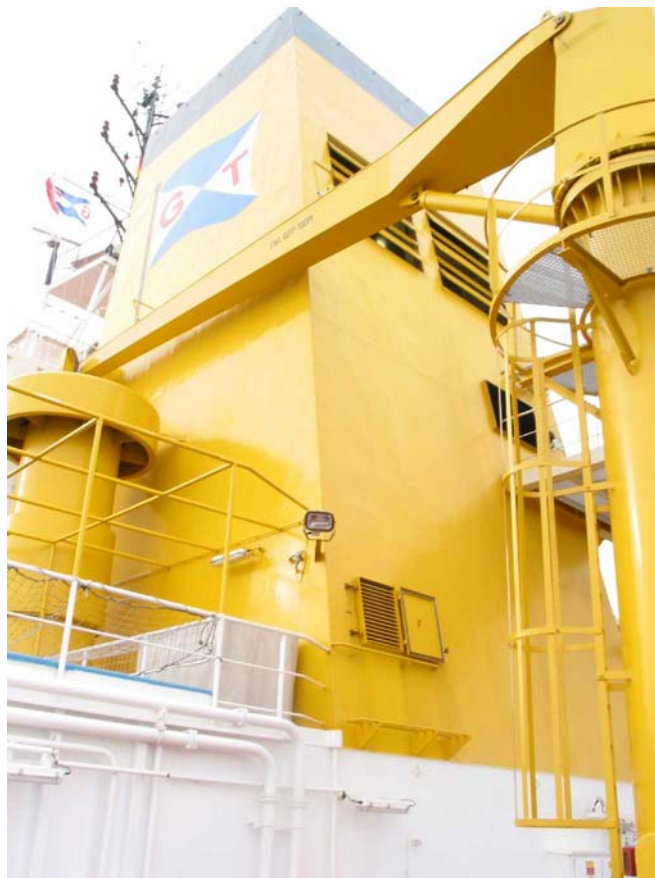
Figure 8: Aft edge of funnel

Inspectors of Messrs. ChevTex and P&I-Club conducted further measurements on the vessel using a portable measuring device for CO and H₂S (hydrogen sulphide). No leak was found in the inert gas lines. Elevated CO concentrations of 125 ppm were measured at the aft edge of the funnel where the outlet to the atmosphere of the inert gas system is located. It was suspected that the gas was carried via the engine room ventilator and the ventilator in the separator room (see Fig. 7). The outlet valve of the inert gas system opened frequently since the discharge rate was low, although the inert gas system was working with a minimum of gas produced. The gas that emerged had an elevated CO component. The Master notified all crew members during a safety meeting and gave special instructions to the officers concerning the conditions that led to the accident, including wind conditions, discharge rate, positions of the ventilator dampers (see Fig. 8).

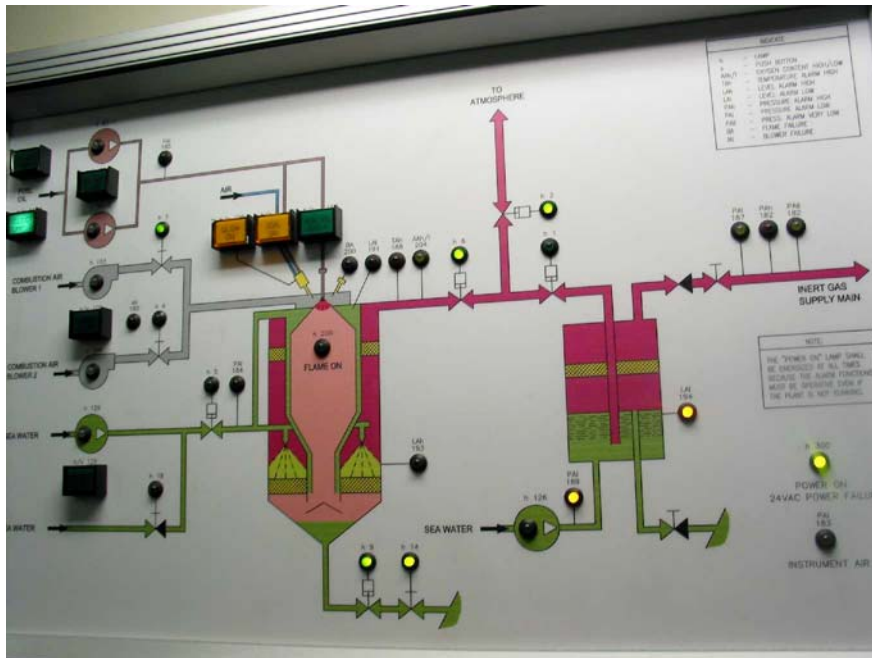
Figure 10: Switch consol inert gas system

According to the special GL regulations for tankers, the spaces to be rendered inert must be equipped with facilities for pressure monitoring and connections for monitoring the tank atmosphere as well as with appropriate excess pressure/underpressure safeguards. Appropriate measuring devices for measuring oxygen and hydrocarbon gases and vapours are to be provided. The faulty combustion with the elevated CO components (the leak in the cooling line in the combustion chamber of the inert gas system) was not identified with this equipment (see Figs. 10 and 11).

As additional measures a plate was to be mounted at the switch consol of the inert gas system (see Fig. 10) indicating that operation of the inert gas system was only allowed when at least one engine room ventilator was running on "delivery", and a switch condition was to be realised that did not allow any other form of operation.

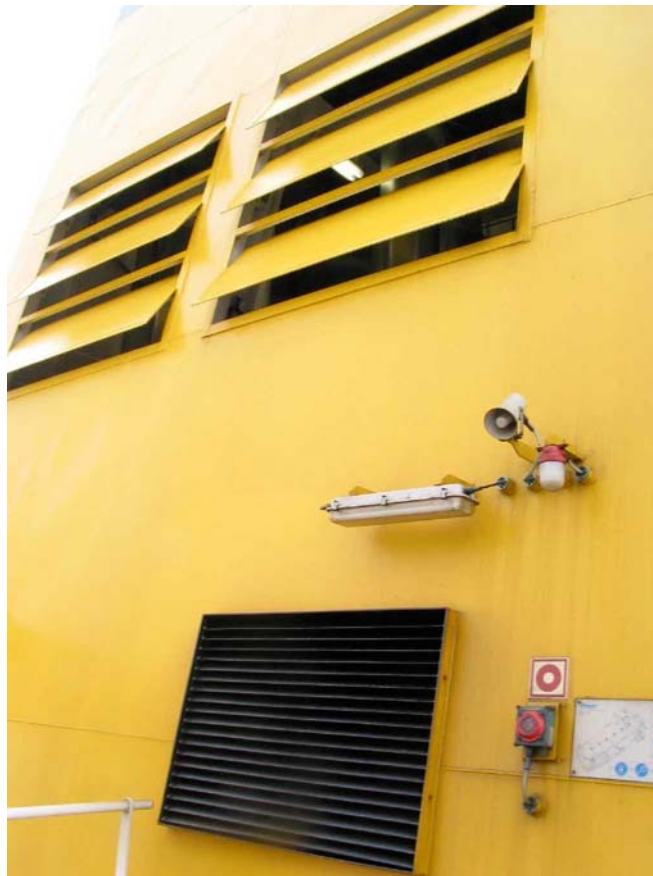
Figure 12: I.G. outlet and louver

After inspection and repair of the inert gas system of MT SEATURBOT, the vessel's command had ascertained that the cause of the elevated CO content in the atmosphere and in the engine room had been water in the combustion chamber of the inert gas system. The water led to incomplete combustion and an increase in the CO content in the inert gas at a constant O₂-content of 3 % (see Fig. 11). The switching off of the engine room ventilator at the time of the accident meant that the auxiliary engines in port operation drew in exterior air via the louvers at the aft edge of the funnel (see Fig. 12) that was mixed with an elevated CO component.

The engine room ventilators are located on the port and starboard sides of the funnel (see Fig. 14). The outlet to the atmosphere of the inert gas system is below the louvers (see Fig. 12). The air inlet for the air conditioner in the accommodations is on the port side superstructures (see Fig. 15). The after edge of the superstructures in the midship area accommodate the ventilator dampers for the galley (see Fig. 16), laundry and sanitation facilities. At the top edge of the funnel (see Fig. 17) are the outlets to the atmosphere for the main engine, the auxiliary diesel engines and the boiler system. The inert gas line (see Fig. 18 and 15) leads along the port side superstructures below the supply air for the air conditioning system to the tanks forward.

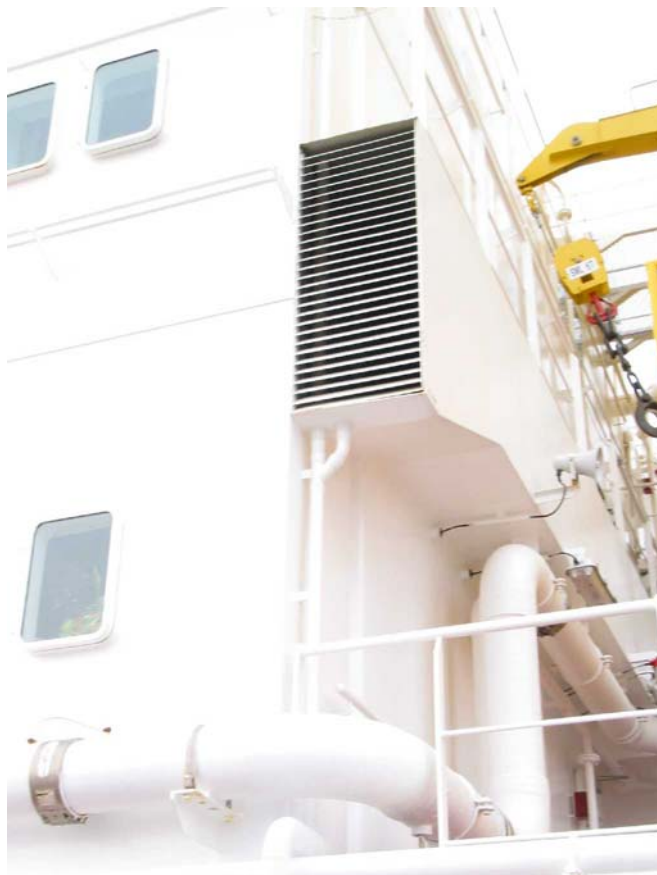
Figure 15: Air inlet air conditioner, provisions room with I.G. line running beneath

It was not possible to clarify how the CO values of 300 ppm measured in the area of the provisions and cold stores and the galley occurred. The frozen food store and vegetable

room are not connected to the air conditioning system. The provisions store is connected to the air conditioning system that is supplied with air from the port side at the aft edge of the superstructures (see Fig. 15). The galley is supplied via ventilator dampers at the aft edge of the superstructures (see Fig. 16). During the survey on board SEALING by the BSU no CO components were measured in the spaces under the most unfavourable conditions (both engine room ventilators set to "suction") with the inert gas system running. The CO component emitted was 60 ppm directly next to the outlet to the atmosphere. The max. value given by the manufacturer lies at 100 ppm.

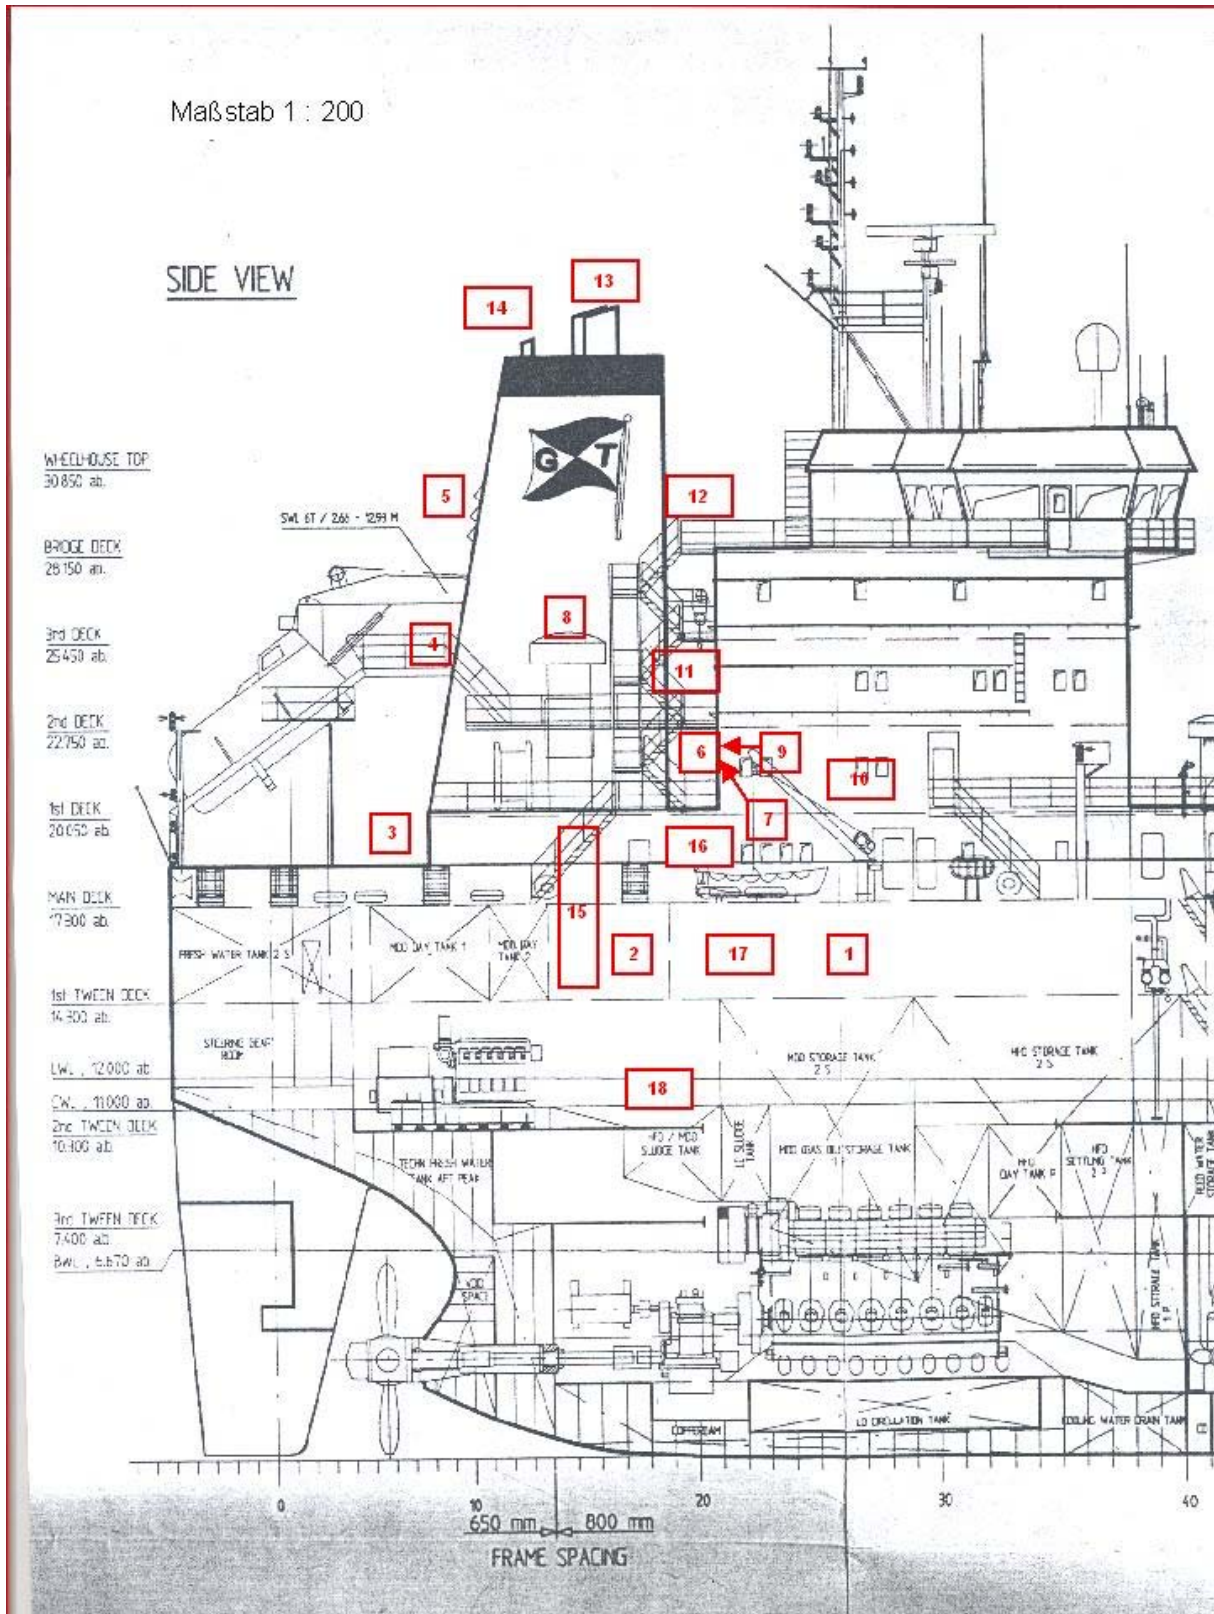
Figure 19: Side section superstructure

Fig. 19 shows a side view through the air inlet and outlets in the way of the superstructures on MT SEATURBOT and the three sister vessels of the same design, as well as the position of the engine control room, the inert gas system, the provisions and cold stores, the galley and the separator room. The ventilation systems of the engine room, accommodations and galley are separated from each other.
