Bundesstelle für Seeunfalluntersuchung
Federal Bureau of Maritime Casualty Investigation
Bundesoberbehörde im Geschäftsbereich des Bundesministeriums
für Verkehr, Bau- und Wohnungswesen

Investigation Report 122/04

Very serious marine casualty

**Loss over board of the skipper
of SY RENI
on 31 May 2004
in the Bay of Mecklenburg
southeast of Fehmarn**

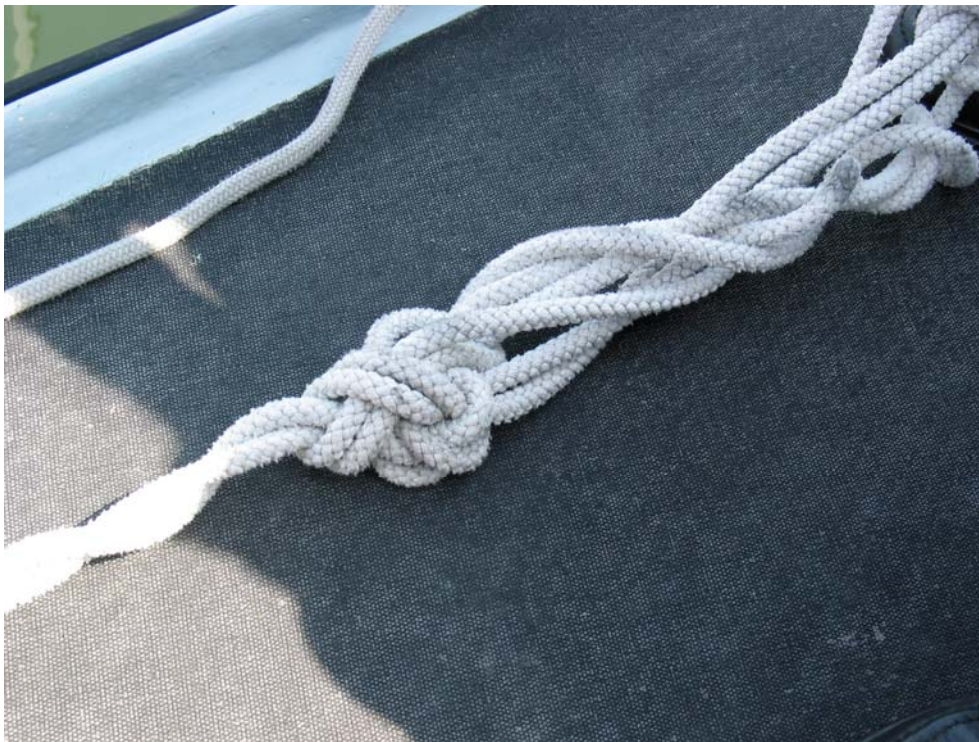
Figure 3: Entangled foresail sheet

The jib was rolled up. The hauling out line of the jib was partly on the drum of the roller jib system and partly loose on deck.

The port sheet was entangled round the starboard sheet and the entire sheet was very stiff and tangled. These sheets were not secured in the sheet block.

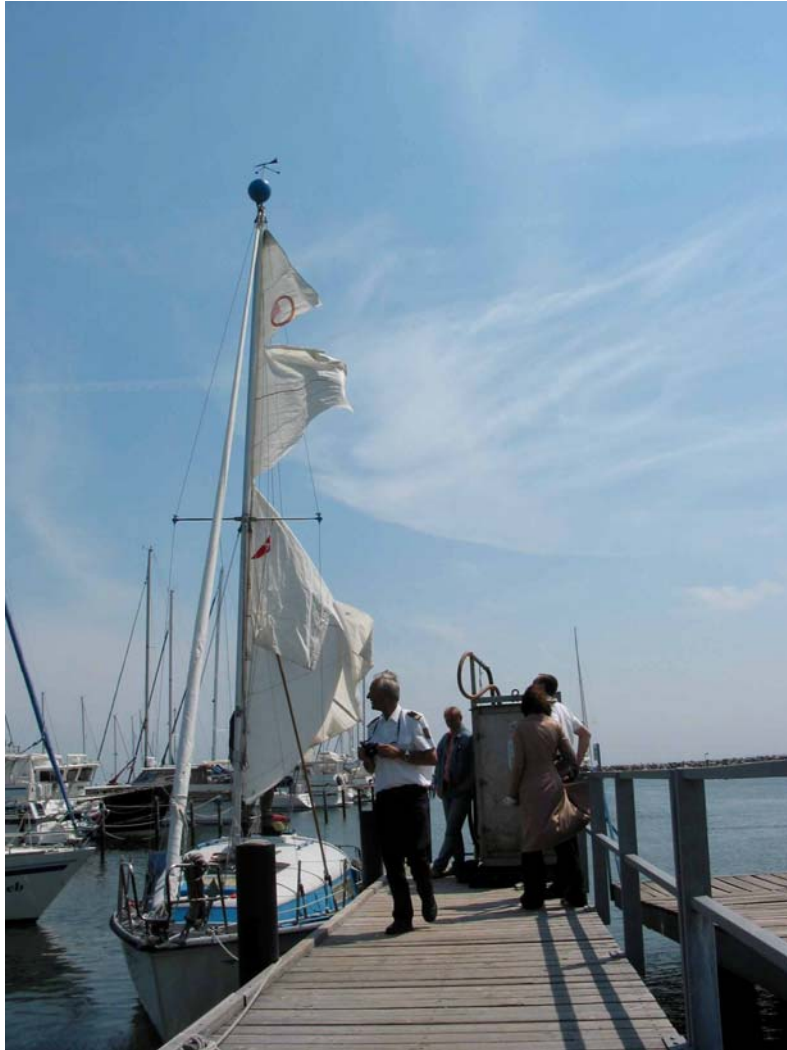
Figure 4: Torn mainsail

The mainsail had been torn out of the bolt rope, the slide travellers were hanging next to it and the sail was torn or ripped in several places. Only the rope end reinforcing the fore leech/luff was still present over the whole length. There were residues of the mainsail on the aft port lower shroud and on the flag line on the port side. The main sheet was wound up and the sheet block was fixed midships on the traveller. The curry clamp of the main sheet was defective.

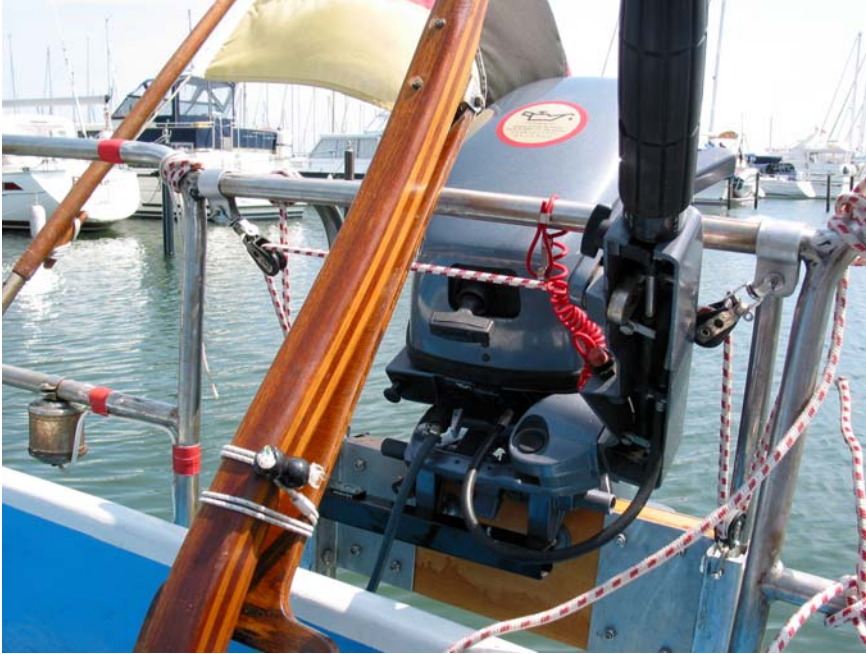
Figure 5: Engine in raised position

The vessel had a Yamaha outboard engine with 8 HP/5.9 kW, 4-stroke, short shaft, secured on a running rail with two clove hitches, that could be lowered at the rear. The engine, year built 2000, Model 2001, had been on board for two years and exchanged as substitute for a built-in engine. A 25 l tank for the outboard engine, 3/4 full, was stowed under the cockpit and the outboard engine could be started simply with a normal hand starter cable.

After pulling a choke and pre-pumping the fuel appropriately, the outboard engine started immediately at the second pull and ran without any problems. After this the engine was lowered into the water without much strength being expended.

No "person-over-board" manoeuvre was practiced on SY RENI. The operable outboard motor was not used in the "person-over-board" manoeuvres.

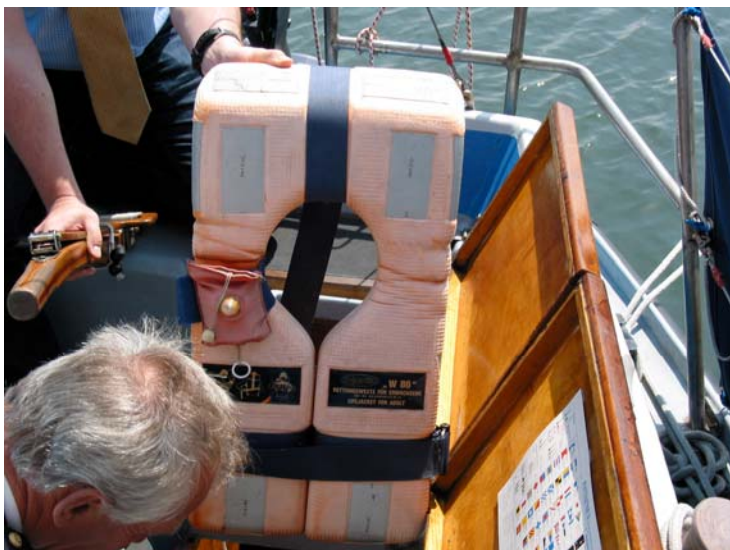
Figure 6: Solid lifejacket

Two relatively new solid lifejackets of type Seepilz D 86 with functioning emergency lamp were stowed below deck on the port side beneath the bunk. One relatively old jacket of the same type was in the stowage chest outside in the cockpit on the port side.

The solid lifejacket/life collar lying in the storage chest in the cockpit was not thrown to the man swimming in the water. Floating rescue bodies should be thrown immediately to persons drifting in the water. In addition to functioning as a swimming aid for the person involved in the accident, this measure would have had an additional positive psychological effect and could have facilitated the search.

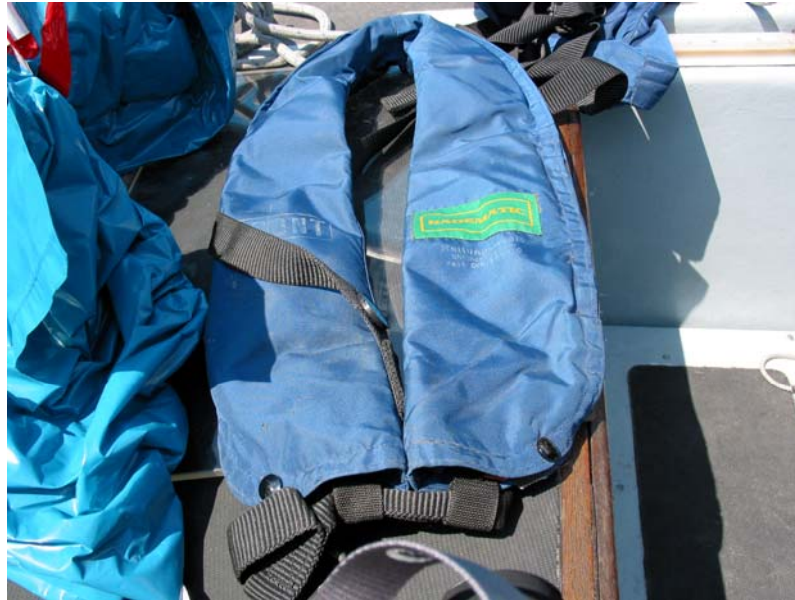
Figure 7: Automatic jacket

Aft, beneath the starboard bunk, three automatic jackets of type Kadematic, last tested 1993, were discovered. These jackets looked as new, and despite the fact that the inspection date had expired they still looked fit for use.

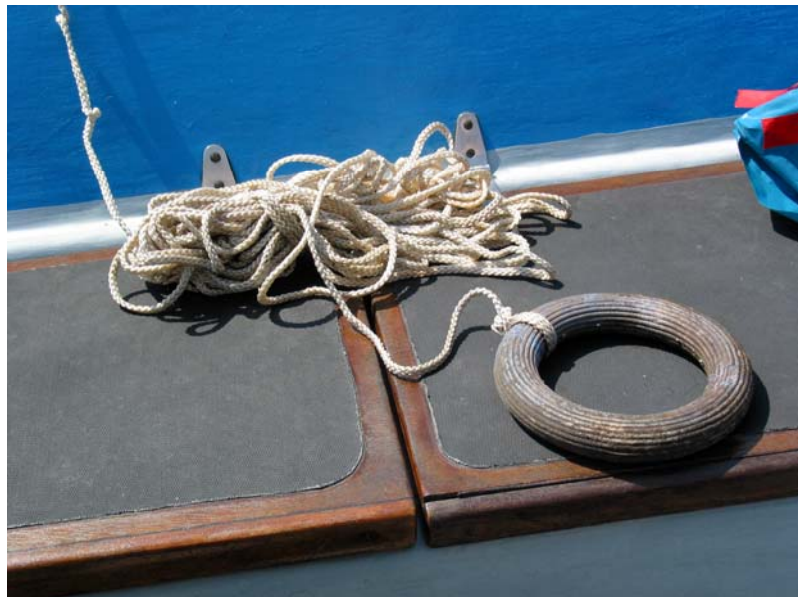
Figure 8: Floating line

There were no lifejackets or rescue loops. A white, twisted floating line 22.5 m long, diameter 8 mm, and a small floating ring with a diameter of approx. 20 cm were lying in the railing bag by the cockpit on the port side.

The 22.5 m long floating line with floating ring on board was not used as a rescue line during the manoeuvres.

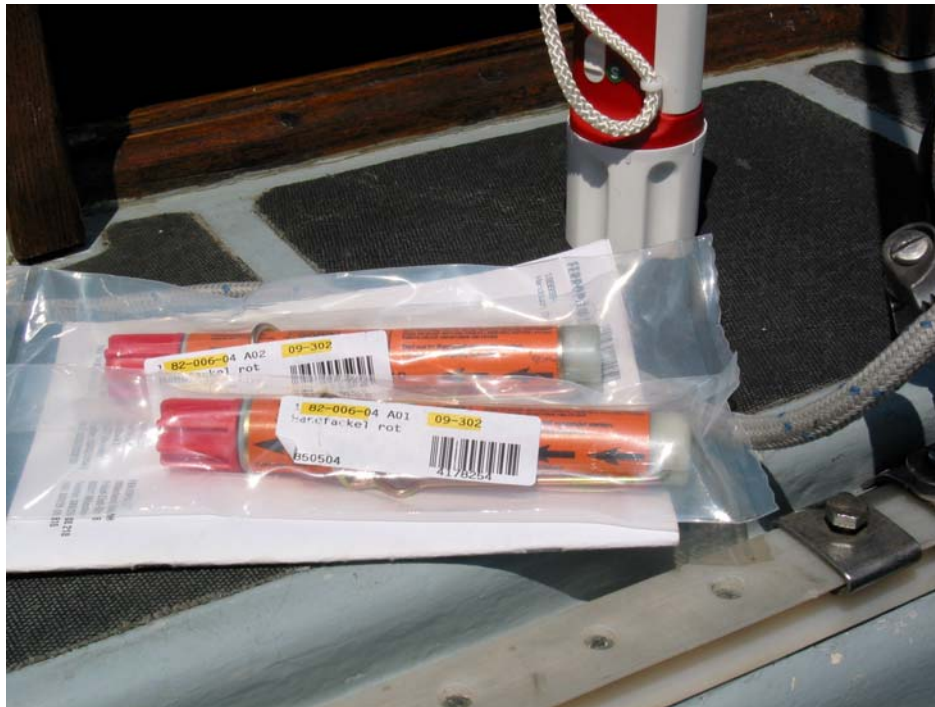
Figure 9: Emergency signals

There were no safety belts and lines on board. Water-tight packed pyrotechnical emergency signals from the firm Nico-Signal, altogether six red shots, secured with a shooting device, and two red hand-torches from the firm Komet, expiry date 2006, were stowed forward on the port side. Mrs. A stated that although she had talked to her husband about purchasing the emergency signals, ultimately she had not been clear whether this had in fact happened.

It would have been desirable for an operable radio set or even an EPIRB to have been on board and if the emergency rockets on board had been fired in order to alert the rescue forces.
