Summary Investigation Report

156/03

**Collision between CMV IVORY STAR I and the
Salvage Pontoons EUROPA and NUMAX on 1 June 2003**

15 April 2004

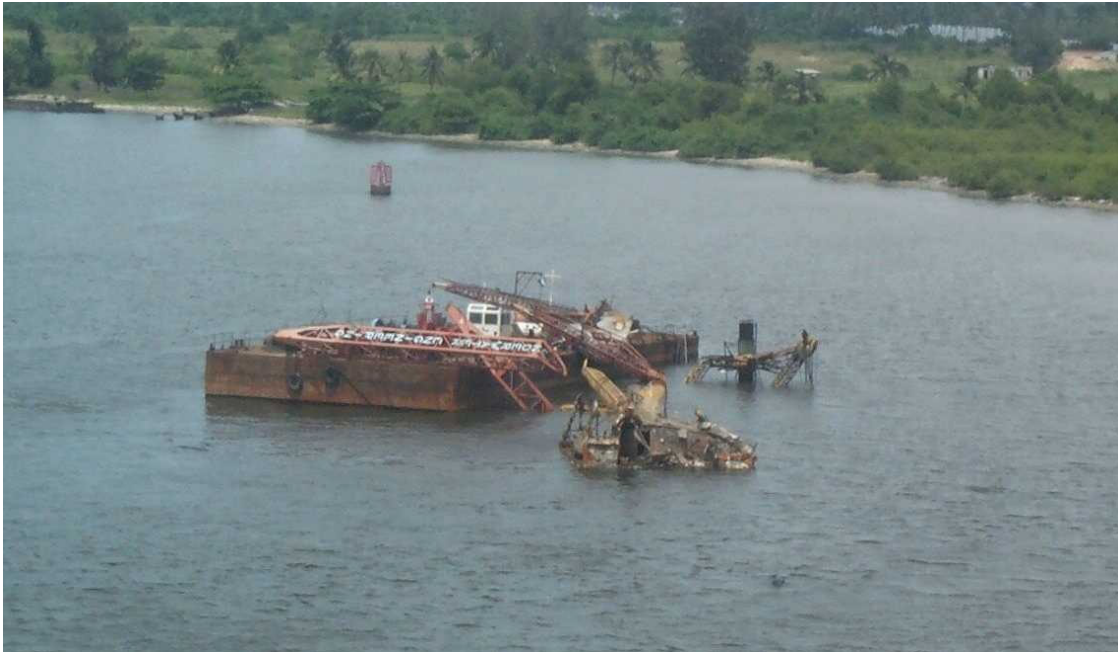
CMV IVORY STAR I was damaged in the forecastle area as a result of the collision. However, the vessel was able to continue its voyage up to the anchorage in Commodore Channel under its own power. The crane on Barge NUMAX broke off as a result of the accident. In the course of the night the Barge EUROPA sank due to a leak in the shell plating.

Unfortunately it was not possible to obtain any technical particulars of the two Barges NUMAX and EUROPA, with which a Nigerian firm was carrying out wreck salvage work at the time of the accident. The photo below shows the Barge NUMAX with parts of the destroyed crane. Remains of the Barge EUROPA can be seen protruding from the water in the foreground.

The barge EUROPA sank in the night of 2nd June 2003 due to a crack in the outer plating. The lifting device on the barge NUMAX was destroyed as a consequence of the sudden, one-sided pull load of the crane.

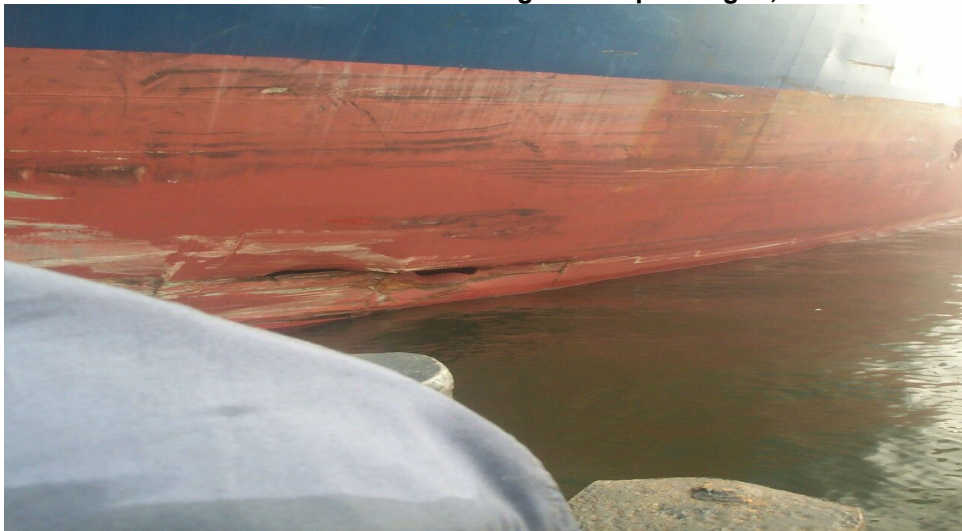
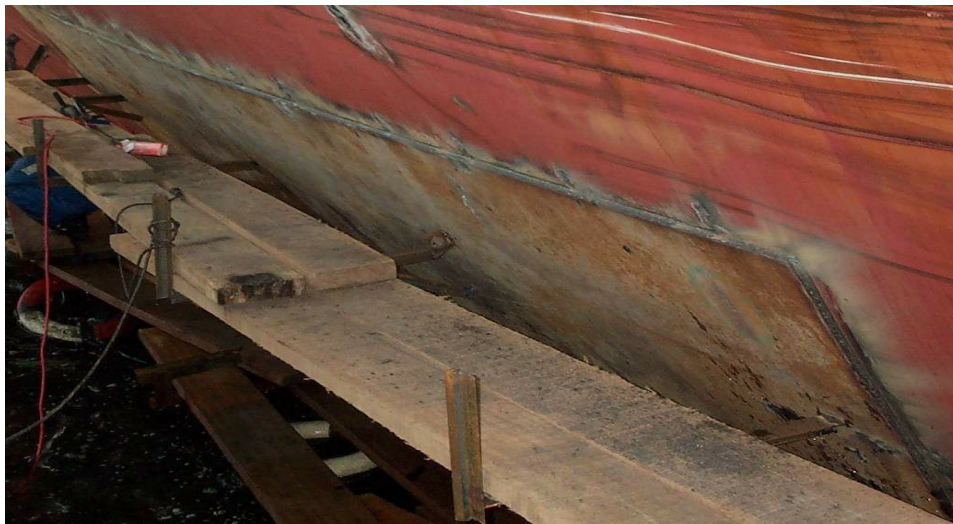
M/V IVORY STAR I / Collision damage and repair Lagos, 02.06.2003

Shortly after that the port side of the bow had collided with the floating crane.

The damage to the hull of CMV IVORY STAR I is partly visible at the bottom on the photos. The bulwark on the port side of the forecastle was ripped over a length of 1.80 m. About 6 m above the keel line a crack 5 m long and 0.3 m wide occurred in the underwater part of the hull, stretching aft from frame 91.
