Bundesstelle für Seeunfalluntersuchung
Federal Bureau of Maritime Casualty Investigation
Bundesoberbehörde im Geschäftsbereich des Bundesministeriums
für Verkehr, Bau- and Wohnungswesen

Investigation Report 213/02

Collision

CMV P&O NEDLLOYD GENOA
and
MT EBRO

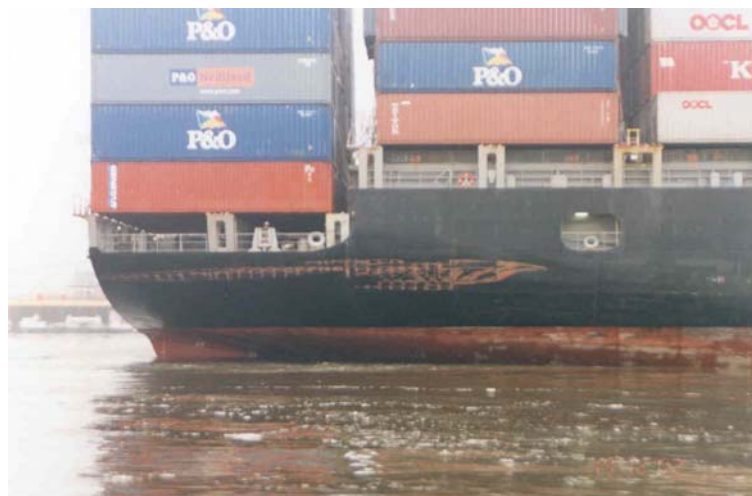
Figure 5: Damage to CMV P&O NEDLLOYD GENOA, starboard side, aft ship 1

Shortly after 09.34 h CET there had been a sliding contact in the area of the starboard superstructures of CMV P&O NEDLLOYD GENOA with the starboard stem of TM EBRO. At this time the engine had been stopped, the rudder had been left "hard to starboard", and the display of the echo sounder had moved in the direction of zero. The speed had been reduced from 6 kn to zero. The vessel appeared to have stranded at the position 53° 47.5'N 009° 23.3'E. A bearing had been taken on buoy 80 at 142° with a distance of 0.2 sm.

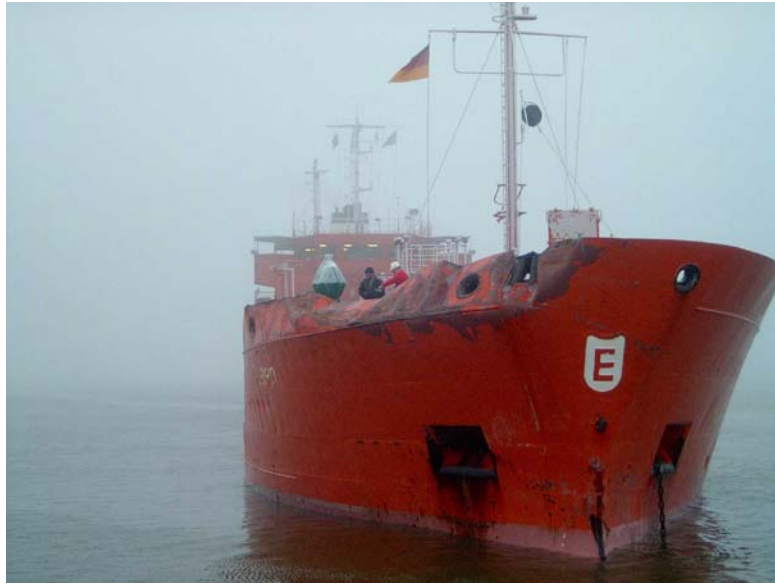
Figure 7: Damage to MT EBRO, foreship

On MT EBRO the starboard bulwark was set in over a length of 10 to 12 m. Furthermore, two frames in the foreship area were cracked / torn. The vessel continued its voyage down the River Elbe up to Brunsbüttel South Roads.
