Bundesstelle für Seeunfalluntersuchung
Federal Bureau of Maritime Casualty Investigation
Bundesoberbehörde im Geschäftsbereich des Bundesministeriums
für Verkehr, Bau- und Wohnungswesen

Investigation Report 226/03

Very serious marine casualty

Foundering of FC NEPTUN
on 30 July 2003
in the harbour entrance of Norddeich

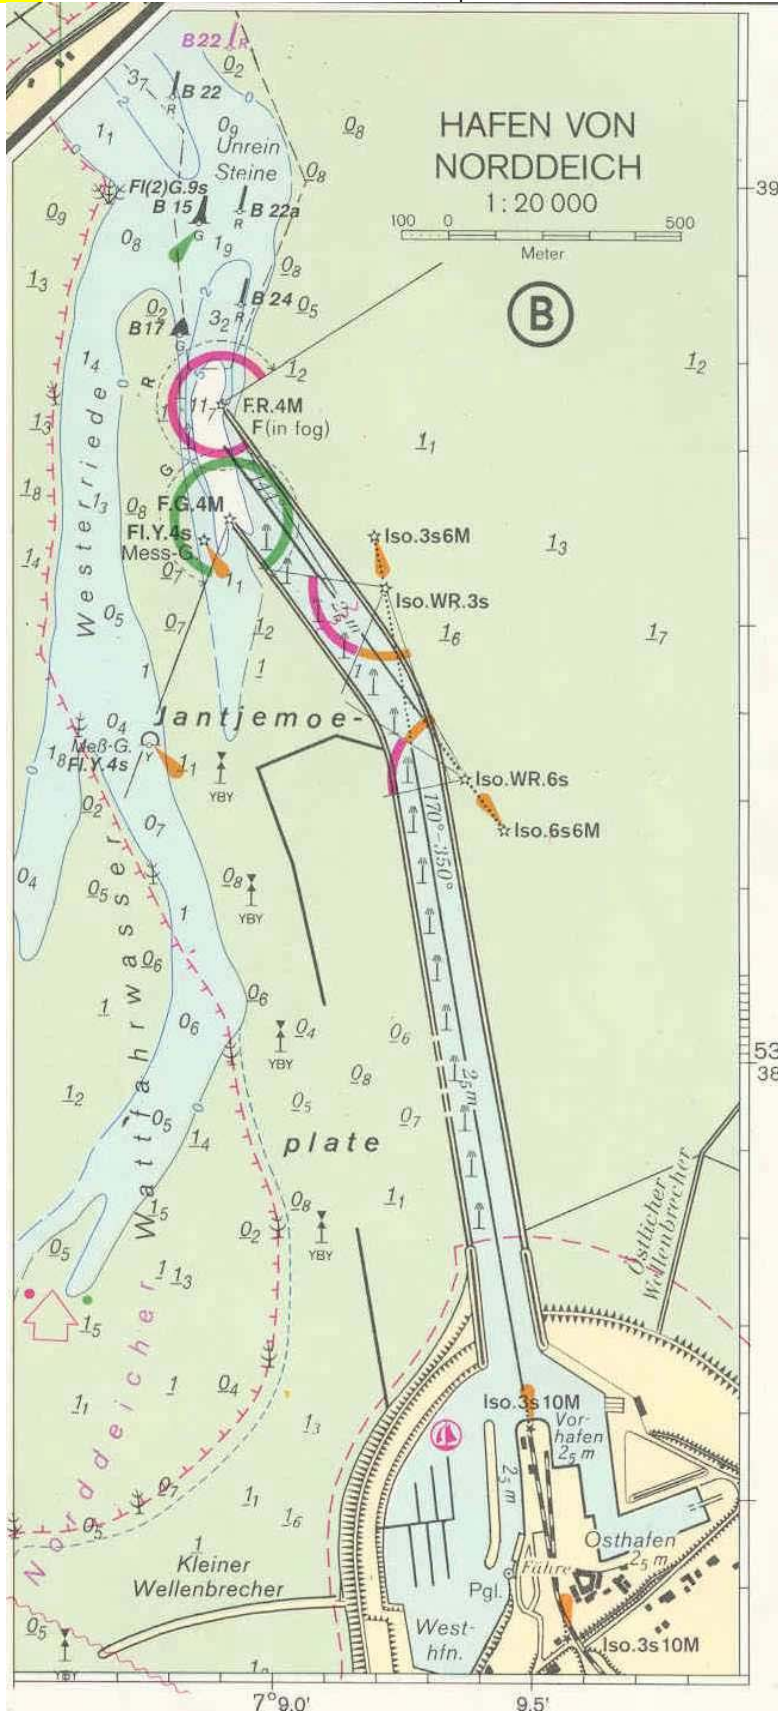
Scene of the accident

Excerpt from leisure craft sea chart 3012 (BSH)

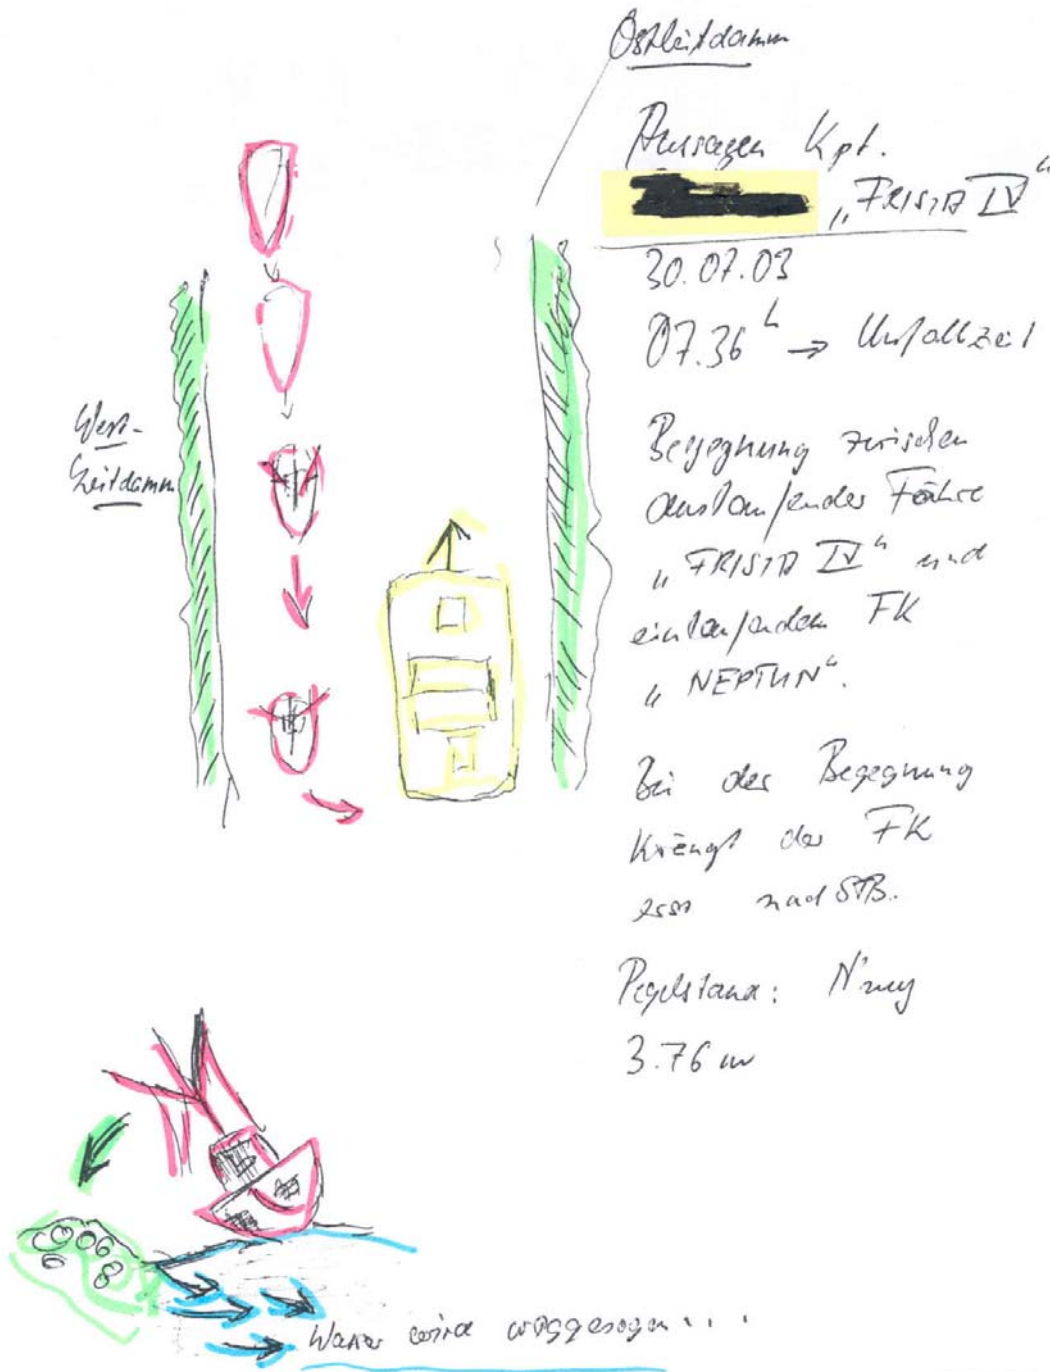
Statement by Captain of FRISIA IV
 30.07.03
 07:36 (l) -> time of accident

Encounter between departing ferry FRISIA IV and incoming FC NEPTUN
 On encounter FC lists to starboard
 Water level Norderney 3.76 m
 Water is sucked away ...

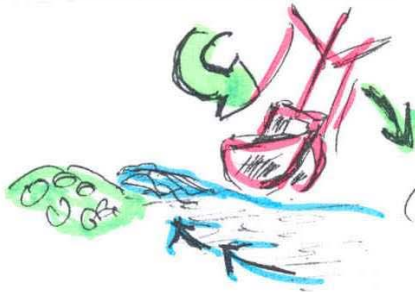
On a level with the stack (aft) the vessel lists in the other direction and the bow veers to port.

After the passage the vessel capsizes to port and sinks. The Captain of the ferry was afraid that the mast of the fishing vessel would collide with the stern of the ferry.

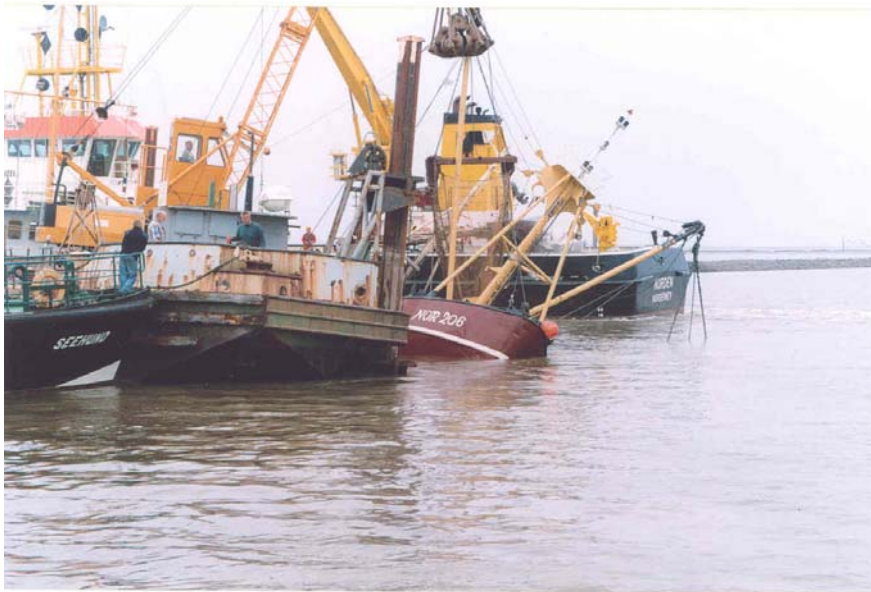
The first salvage attempt was carried out with Barge S28. A working crane on board this barge had grasped the starboard cargo boom with the grab and tried to upright the foundered vessel from its side position. This was unsuccessful, and as the tide came in more water ran into the vessel, which then remained lying completely under water in the middle of the navigation channel.

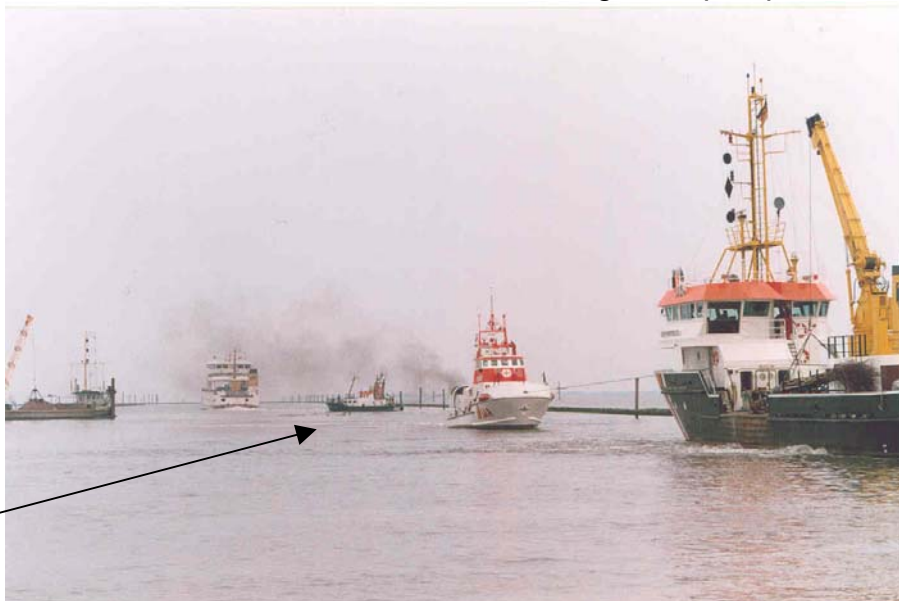
FC
"NEPTUN"

In the second salvage attempt the rescue cruiser BERNHARD GRUBEN and the Buoy Layer NORDEN pulled the foundered cutter approx. 250 m through the mud to the Muschel Pier. After this the cutter was lifted so far out of the water by a shore-based crane that the open apertures through which water flowed were above the water level. The cutter was then freed from mud and water using drain pumps.

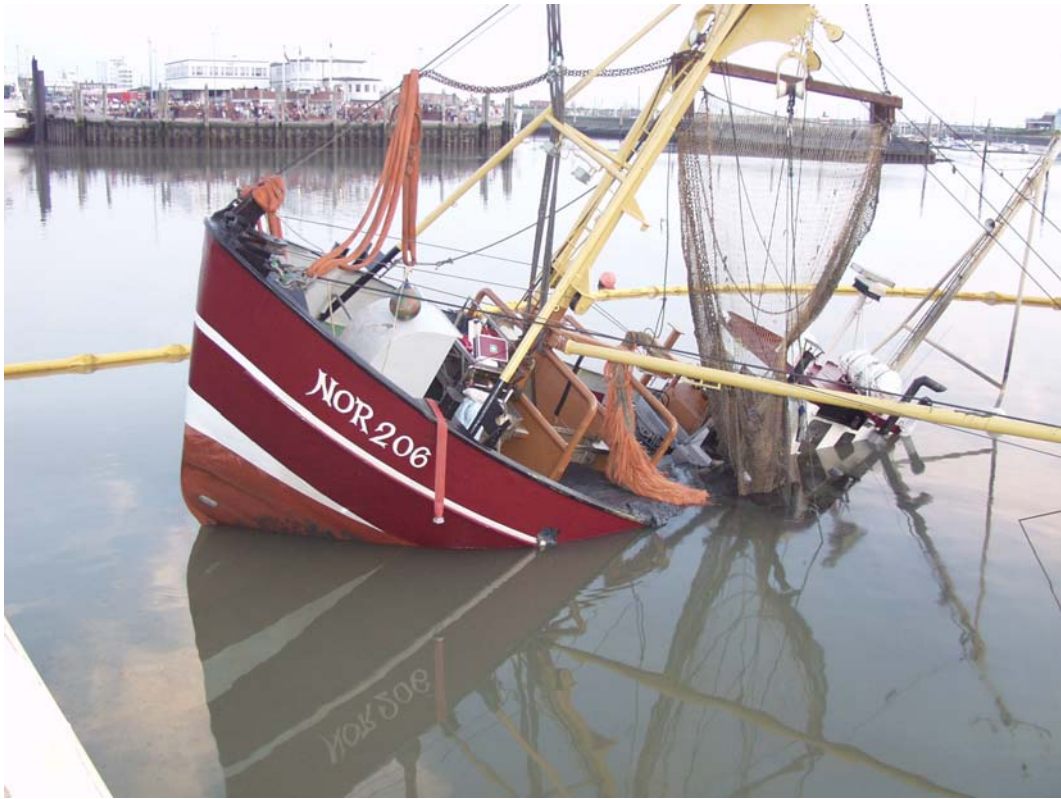
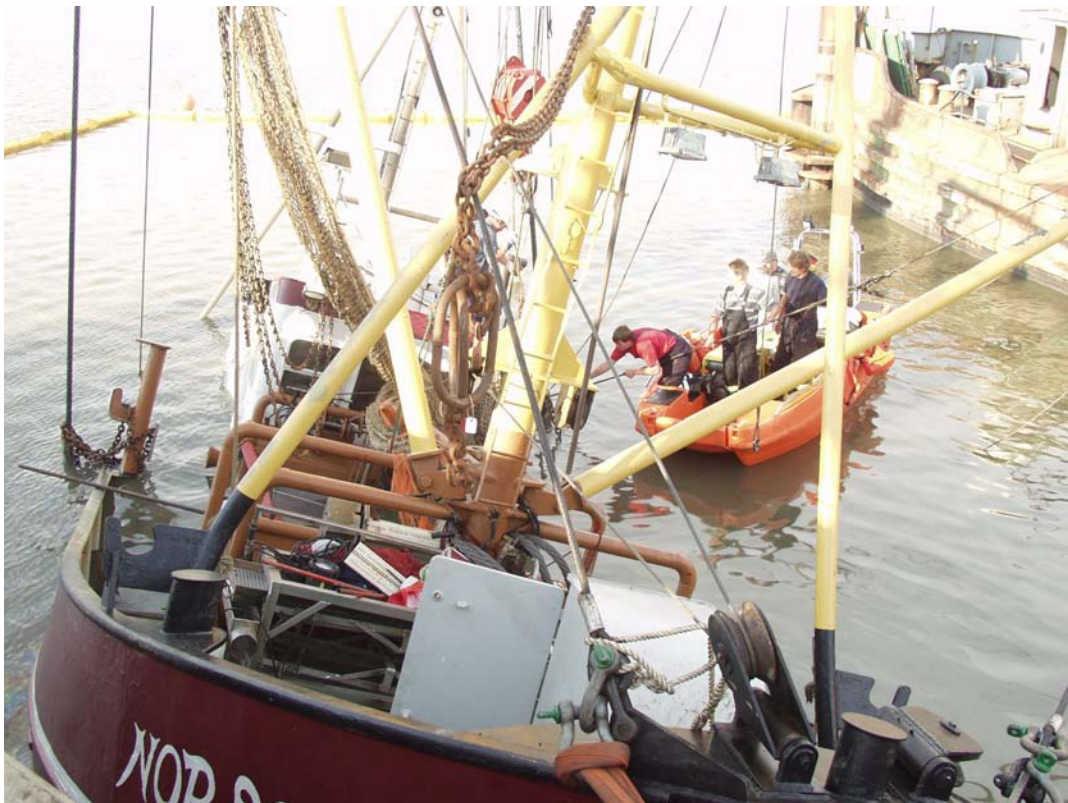
5 Summary of damage/photos of damage

As a result of the unusual pulling of the vessel under water over the mud, it was ultimately possible to salvage the cutter from shore. The BSU was unable to determine whether the damage on board was caused by this kind of salvage operation, or whether it had been sustained already prior to sinking. To secure the evidence it would have been better to salvage the vessel at the point where it sank. The cutter had not blocked the entire navigation channel, so that general shipping would have been able to pass the scene of the accident.

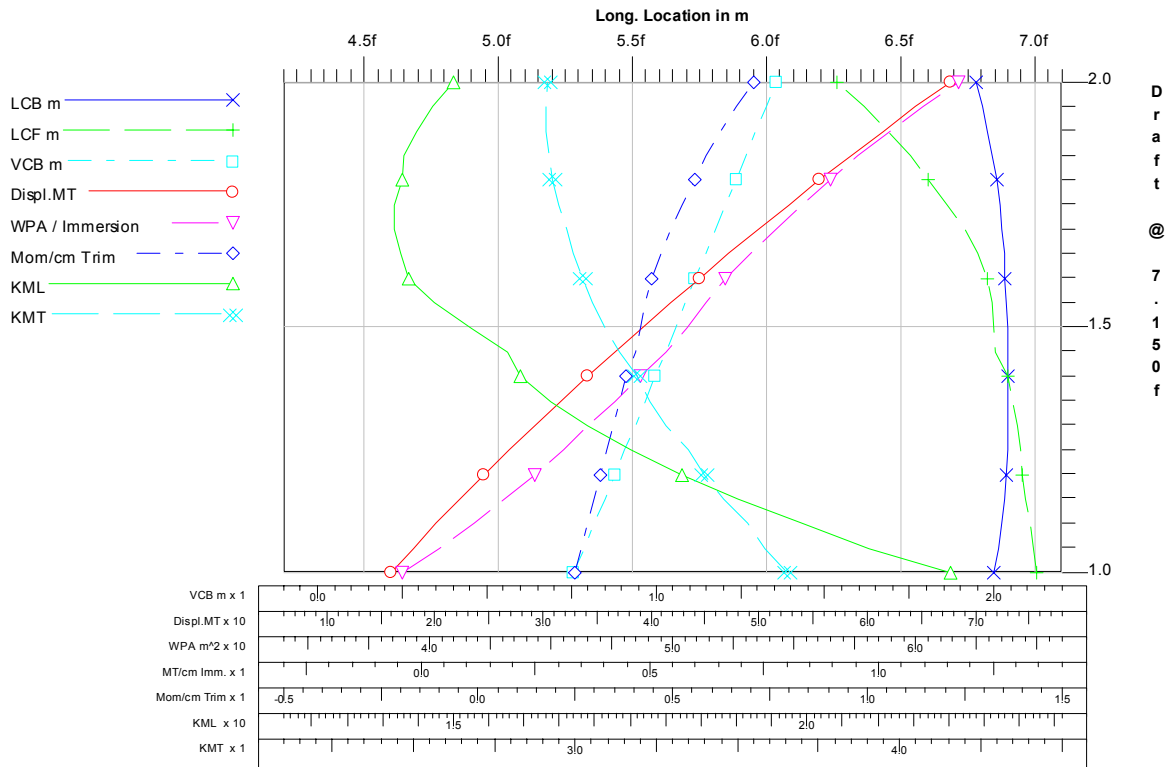
Hydrostatic Properties at zero, Heel = 0.00

The deviations of the values from the vessel measurements of GL are not significant. The heeling test in 1999 was carried out and evaluated correctly in accordance with the IMO Code via intact stability A.749 (18).

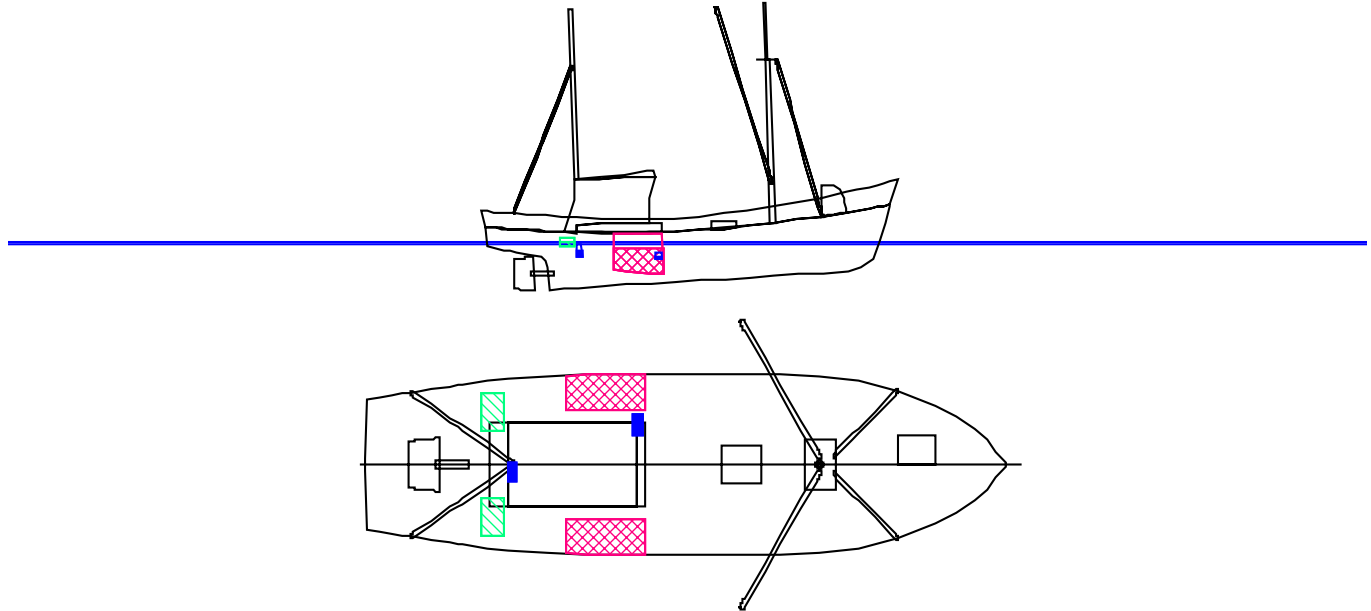
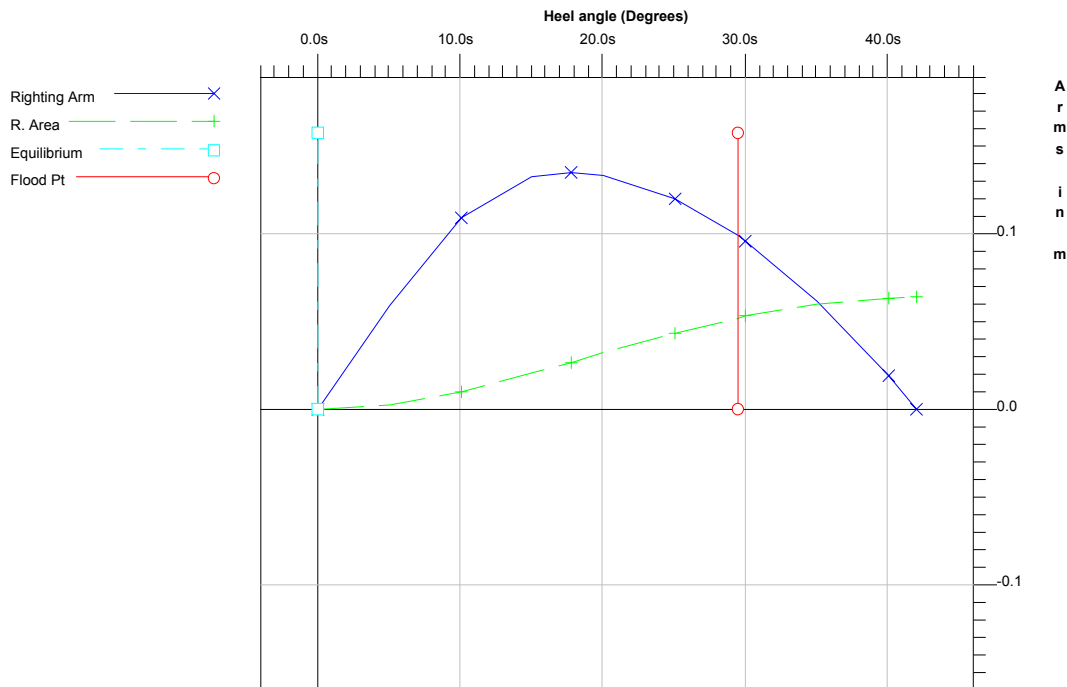
Stability with heavy trawl beams

In particular in this calculated stability case the range of stability is only 43.41° (60° required), the righting arm at 30° is only 0.108 m (0.20 m required), and the areas below the righting arm curve from 0° to 40° and from 30° to 40° are not sufficient either.

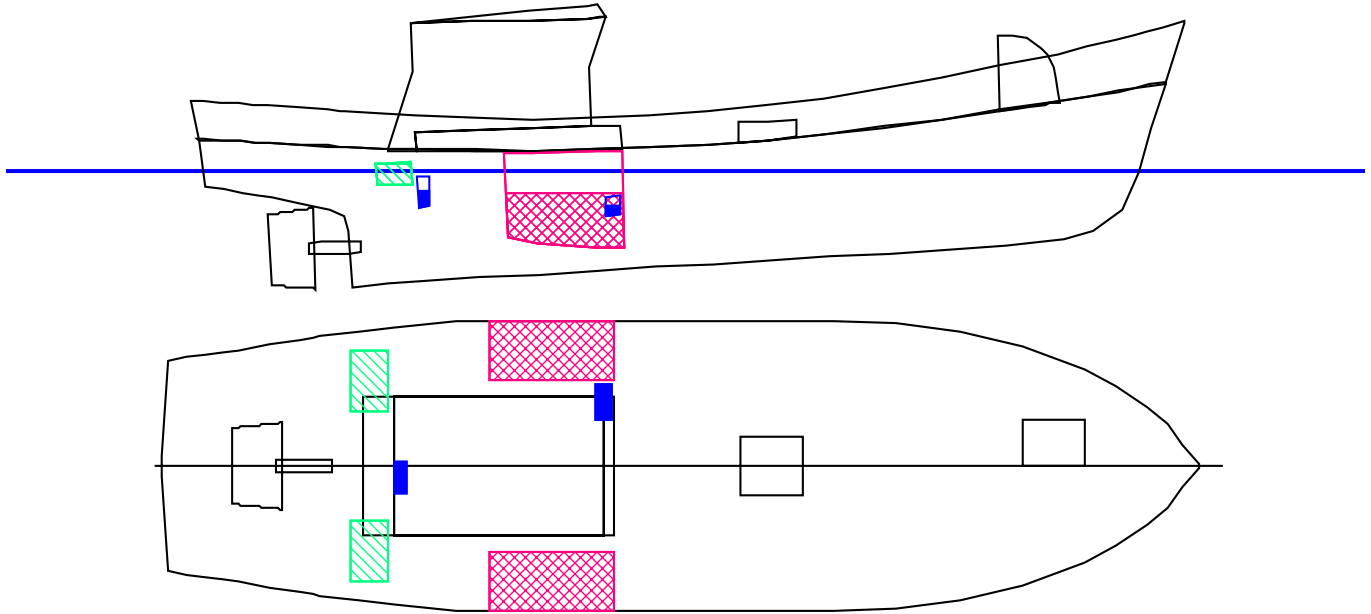
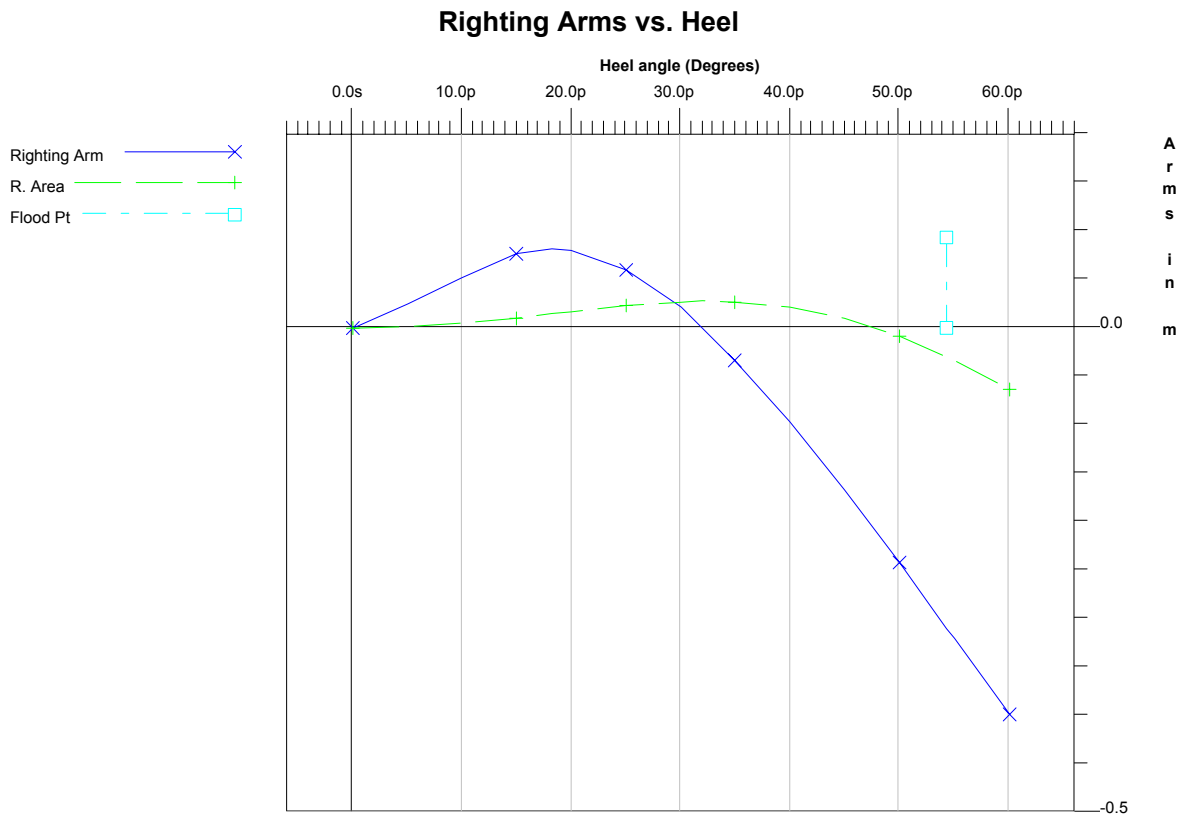
Stability following repair in Holland 2001

The heeling test in Holland following the repair of 29.11.2001 was not approved by the See-BG. The checking of this test revealed a few irregularities. The determination of the over and under-weight says nothing about the equipment condition of the vessel. In particular it cannot be seen whether the fishing gear was on board. Nor can it be seen how many measurements of heeling were carried out. The displacement path (L) is stated in the summary as 3.50 m and calculated with 3.95 m. A stability case "Departure Port" was calculated with the height moment of the fuel oil calculated wrongly. A comparison of the evaluation with the heeling test of 30.6.1999 results in the following discrepancies.

The empty weight of the vessel determined is 11.45 t (approx. 18%) lower, the longitudinal centre of gravity is displaced 0.79 m (11%) further forward, and the centre of gravity above base is 0.30 m (15%) higher than the values shown in 1999. A stability check with these values results in considerably poorer stability values.

The GM is 0.269 m (required 0.35 m), the range of stability in this case is only 32°, the righting arm at 30° is 0.02 m, and the areas beneath the righting arm curve are absolutely insufficient.

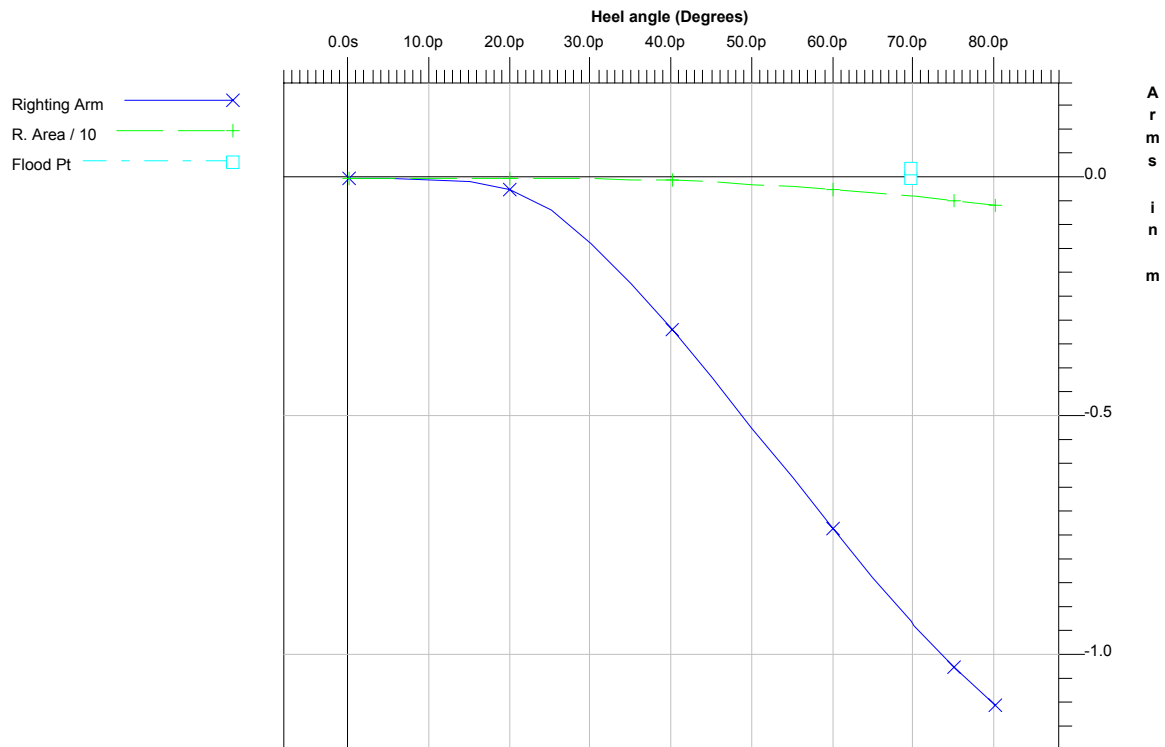
Stability on grounding of the cutter

The stability case is even worse when even more water runs out and the water line area is reduced even further. At a water line 29 cm lower than the water line existing in deep water there is a negative initial stability and no righting moment any more.
