Investigation Report 234/03

Very serious marine casualty

Foundering of SY DEERN
following a collision with an unknown vessel
northeast of Rügen
in the night of 3 August 2003 to 4 August 2003

20 March 2004

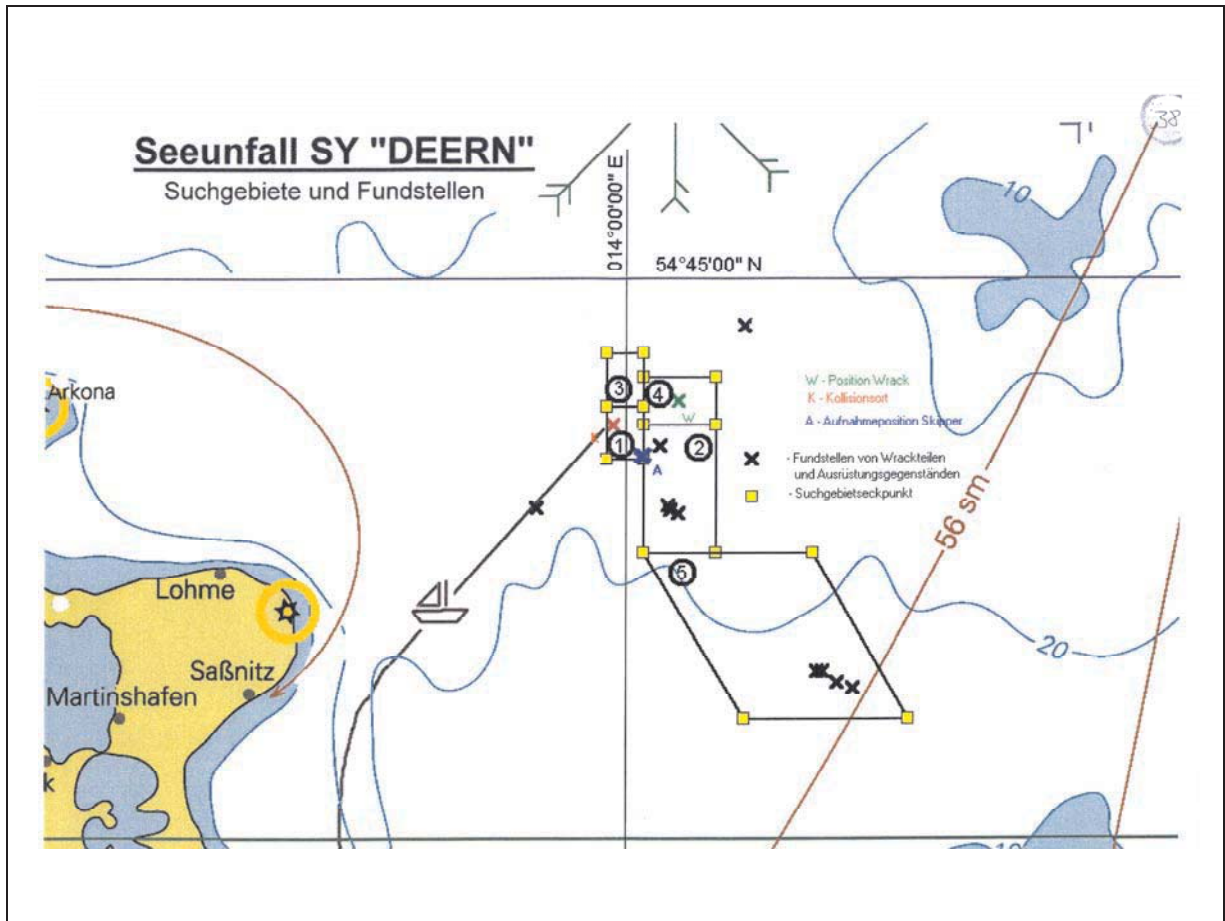
Figure 2: Scene of the accident - details

Marine Casualty SY "DEERN"
 Search area and locations of items found

The yacht was found at position 54°40.83'N 14°02.76'E. In view of the difference to the approximate location of the collision, BSU has examined various theories.

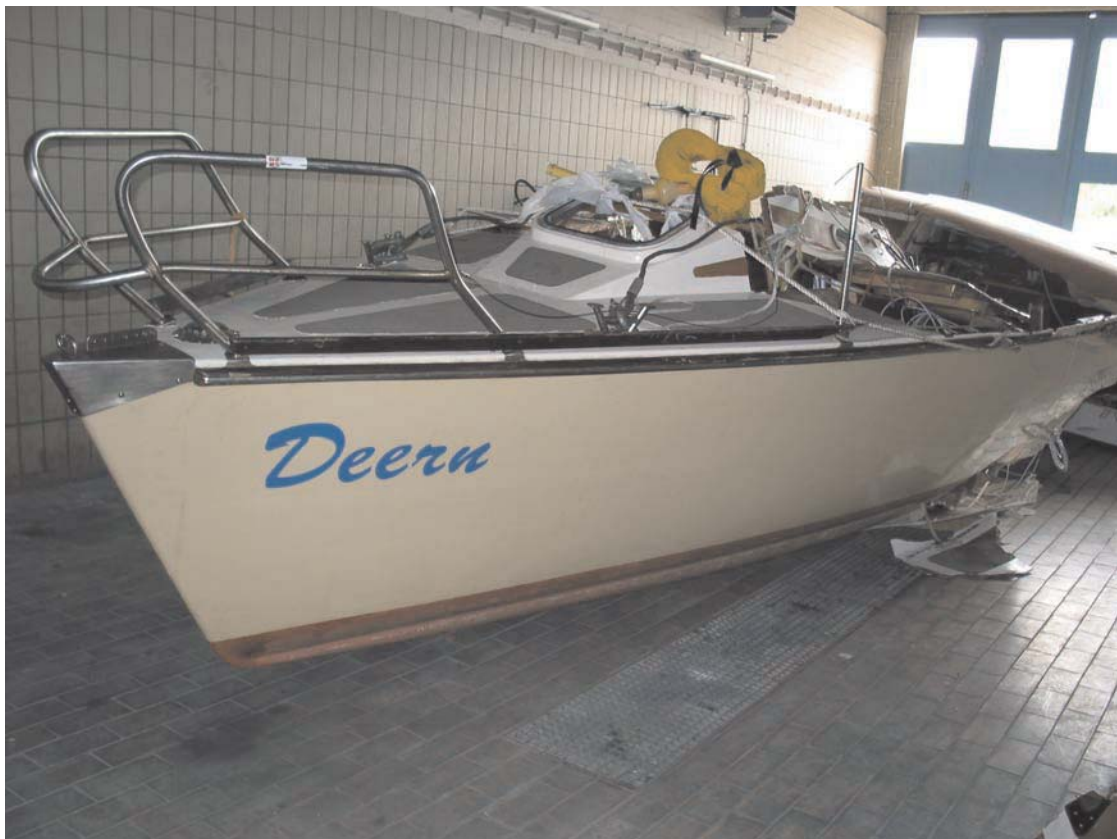
The wreck of the yacht was lying in a northwesterly direction with its bow pointing to NW in water 24 m deep and had sustained heavy damage mid-ships on both sides. There were traces of blue paint on the portside which was not completely severed. The bow and the stern had remained relatively undamaged. The centre-board that was bent towards the starboard side of the SY had buried its way into the sea bottom according to the information supplied by the police divers and was thus not visible under the wreck.

The vessel owner's wife drowned in the sunken yacht as a result of the collision. The yacht was declared a total loss after recovery, since it had been divided into two halves by the party in the collision.

Figure 4: Photo of damage - view from the front

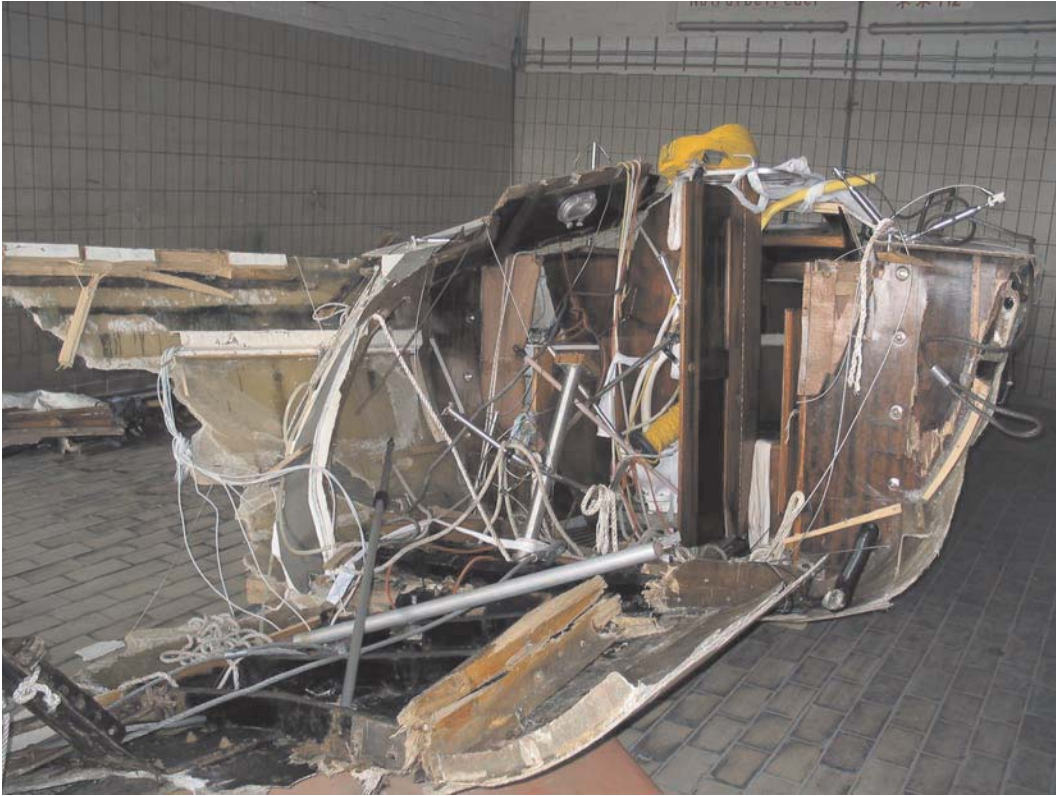
Figure 5: Photo of damage - view to the forward part - interior

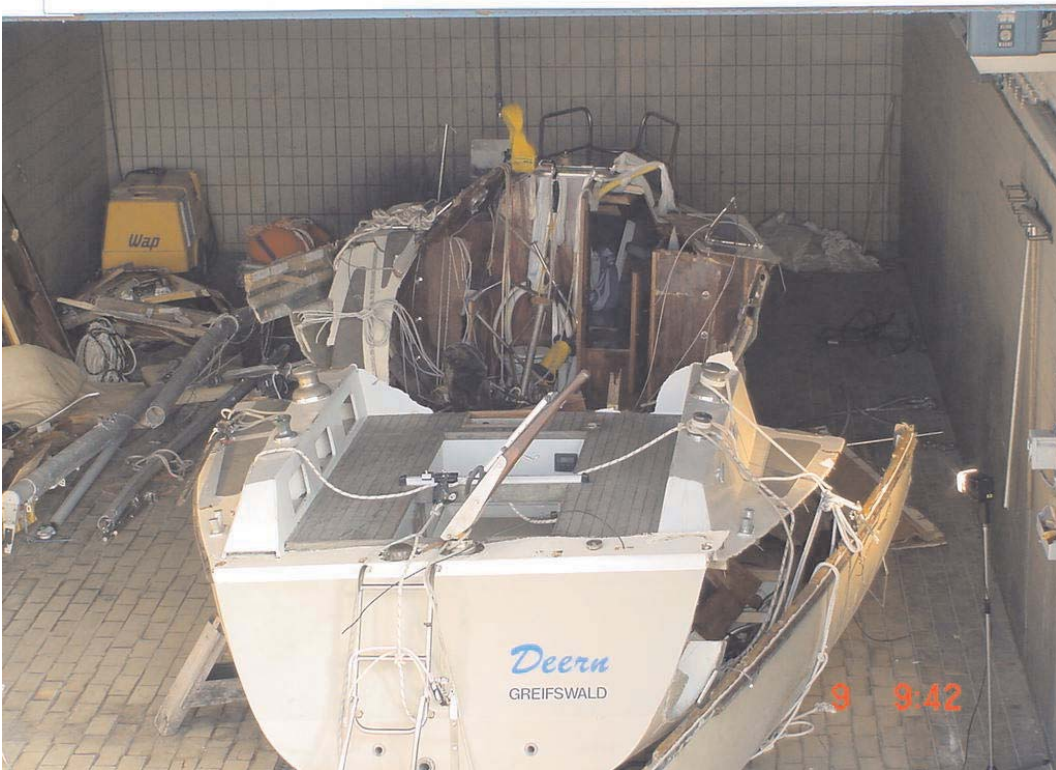
Figure 6: Photo of damage - view from aft

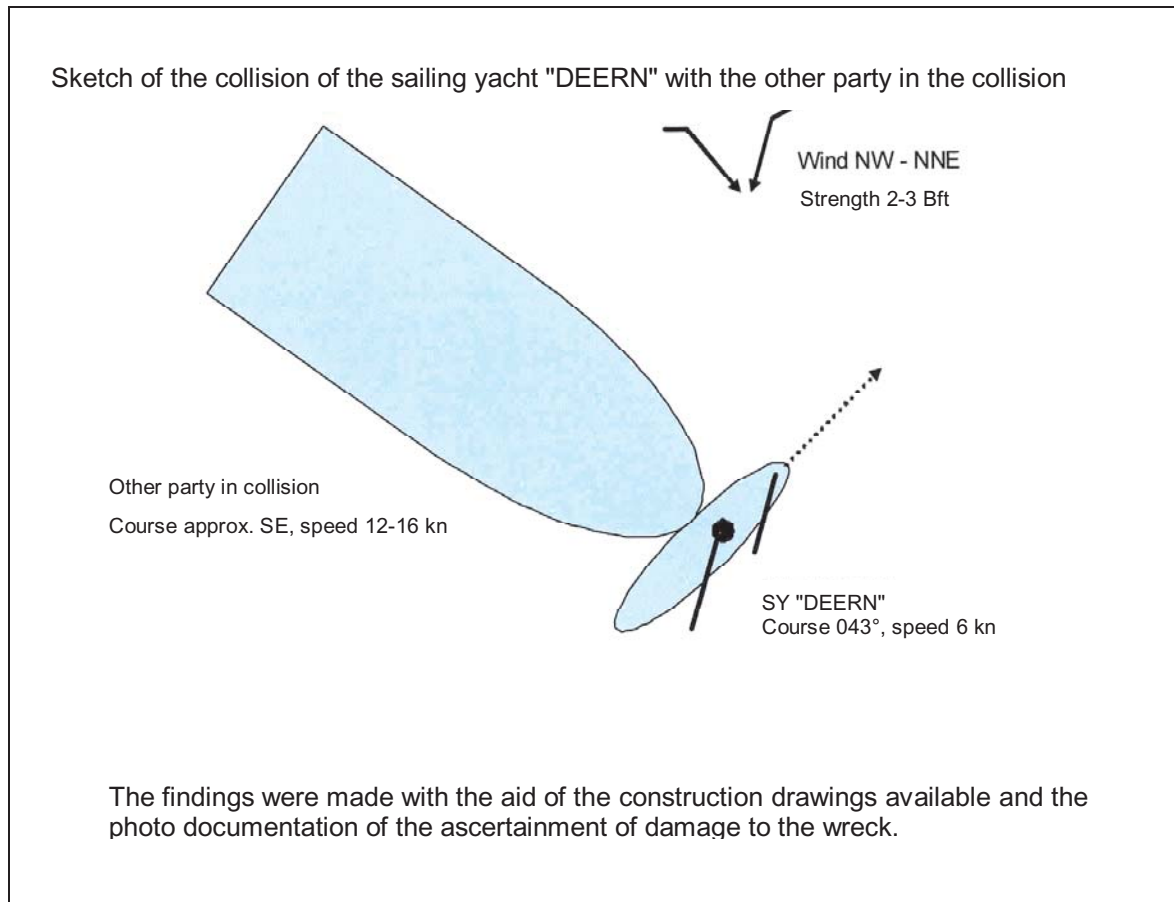
Figure 7: Sketch of the collision

As a result of the investigations it is clear that the SY DEERN was rammed on the port side midships by an unknown vessel at an angle of approx. 100° and overran after capsizing. According to the statement by the Skipper the two vessels perceived at about 23:30 h come into consideration as possible parties to the collision. The results of the BGSAMT SEE on the presumed angle of collision show that the vessel perceived aft of port abeam was most probably the other vessel involved. In any case the yacht was rammed on its port side. In so far the other party to the collision must have had the yacht on his starboard side and should have assumed that he was liable to take avoiding action in accordance with Regulation 15 of the Collision Prevention Regulations (Colreg), since SY DEERN was carrying the lights of a power-driven vessel (see below).

Further attempts to explain the difference between the stated collision location and the place at which the wreck was found are imprecise values noted for the last bearing (35 nm / 43° to Rönne), an imprecisely programmed waypoint in the GPS receiver, and also the possibility that although the DEERN sank in front of the eyes of the skipper, it might possibly have been pulled along under the water until the last connection with the other party in the collision was severed. It is conceivable that pieces of sail ropes might have become caught under the bulbous bow.
