**Bundesstelle for Seeunfalluntersuchung**  
**Federal Bureau of Maritime Casualty Investigation**  
Bundesoberbehörde im Geschäftsbereich des Bundesministeriums  
für Verkehr, Bau- and Wohnungswesen

Investigation Report 262/03

**Rupture of the towing line  
during towing between  
VOC FRONTIER and  
the Tug AXEL  
on 1 September 2003  
in the port of Lübeck**

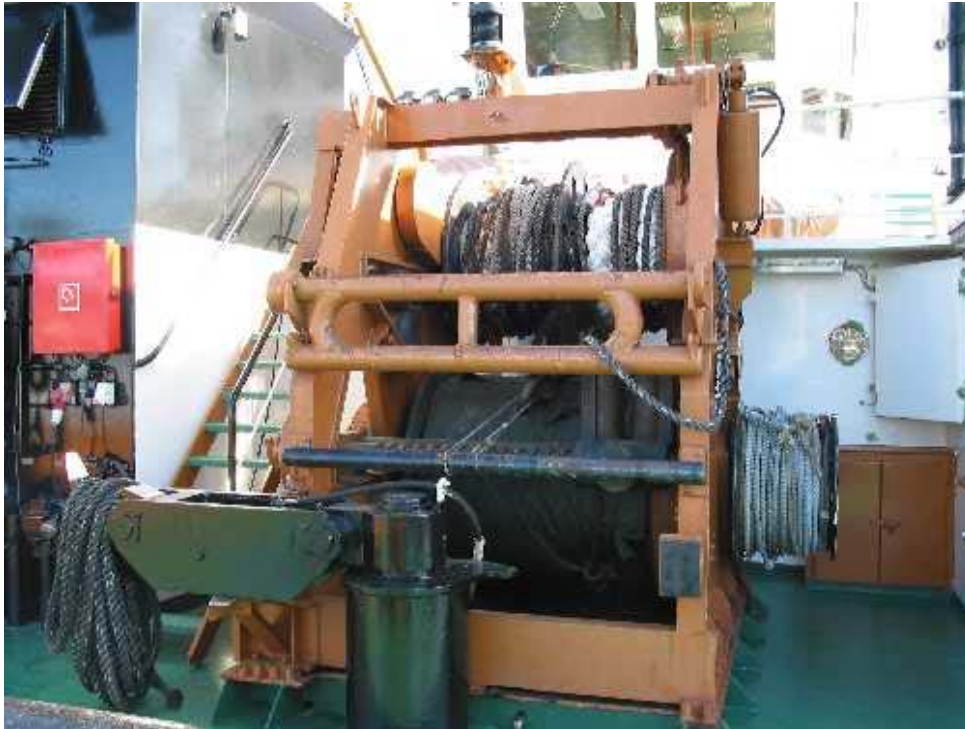
**Figure 4: Towing gear AXEL**

According to the statement by the Master of AXEL, the tow connection consisted of a 5 to 6 m long forerunner (diameter 9", T-Flex) and a 45 m long wire line (diameter 28 mm, 6-strand \* 36 wire with core, see Fig. 4). The eye of the wire was secured to the bolt of the fairlead shackle, the forerunner to the other end of the shackle and the tow hook. The Master was on the bridge, while the crew members stood on the port and starboard side on the superstructure. During casting off the tug pulled crossways to port, whereby the tug was already at the opposite quay with its stem. Then the tug was to pull to starboard and since there was not much space ahead, a little slack came into the tow line. At the same time VOC FRONTIER was proceeding well astern and the tow line soon reached its full length. After a bang a bolt flew in the

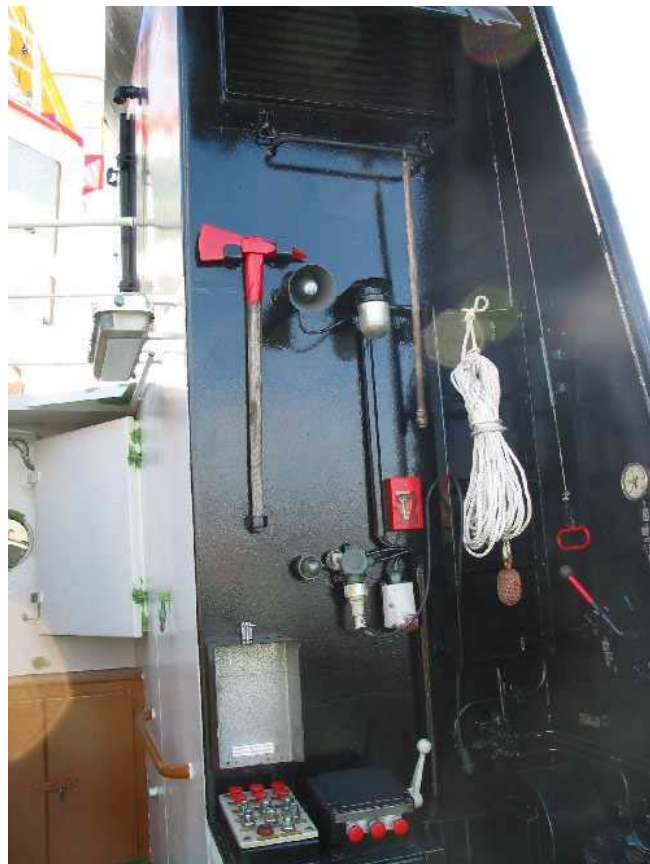
**Figure 5: Control console, Towing winch**

direction of the starboard side at the aft edge of the control console of the winches (see Fig. 5). The tow connections broke because the fairlead shackle failed. Damage was sustained to the self-winding device of the tow wire, the bunker connection, and the door of the halone trigger station. The forerunner was lying in front of the tow hook and according to the statement by the Master of AXEL the tow wire was hanging loose in the water midships from the middle hawse from the fore-castle of VOC FRONTIER.

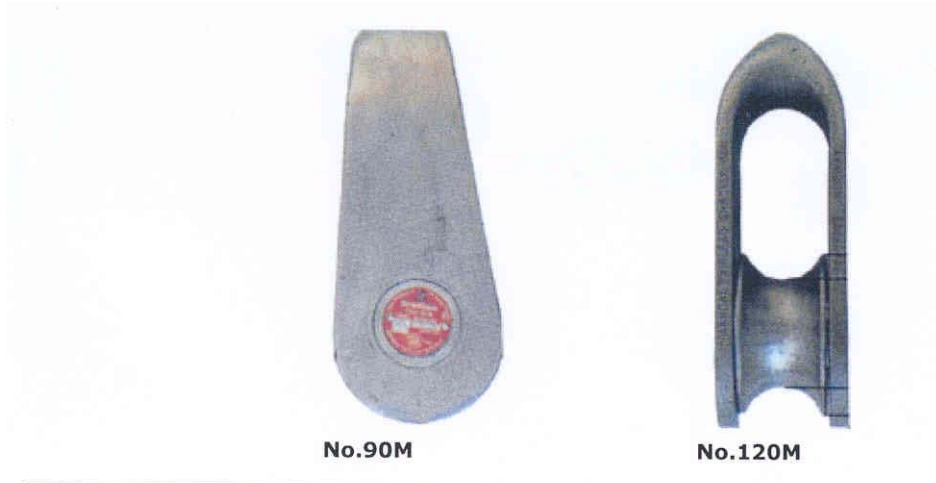
**Figure 6: Mandal Fairlead-Shackle 90M, 120M**

There were no injuries on the tug. The crew was unable to make any statements about the direction of flight of the broken shackle and the tow wire. The shackle is a licensed 90M shackle. The shackle has a workload of 35 t. The proof load is 55 t and the rupture load 90 t (see Fig. 6). The tug has a bollard pull of 41 t. According to the information supplied orally, the tow lines have a rupture load of approx. 90 t. The possibility that the shackles were subjected to stress beyond the normal workload cannot be ruled out. A comparison with the shackle now installed shows a workload of 35 t. A 120M shackle is installed on the Tug MICHAEL that has a workload of 40 t. Only the bolt of the damaged shackle could be secured. The other parts went overboard (see Fig. 7). The steel nose that sheared off and deformations are evident on the bolt.

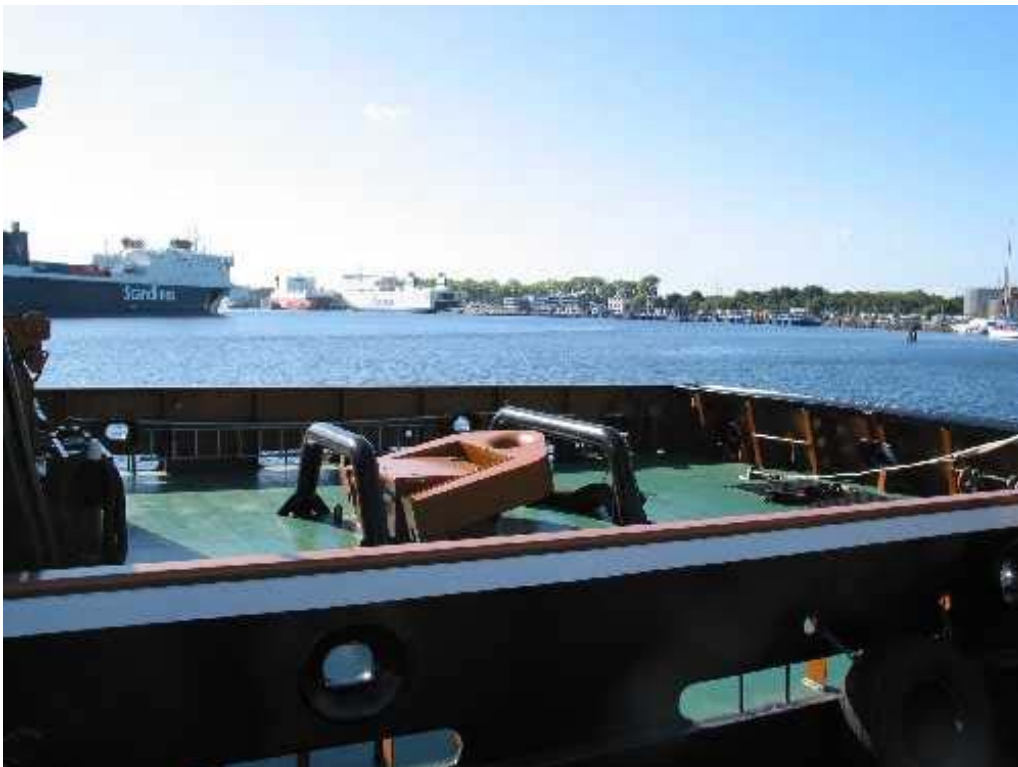
**Figure 8: Aft part of Tug AXEL with A-Frames**

During towing the fairlead shackle is located free-moving behind the two A-frames of the tug (see Fig. 8). The tow connection is not examined during class renewals. Only the insurer imposes conditions about the nature of the tow connection. The tug crew could not explain why three crew members were injured when the tow connection broke. They do not consider it possible that a 35 m long tow line can fly back up to the fore-castle of VOC FRONTIER. In their opinion it was an unfortunate reflex action that led to the injuries.

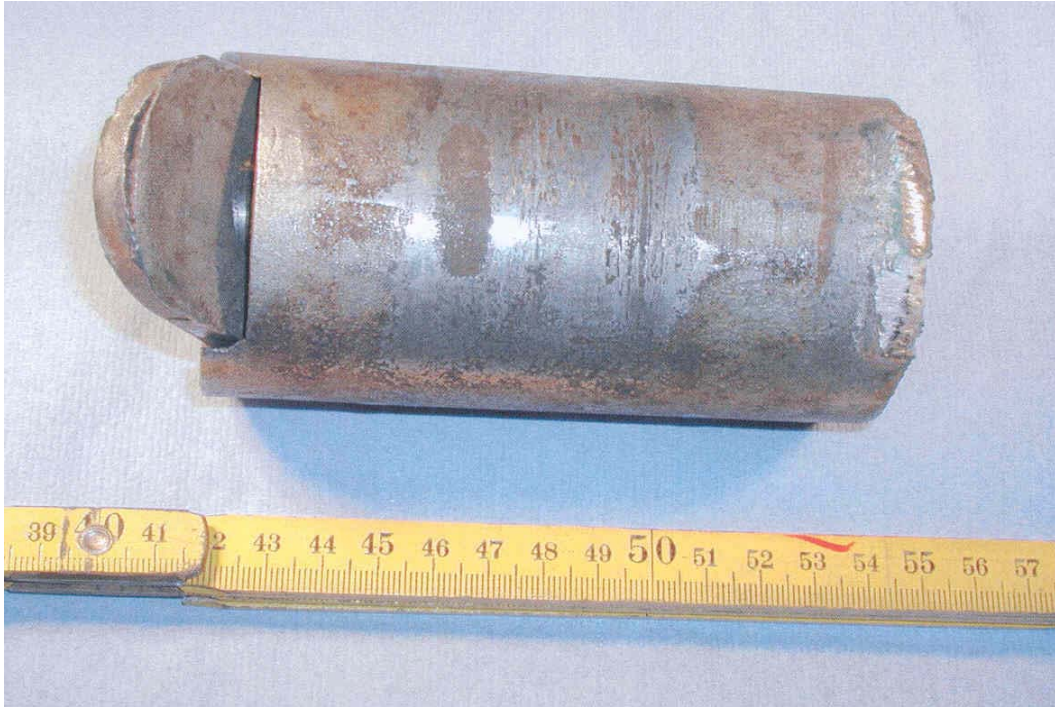
**Figure 9: Shackle bolt, Tug AXEL**

The bolt supplied had a diameter of approx. 69 mm and was approx. 122 mm long (Fig. 9). A securing strap was bolted on one side and this was bent during the accident. There had been a securing strap casting on the opposite side that had sheared off. The sheared-off area was approx. 8 x 48 mm.

The bolt is evidently a steel casting and largely non-machined on the surface. The casting skin and mould partition can still be seen. The bolt shows various traces of use. On the one hand there are traces of a wire rope twisted in cross-lay visible on the bolt surface as score marks on the circumference. Next to these score marks traces of a synthetic fibre rope can be seen on a part of the surface, characterised by smoothening of the casting structure. Under examination with a magnifying glass traces of abrasion of a dark grey material evidently used as a protection for the synthetic rope were found on the smooth surfaces. The traces of abrasion on the shackle show that the fairlead shackle was used on the bolt without a roller. The traces of the synthetic rope further show that the rope was arranged on one side round the bow of the shackle and not in the middle.

A hardness test was carried out on the bolt. A hardness of 209 HV 50 was determined from the average of three measurements. According to DIN 50150 a tensile strength of approx. 660 N/mm<sup>2</sup> can be derived from this. Since the shear strength of the steels can be estimated at approx. 80% of the tensile strength, this results in a shearing force for shearing off the safety strap of approx. 185 kN (approx. 18 t). If one further assumes that the rope was wound at the side of the strap, it can be estimated that the transverse force necessary to shear off can occur at a tensile force of approx. 600 kN. It is only possible to determine this tensile force very roughly since the geometry of the shackle bow is not known and would have to be estimated.

The forces needed for the shackle to fail could only develop because a fairlead shackle without a roller was used. If a roller had been used, the rope would have been guided in the roller in such a way that no transverse forces of any notable extent could have occurred. The necessary forces lie well above the bollard pull of the tug. In other words they could only occur as a result of a shock-type load.

It must therefore be assumed that slack had developed in the line between the tug and the cargo vessel and that the line was tightened again by a tug manoeuvre. The sudden load occurring as a result then led to failure.

It should be examined whether a longer tow forerunner could have reduced the impact and prevented the failure.

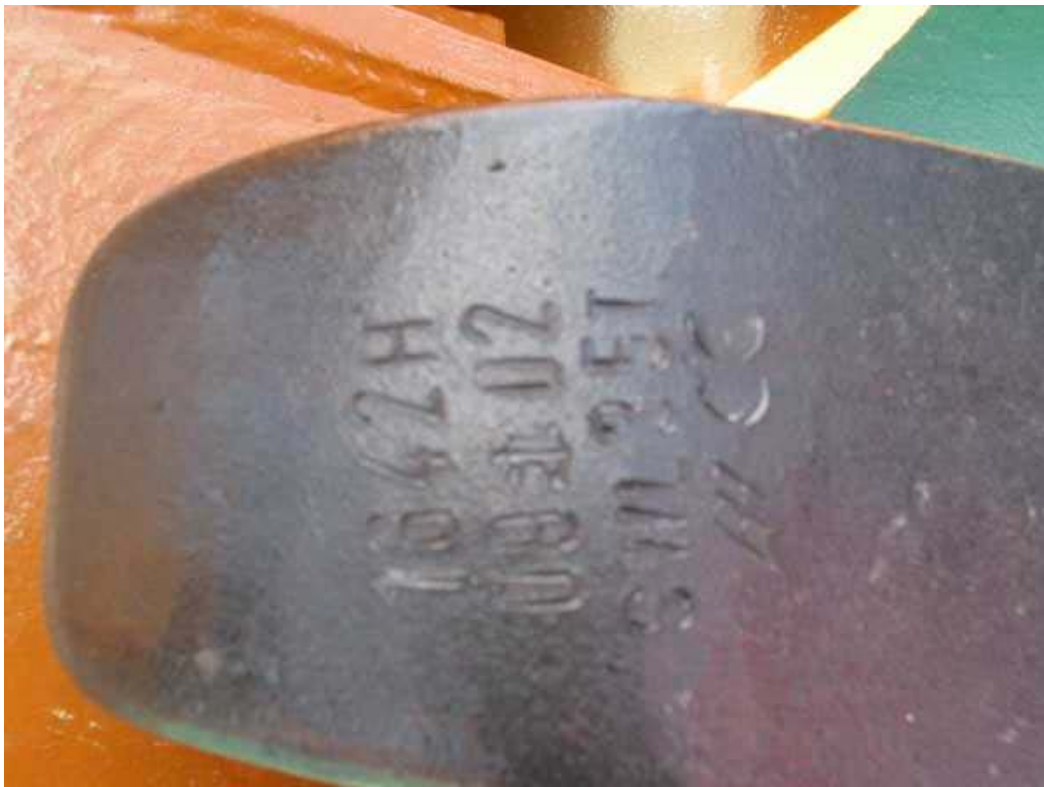
**Figure 10: Certified fairlead shackle, Tug AXEL**

According to the information supplied by the Master and operator, certificated material was used for the tow connection (see Fig. 10). According to a purchase voucher of 5 August 1998 the broken fairlead shackle was a shackle with the designation 90M SEL-1071 GL. However, no GL certificate (LA3) for the load test could be submitted. This type of shackle had a stated workload of 30 t, whereby the

tensile strength of the bolt determined in the expert opinion was approx. 660 N/mm<sup>2</sup> (66 t). A 120M fairlead shackle with roller like that fitted on the tug MICHAEL with a stated workload of 40 t would without any doubt have provided more safety.

The owners, operators and masters of the tug must ensure that test certificates on individual parts of the tow connection are kept in storage and that the material used corresponds to the recognised test standards.
