Investigation Report 314/03

Marine Casualty

**Serious back injury of a passenger on board
HSC HALUNDER JET
on 11 October 2003
on the Elbe estuary/German Bight**

3 May 2004

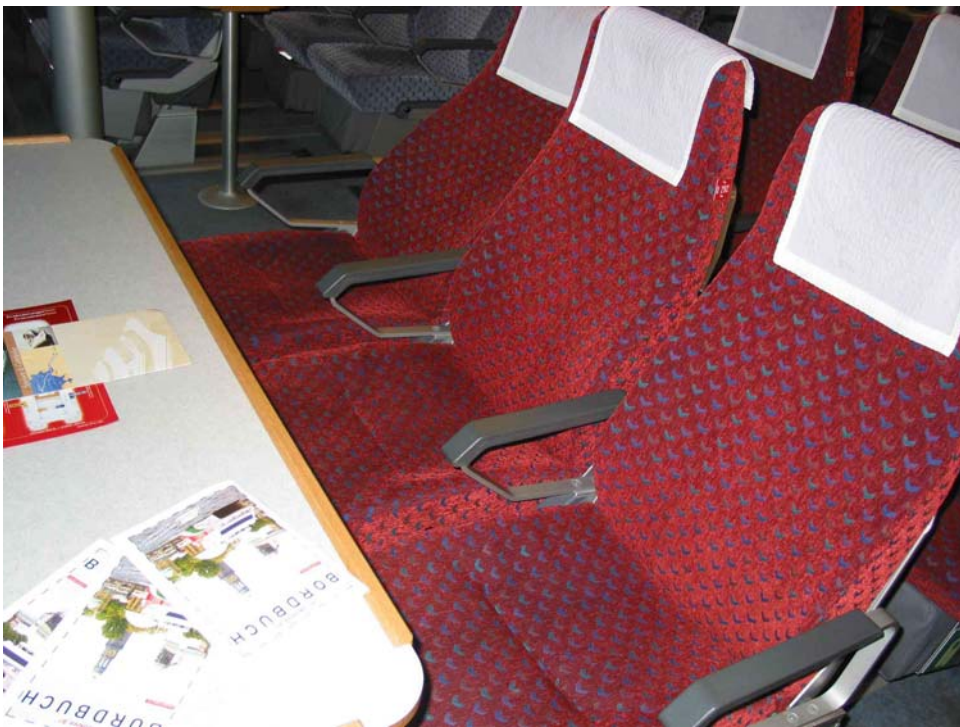
Because of the heavy weather both the mother and the daughter had had to hold themselves fast on the tables in front of their seats in the first row on the main deck.

The mother, who suffered from a valvular heart disease, had looked very ill. Worried about the health of her mother, the daughter had suggested moving to other seats. When the sea appeared to be sufficiently calm first the daughter and then the mother had stood up. There had been nothing in the aisle on which they could hold themselves fast. During the first or second step the vessel had moved suddenly and both of them had fallen. While nothing had happened to the daughter, her mother had fallen on or against an armrest.

Figure 3: Seats on the main deck
HALUNDER JET

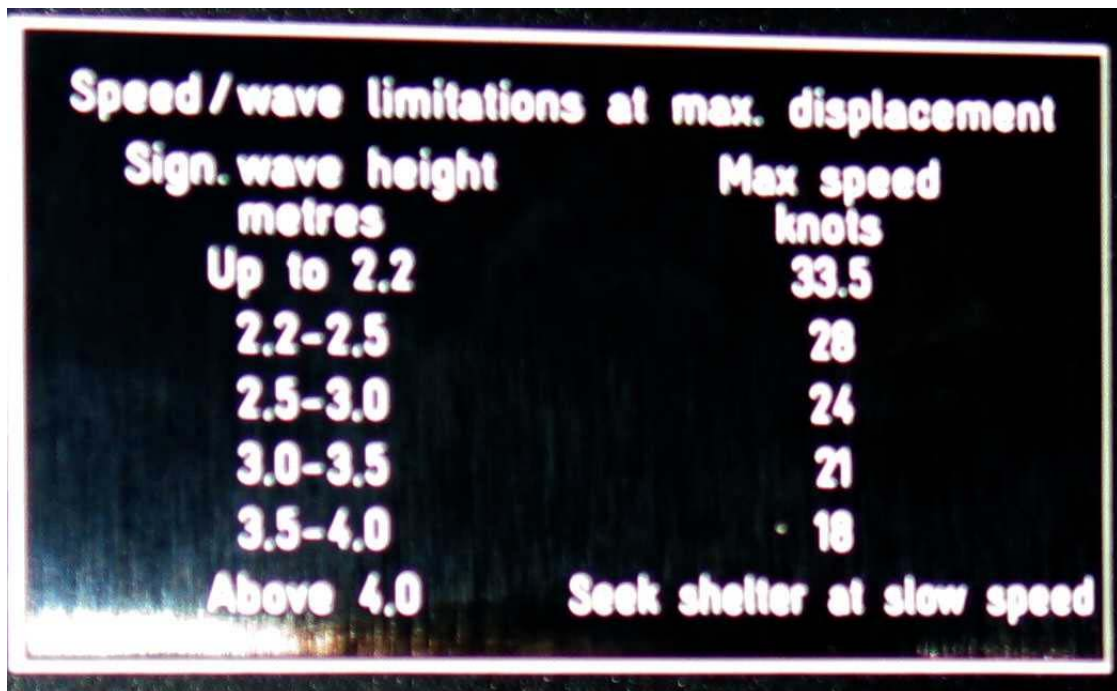
The maximum permissible speeds depending on the prevailing significant wave height were specified as follows in the Route Operating Manual:

Figure 4: Speed/wave height limitations
Plate on the bridge of HALUNDER JET

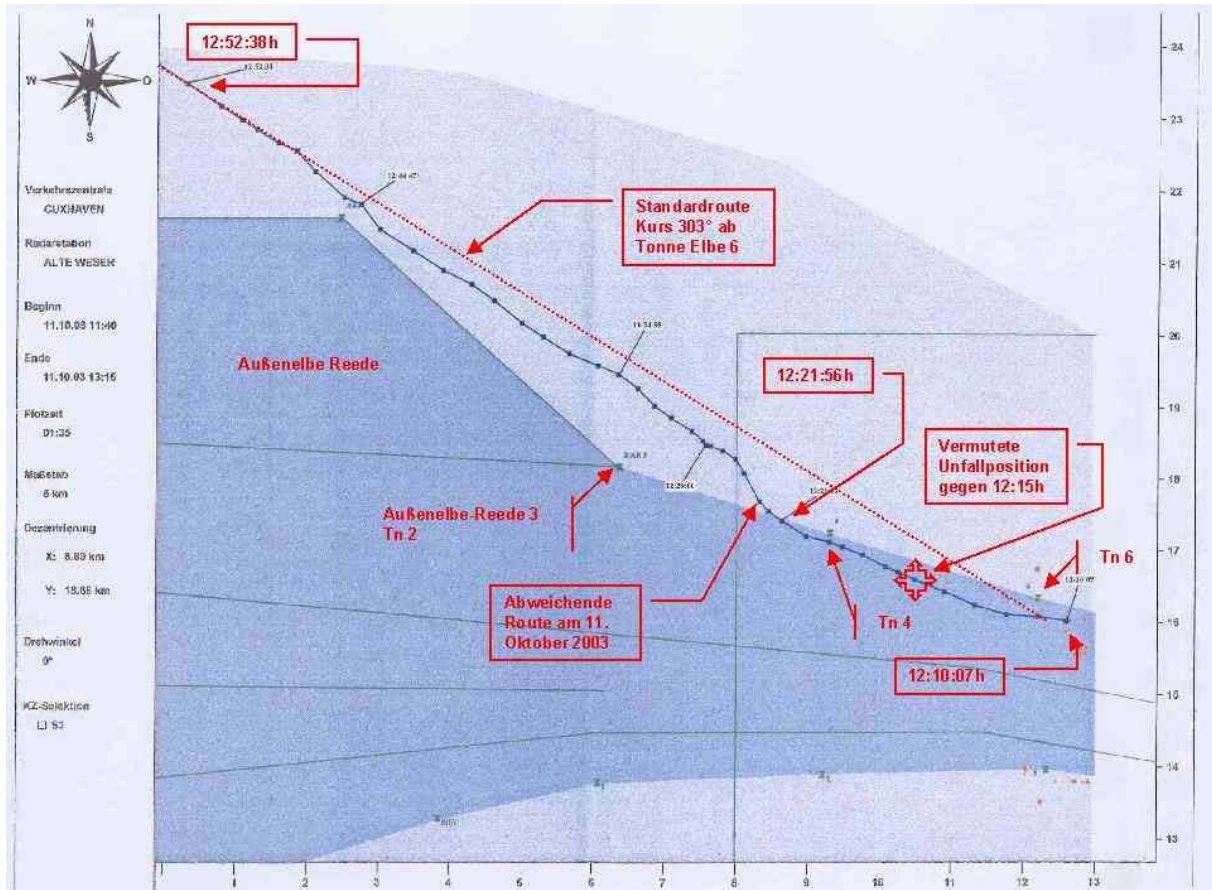
On 11 October 2003 the total voyage from Hamburg to Heligoland took 4 hours and 29 minutes, and the leg Cuxhaven to Heligoland took 2 hours and 2 minutes. At the time of the accident the speed had been reduced to as slowly as 5 kn. In deviation from the normal route the vessel did not leave the Elbe fairway at buoy Elbe 6 with a north-north-westerly course to Heligoland. In order to keep clear of the edge of the sea at Grosser Vogelsand, HALUNDER JET only left the Elbe fairway at the easterly border of the Elbe estuary roads between buoys Elbe 4 and 2.

Figure 5: Deviating voyage route
 from buoy Elbe 6
 Radar plot VTS Cuxhaven, radar station Alte Weser
 from 12.10.07 h to 12.52.38 h

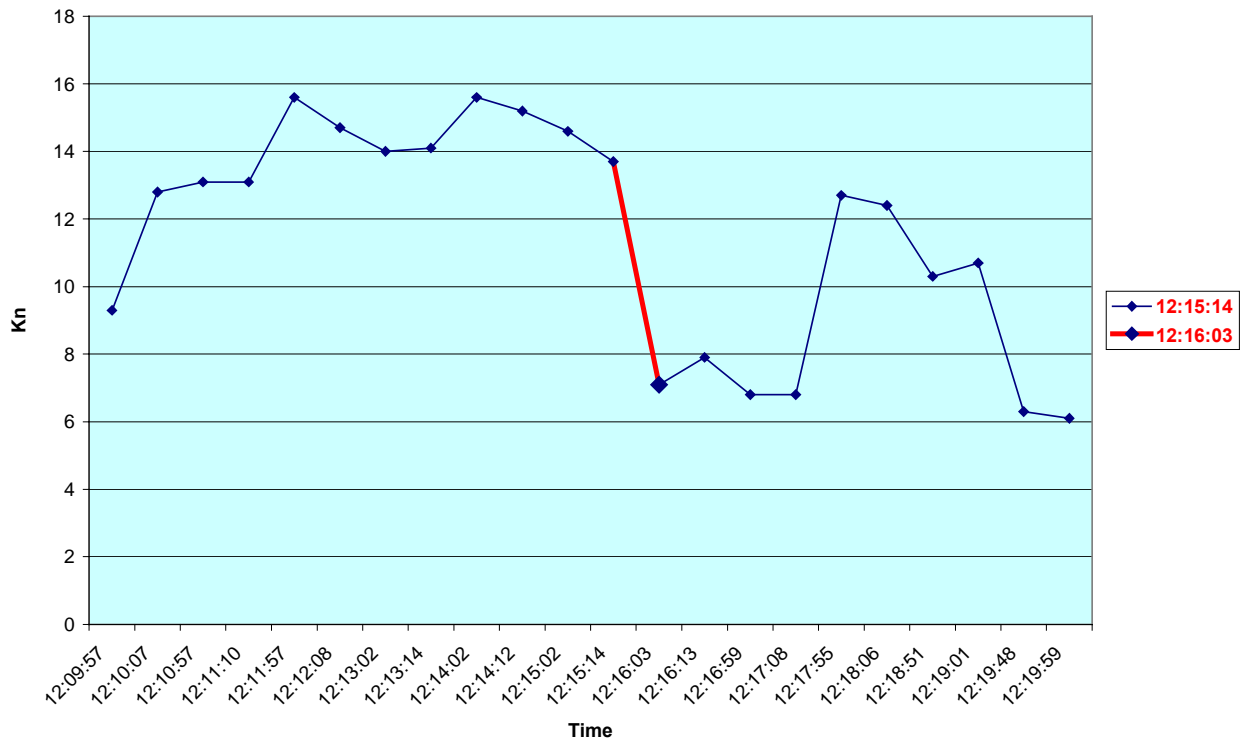
Figure 6: Speed
HALUNDER JET at the time of the accident

After leaving Cuxhaven at 11.27 h HALUNDER JET proceeded up to the buoy Elbe 10 at the usual speed for this leg of above 30 kn. A first distinct reduction of speed to about 20 kn took place between buoy Elbe 10 and passing buoy Elbe 8 at shortly after 12.00 h. According to the official meteorological expert report, a significant wave height of 2 m to 2.5 m could be expected for the area from Cuxhaven up to about Scharhörn, and from Scharhörn, off buoy Elbe 12, a significant wave height of 2.5 m to 3 m was expected. Actual sea data were not available for comparison purposes (see 6.2). The critical value for reducing the maximum permissible speed from 33.5 kn to 28 kn was at a significant wave height of 2.2 m according to the table in the Route Operating Manual. Consequently the time and place at which the speed of HALUNDER JET was reduced and the time and place at which it was expected that the critical value would be exceeded virtually coincided. At about 12.05 h a brief increase in speed to 24.7 kn was registered. At the time of the accident at about 12.15 h a clear reduction in speed from 13.7 kn (12.15.14 h) to 7.1 kn (12.16.03 h) (see Figure 6) was carried out. It was not possible to ascertain clearly whether this measure occurred directly before the accident, as a reaction to it, or completely independently of it. Finally, up to the end of the radar observations at 12.53 h speeds ranging from a maximum of 20.1 kn to the lowest speeds of 2.2 kn were recorded. At about 12.20 h the vessel left the Elbe fairway after passing the buoy Elbe 4 with a north-north-westerly course, and the shipboard management began to counter the bad weather situation with changes in course in addition to reducing speed.

It is assumed that the visual determination of the significant wave height by the shipboard management after passing Scharhörn/buoy Elbe 12 was correct. The resulting reduction of speed during the passage up to Heligoland was partly well below the maximum speed still permissible according to the Route Operating Manual. In so far the speed factor is not considered to have triggered the accident. It was not possible to determine precisely to what extent excessive speed directly prior to the incident promoted the accident.

Recommendations derived from this must be provided for the shipboard management in the Route Operating Manual by the vessel operator in accordance with Section 18.2.2.3 in conjunction with Sections 18.2.2.2 and 17.2.2 HSC Code 2000. Taking into account the restricted freedom of course, especially in the Elbe estuary area, it is necessary to think about a greater operating restriction than the maximum permitted significant wave height specified in the Permit to Operate High Speed Craft.

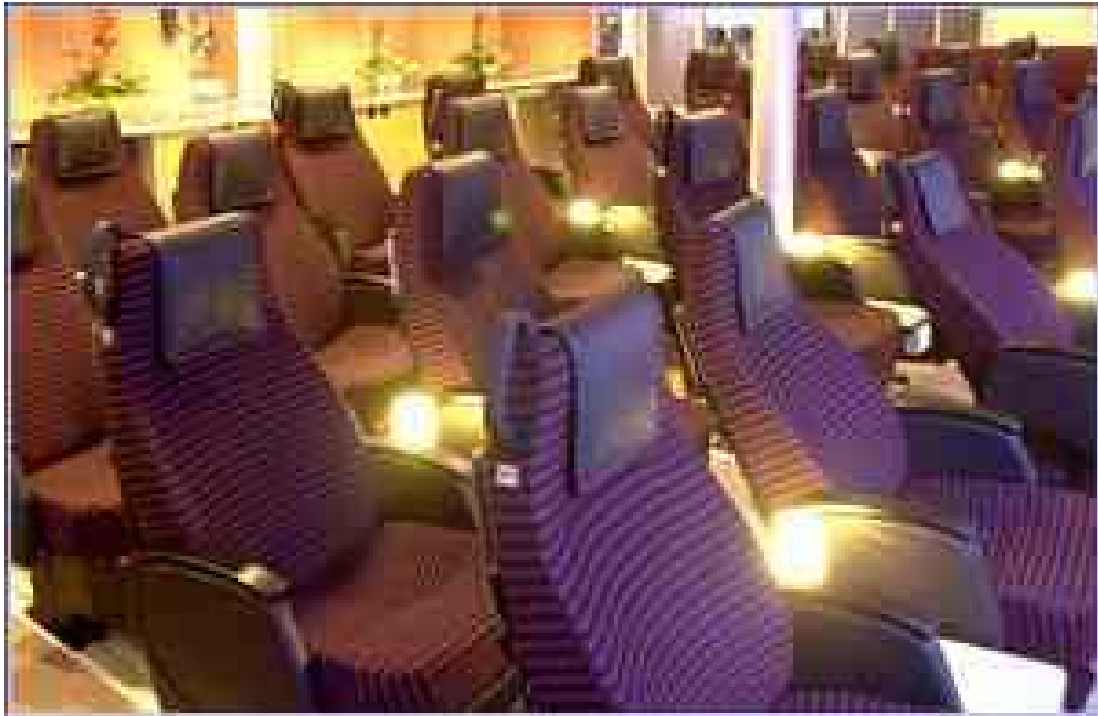
The only opportunities for passengers to hold fast when walking round the salon were the ceiling support columns located on a level with every third or fourth row of seats on one side of an aisle, and the backrests and armrests of the aisle seats. The latter are recognised as adequate by both the safety organisation See-Berufsgenossenschaft as flag state authority and Germanischer Lloyd as classification society as fulfilling the requirements in accordance with Section 4.4.5 HSC Code 2000 for „adequate handholds on both sides of any passage to enable passengers to steady themselves while moving about“. Real hand grips were only fitted in the corridors bounded by flat walls in accordance with the specification of Germanischer Lloyd.² Whereas mounting such grips also in the seating area would involve additional hazard potentials as a consequence of exposed components. The safety organisation See-Berufsgenossenschaft voices concerns against mounting additional grips in the area of the seats, pointing out that there is no type approved seating on the market, respectively an existing type approval would be invalidated if grips were mounted supplementary.

Figure 7: Passenger seats with additional handholds
(Photo: advertisement of seat manufacturer)

The Federal Bureau of Maritime Casualty Investigation (BSU) considers it problematic to accept only the grip facilities offered by the seats without any additional handholds as sufficient for passengers to steady themselves. Due to their mounting height the armrests are without doubt basically suitable for children and relatively small persons, but not for tall persons. If the seat is occupied and the armrest is used for its original purpose, it is not available for other passengers to hold onto fast at all. The same also applies for the backrests, since if the seats are occupied there is not sufficient opportunity for other passengers to hold fast on them. Even an empty seat is only restrictedly suitable for providing passengers with a firm hold while moving about due to its upholstery fabric.

Handholds in passages: Prior to restarting operations in spring (probably at the beginning of April) 2004, Section 4.4.5 HSC Code 2000 requiring "adequate handholds on both sides of any passage to enable passengers to steady themselves while moving about" is to be implemented consistently.
