Investigation Report 315/03

Serious Maritime Casualty

Collision between
MV GERMA and MV ESTECLIPPER
in the Kiel Canal, siding area Schwartenbek
on 13 October 2003 at 05:33 h CEST

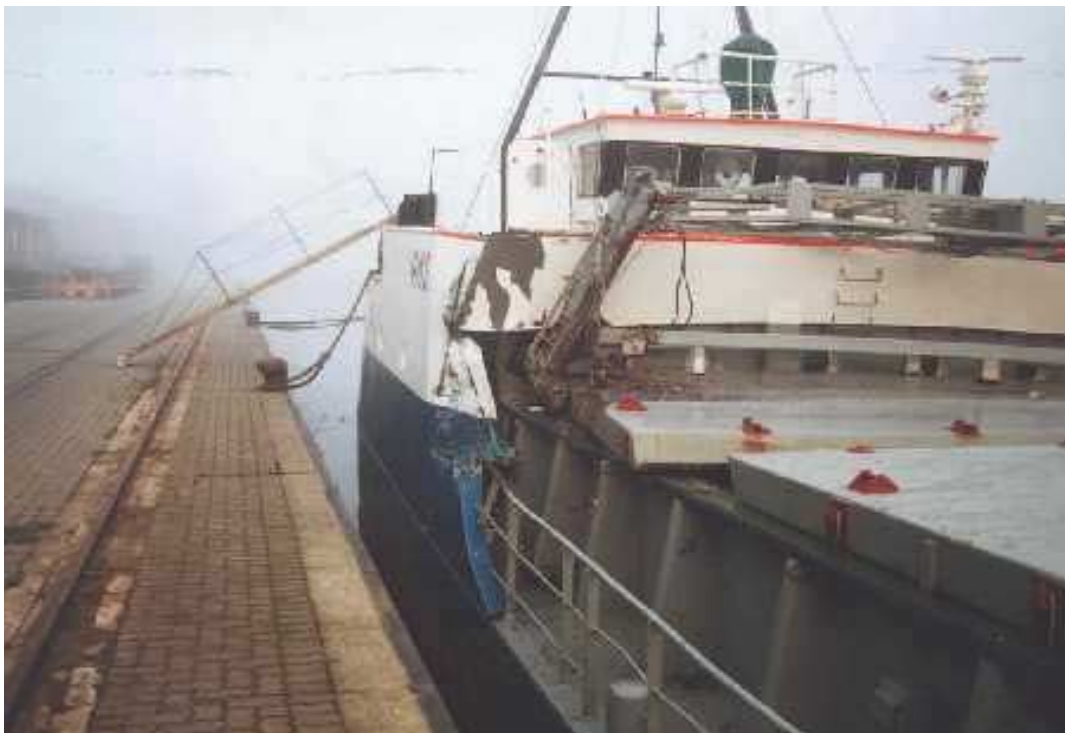
Figure 7: Photo of damage 1

In the meantime the stern of MV ESTECLIPPER had moved further to the south so that ultimately it hit the starboard side of MV GERMA on a level with the forward edge of the superstructures. Not only was the crane on the hatchway heavily damaged by this, but also the superstructures, in particular the Master's cabin.

MV ESTECLIPPER sustained minor paint damage. MV GERMA sustained property damage costing approx. Euro 100,000 which made it necessary to spend time in the shipyard. There was no personal injury or environmental pollution.
