Investigation Report 330/03

Very serious marine casualty

**Fatal accident during welding in the
engine-room workshop of
MV DRESDEN EXPRESS
on 26 October 2003**

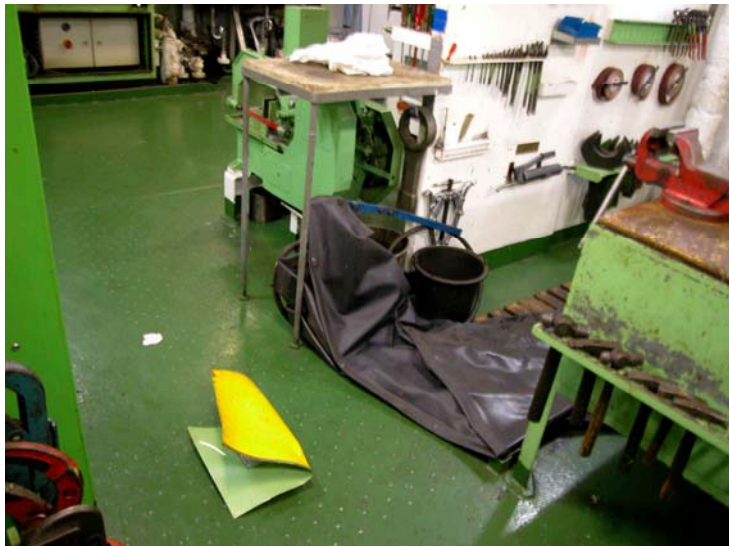
The fitting cabinet of the gas outlet station was heavily deformed as a result of the explosion and the pressure gauges and shut-off devices inside were destroyed. The cabinet door was ripped off and flung over several meters into the workshop room by the force of the pressure wave.

The welder was hit so unfortunately by the door flying like a projectile through the room that he died shortly afterwards, despite first aid measures initiated immediately. The other crew members present in the engine-room workshop (Second Engineer and ship's mechanic) were not injured. The explosion did not trigger any fire or other impairment of the ship's safety.

Figure 6: Curtain ripped away and heavily deformed fitting cabinet door

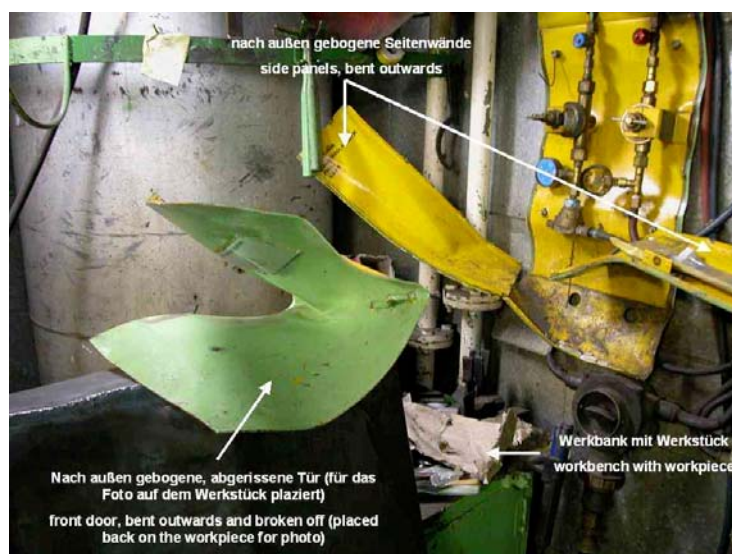
Figure 7: Detonated fitting cabinet (view 1)

There must have been a leak in the acetylene supply line (pipe lengths, pressure gauges, shut-off valve, pressure regulators) in the fitting cabinet or in a union fitting located between these components (hereinafter referred to altogether as "acetylene line"), which led to acetylene escaping. As a result it was possible for an explosive mixture of air (oxygen!) and acetylene to form in the cabinet that must have been ignited by a spark or welding spatter.

In the subsequent explosion the cabinet was destroyed completely and the welder working directly next to it was hit fatally by the cabinet door ripped off in the detonation.

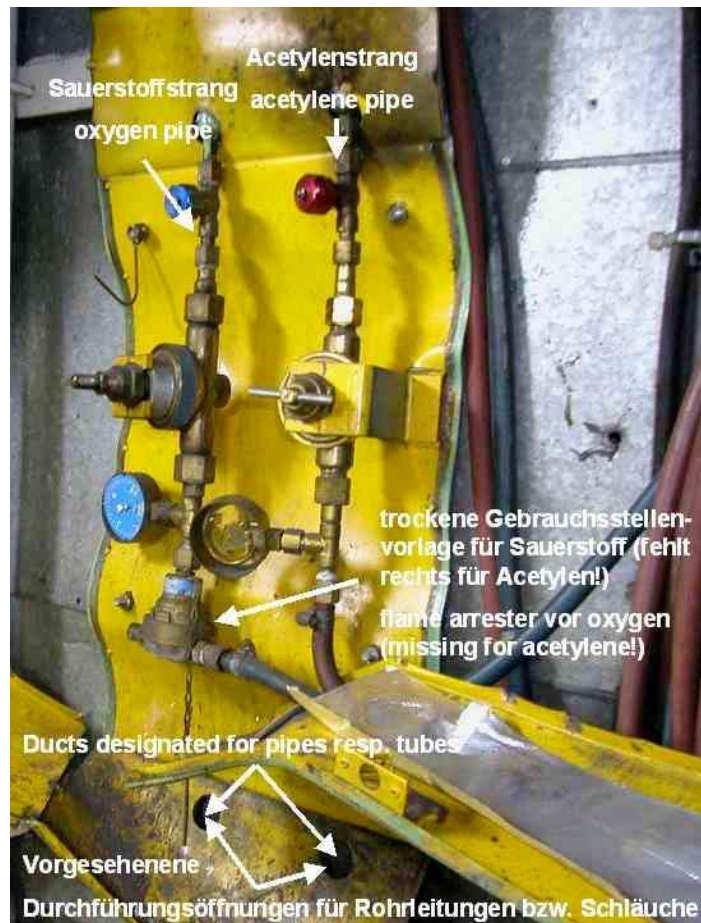
However, the analysis of the photos submitted (cf. figure 10) shows that changes to the original equipment status must have been made at some stage prior to the accident in the acetylene line inside the fitting cabinet. Although the surveyor of Germanischer Lloyd did not find defects or (inadmissible) modifications of the system during his survey of the destroyed welding station in Yokohama, the accuracy of these statements must be doubted.

This is due on the one hand to the different material condition of the acetylene line (shiny material that appears newer) by comparison with that of the oxygen line. Furthermore, the so-called Dry User Station adapter that is mandatorily specified in accordance with the aforementioned Welding Guideline to avoid flame backfiring is missing in the acetylene line.

(Note: The lack of the User Station adapter is not by itself connected with the accident, however.)

Figure 10: Detonated fitting cabinet (view 2)

Instead there were only through apertures for pipes/hoses in the box that was closed in a relatively airtight manner. Although the two drill holes located at the bottom of the cabinet (cf. figure 10) were not used to pass the gas hoses through, since these were guided out of the box at the sides, these apertures were in any case too small to ensure the necessary ventilation of the fitting cabinet.

3. The **owners and operators** of seagoing vessels are requested to equip cabinets already installed on board subsequently with correspondingly large cut-outs in the top and bottom areas if the ventilation apertures are not yet sufficiently dimensioned.

6. The **owners and operators** of seagoing vessels are called upon to ensure that no inadmissible modifications and inexpert repairs are carried out to gas welding installations on board their vessels.

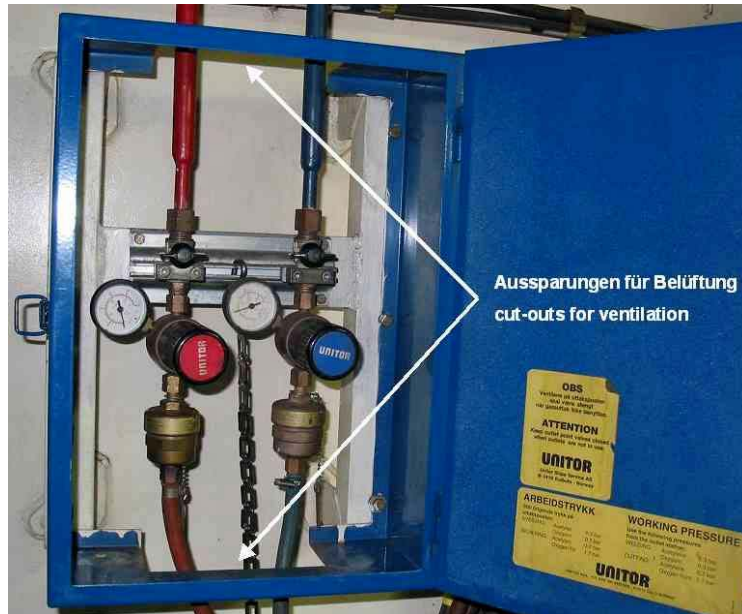
Figure 11 shows a fitting cabinet that satisfies the ventilation requirements defined under section 6.4 in model manner. Cut-outs are evident at the top and bottom which according to the manufacturer's data measure 180 x 75 mm each and are thus even one third larger than the required value of 100 cm².

Figure 11: Fitting cabinet ventilated in accordance with regulations

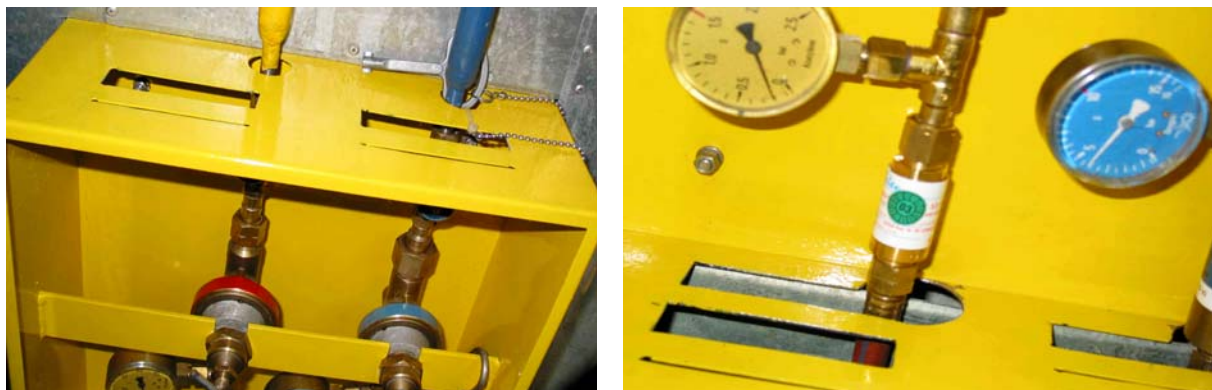
In the cabinet model illustrated below, ventilation apertures were worked into the box housing at the top and bottom. This alternative is expedient especially when cabinets existing on board are to be adapted to the necessary ventilation requirements with little outlay. However, it should be noted here that the apertures to be worked in must indeed achieve the necessary size of at least 100 cm² each in order to ensure sufficient air circulation.

Figure 12: Fitting cabinet with ventilation apertures worked in at the top and bottom sides
