## **Investigation Report 338/03**

**1 July 2004**

**Very Serious Marine Casualty**

**Loss overboard of a yachtsman  
sailing on board SY LISA  
on 8 November 2003  
east of Fehmarn at the  
buoy "Staberhuk Ost"**

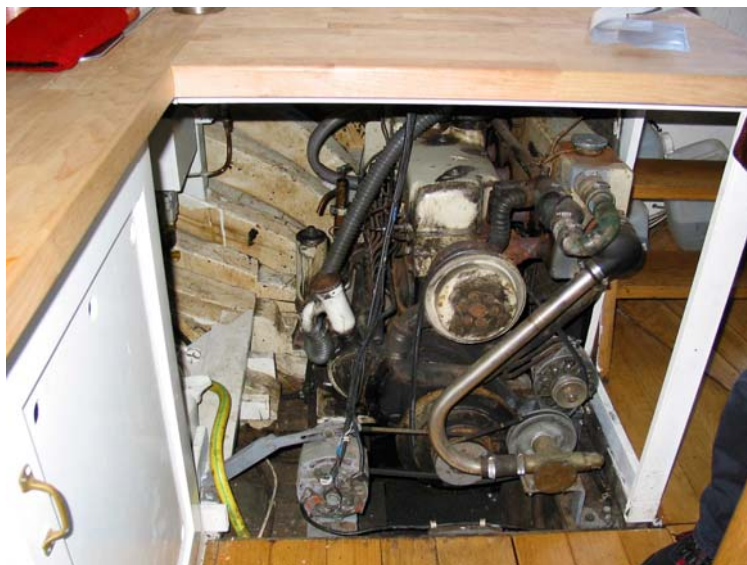
Figure 4: Main engine viewed from forward

At the time of the survey by the BSU the vessel was in a good state of maintenance. The main engine is a 6 cylinder Mercedes Diesel engine of type OM 312. The engine is arranged directly next to the companionway. The engine plates and sound insulation towards the front and middle of the vessel were not on board.

With the engine standing open like this there is a risk that during swell and with a running engine hot or turning parts could injure someone. Since there is no sound insulation it is problematic to communicate using the radio set installed directly next to the engine on the port side, and communication on the aft deck is probably covered by the noises.

The owner, Mr. A, informed the BSU that he had had the engine plating at home, since he had planned to paint the engine before installing it. As he was going to be spending most of the time on deck during the voyage in any case, he would not have had any problems with the high noise level of the engine without its sound insulation. All the co-yachtsmen had been informed of the open condition of the engine compartment and had been instructed to keep away from it.

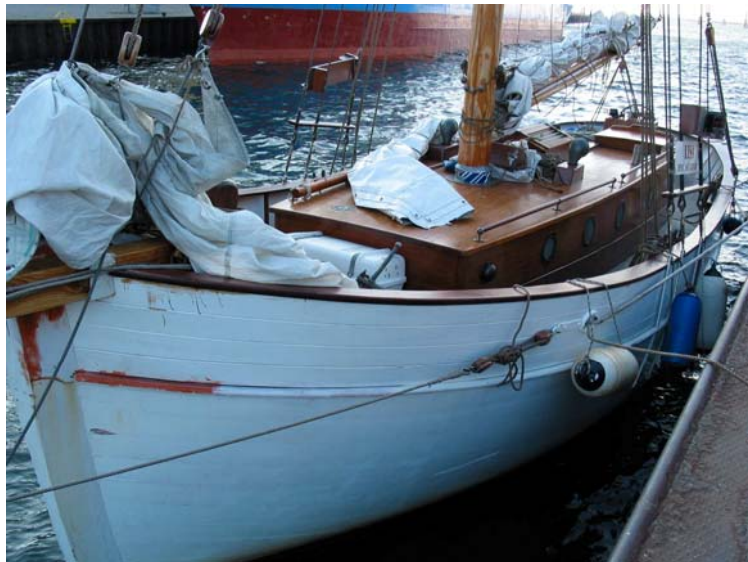
Figure 5: Bulwark and superstructure

SY LISA has handrails on the port and starboard sides throughout the entire superstructure area. There is no possibility of securing stretch ropes on deck. The steering stand with the most important engine operating and display instruments is arranged unprotected in the aft part of the vessel. A check of the hydraulic rudder system revealed that the rudder position indicator did not react and there was no possibility of inserting an emergency tiller directly on the rudder head. There was no bow pulpit or stern pulpit.

The bulwark is 0.50 m high and thus does not comply with the safety guidelines of the Cruiser Division of the German Sail Association (DSV) for equipment and safety on sailboats. This guideline states that the sea railing must be at least 0.60 m high above the working deck.

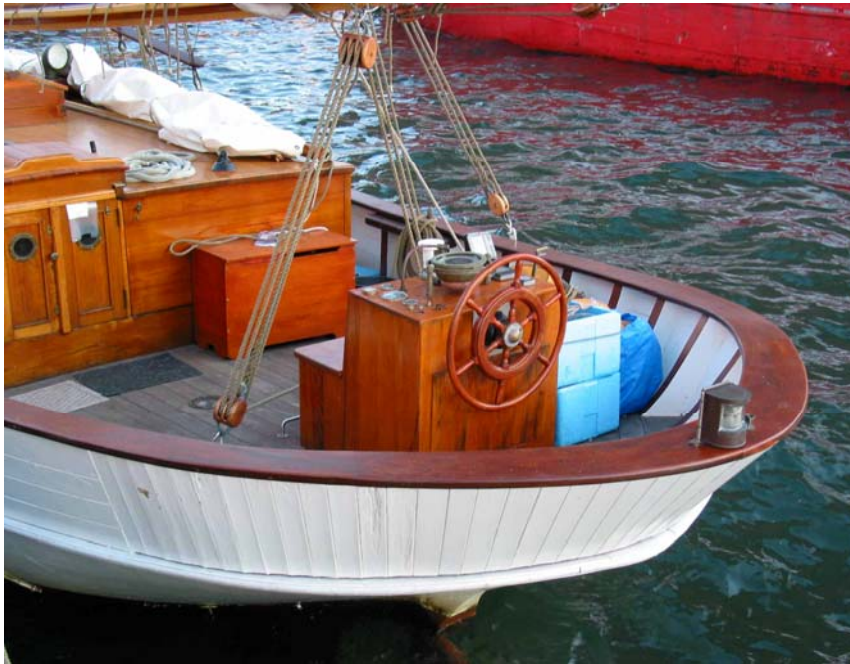
Figure 6: Mainsheet arrangement

The main sheet consists of 18 mm brown Roblon rope. A 2-sheave block with becket is mounted on the port side and a single-sheave block on the starboard side, while a 3-sheave block is secured to the main boom.

There are no swivel shackles on the blocks so that the sheet lead is firmly fixed. The fastened end of the sheet is secured to the becket on the block on the port side and runs from there to the 3-sheave block on the main boom and then to the single-sheave block on the starboard side, back to the block on the main boom and altogether twice again to the block on the port side. The loose part is guided from the port side to the starboard belaying cleat. The deck-horse midships is not equipped with blocks. The distance between the blocks and the deck is approx. 1.40 m. This sheet arrangement means that the boom has a slack of approx. 0.80 m to 1.30 m when the sheet is pulled in tight. The simple 12 mm securing line, not executed as a pulley, is only to be considered as a safeguard measure against the boom swinging round when the sails are down, and does not represent any assistance when jibing. Performing a jibe without the assistance of a multiple-sheave securing pulley is problematic, since the boom cannot be brought midships due to the arrangement of the sheet lead.

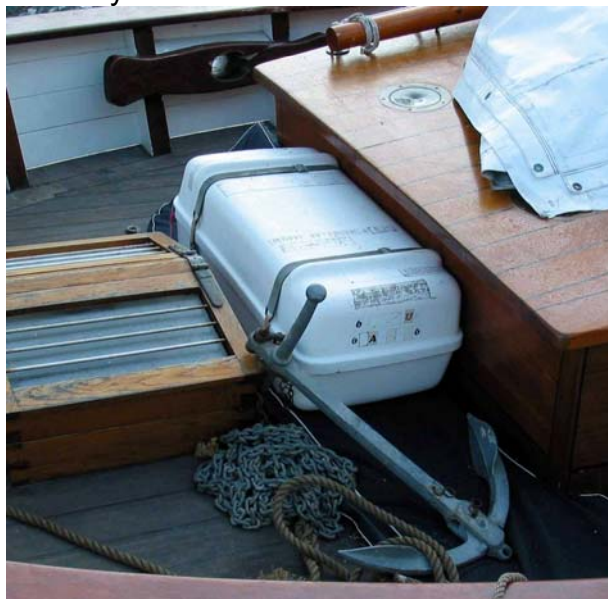
Figure 7: Liferaft

There was a liferaft lying unlashd on a ship's pad on the fore ship. The manufacturer and type could no longer be clearly ascertained.

The pull-line/release line was projecting from the liferaft and was not fastened anywhere. According to the print mark still legible on the liferaft container, the last date of testing was 4/88 and the liferaft was licensed for 6 persons.

The owner stated that this had been checked technically by a non-authorized person and had not received any current sticker with the test date.

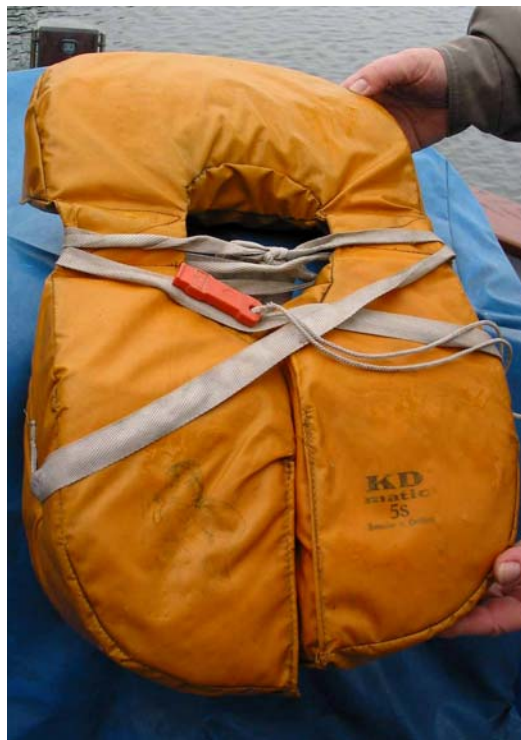
Figure 8: Life jacket

Altogether seven old solid life jackets from the firm Kadematic were found lying on the aft deck packed in two plastic bags, next to the steering stand on the starboard side. These jackets that were formerly authorized by the safety organisation See-BG did not have any reflecting strips or any life jacket lamps. The owner stated that he had received altogether 20 jackets from the former ferry DEUTSCHLAND. The following different statements were made regarding the storage location on deck at the time of the accident. One person stated that the two bags had been at the front. The second statement was that two bags were aft, and the third statement claimed that two bags had been at the front and an additional third bag aft on deck.

Five inflatable life jackets were found below deck in a cupboard on the starboard side. None of the jackets were operable anymore. The carbon dioxide cartridges for automatic/manual filling were no longer present in four jackets, so that these were totally unfit for use, since without the cartridges the air would have escaped again through the open screw aperture if the jackets had been blown up by hand. The CO<sub>2</sub>-cartridge of the fifth jacket was empty. However, it would have been conditionally fit for use if the jacket had been inflated by hand.

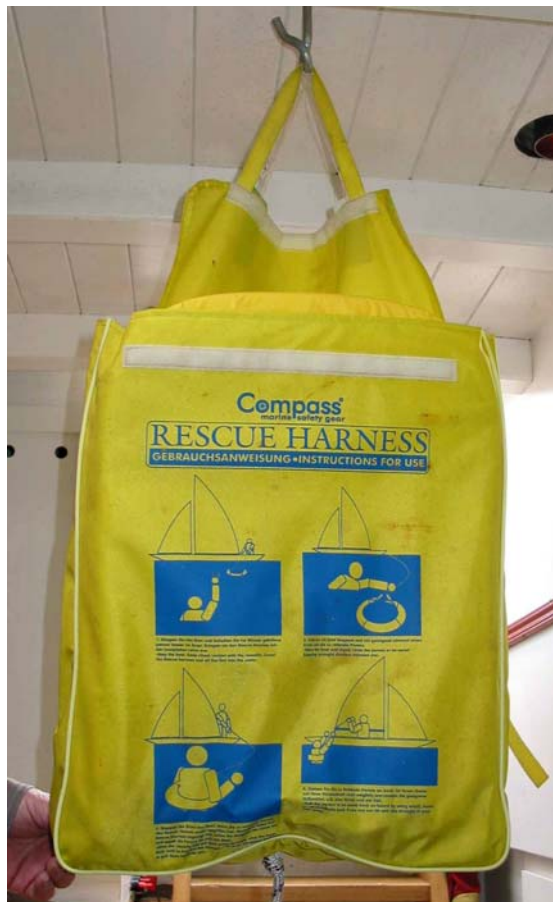
Figure 9: Rescue harness

No life buoy or solid life-cape was found on or below deck. There was only a new "Compass" rescue harness, fit for use and firmly packaged, beneath the starboard berth below deck, provided with 45 m floating line and a holding bag for attaching ready for use on a sea rail.
