Investigation Report 350/03

Very serious marine casualty:

**Death of a crew member of
MV AUTO ATLAS
on 11 November 2003
in the North Lock Bremerhaven**

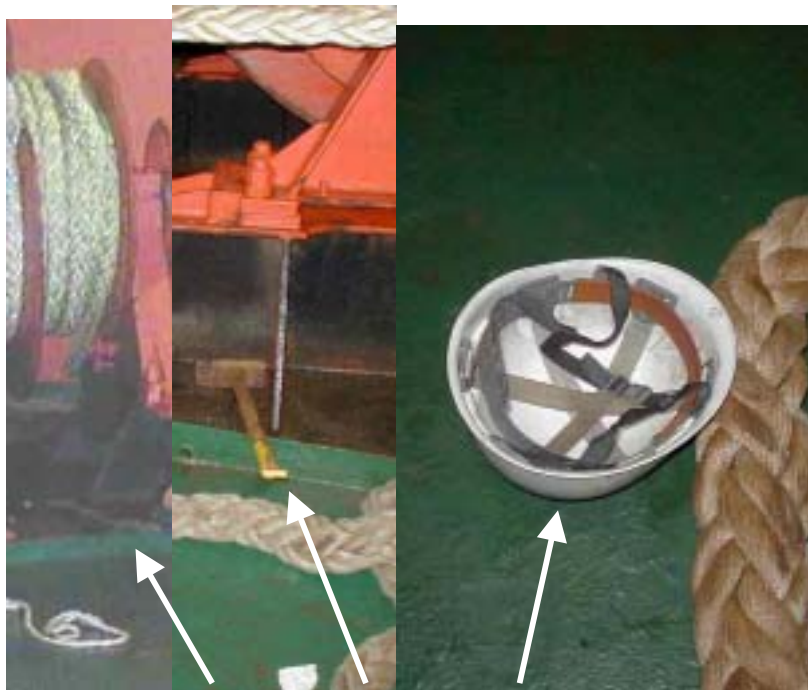
On the basis of this first questioning it was determined that the fatal head injuries had been caused by a crowbar found in the area of the port winch. The seaman had reportedly attempted to clear the jammed bow spring with the aid of this crowbar. The line reportedly became tight and the crowbar was flung out of the deceased's hand. He reportedly started to stumble and as a result lost his helmet. The crowbar reportedly then hit him on his unprotected head and caused the fatal injury.

The tool was secured. Furthermore the seaman's safety helmet which was lying intact on deck next to the winch was also secured. Investigations revealed that the helmet had not been fastened with the chin belt and that is why it had been flung from the seaman's head. A hammer also lying near the winch was not secured since its connection with the accident was only mentioned in the written comments by the Chief Mate and the Boatswain produced later.

Figure 3: Crowbar, hammer and helmet in the area of the winch
(Photos River Police Bremerhaven)

The crowbar initially suspected to have been connected with the accident and thereupon secured on board can be clearly ruled out as the direct cause of death. No serological traces could be found, either visually or on the basis of microscopic preparations prepared on the basis of random samples. Nor do the photos taken on board of the evident head injury show the typical configuration of injury caused by crowbar contact. In the same way, the possibility that a hammer could have caused these head injuries directly can also be ruled out.

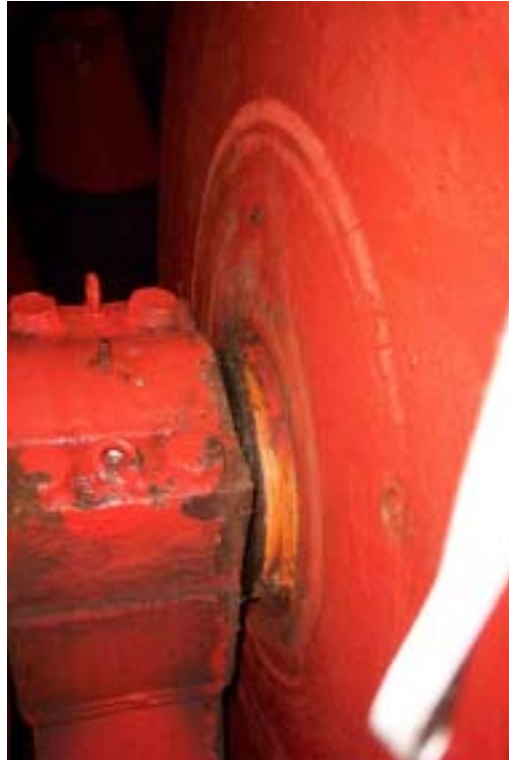
A grinding/abrasion mark was ascertained on the left side plate of the winch drum - viewed in the direction of travel - and photographed.

Figure 4: Grinding/abrasion traces on the side plate
(Photo Criminal Investigation Department Bremerhaven)

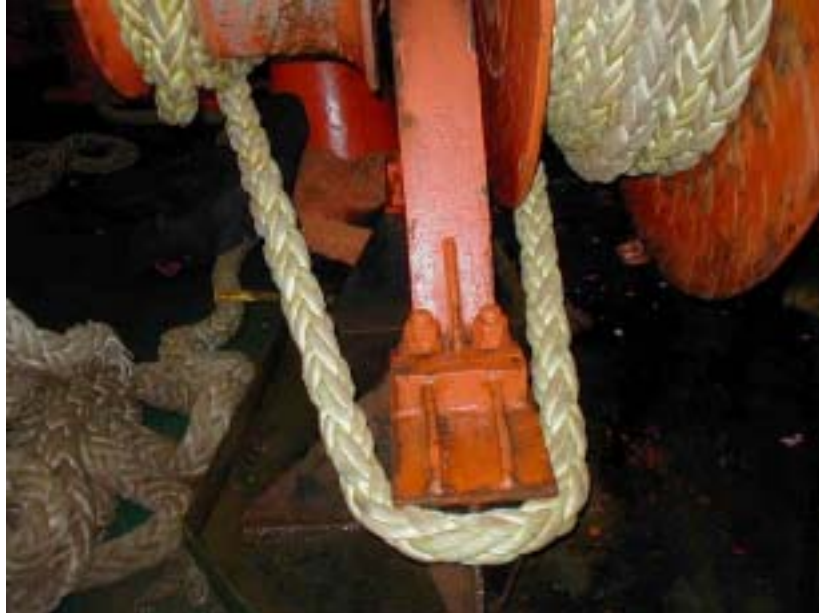
On arrival of the River Police on board AUTO ATLAS about 15 minutes after the time of the accident the bow spring was running from the working part of the winch drum, round the foundation of the winch bearing pedestal and from below to the forward side of the capstan head.

Figure 5: Line management on arrival of the River Police
(Photo River Police Bremerhaven)

The line had been made fast on the capstan head with three turns, and then ran from the capstan head again from below to the forward bulwark, with the moving part being jammed to the winch drum.

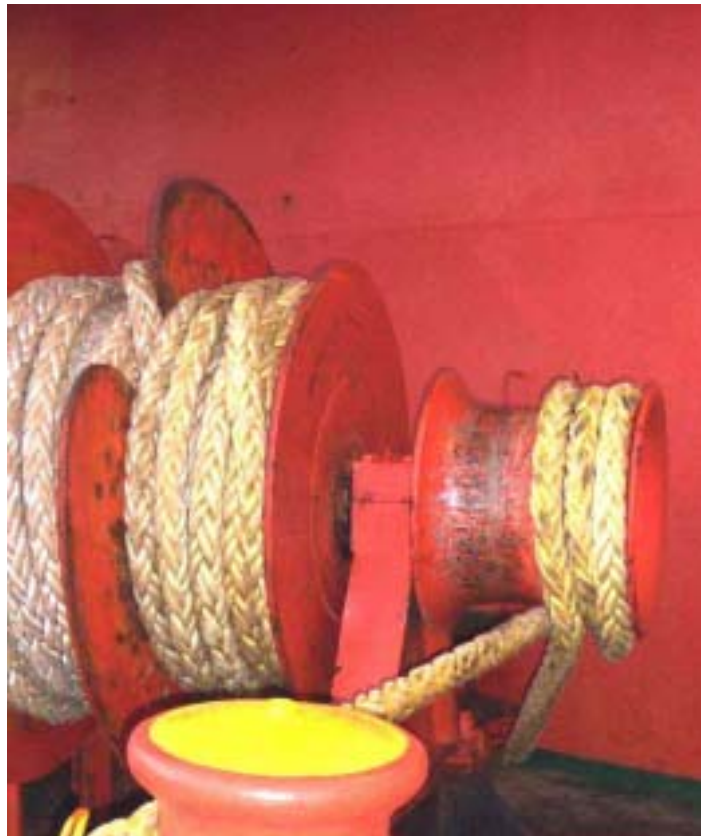
Figure 6: Line management on arrival of the River Police
(Photo Criminal Investigation Department Bremerhaven)

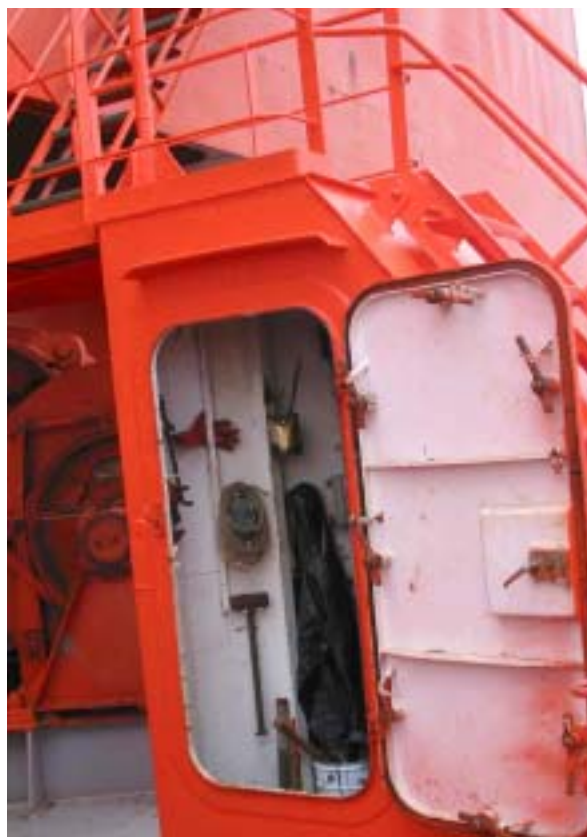
Figure 7: Storage place for tools on the forecastle

The hammer was reportedly usually kept below the companionway to the forecandle, close to the entrance door. The seaman had fetched the tool from there without having received any express instruction to do so. Following his own suggestion and with the tacit agreement of the Chief Mate, he had tried to free the bow spring with the hammer. Furthermore the seaman had apparently also brought the crowbar, subsequently found in the area of the winch and secured by the River Police, from the forecandle companionway.

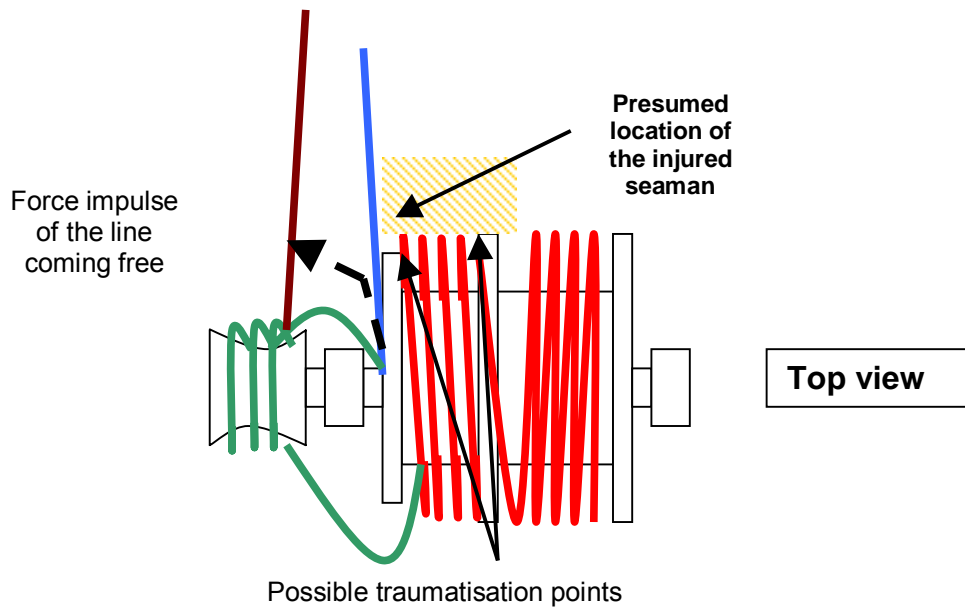
The course of the accident cannot be clarified with complete certainty by forensic medicine either. However, in order to be able to explain the situation of the victim of the accident and the place in which he was found sufficiently, the traumatising of the seaman concerned must have occurred directly in the area in front of the winch drum. Accordingly the seaman must have been midships of the jammed line. A violent force impulse resulting from considerable acceleration then led to blunt force acting on the skull of this seaman. It appears most probable here that his head hit the left side plate or middle plate¹² of the winch drum. Stumbling against one of these plates caused by movement of the vessel can be ruled out, since the injuries to be expected as a result of this would not have reached the extent of the injuries sustained in this case. The acceleration of the injured seaman's body necessary to cause such injury could accordingly only have been caused by the force impulse of the line coming free. The main vector of this impulse was directed to port; when the line springs free, however, an additional short vector directed upwards is also possible. It is conceivable that the seaman was admittedly standing midships, but despite this so close to the line that the necessary acceleration could have been caused as a result. It is also conceivable that he tried to support the freeing of the jammed line using a tool as lever, e.g. the crowbar found right in front of the winch. As the line came free the resulting force impulse would then have been transmitted via the tool and could thus have caused the necessary acceleration of his body.

Figure 8: Forensic reconstruction

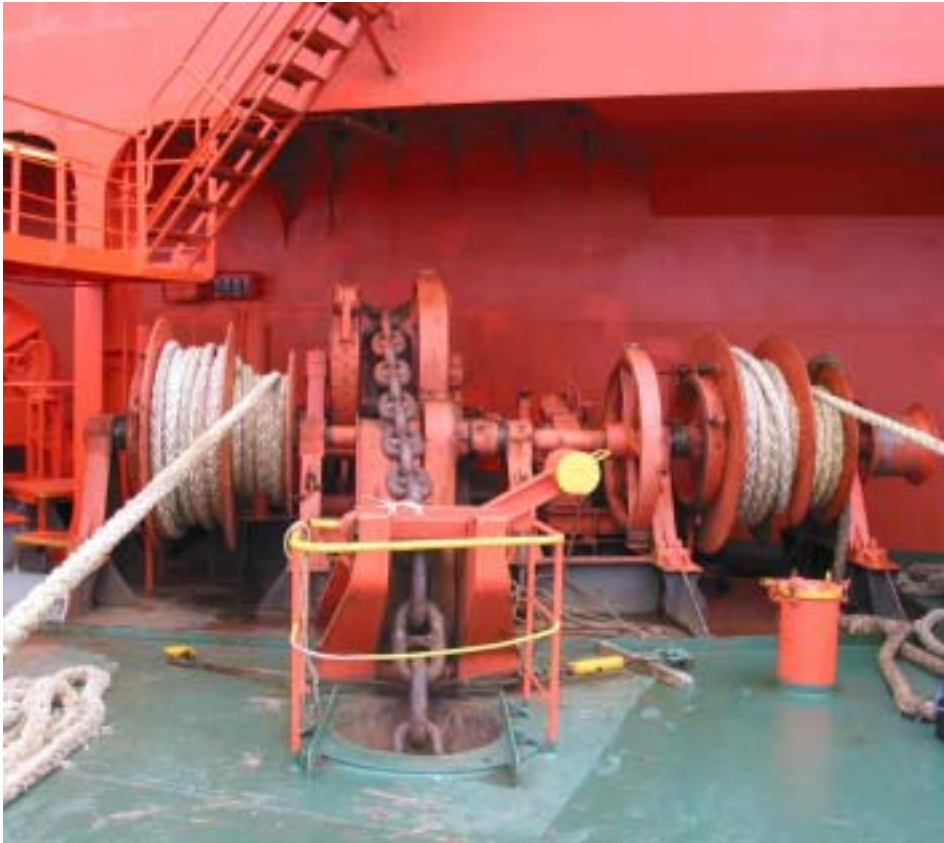
The port winch relevant for the accident is a winch of type Fukushima K7681 III–W320 with the following technical details:

Figure 10: Port winch

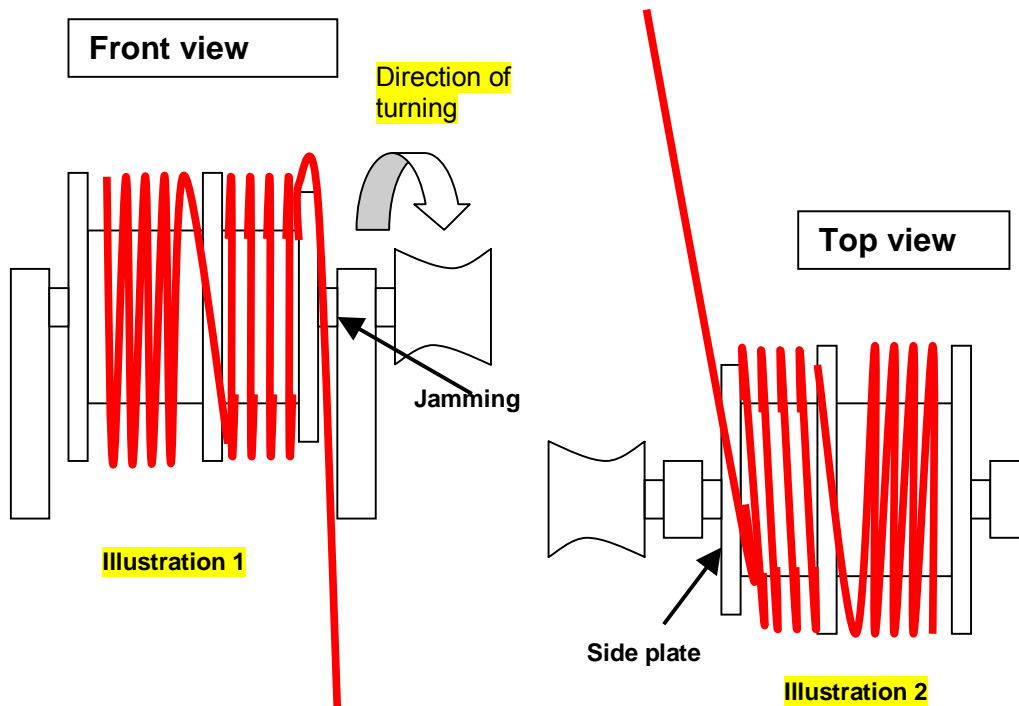
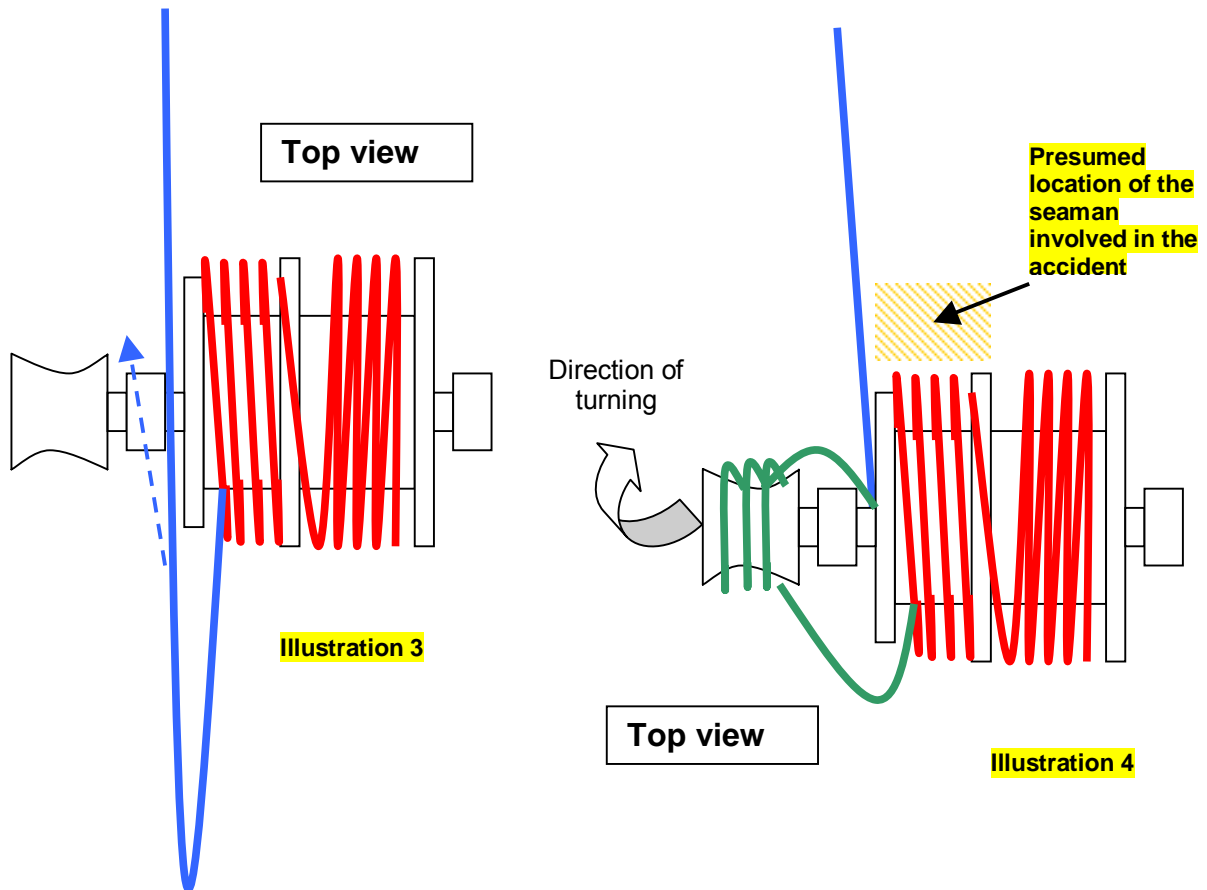
When slacking the bow spring, it ran over the left side plate - viewed in the direction of travel - of the winch drum of the port mooring winch. Due to continued slacking the line was drawn from the front into the lower area between the side plate and the winch bearing pedestal and became jammed there (illustrations 1 and 2) while the vessel was still moving and at this time there was still slack in the part of the line made fast on shore.

At the same time as a result of the continued slacking some slack was taken in the area behind the winch (illustration 3). After the unsuccessful attempt to free the jammed line with a tool, the crew turned the line in three turns round the capstan

head in order to free the bow spring from its jammed position by heaving¹³ with the capstan head (illustration 4).

As a result of the fact that AUTO ATLAS was still moving forward at this time the part of the bow spring made fast on shore became tight; by heaving of the line at the capstan head the part between the jammed location and the capstan head also became tight. After this the bow spring freed itself from the jammed position and struck out to port with enormous force. At the same time the line slipped over the capstan head and the slack still behind the winch was pulled through (illustration 5).

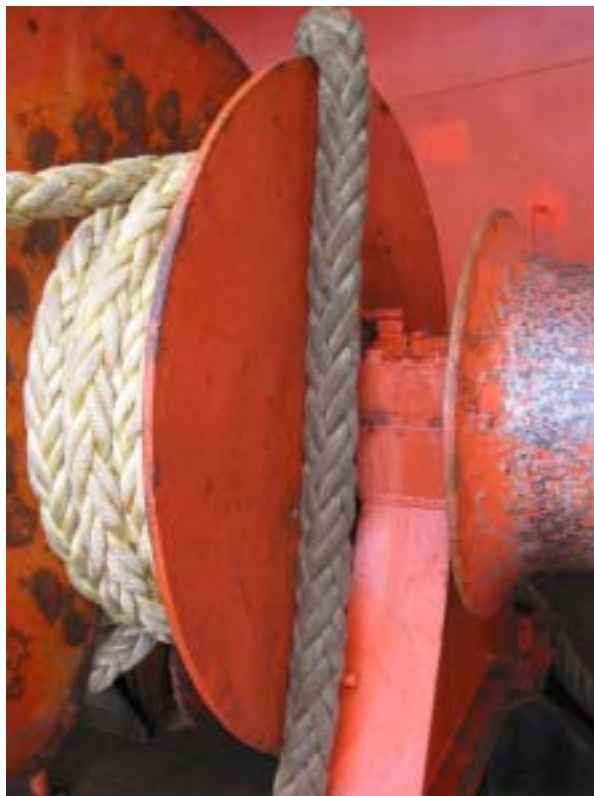
Figure 12: Reconstruction of the line clamp according to testimony of Boatswain on 5 February 2004

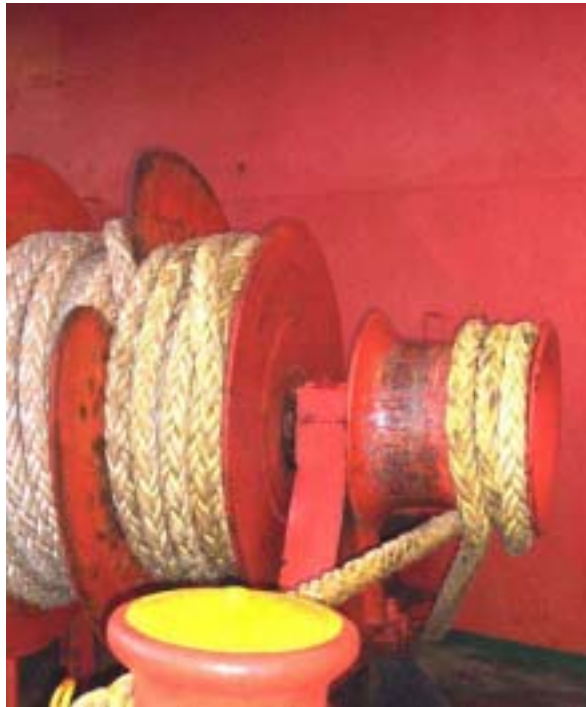
designated 4 layers were regularly used during stowage, and more than the planned first layer was used in the working part of the drum during mooring.

In addition to the effects of too many layers in the working part already described, with line wound so high the king bollards additionally lose their function as the means for sound line management, since these are lower than the running height of the line.

Figure 13: Port winch in the lock
afternoon of 11 November 2003 (Photo Criminal Investigation Department Bremerhaven)

The line handling on board, in particular the coiling of the line in the working part of the mooring winch contrary to the manufacturer's instructions, is assessed as the starting point of the accident occurrence. This was the cause of the line running from the left drum of the port mooring winch over the side plate of the working part and subsequent jamming of the bow spring. The following course of events up to the fatal accident was then promoted by a series of factors.

- Lines used on board must be suitable and admitted for the designated use as regards nature, material, length and diameter. When lines are heaved in, the maximum number of layers in the storage and working parts of the winches stated by the manufacturers must be observed. If circumstances require that more than these proposed layers be taken onto the drum, especially in the working part, the condition provided for by the manufacturer is to be restored immediately after completion of the manoeuvre. The manufacturer's data concerning maximum number of layers in the working part of the drum relate exclusively to stowage of the line. During mooring operations basically only one layer of line is to be used in the working part in order to have maximum winch pulling force available and to prevent any unintentional damage to the line by cutting into the layers beneath. The procedure described above applies by analogy for shifting of the rope after completion of the manoeuvre.

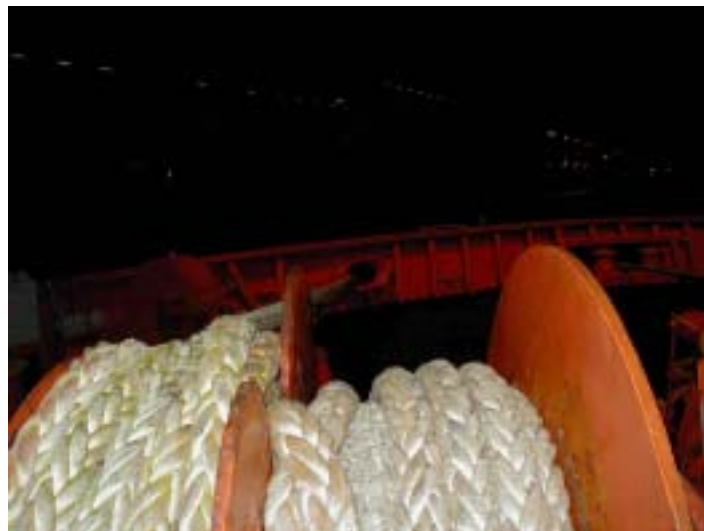
Figure 14: Port winch at the Columbuskaje pier
evening of 11 November 2003 (Photo River Police Bremerhaven)

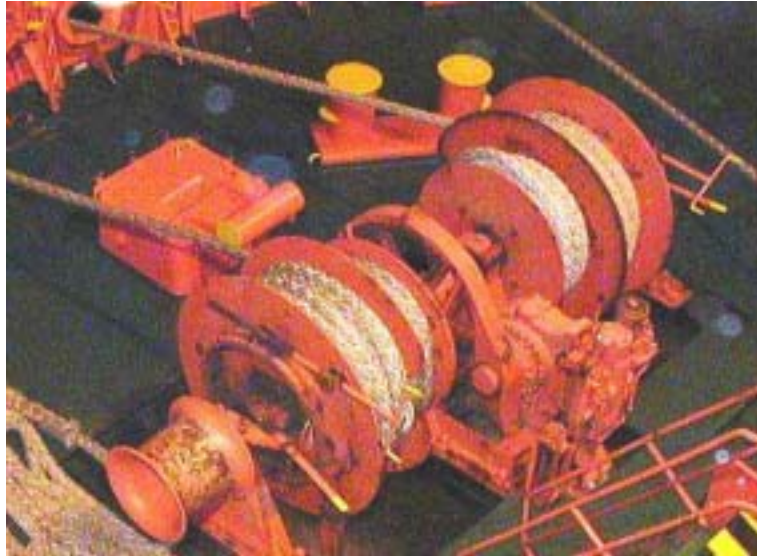
The photos taken on the date of the accident additionally show a similar situation on the other winches on the forecastle too. In addition on the midships winch the division into storage and working part was not observed consistently. Here the line from the right drum was made fast on shore from the storage part instead of from the working part.

Figure 15: Midships winch, 11 November 2003
(Photo River Police Bremerhaven)

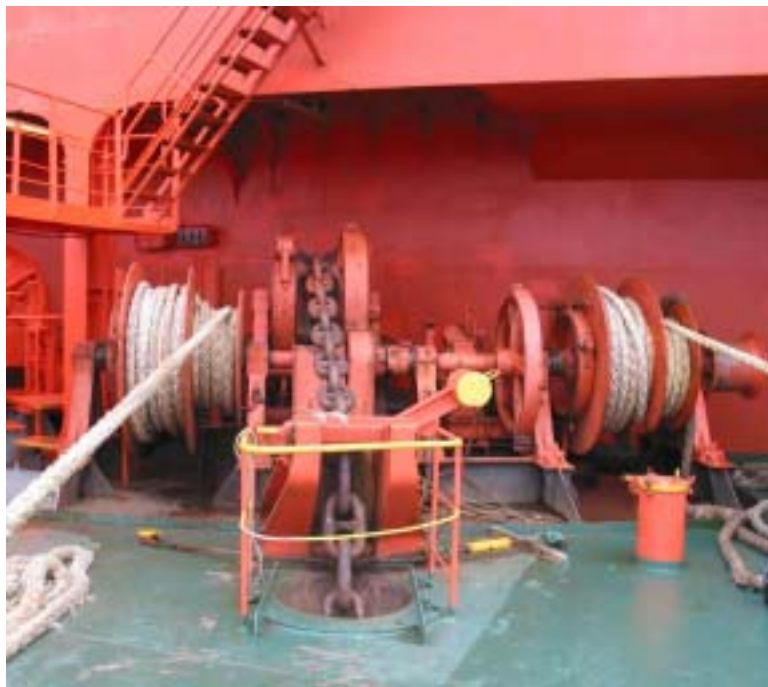
During the next call of the vessel in Bremerhaven the line winding situation on the forecastle mooring winches was unchanged. Both drums of the port winch had more than one layer used in the working part.

Figure 16: Port winch on 5 February 2004

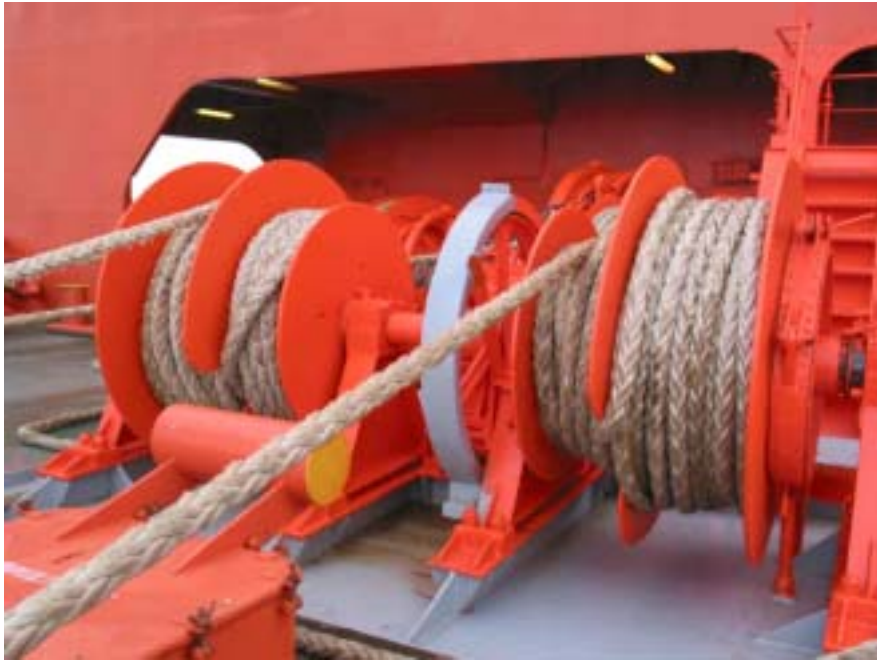
The drums of the midships winch were also used with more than one layer in the working part; in addition the division into storage and working part on the right drum still had been interchanged.

Figure 17: Midships winch on 5 February 2004

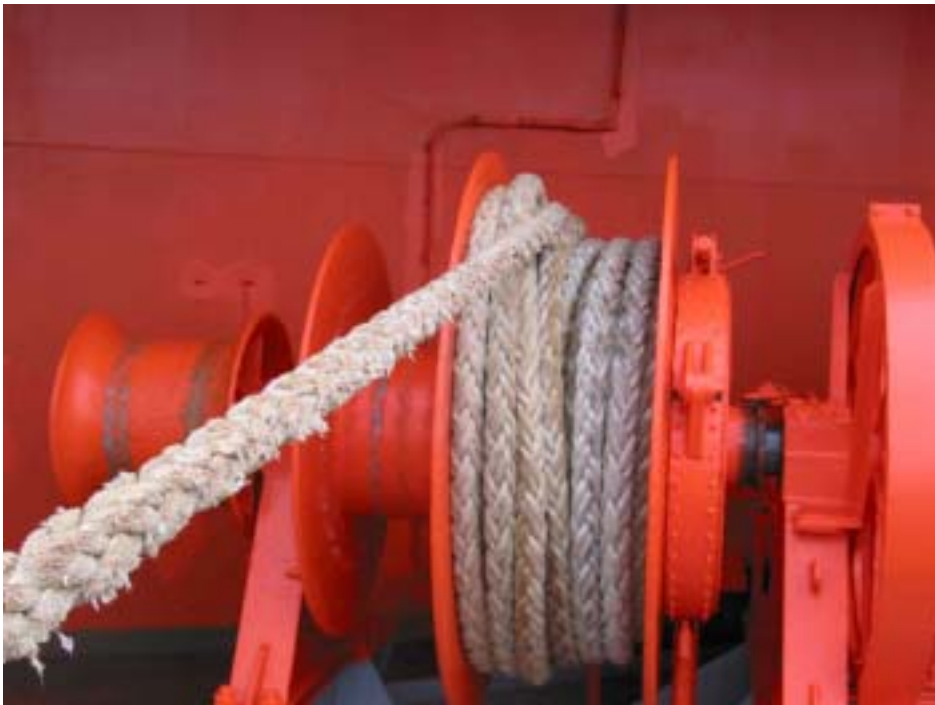
The working part on the right drum of the starboard winch was empty. At this time AUTO ATLAS was moored with its starboard side alongside; the bow spring was directly taken from the storage part.

Figure 18: Starboard winch on 5 February 2004

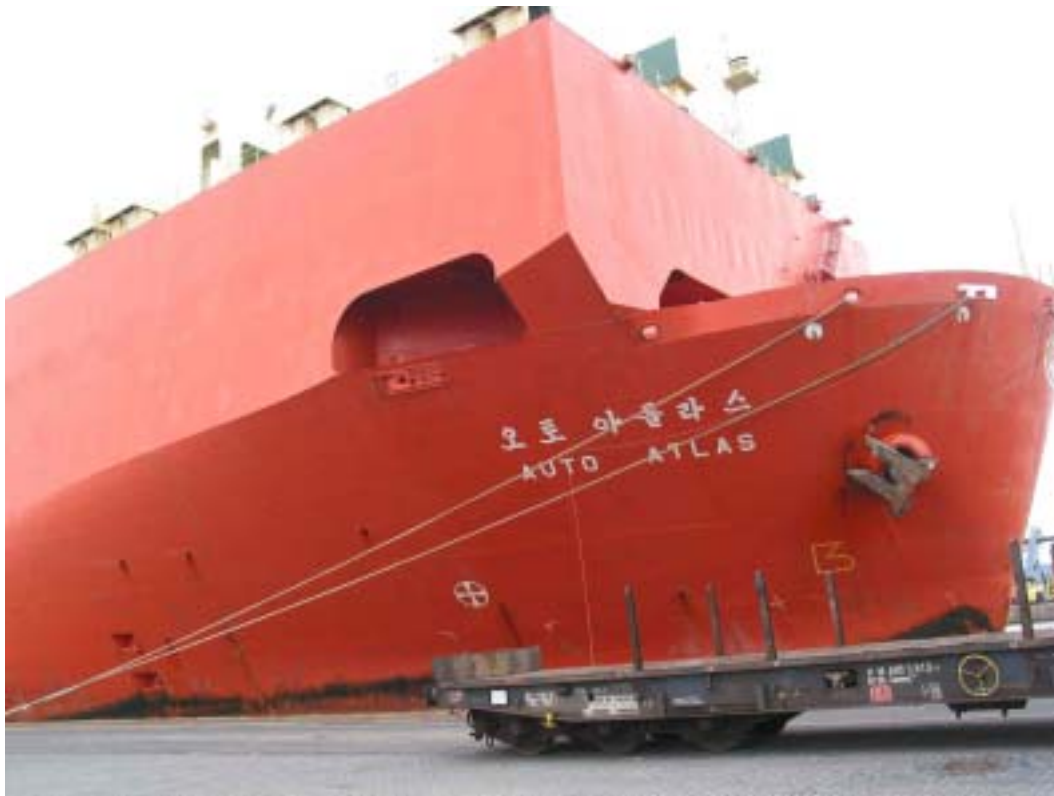
The crew's attempt to free the jammed line first by using a tool and then with the aid of the capstan head, especially at a time when the mooring manoeuvre was evidently not yet completed, and when the line became tight due to the movement still in the vessel, documents a serious misestimating of the hazard potential here on the part of all concerned. In particular the type of construction of the AUTO ATLAS as a car carrier with a far-projecting fore ship virtually deprived the crew of any possibility of observing the bow spring made fast on shore over the vessel bulwark. The warning time for leaving the hazard area when a jammed line became tight was thus extremely short.

Figure 19: Bow spring beneath the forecastle superstructure

from the jammed line by suitable measures such as shifting the vessel aft. The selection of location for freeing of a jammed line is to be made taking into account all possible directions of danger when the line comes free or ruptures. On deciding when and at what time a jammed line is to be freed, attention must be paid especially to whether the line is needed immediately for reasons of ship safety.

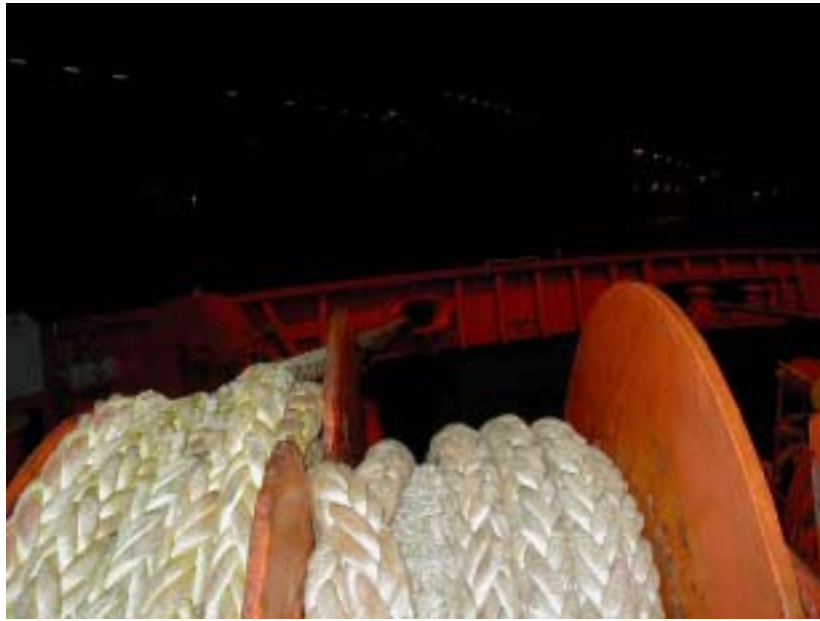
Figure 20: Rope in the working part of the winch under load and exceeding the proposed rope layers

Not only does the nominal pulling power of the winch decrease here with increasing number of layers with the same input torque, but also the danger of the rope springing over and subsequently becoming jammed is substantially magnified. At the time of the accident the bow spring was already fast on shore; after the line length necessary for this had already been taken from the working part of the drum, the line ran over the side plate despite this. The bow spring was then jammed between the winch drum and the bearing pedestal. The design distance specified here is 50 mm. Although a line with a diameter of 80 mm as designated by the manufacturer was used in this case, the turning winch drum caused the line that had jumped over to be drawn into the intermediate space between the side plate and the bearing pedestal and thus become jammed. At the time of the accident there were no deflectors that would prevent any line jumping over from becoming jammed.

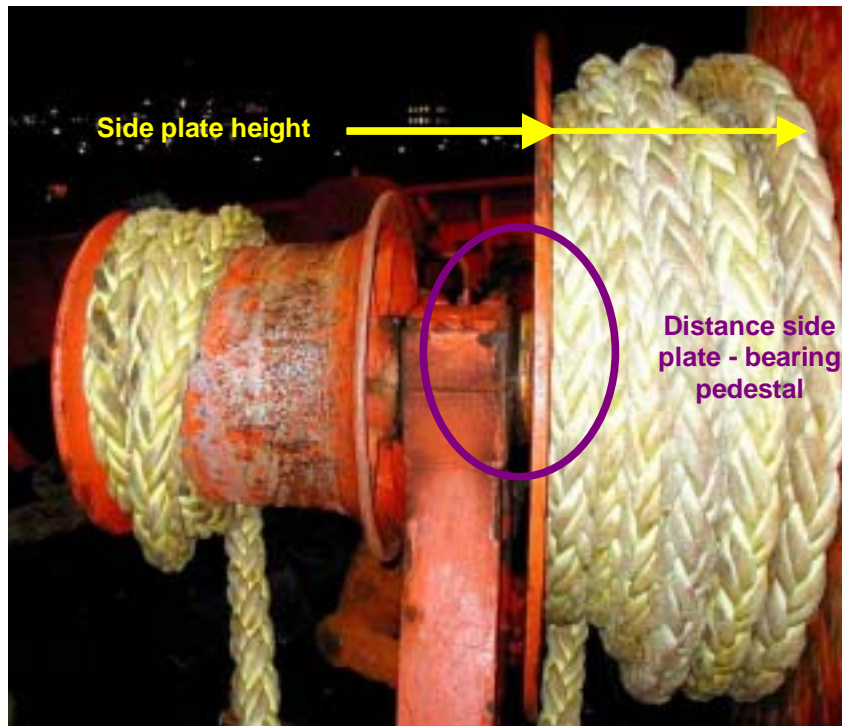
Design specifications were not the cause of the accident. It was only in interplay with line handling on board that they promoted both the developments up to the accident and the further course of the accident.

Figure 21: Design points
(Photo River Police Bremerhaven)

- Regardless of the design of the drums and side plates there is a risk of a line running over. Immediate design measures in the form of deflectors welded on as protection against lines becoming jammed should be considered by the shipping company for other vessels in its fleet too. This measure should be considered by the winch manufacturer as a basic structural improvement.

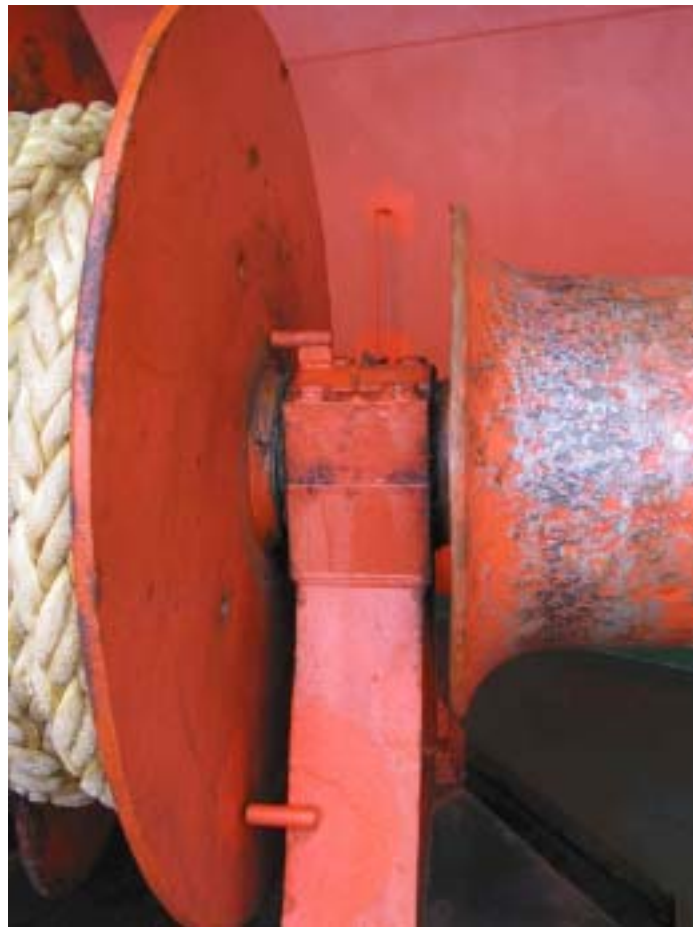
Figure 22: Deflector welded on
