Investigation Report 382/03

Serious marine casualty

**Collision of
MV BOUNDER with MV BBC SWEDEN
in the Kiel Canal, canal kilometre 43
at 18:15 h on 19 December 2003**

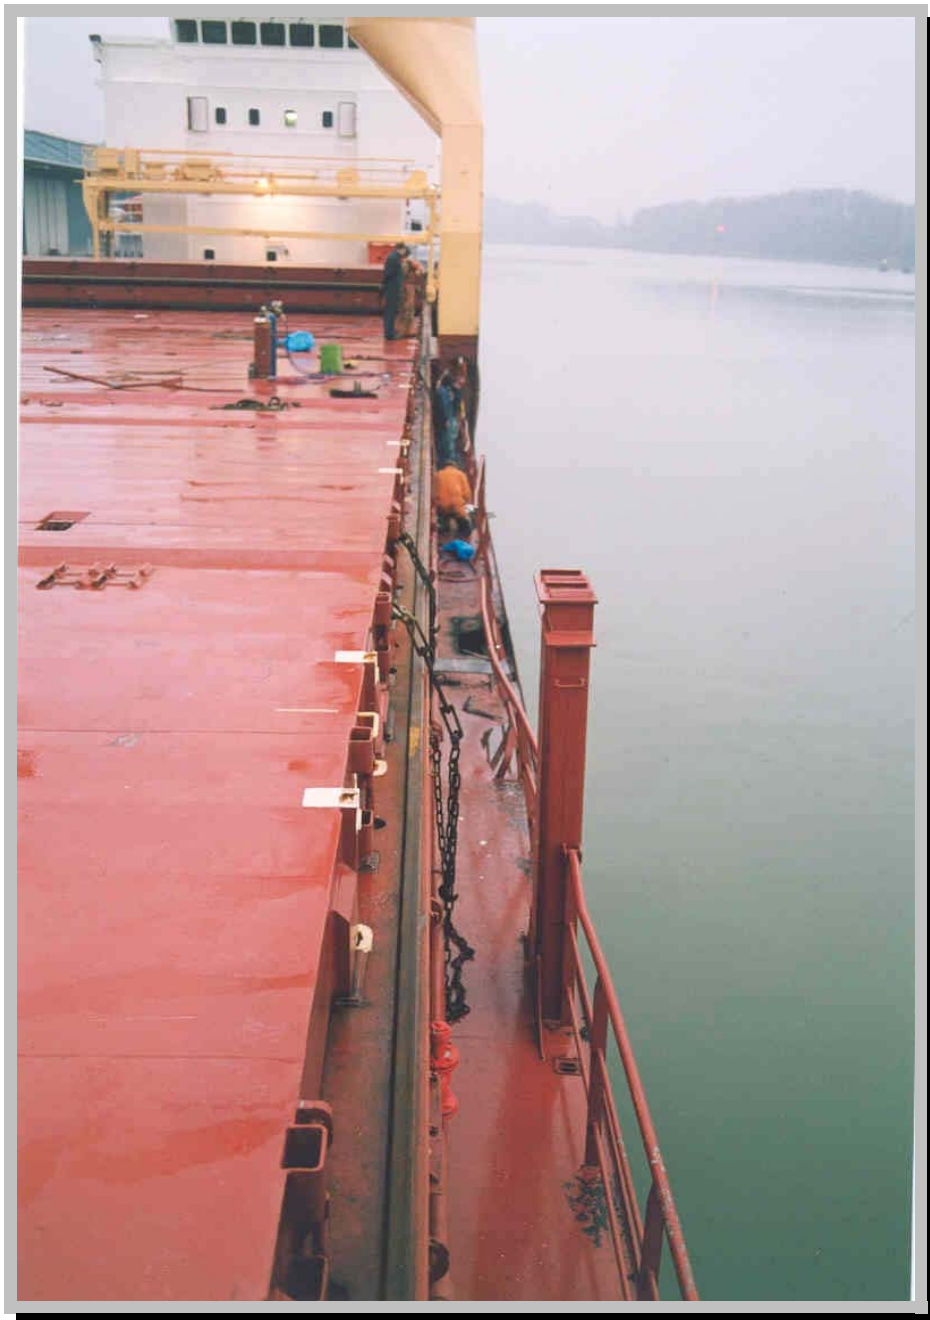
Figure 5: Photo of damage MV BBC SWEDEN

Both vessels sustained considerable property damage above the waterline so that it was necessary for them to visit a yard. There were no personal injuries and no environmental pollution. MV BOUNDER sustained heavy destruction of the bulwark on the port bow. MV BBC SWEDEN was set in over a wide area on the sidewall on the port side. As a result container supports were destroyed and one ballast water tank developed a leak.

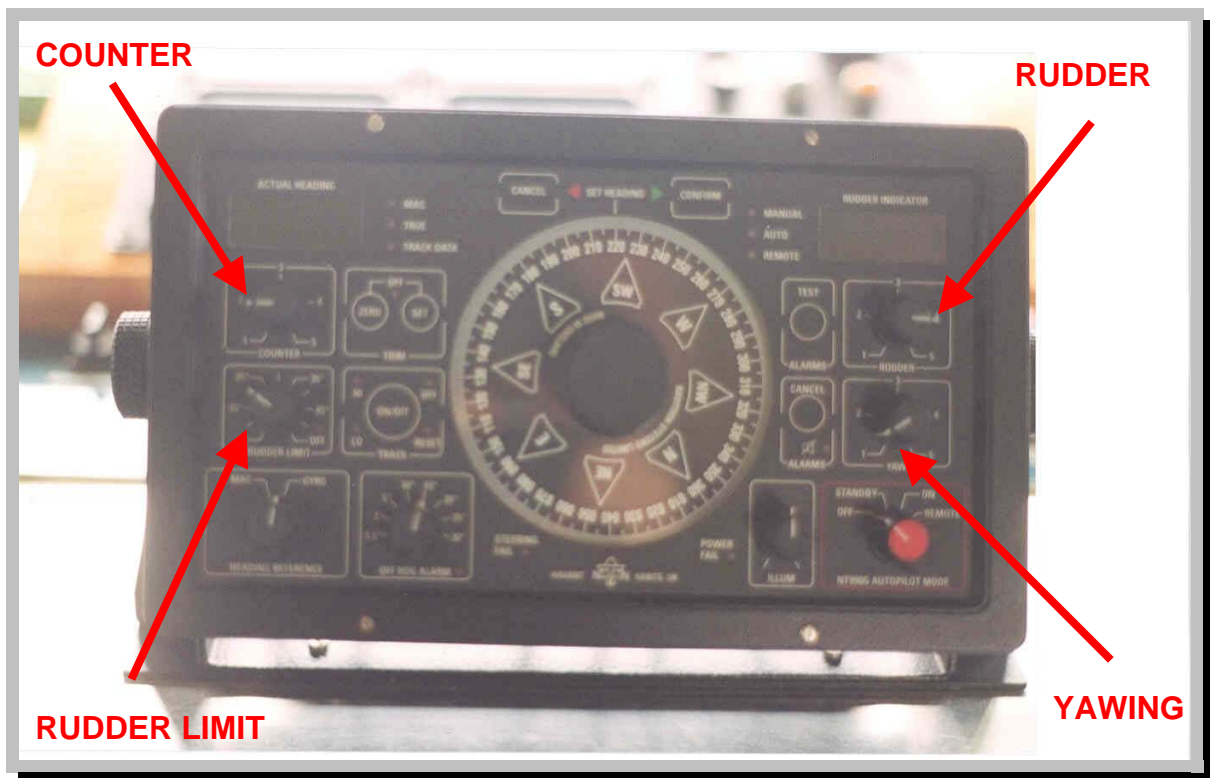
Figure 8: Automatic steering system MV BOUNDER

A little later the Master had found out that the setting for "counter rudder" on the automatic steering system had been changed from its original setting of "1" to "4.2". He had asked the Pilot and the Pilot had admitted that he had made these changes. Furthermore the Pilot had said that he was aware of the serious difficulties that he would now have with the Canal Authorities due to inadmissible use and adjustment of the automatic steering system.

According to the statement by the pilot the vessel was not sailing properly straight ahead at the start of his pilot activity.² The BSU considers that a possible cause of this was formed by the small course corrections made by the pilot that are necessary on passing through the Kiel Canal. On the grounds of the photos taken of the automatic steering system after the casualty it appears that the value for RUDDER was set too high.

Since this value was not mentioned by witnesses in any of the statements, the BSU assumes that this setting was not altered. It can be seen clearly that the control is set at **4**. This means that the automatic steering system performed each small manual course change with a relatively large rudder angle. At the same time the statements by the witnesses indicate that the YAW value was reduced, in other words it was originally higher than **1**. Thus the automatic steering system initially reacted with a slight delay; not during the new course set, but probably during the following automatic course adjustment. To summarise, this means that on each small course change by the pilot the automatic steering system tried to reach the course required with a clear time lag, but with a large rudder angle.

However, COUNTER was set so low that it did not have any notable influence and so the vessel repeatedly shot over the required course and then steered back again. This resulted in a behaviour pattern that the pilot tried to stop by reducing the YAW control and turning up the COUNTER. By setting the control at YAW **1** the pilot achieved a situation in which the automatic steering system reacted immediately to each course deviation, although still with large rudder angles due to the fact that the RUDDER value was still high. The new setting of COUNTER did not have any notable effects since the course deviations were slight.
