Investigation Report 54/03

Collision
MV FALCON BAY
with the Edgar-Engelhardt Quay and the Köhlbrandhöft
on 4 March 2003

15 February 2004

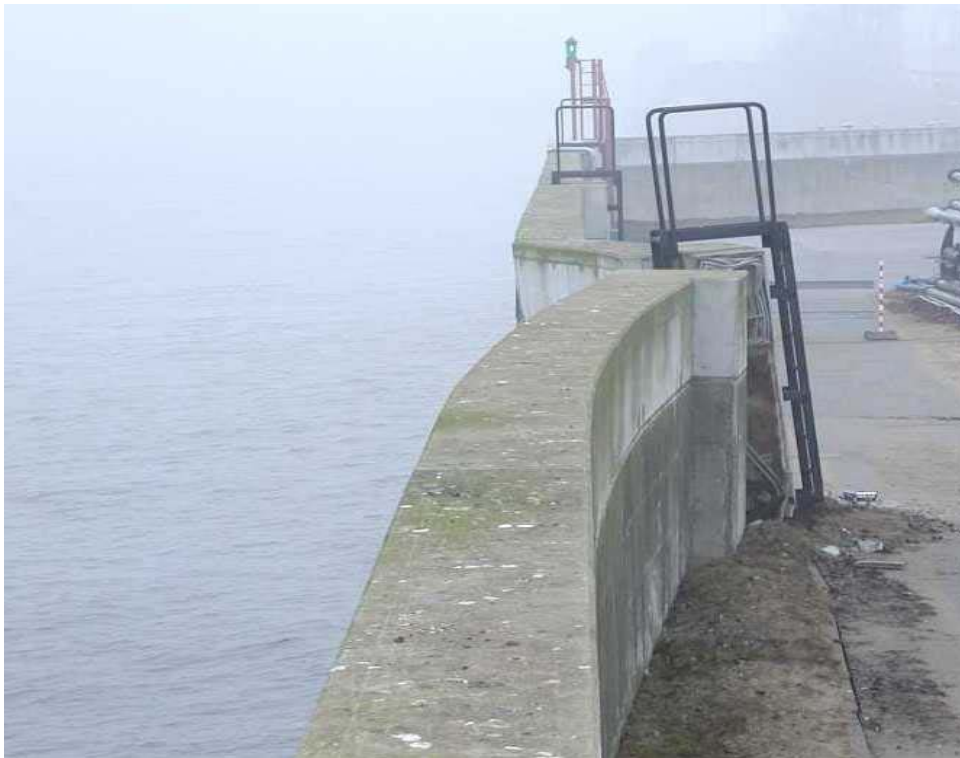
Figure 18: Photo of the damage 4 - Köhlbrandhöft

too late. At 01:30 h CET the vessel had touched the Köhlbrandhöft quay wall with her stern. The stern had been badly dented and the wharf wall damaged.
