Bundesstelle für Seeunfalluntersuchung
Federal Bureau of Maritime Casualty Investigation
Bundesoberbehörde im Geschäftsbereich des Bundesministeriums
für Verkehr, Bau- und Wohnungswesen

Investigation Report 88/03

**Fatal accident of the
Second Nautical Officer
on board MV PETUJA**

on 11 March 2003
in Hamburg

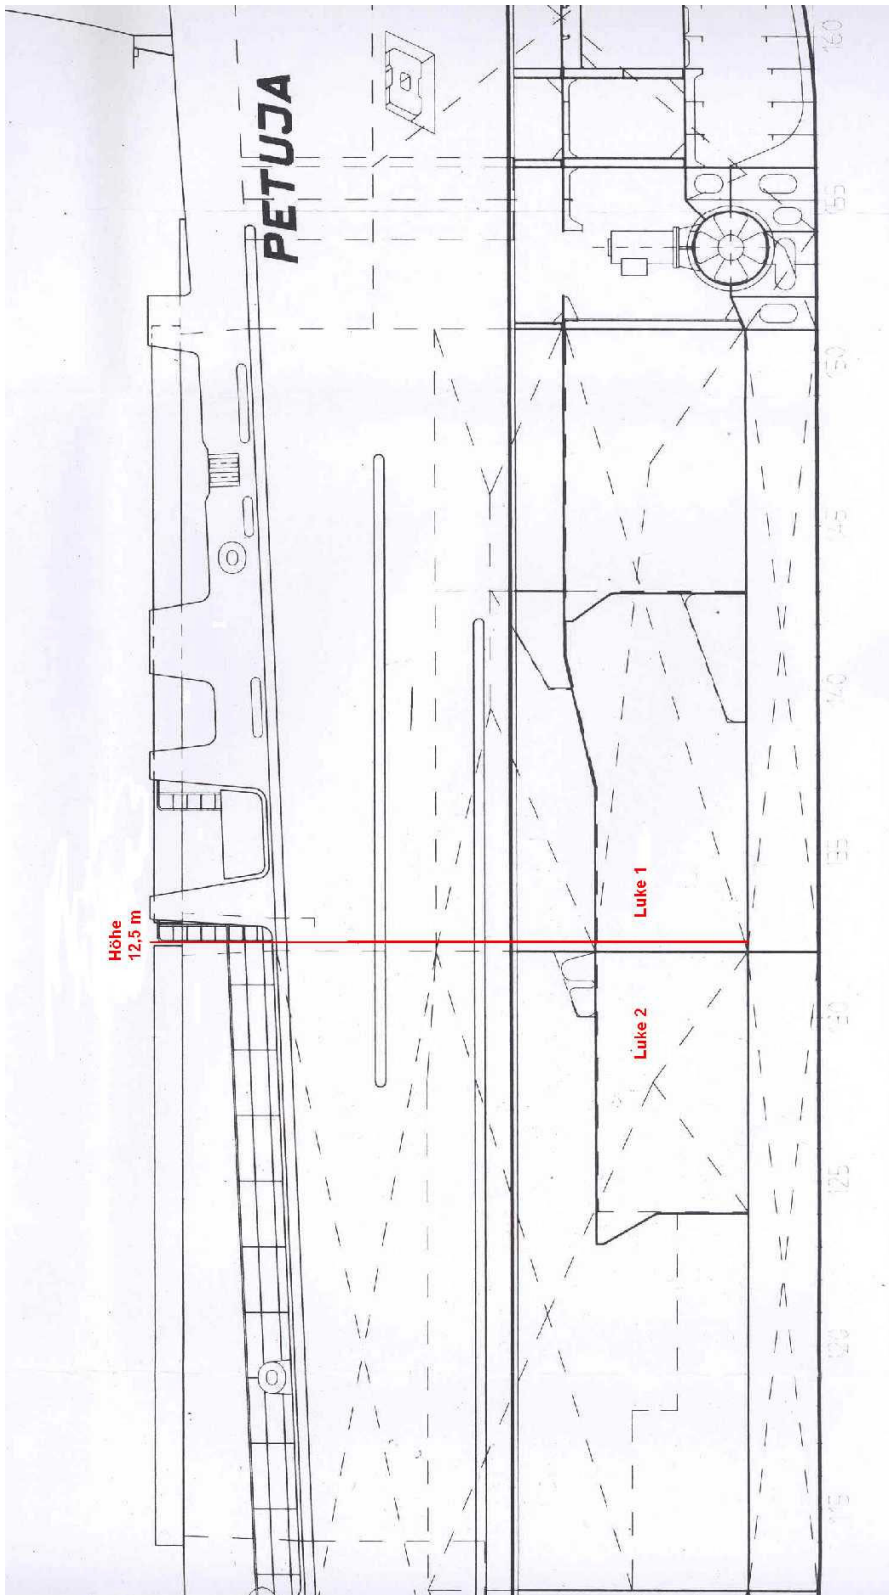
Figure 3, Side elevation, hatch

The investigations by the river police revealed that the injured man had been at the aft edge of hatch 1. The hatch was closed and loaded with containers. The injured man was on the approx. 0.5 m wide catwalk. Hatch 2 follows on from hatch 1 at the same level (see figure 3) and hatch 2 was open. The cargo compartment was empty except for three layers of containers on the port and starboard sides. The person involved in the accident fell into the part of the hold without any cargo, landing on the tank top (see figure 4).

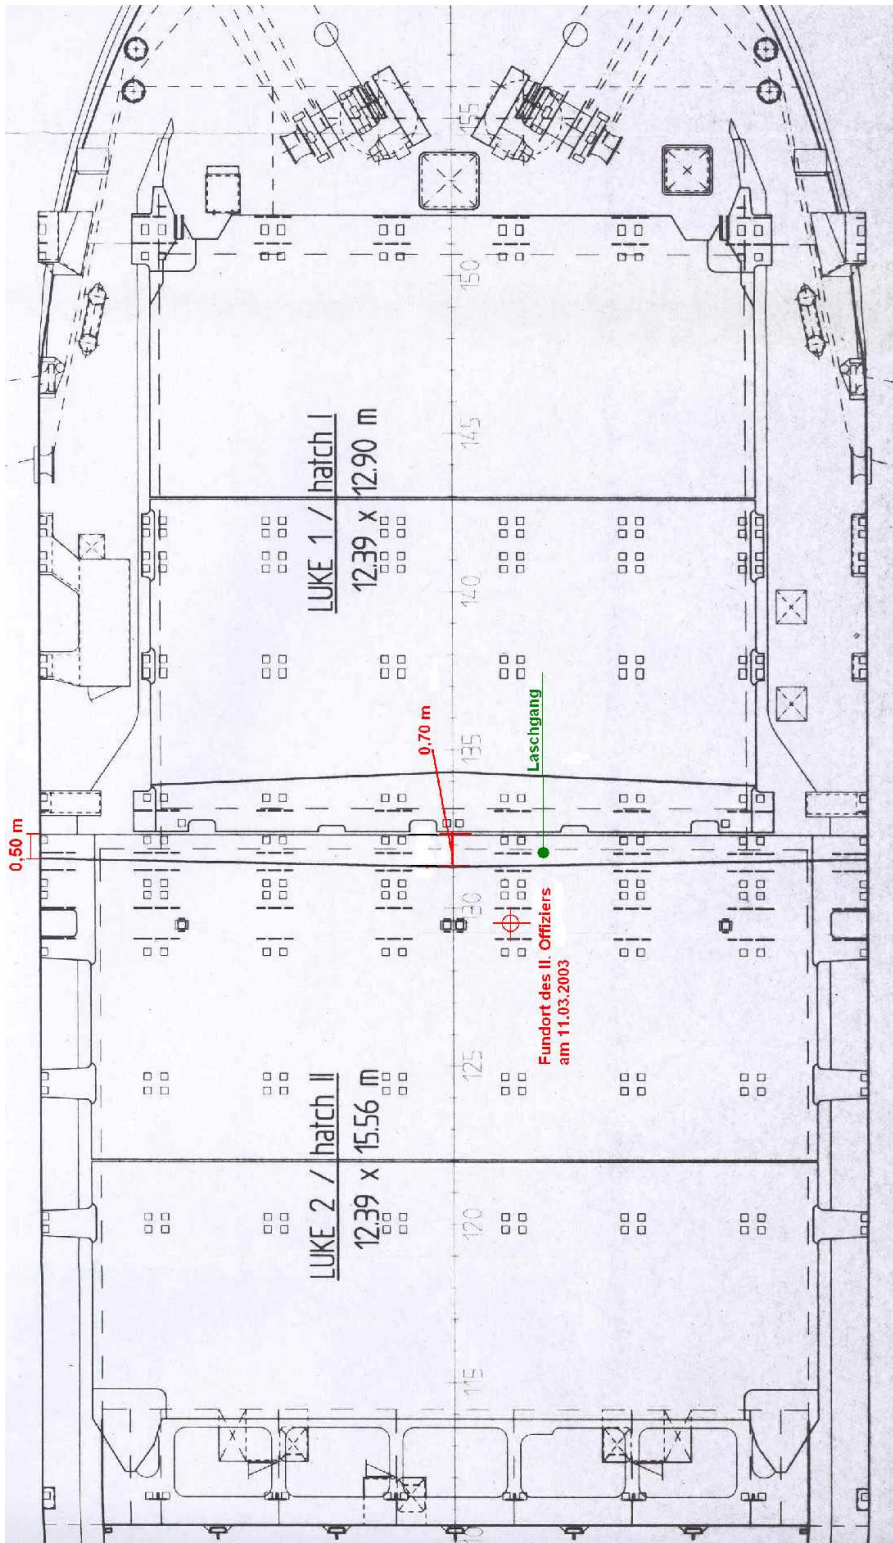
Figure 4, Top view, hatch

The person involved in the accident was probably at the empty container position at the aft edge of hatch 1 (see figures 4 and 5) in order to check the stowage or lashing of the containers and turn to the open hatch 2 also. The deck lighting and hatch lighting of PETUJA were switched on and the deck was illuminated in the way of hatch 1 and 2 by the container bridge shifting to hatch 2. It must have been clear to the person involved in the accident that hatch 2 was open and that he was in a danger area that was not secured. The fall into hatch 2 can have been caused by distraction or stumbling or a disturbance of the sense of balance.

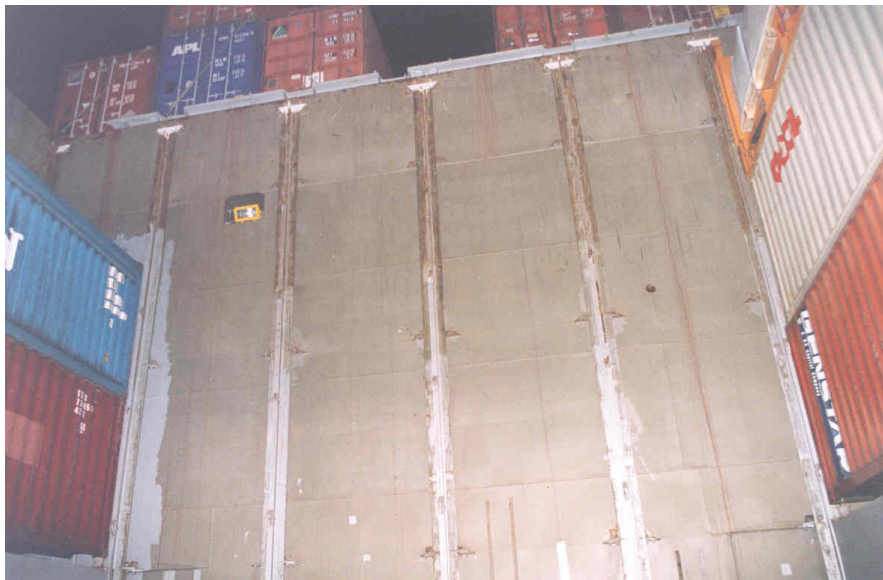
Figure 5, Loading and lashing of the containers on hatch 1

One supposition is that the person involved in the accident had been checking loaded containers on hatch 1 and had then stumbled at the aft edge of hatch 1 over the lashing rods or eyes or container fittings on deck from hatch 1 into the open hatch 2. It was not possible to observe whether he fell forwards or backwards.

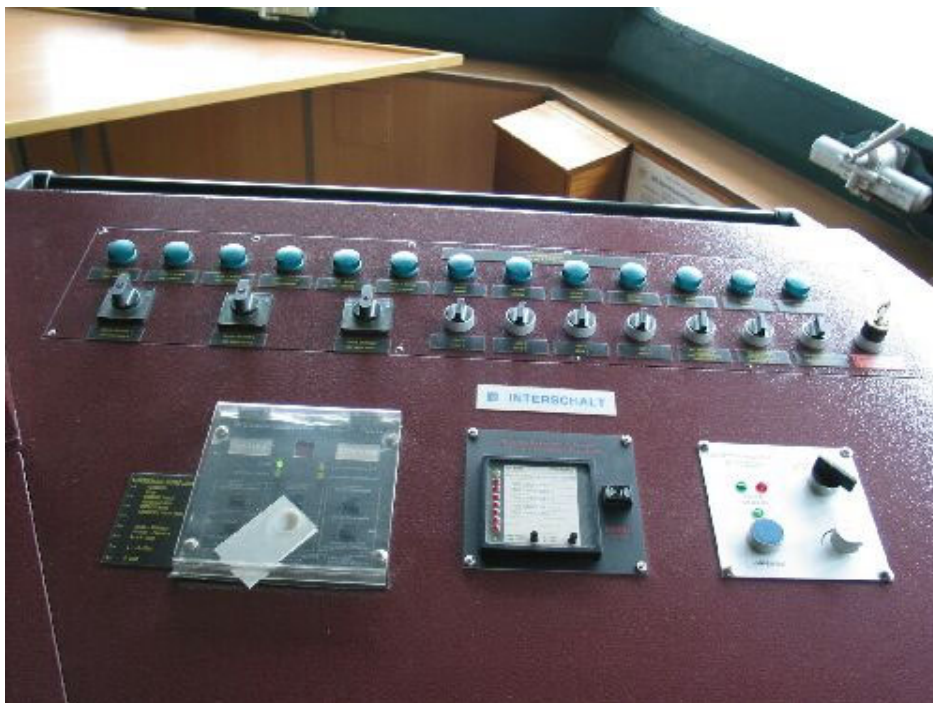
Figure 7, Switch consol deck and hatch lighting

There are no precise procedural instructions for port watches on this vessel in the International Management Code for the Safe Operation of Ships and for Pollution Prevention (ISM-Code). On MV PETUJA the officer on duty supervises the loading and discharging operations from the bridge (see figure 7). The cargo computer and the stowage plans as well as the switch control of the deck and hatch lighting (see figure 8) are on the bridge. The persons on watch from shore and sea are connected with each other via "walkie talkies" and telephone.

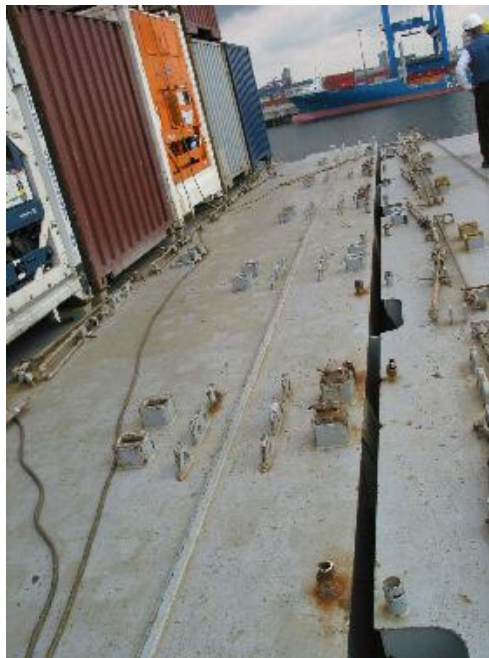
Figure 9, Catwalk between Hatches 1 and 2

At about 04.00 h in the morning on 11 March 2003 the 35-year-old second nautical officer fell about 12.5 m down from the catwalk between hatches 1 and 2 into hatch 2 during loading work on the Container Vessel PETUJA lying in the Port of Hamburg. He sustained injuries as a result to which he succumbed three hours later, despite immediate recovery and medical aid in the hospital.

The hatches are normally opened on instruction by the officer on watch. The hatch controllers are located on the starboard side of the hatch middle (see figure 9) and can be reached via a platform. From the platform it is possible to observe the movement of the hatch covers, which in the case of hatch 2 move aft. In the open position the MacGregor folding lids of hatch 2 can be seen from the bridge. Generally the officer on watch and the deckhand are on deck to open the hatch. MV PETUJA is an open-top container vessel, in other words hatches 1, 2 and 4 of the 4 holds have hatch covers, while hatch 3 is always open.

During loading and discharge operations the side deck on the sea side should be used as far as possible when carrying out work. The catwalk between the hatches should be fundamentally avoided.
