Investigation Report 134/04

Very serious marine casualty

**Accident involving personal injury with fatal
consequence
on board
MV Hamburg Express
on 7 June 2004
off the French Atlantic Coast**

15 May 2005

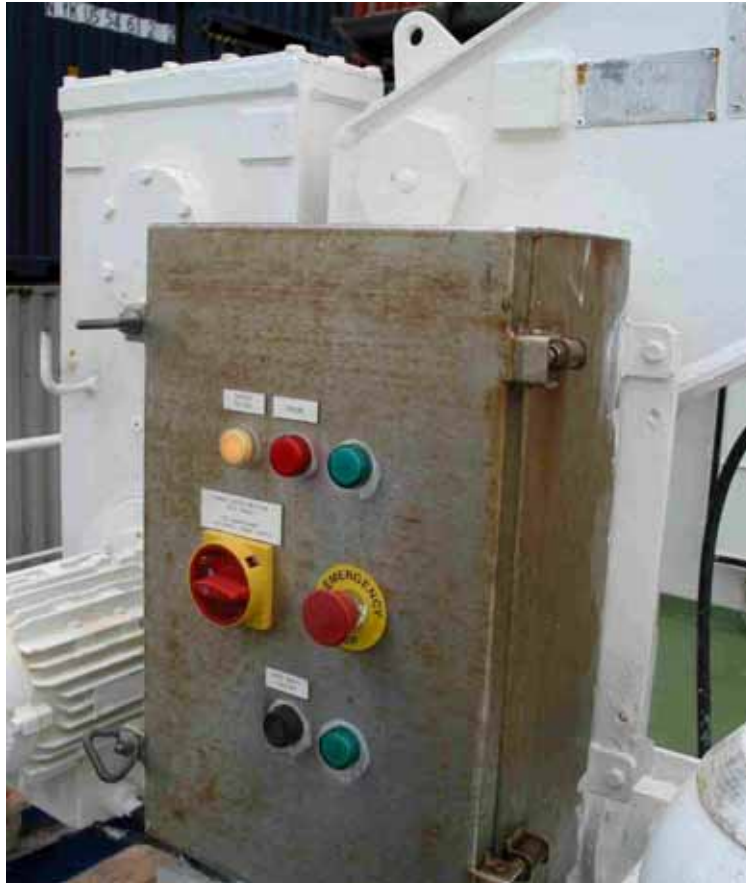
Figure 9: Dead angle behind the operator's location

Due to the dimensions of the crane jib, the cable drum, the winch motor and the crane column carrying the switch cabinet, it is not possible to see the area in front of the opposite side of the launching device from the operator's position at the winch motor. Consequently there is a not inconsiderable dead angle here.

Accordingly, for instance, it is not possible to see from the switch cabinet whether or not the crank-handle is in place, or whether anyone is standing in this area. The dimension of this dead angle is clearly illustrated in Fig. 9.

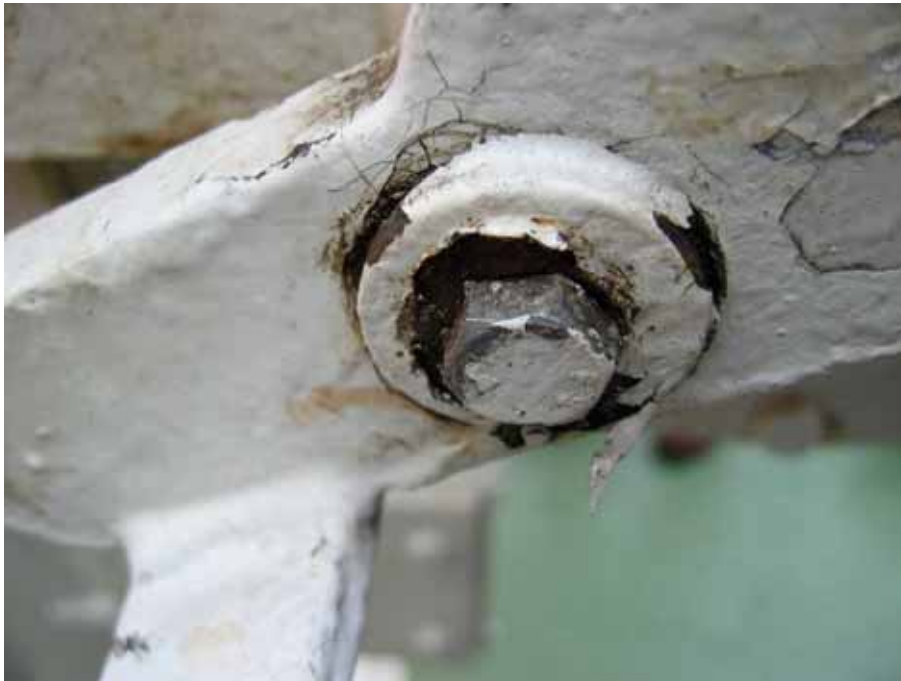
Figure 12: Safety bar, fastening screw

The launching device was inspected on 11 June 2004 four days after the accident at the Container Terminal Altenwerder. According to the information supplied by the crew, nothing on the crane had been changed. The vessel operator and the vessel command had given instructions that the scene of the accident was to be cordoned off and left completely unchanged. However, directly after the accident a function test had been carried out on board, but this had not produced any indications of a malfunction. The crane itself was standing in the position of rest (Fig. 3). About half the rope length was unwound and lying on the deck. The crank-handle was lying at the side next to the crane (Fig. 5). The safety bar was in the operating position for electric winch operation (Fig. 6). The inspection of the safety bar revealed that the single screw securing this bar had been loosened once (Fig. 12).

In response to questioning it was explained that this bar had been removed once in Shanghai for maintenance purposes. The joint of the bar was moving with difficulty, the bar had not fallen back into the starting position by itself. After dismantling the bar it was ascertained that the grease in the joint had become resinous (Fig. 13)

- *All safety-relevant mechanical parts of the winch were optically in sound technical condition. It was noticed that the fastening screw of the safety bar showed signs of paint damage. This indicates that the bar was removed after the last conservation treatment. According to the information provided by the crew this occurred during the period in the yard in Shanghai for maintenance purposes.*

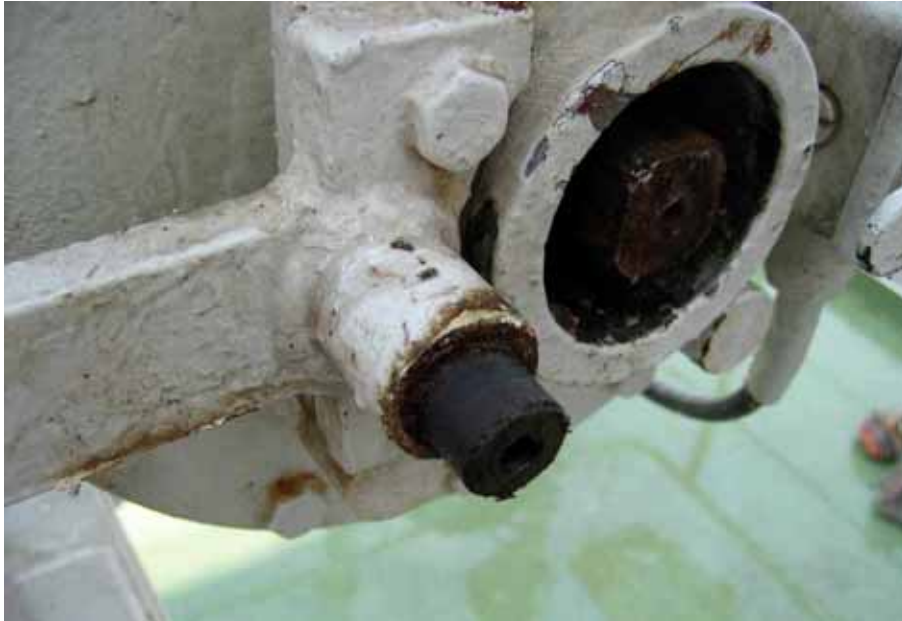
Figure 13: Resinous joint

The survey on 11 June 2004 four days after the accident showed that apart from the grease becoming resinous in the joint of the safety bar, there were no technical defects on the davit. The joint of the bar was difficult to move as a result, and after drawing off the crank-handle the bar did not automatically drop down into its original position. (However, indirectly this created a further "safety mechanism", since in addition to drawing off the crank-handle it was now necessary to press the safety bar down by hand in order to move the limit switch over for winch operation.)

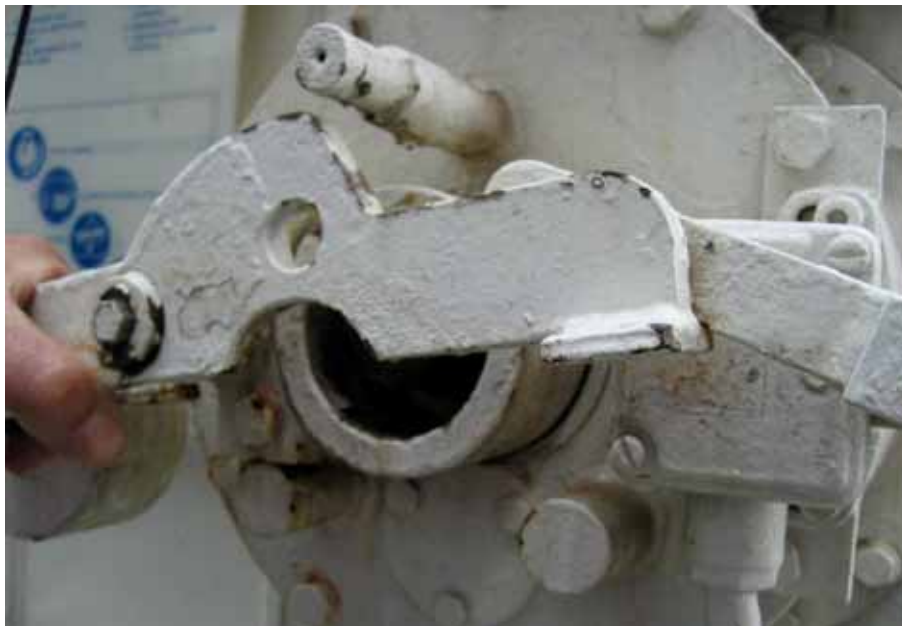
Figure 14: Switch-off position

On raising (swivelling up) the bar, the current for the winch operation was switched off as of an angle of deflection of approx. 15° (Fig. 14), in other words well before the complete release of the square mounting necessary to mount the crank-handle.

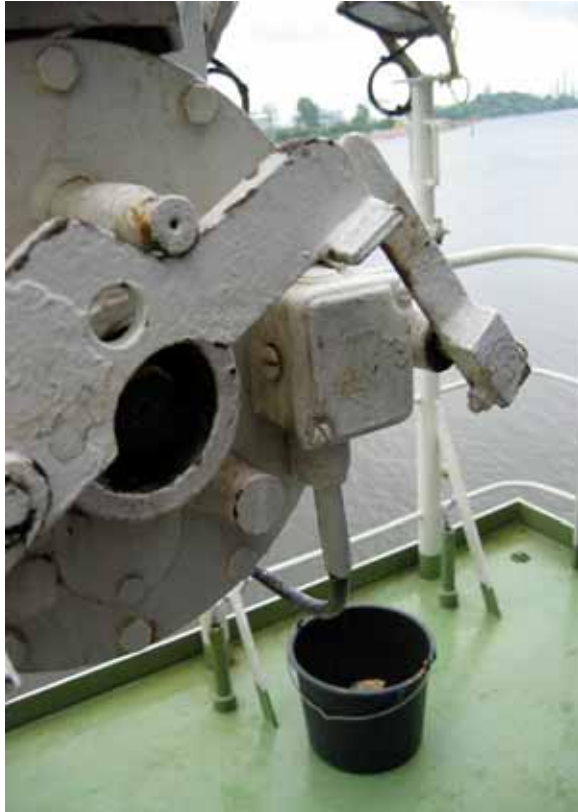
Figure 15: Limit switch, end position

The final position of the safety bar is documented in Fig. 15. The triggering of the bar was repeated several times, the switch-off position was always the same. It was impossible to mount the crank handle before the switch-off position was reached. Since the outer visual and function checks had not revealed any clues for malfunction of the system, the limit switch was subjected to a detailed inspection. The housing of the limit switch was opened. Inside there were no traces of corrosion or any other

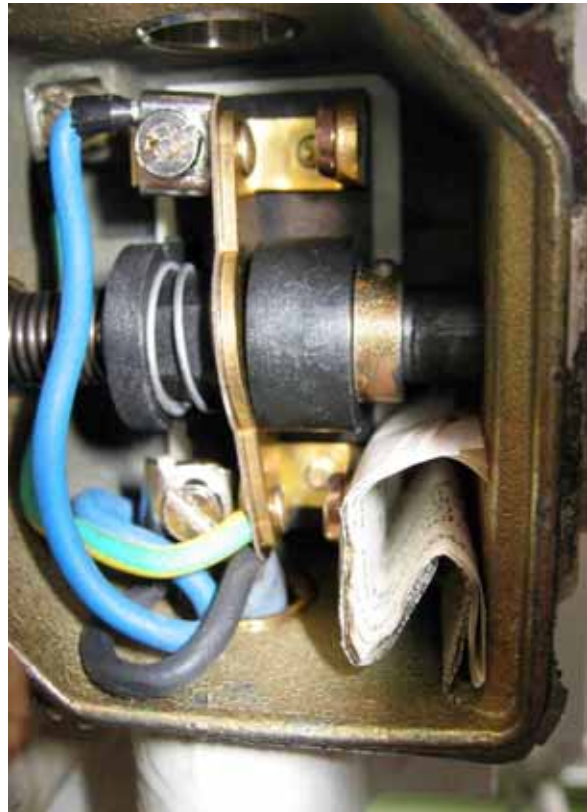
Figure 16: View of interior of limit switch

indications of inoperability (Fig. 16). The springs returning the limit switch to the working position did not show any evident signs of faults either. Altogether, the interior of the limit switch made a very sound impression. It was not possible to turn the limit switch excessively so that electricity would have been switched on again.

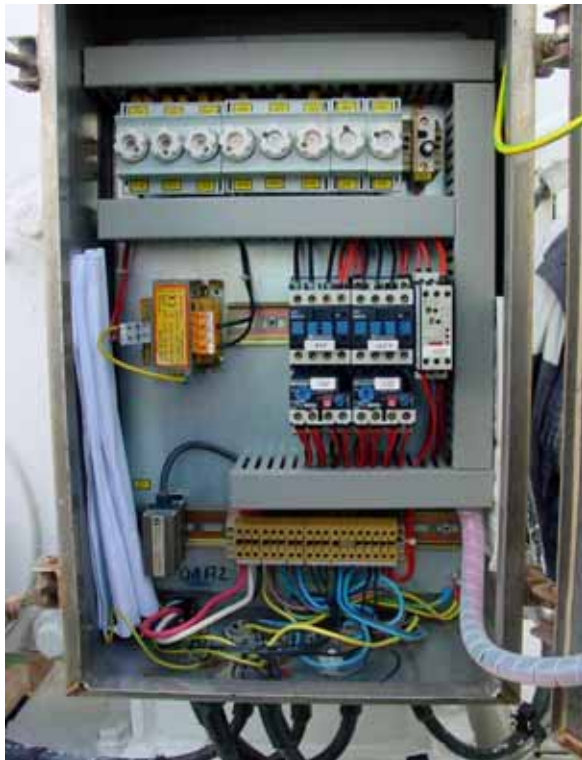
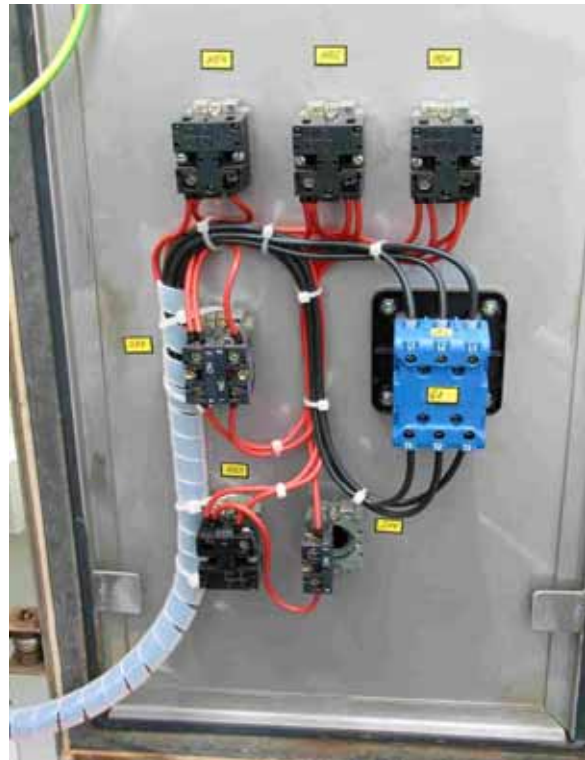
The switch cabinet and the wiring inside it were also in an excellent condition of maintenance (Fig. 17, 18). No loose cable connections or traces of corrosion were found here either.

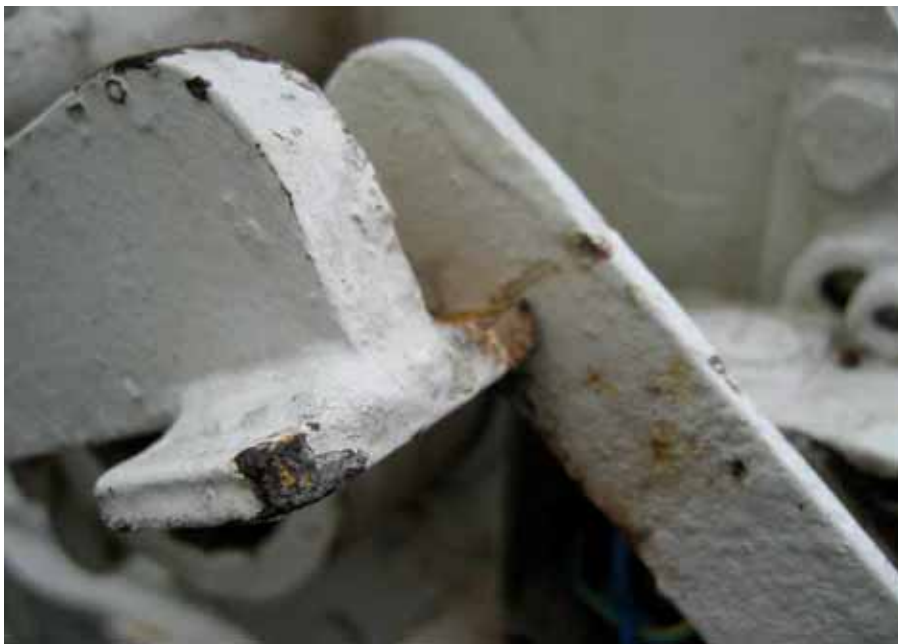
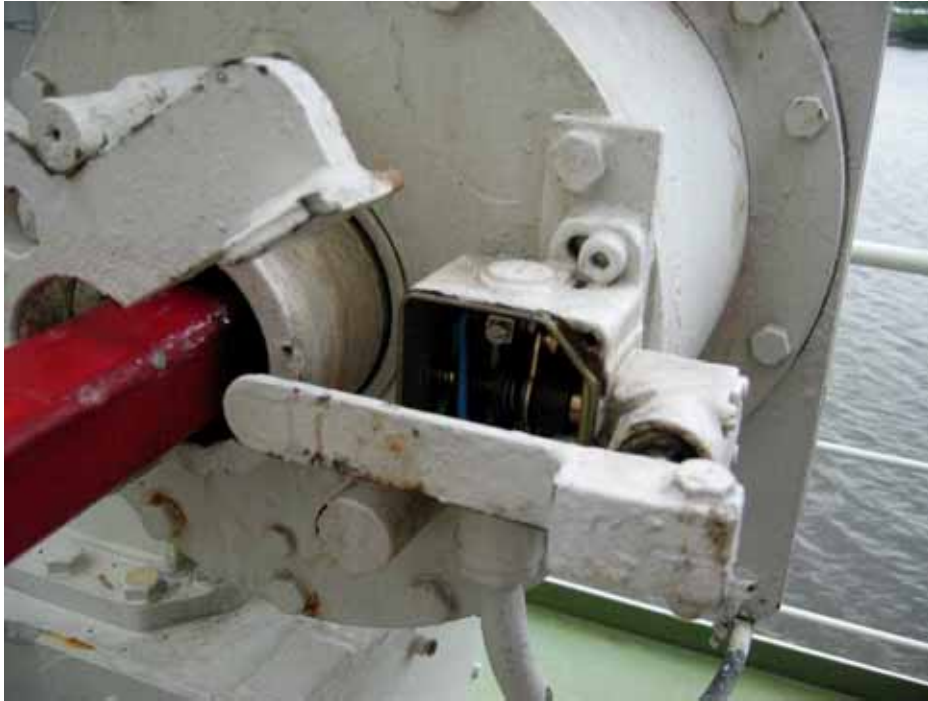
Finally, an attempt was made to push the limit switch behind the safety bar with the crank-handle mounted in order to close the limit switch in this way. This was possible with slight effort (Fig. 19 and 20). However, the possibility of the safety bar "being pushed past" without specific application of force from the exterior can be ruled out.

- *In a further test it was ascertained that the limit switch lever can be pushed with force past the support plate of the safety flap. Visible damage to the conservation coating was sustained here. However, this damage was not present at the time of our arrival at the scene of the accident.*

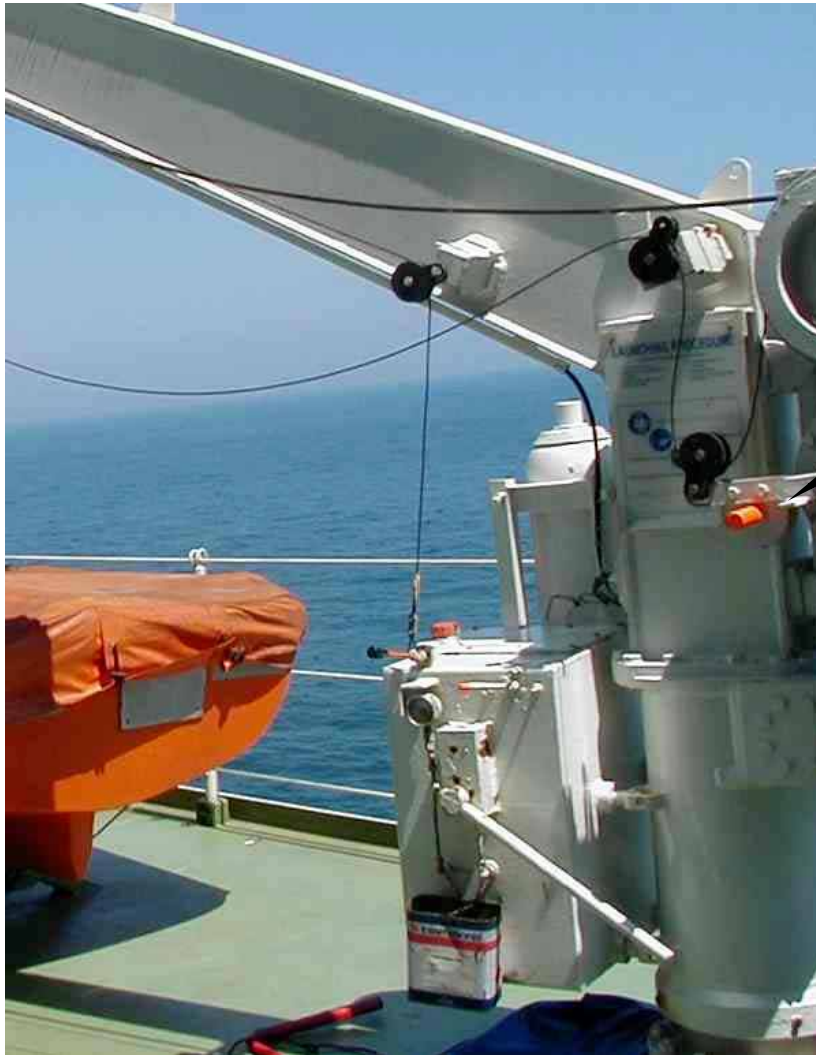
Figure 21: Mounted safety bar shortly after the accident

- Both the Second Officer and the German crewmembers who tried to investigate the cause of the accident after it had occurred have stated that the safety bar was not dismantled.
- In reply to the deliberately inconspicuously asked question as to whether and what tools were used for the maintenance work, the Second Officer replied that apart from the necessary utensils for greasing the wire rope, no special tools had been available at the scene of the accident (these would have been indispensable to unscrew the bar).
- The vessel operator has provided photos of the scene of the accident. According to this altogether 13 photos were taken by a digital camera, two series on the date of the accident and one two days later. The first series (5 photos) was taken on

the date of the accident between 13.45 h and 13.48 h camera time¹⁴ according to the electronic time stamp, in other words probably less than 1 hour after the accident. On close inspection, the mounted safety bar is evident on one of these photos of the first series.

Flat steel edge of the safety bar can be seen; stop brake not tied up!

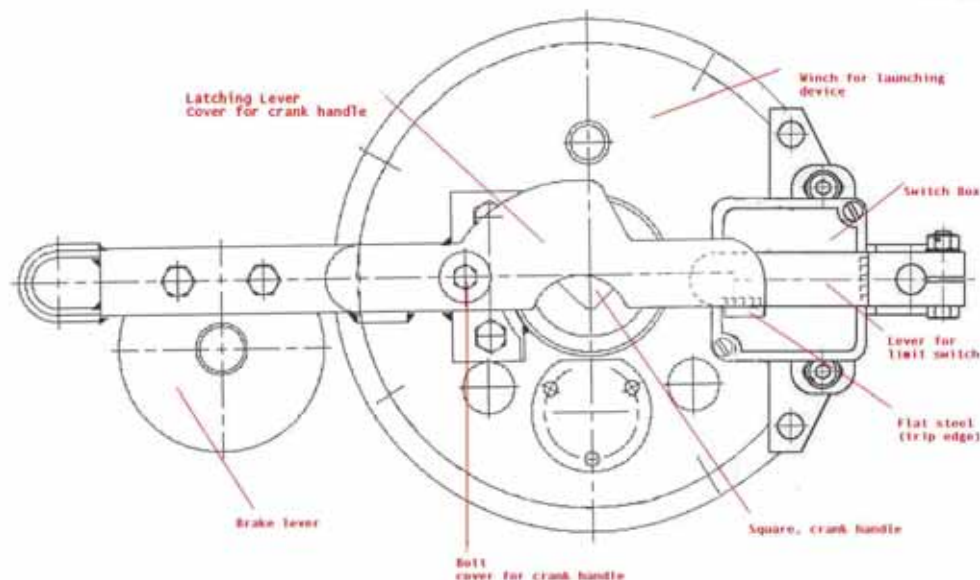
not known to be susceptible to any particular malfunctions. Despite this a second fatal accident has occurred because the winch motor started despite the fact that the crank handle was in place. It is not yet clear in detail how the accident currently being investigated could occur and why the blocking system failed. However, within the framework of the investigation to date it has been generally ascertained that although the safety system used functions soundly and is suitable for use in practice in every respect, there is at any rate a theoretical possibility that the safety mechanism can be switched off relatively simply – for whatever reasons and possibly in ignorance of the accompanying dangers. On the one hand it is possible to unscrew the latching lever quite easily – it is only secured to the housing box by a bolt. In addition it is possible by using a little force to push the lever of the limit switch past the trip edge of the latching lever and press it downwards, thus cancelling the current interruption to the limit switch.

On all vessels whose boat launching systems have a mechanism corresponding or similar to that shown in the sketch for blocking the electric winch when a crank handle is mounted, the latching lever should be secured especially, for example by the use of a bolt with a split pin, in order to raise the inhibition level for thoughtless, negligent dismantling by simply loosening the only screw. In addition it is recommended that the flat steel beneath the latching lever (trip edge) be extended in order to make it impossible to force the limit switch lever past the latching lever.
