Investigation Report 138/04

Very serious marine casualty

**Collision of
FV GRIETJE BOS with FV GRETJE GRE8
with one fatality
near Borkum
on 11 June 2004
at 02:32 h CEST**

21 February 2005

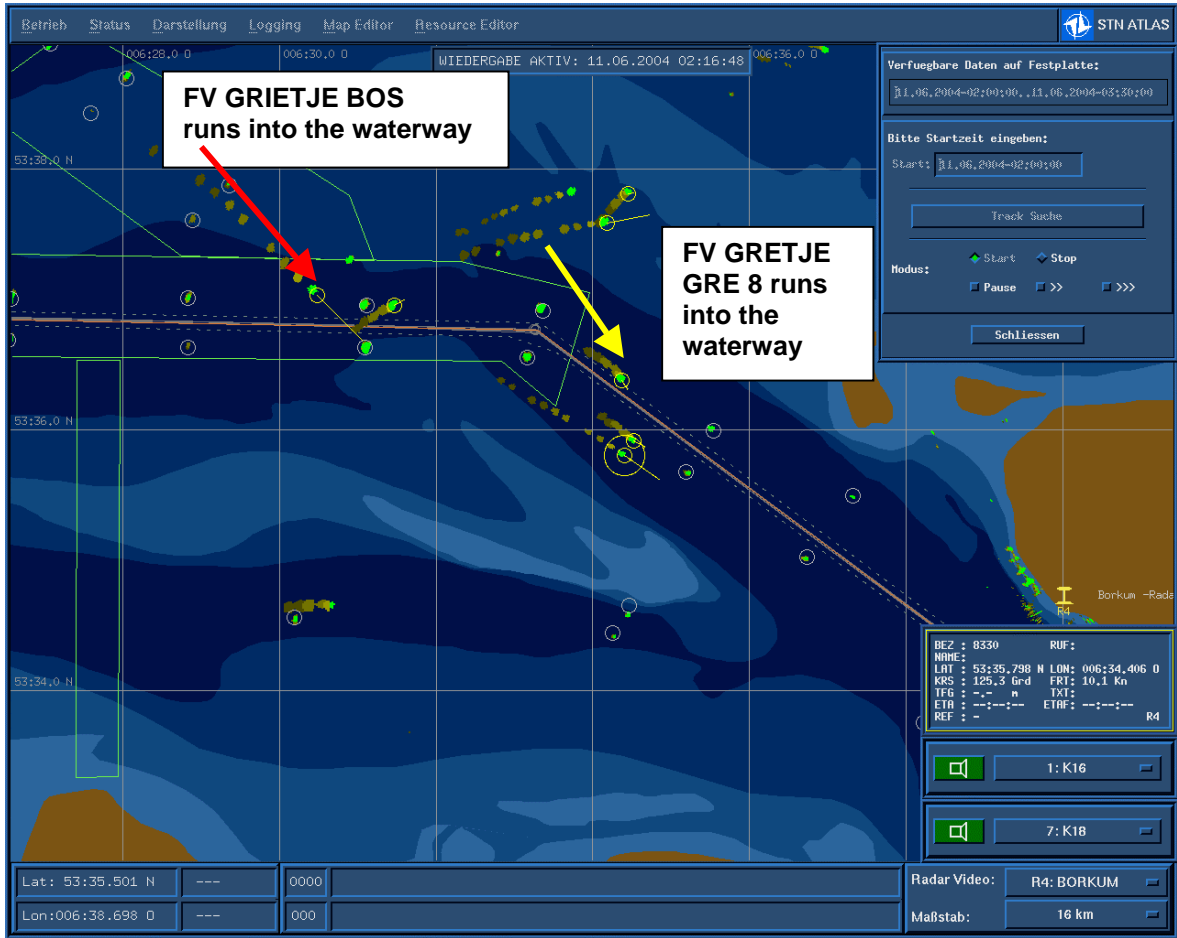
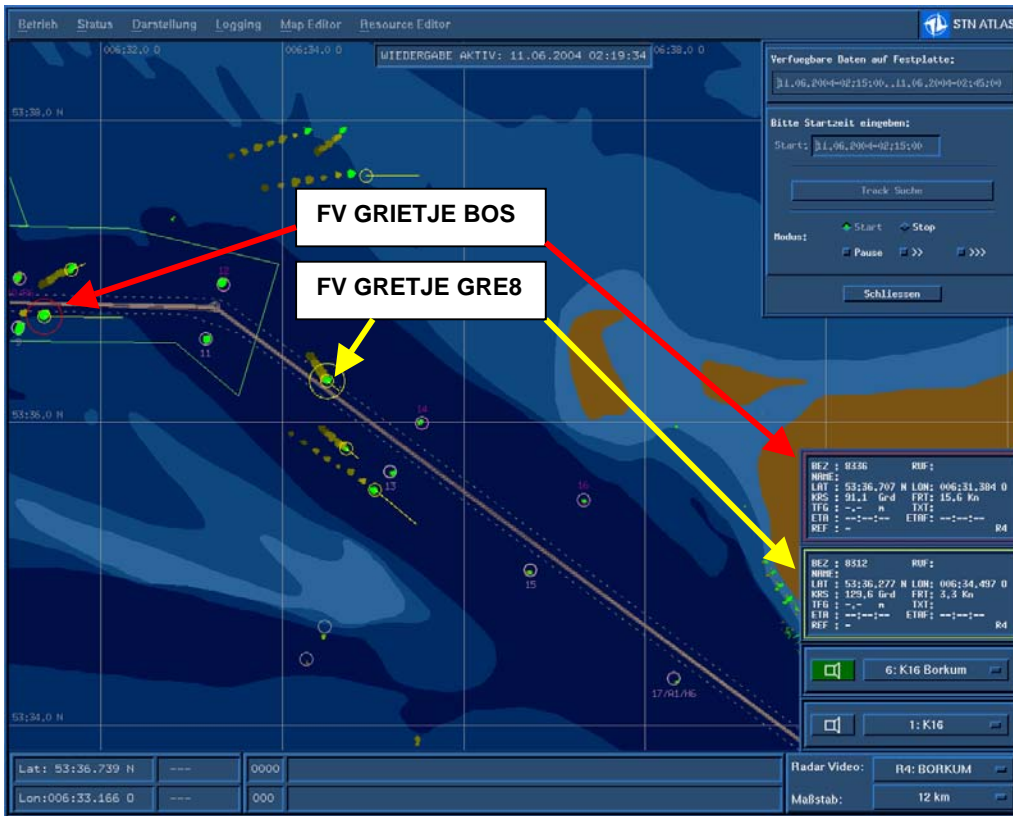
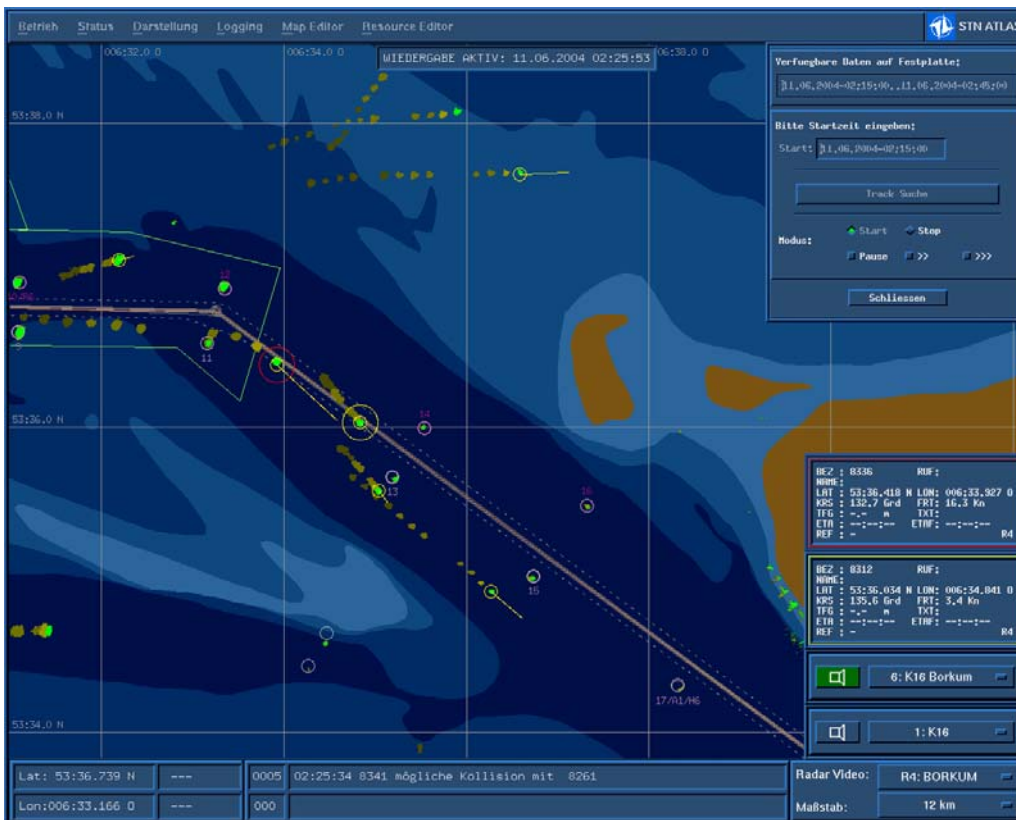
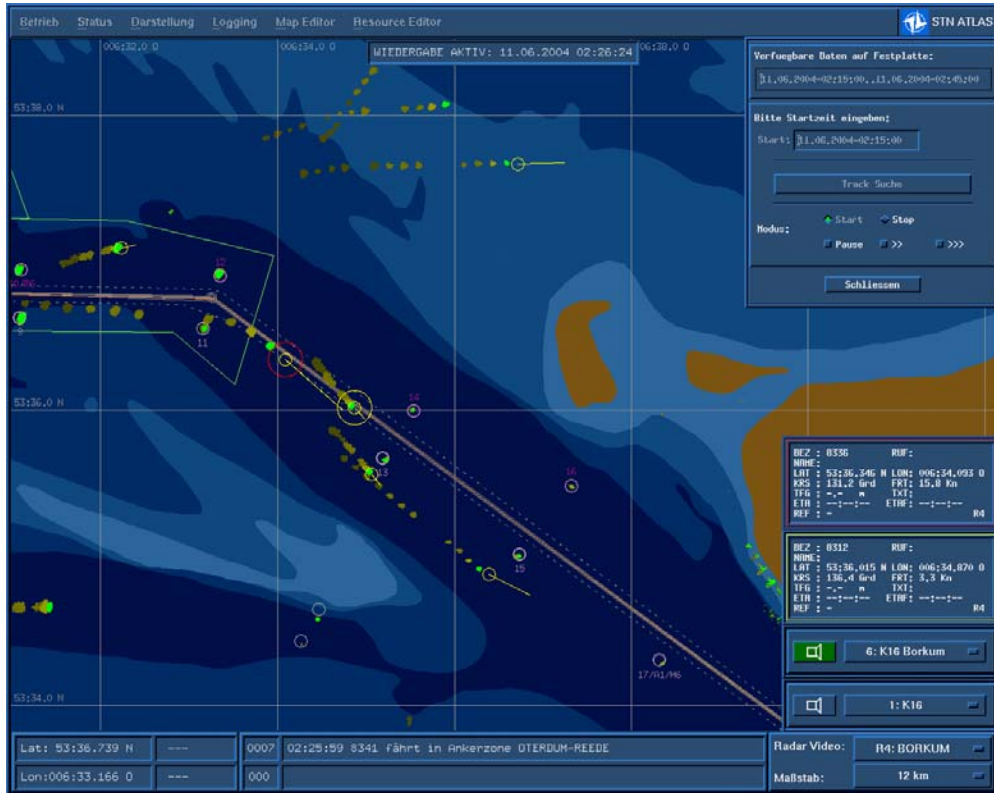
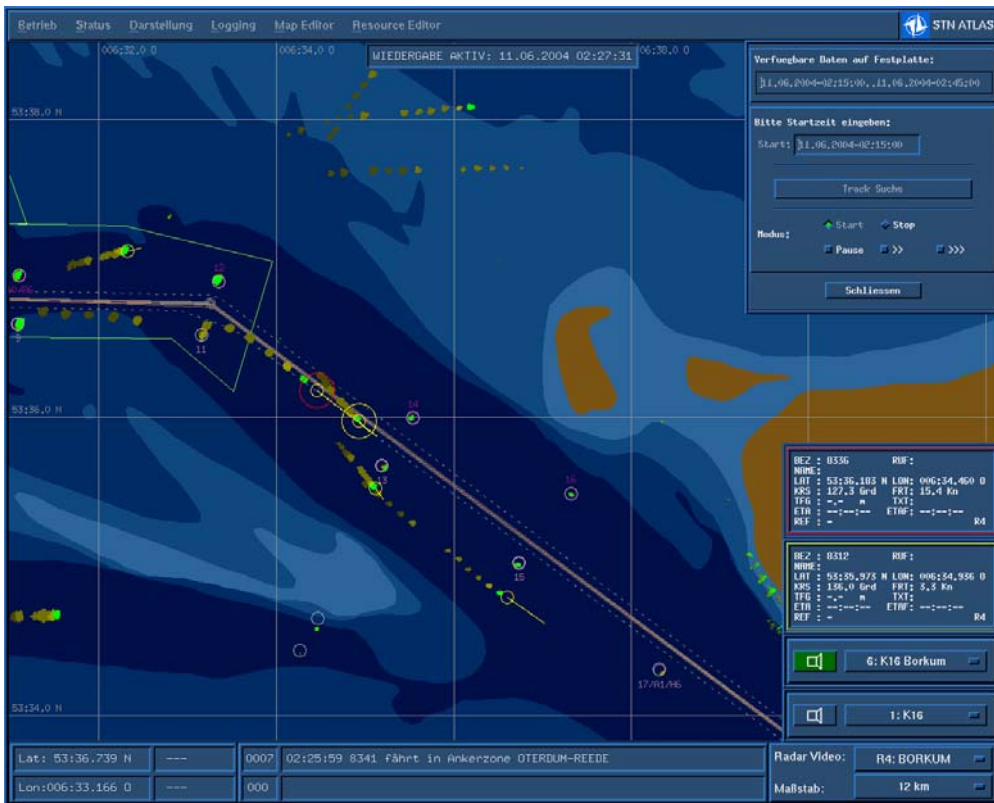
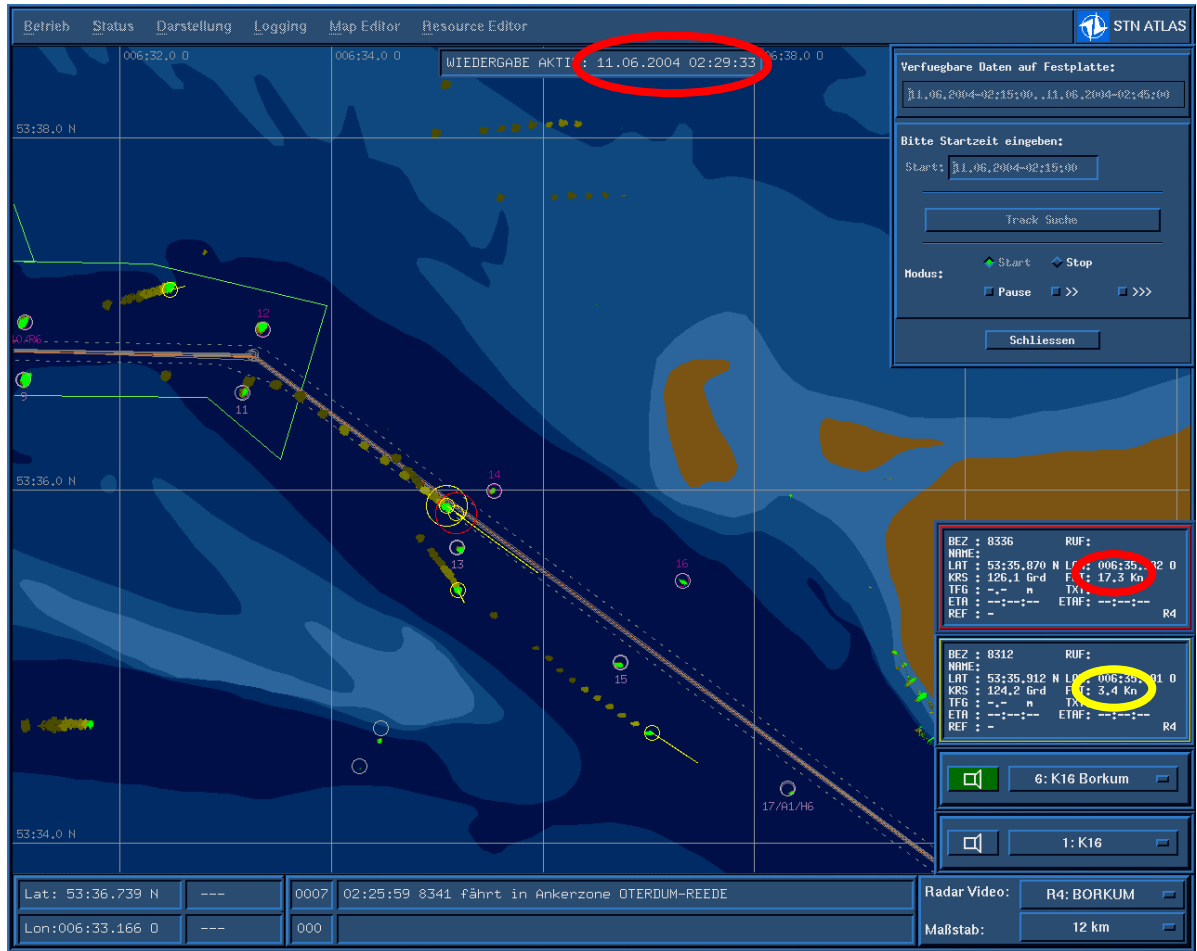
At the time of the collision he had set the radar image of the transmission station Borkum to one of the two screens at his workplace. He had not been able to foresee the collision from the traffic situation, however.

Images of the radar records as seen by the Nautical Officer on Duty are shown below. The rings around the participating vessels were added by the BSU to make matters clearer. When the Nautical Officer on Duty plots a vessel as well, rectangle is placed around the echo instead.

Under the given circumstances the Nautical Officer on Duty in the VTS Emden would not have had any reason to observe the progress of the two fishing vessels especially, since on the radar display available to him this would have looked like the beginning of a normal overtaking manoeuvre, and furthermore he had to set other priorities.

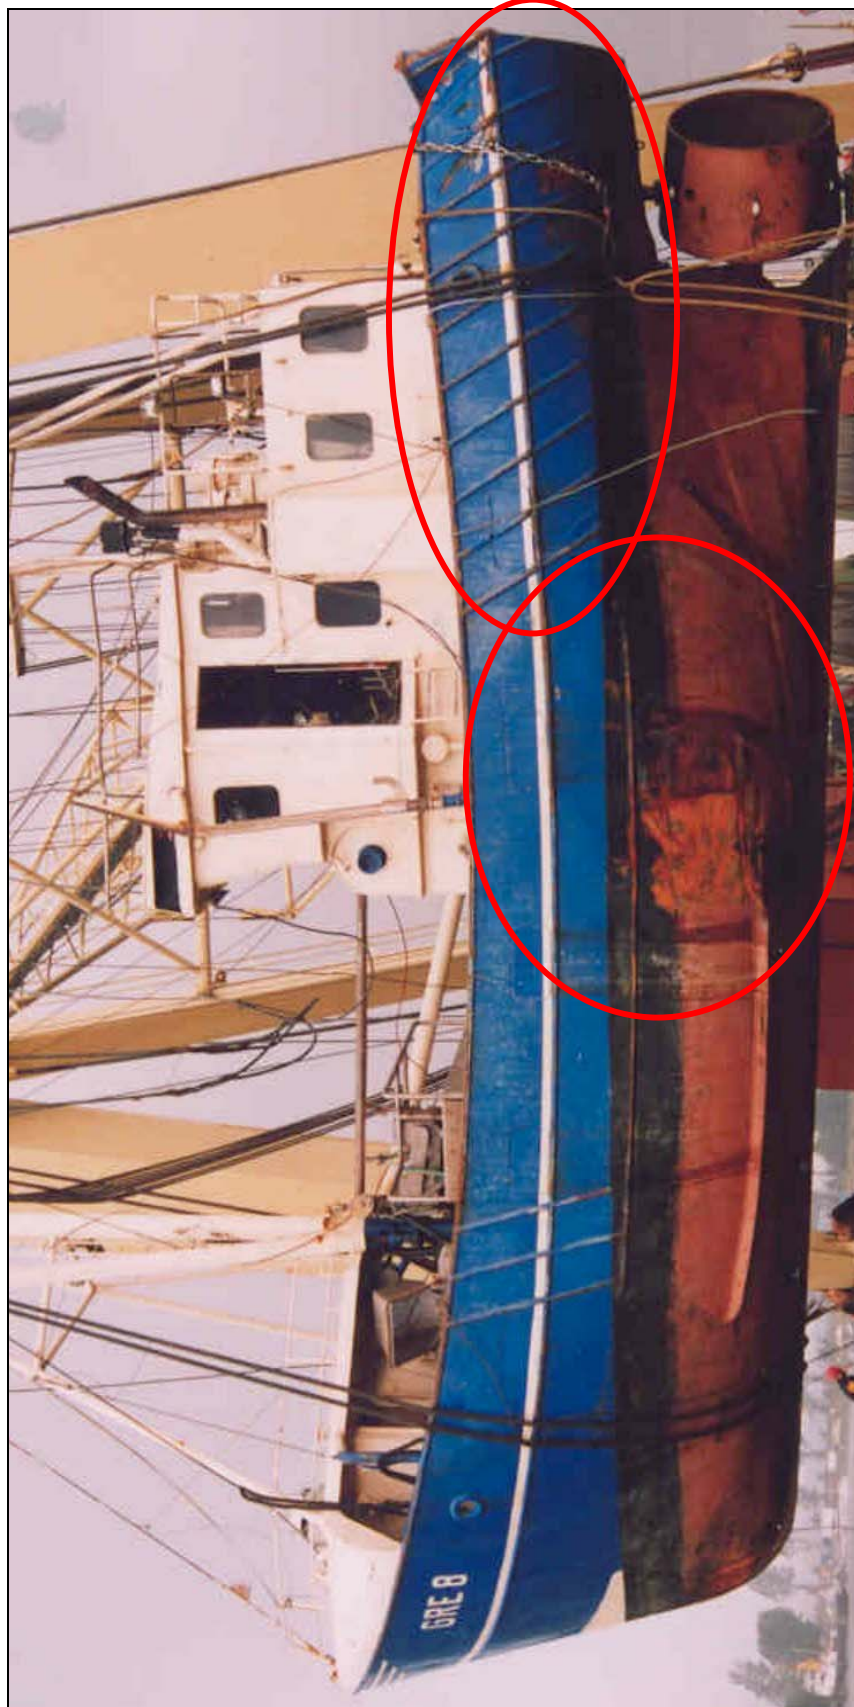
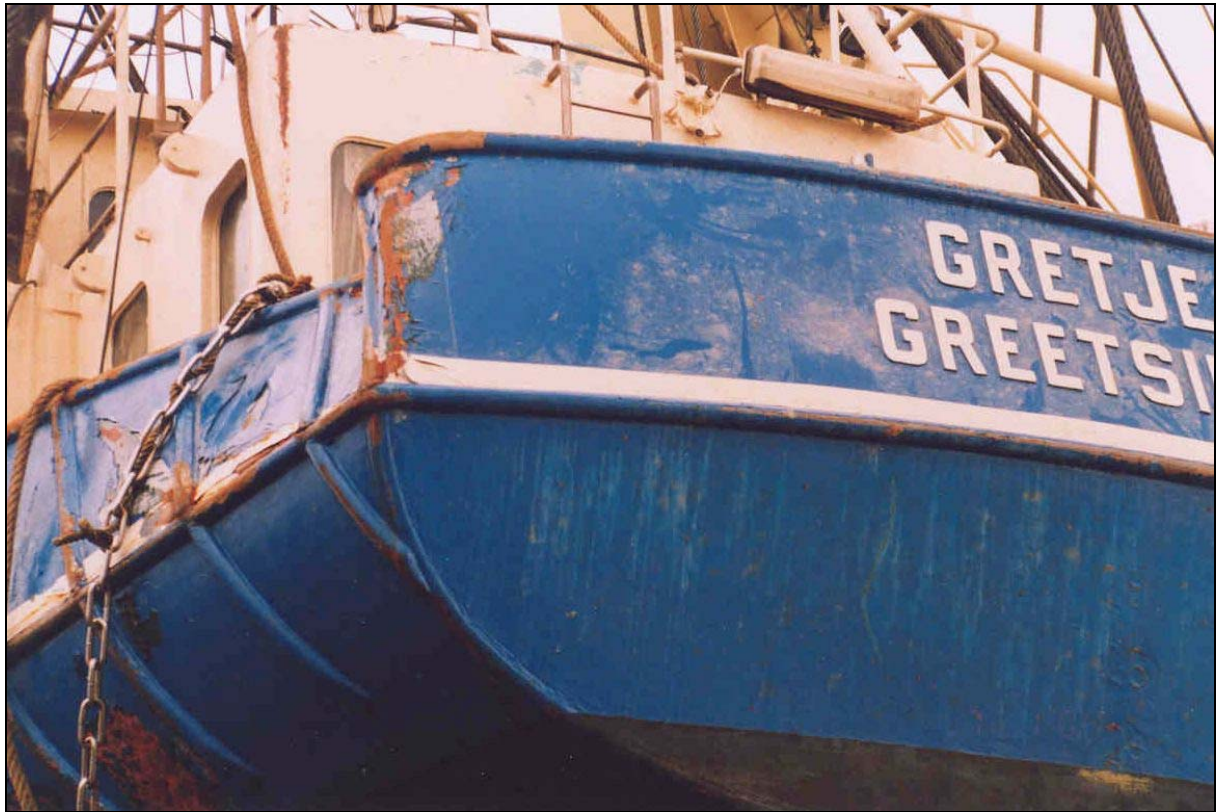
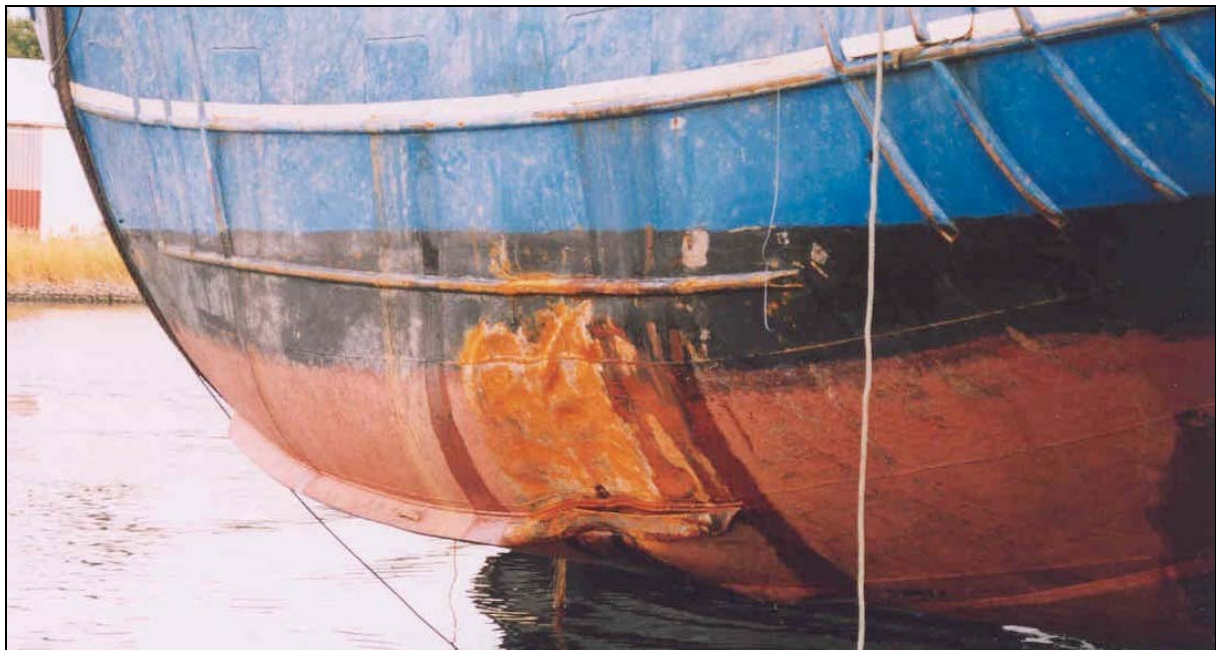
Figure 12: Photo of damage 2 – FV GRETJE GRE8

Figure 13: Photo of damage 3 – FV GRETJE GRE8

Figure 14: Photo of damage 4 – FV GRETJE GRE8

The outer damage to the underwater vessel of the fishing vessel indicates that the first collision occurred aft at the corner of the portside transom. There are traces of scraping on the hull, extending up to the middle of the vessel. There a large indent can be seen below the waterline that indicates the bulbous bow of the other vessel in the collision. Since the scraping marks from there continue below the keel, and the bilge keel on the starboard side of the vessel is bent upwards, just as the two masts above are bent to port, it appears that after capsizing over its starboard bow GRETJE was run over completely and then emerged again with its keel up. The port cargo boom was bent upwards and the aft span was ripped off.

One thesis is that the port net was ripped off during the collision and the vessel was forced to capsize over its starboard bow by the starboard net that acted as a drag anchor on one side. The fishing vessel drifted in this position for a good two hours until so much water had run into the ventilators that it sank.

According to the statements by the crew members of GRETJE, the fishing hatch was closed, as was the bulkhead to the engine room. The water can have entered by the bridge as well as via various goosenecks.

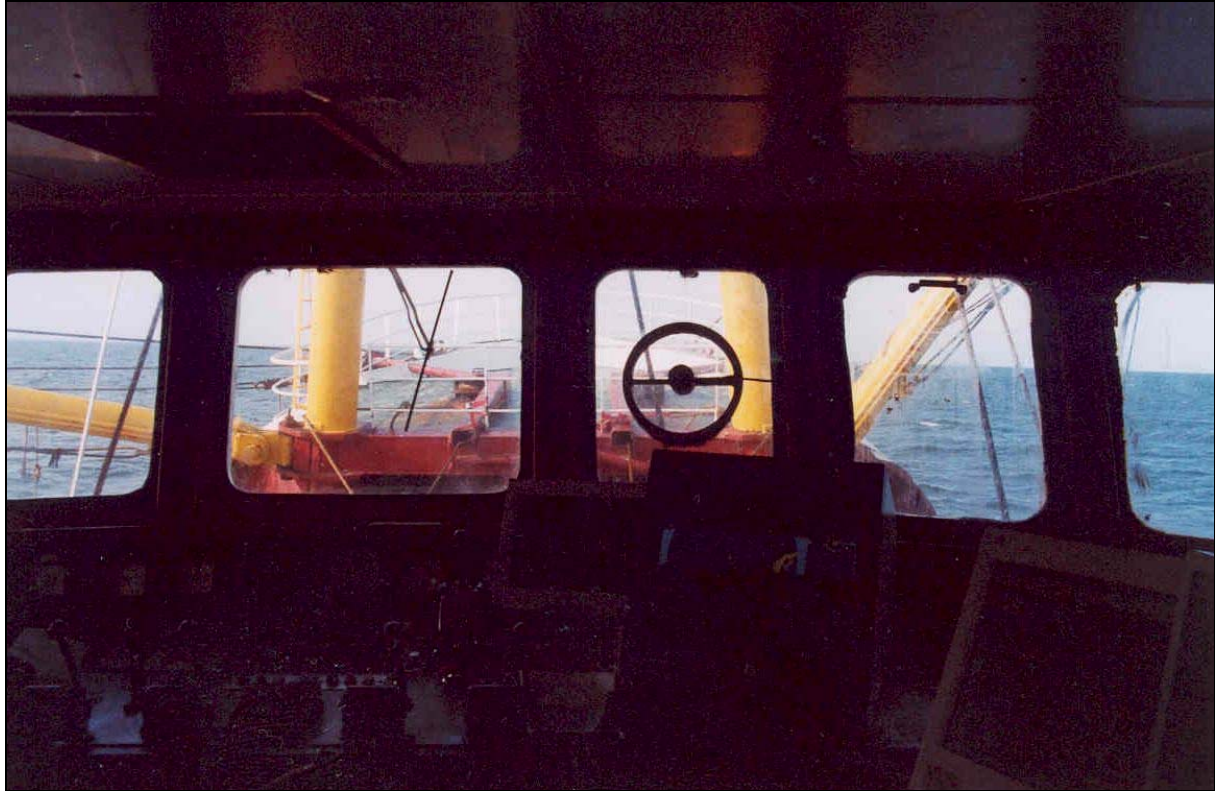
Figure 15: View from the bridge - FV GRIETJE BOS UK-237

At the time of the accident the Dutch skipper could not see the German fishing cutter since his bridge is arranged relatively low and his own deck lighting was switched on so that he was dazzled by this.
