Bundesstelle für Seeunfalluntersuchung
Federal Bureau of Maritime Casualty Investigation
Bundesoberbehörde im Geschäftsbereich des Bundesministeriums
für Verkehr, Bau- und Wohnungswesen

Investigation Report 145/04

Very serious marine casualty

**Loss over board of the Skipper of SY ALENA
on 20 June 2004, southwest of Gedser**

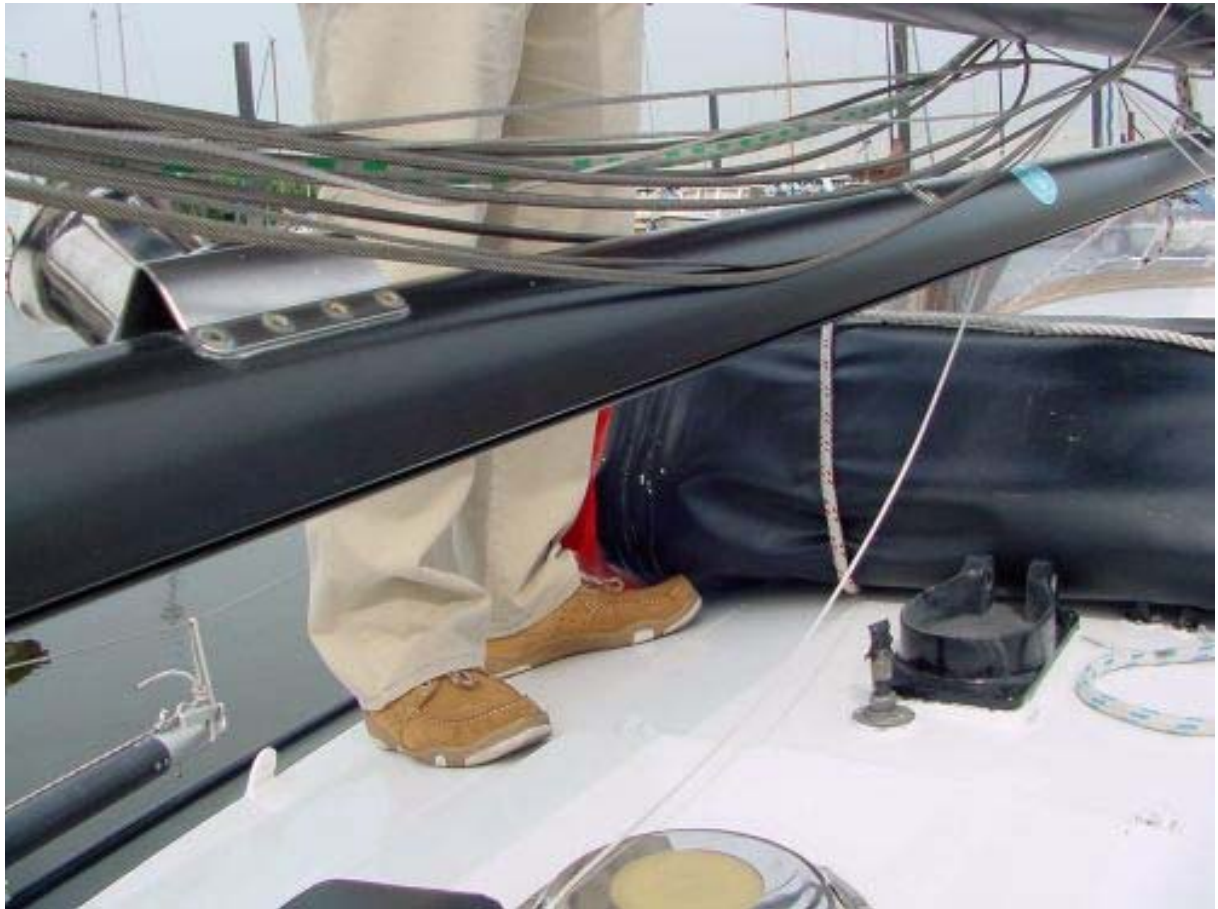
Figure 3: Position of the injured person

The slipping while pulling down the main sail was promoted by the fact that there was no anti-slip covering on deck (see Fig. 3) and by a characteristic wave height of about 0.5 m with periods of about 3 s at wind strength of 3 to 4 Bft. and the associated rolling of the boat. No impairment attributable to the health condition of the injured man could be demonstrated.

The very serious marine casualty with resulting death is attributable to the fact that the skipper, not secured by a lifebelt, a lifejacket or an inflatable working jacket, slipped on the smooth deck at the mast foot while bringing down the main sail and fell over board. The direct rescue measures that were not carried out properly can be explained by the condition of shock of the wife on board.

All operators and skippers of leisure craft must ensure that depending on the area sailed (high seas, coastal waters, protected waters) their boat is of such a nature that the risk of falling over board is reduced as far as possible and re-entry is facilitated. Even experienced leisure craft skippers should constantly review their readiness for risks. The structural requirements of the Directives 94/25/EC and 2003/44/EC of the European Parliament and the Council, the CE-Guidelines for Leisure Craft and the Safety Guidelines of the Cruiser Department of the German Sailing Association (Deutscher Seglerverband e.V.) as well as the brochure "Safety at sea and in coastal areas" (Sicherheit im See- und Küstenbereich) of the Federal Maritime and Hydrographic Agency (BSH) should be observed. As regards the "Person over board" manoeuvres, reference is made to the training in sailing schools, regular practical exercises and the relevant technical literature. The BSU also refers to its Investigation Reports 338/03 SY LISA and 122/04 SY RENI.

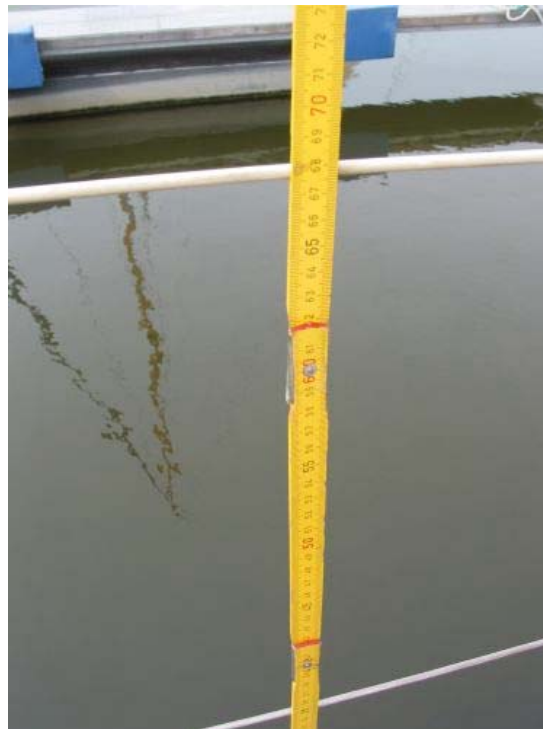
Figure 4: Height of railing

The investigations of the BGS into the course of the accident and according to the report by the Danish Forensic Medical Institute the autopsy and subsequent post-mortem examination conducted revealed no indications apart from age-related health condition other than death by drowning. Accordingly it can be assumed that the man standing at the mast foot on the starboard side of the cabin superstructure slipped shortly before 22.15 h on 20 June 2004 while pulling down the main sail on deck and fell backwards into the water over the starboard boat railing, which was 68 cm high measured from the upper deck (see Fig. 4).

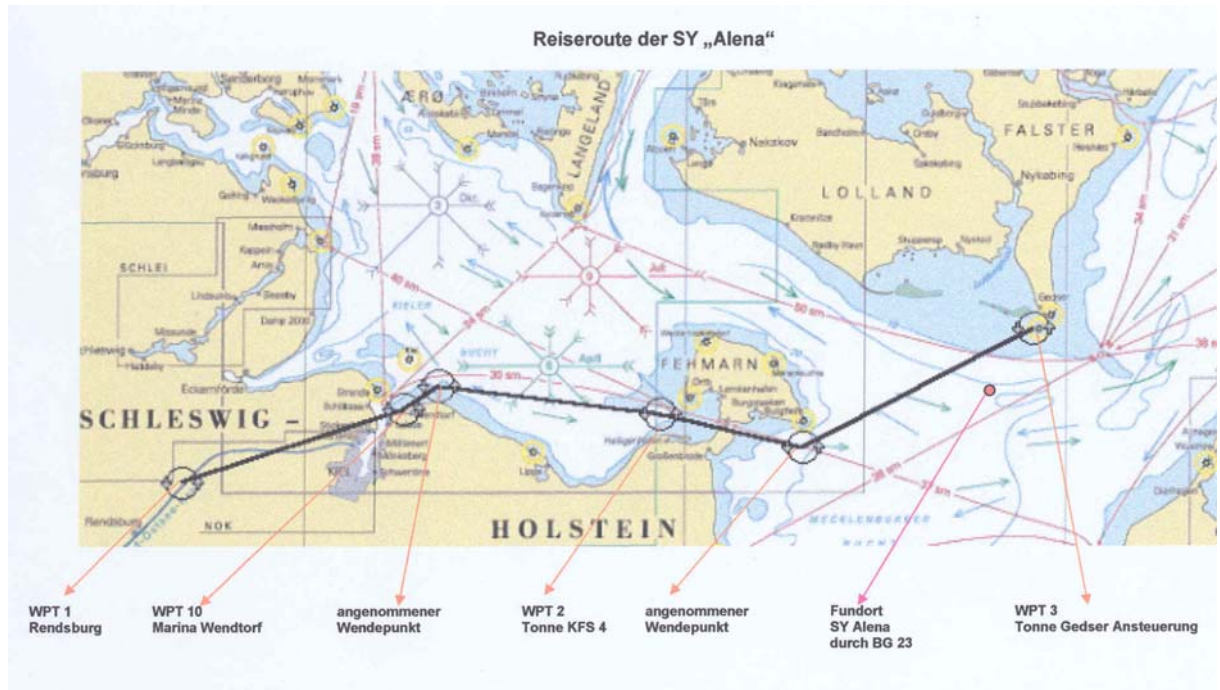
Figure 5: Travel route

The navigation and radio equipment consisted of a GPS receiver Navman Tracker 500, a magnetic compass midships on a fixed stand in the cockpit, a Seafarer 501 echosounder, a Navman log system and a VHF radio set DEBEG 6310, as well as a world receiver. All the equipment was in working order. Waypoints were entered in the GPS receiver that were subsequently evaluated by the BGS (see Fig. 5).

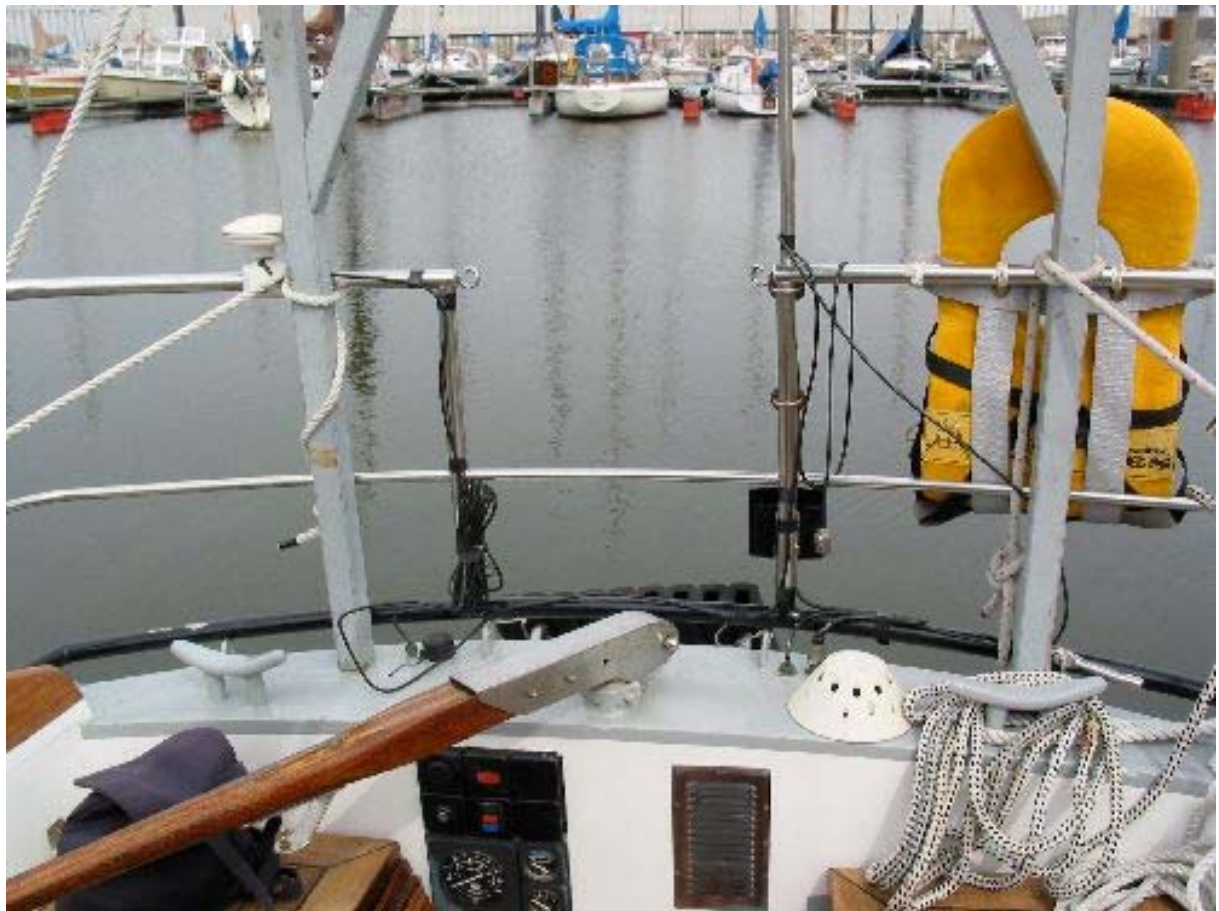
Figure 6: Lifejacket and mast mount

The safety equipment consisted of a lifejacket with bracket (see Fig. 6), two further solid lifejackets, an inflatable boat (see Fig. 7), two self-triggering working jackets with replacement cartridges (see Fig. 8) and a NICO distress signal unit with ammunition (see Fig. 9). The working jackets of type Secumar BS8 showed a maintenance date of July 1981. The couple had not put on any working or lifejackets during the sailing tour and were not secured with the lifebelt. The inflatable boat was secured aft ready for operation in inflated condition (see Fig. 12).

As regards the use of life saving appliances the witness stated that she and her husband generally did not wear any lifejackets at sea. Lifejackets only had to be worn when they had children on board. She also stated that after her husband had gone over board she did not think of throwing life saving appliances to him or loosening the small inflatable boat. She was of the opinion that she would be able to pick up the man over board from the water without any further problems. After she did not succeed in doing this, she was no longer in a position to provide any immediate aid or call for assistance quickly.

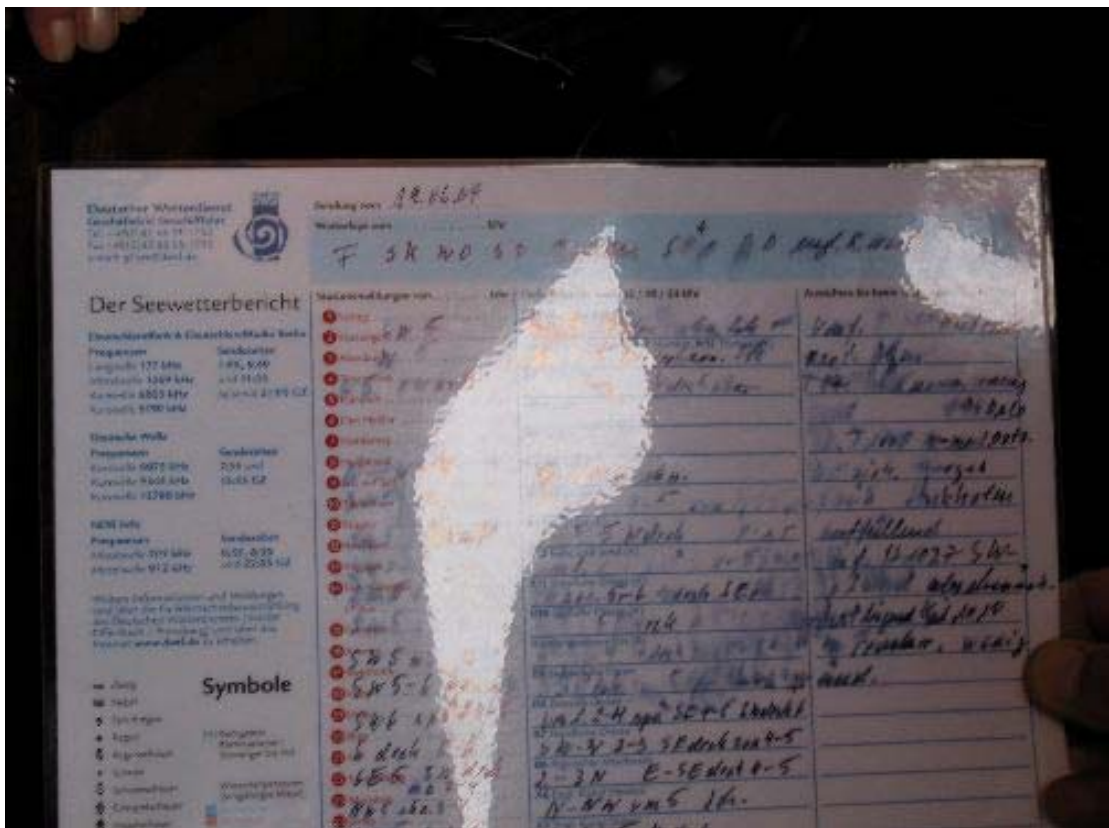
Figure 10: Weather panel

weather report on 19 June 2004 (see Fig. 10). At the time of the accident sea chart S 15 (see Fig. 11) was being used. No courses were entered. According to the information supplied by the wife, a practical "Person¹ over board" manoeuvre had never been practiced.

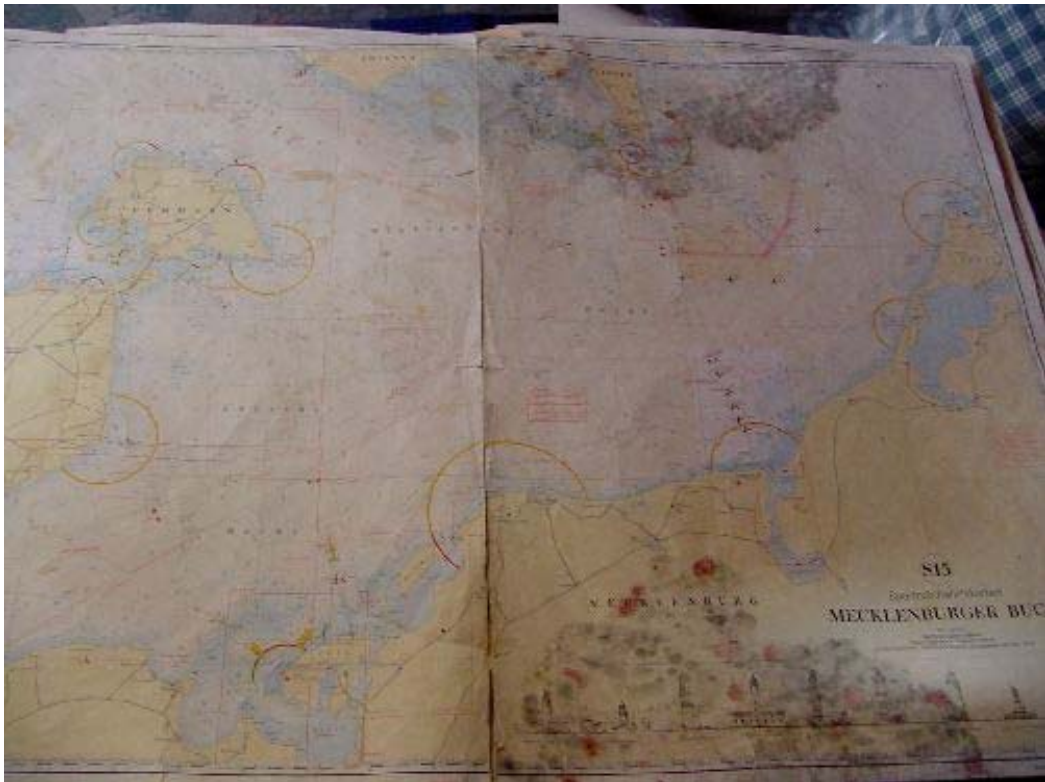
Figure 11: Plotting chart

The transmission of the exact position of the emergency call issued and the search initiated by herself and by others were made more difficult since the "Person over board" key on the GPS receiver was not pressed and no courses or positions were entered in the sea chart used. Moreover, the nautical publications (sea charts, sailing directions) were obsolete and had not been kept up to date. The automatically inflatable working safety jackets were not maintained, and in view of their age should have been replaced. However, like the lifejacket at the stern and the distress signals on board, they were not used. The fact that the wife was in a condition of shock explains why the life saving appliances on board and the inflatable boat that was secured ready for use at the stern were not used. Although she is an experienced sailor, she did not succeed in bringing in her husband - who was within sight - on board.
