Investigation Report 155/04

Very Serious Marine Casualty

Collision
MV PUDONG SENATOR
with
MT ENA 2
and subsequent capsizing of
MT ENA 2
on 28 June 2004
in the Port of Hamburg
Parkhafen Waltershofer Hafen
and Petroleumhafen

15 June 2005

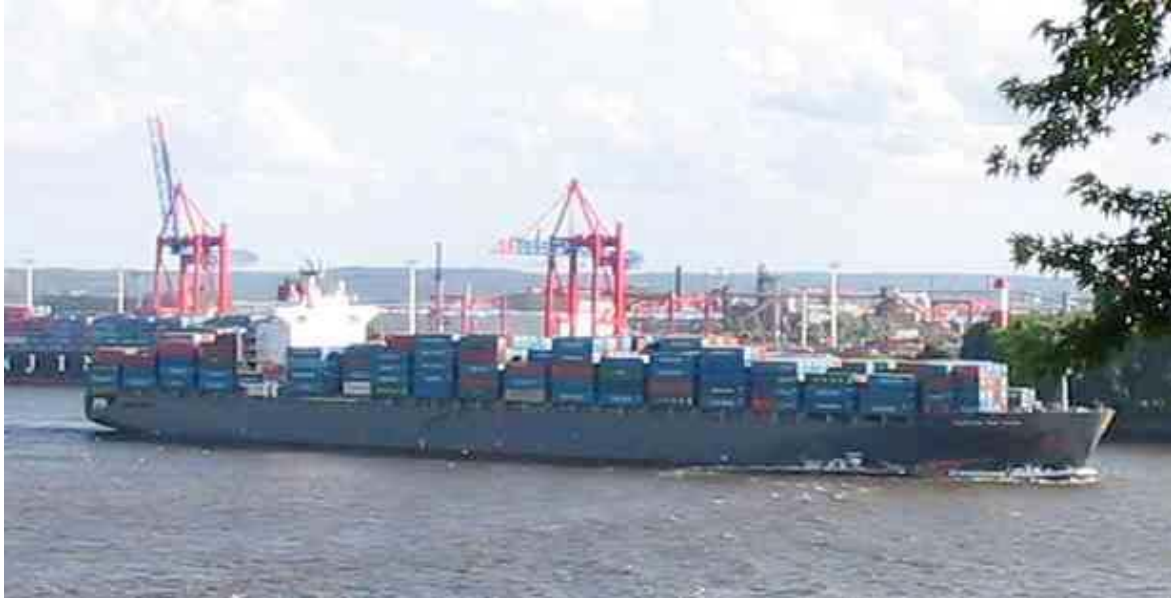
Figure 2: MV PUDONG SENATOR

Directly after the collision with ENA 2 (Photo: Gyde Thönnessen)

In the meantime the Chief Officer on board the departing PUDONG SENATOR had been commissioned to assess the damage, but apart from paint abrasion nothing else had been ascertained. During the running check of the ballast water tanks on the starboard foreship, no changes had been evident.

The Elbe pilot departing at 21:35 h had noticed two slight dents on the starboard side of the foreship in the area of the waterline and just above it. At about the same time, just before Brunsbüttel, the Waterway Police instructed PUDONG SENATOR to have the class confirmed in Rotterdam as next port of destination. The Waterway Police also ran along the starboard side of the container vessel at 21:40 h. Apart from paint abrasion no further damage was discovered. On 30 June 2004 PUDONG SENATOR was surveyed by Germanischer Lloyd. The two dents in the area of the starboard wing tank No. 1 between frames 291 and 297 were confirmed and measured as 1600 x 700 x 25 mm and 1400 x 800 x 25 mm. In addition deformations of frames 354, 358 and 362 port were ascertained in the fore peak tank.²⁴ The damage is to be repaired permanently at the latest by renewal of class in June 2007.

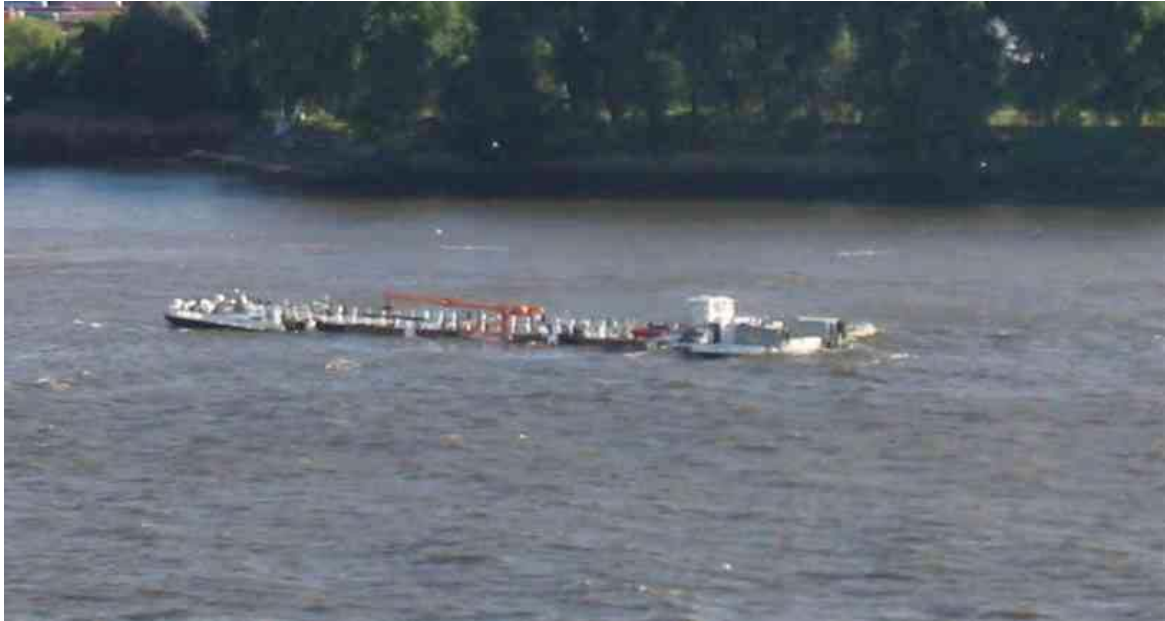
Figure 3: MT ENA 2

The special transport vessel ENA 2 carrying a cargo of sulphuric acid was damaged on its port side. Parts of the outer plating in the foreship area were deformed, water flooded in to the forward port wing tank. In addition the port Schottel drive in the aft area became inoperable as a result of the collision with PUDONG SENATOR. However, ENA 2 initially remained floating, continued under its own power without losing cargo into the Petroleumhafen and tied up with a slight list to port at the intended berth. The Waterway Police and two fireboats of the fire brigade hurried to the damaged vessel.

shortly after the collision with PUDONG SENATOR (Photo: Gyde Thönnessen)

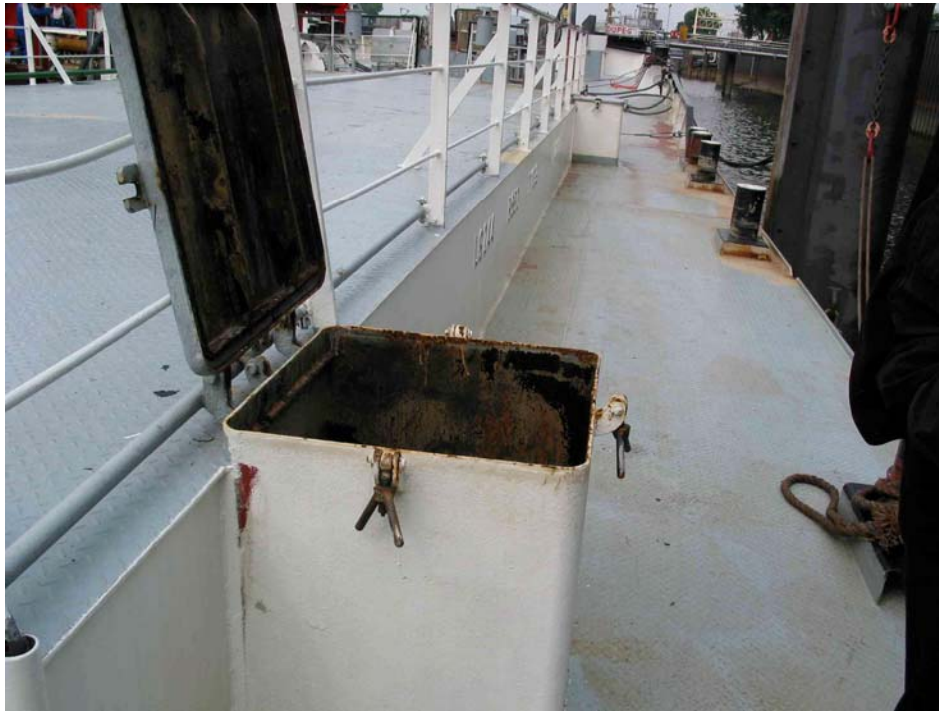
Figure 7: Entrance hatchway, wing tank

The fire officer accompanied the deckhand during the check of the entrance hatches to the wing tanks on the port side that were let into the side deck. Since the side deck was already 30 cm below water, they crossed the cargo tank deck to get to the foreship. After opening the forward-most entrance hatch to the wing tank on the port side the officer noticed noises of flow there and saw liquid in the hatchway. In the meantime at about **18:48 h** the fire fighting boat BRANDDIREKTOR KIPPING (LB 35) manned with nine firemen had reached ENA 2 and went alongside on a level with the open hatch entrance. The unit leader of fire fighting unit 35 assumed the command of the assignment. Two electrical immersion pumps were passed over to the officer acting on ENA 2 by LB 35 in response to his request. The immersion pumps were let down into the wing tank through the opened entrance hatch. Work commenced immediately on draining the tank chamber. According to the statement by the master of ENA 2, draining measures had not been started immediately after the collision by the vessel using its two firmly installed drainage pumps (location: port side deck midships and engine room). He justified this subsequently vis-à-vis the BSU by stating that directly after the collision it had not yet been clear at all whether there had in fact been any flooding or a leak in the acid tanks. After he had reached the berth and the leaky wing tank was located, the fire brigade had immediately started with its drainage measures. For the rest it would have been necessary to start a generator to operate the pump(s). In the meantime, however, the gate valve and shortly after that the switch of the large drainage pump on the port side side deck had already been under water.

whether they were opened within the framework of ascertaining the damage after the collision and not closed again. It is also conceivable that the hatch covers in question had not been properly bolted already prior to the collision. The latter assumption contradicts the statement by the Master and the deckhand of ENA 2, however, as both stressed that bolting was expressly specified by the operator and was therefore regular practice. Moreover the fact that the hatches of the two aft tanks were all properly barred initially indicates that the forward hatches were still closed, at least during the passage.

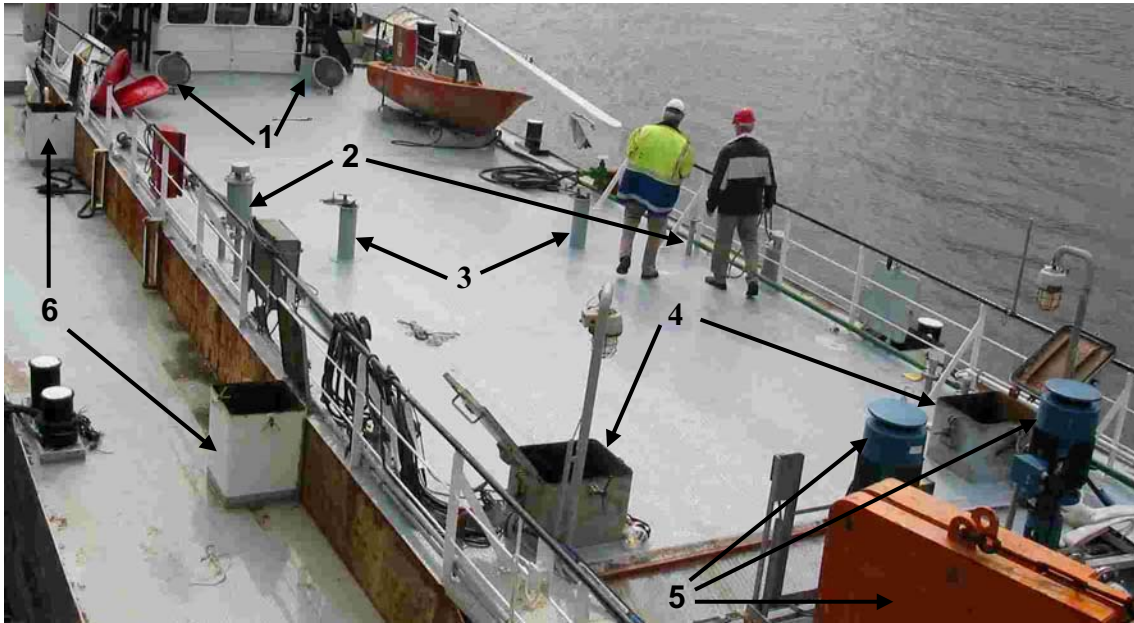
Figure 8: Tank apertures ENA 2²¹

1. **Inspection hatches**: one per cargo tank, no regular entrance into the tank, specified as second tank aperture when work is in progress in the tank; are otherwise used for sampling and/or checking the filling level; are not to be closed during travel, but otherwise always during loading and unloading (according to a circular letter from the operator to all the crews).

2. **Ventilator with moisture filter**:²² two per cargo tank; only venting and bleeding possibility during loading and unloading, not lockable, permanently open, sulphuric acid could escape here from ENA 2 after complete capsizing.

²¹ Photo section shows the rear part of ENA 2 after uprighting the capsized vessel; the forward part of the vessel not in the picture is also equipped with the same tank openings.

²² The moisture filter of the ventilator on the port side is missing (probably ripped out during salvage).

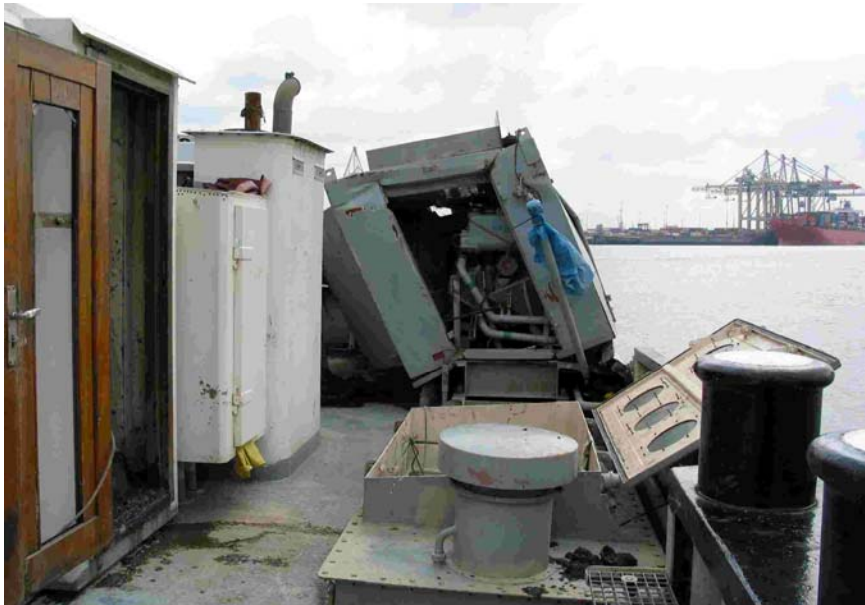
Figure 10: Deformed port Schottel drive housing

Directly after the collision the drive house of the port Schottel rudder propeller was deformed on ENA 2 and several cracks and deformations occurred in the port foreship, but the cargo tanks remained undamaged. The Master managed to run into the Petroleumhafen under his own power. Indirectly as a result of the collision and the water flooding into the wing tank caused by this, ENA 2 capsized at its berth and was additionally heavily damaged.

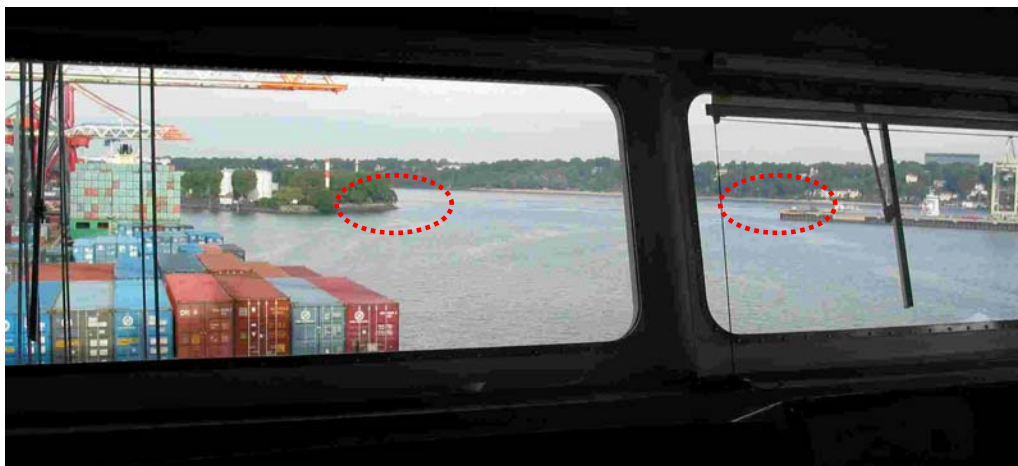
Figure 16: View from the bridge window of PUDONG SENATOR⁴⁸

⁴⁸ PUDONG SENATOR during the next run through the port (09/2004) lying at Predöhlkai: left part of picture Bubendey Shore, right part Athabaskakai; on the day of the accident a container vessel lying at Athabaskakai additionally prevented visibility (cf. here Figure 15, foreground)

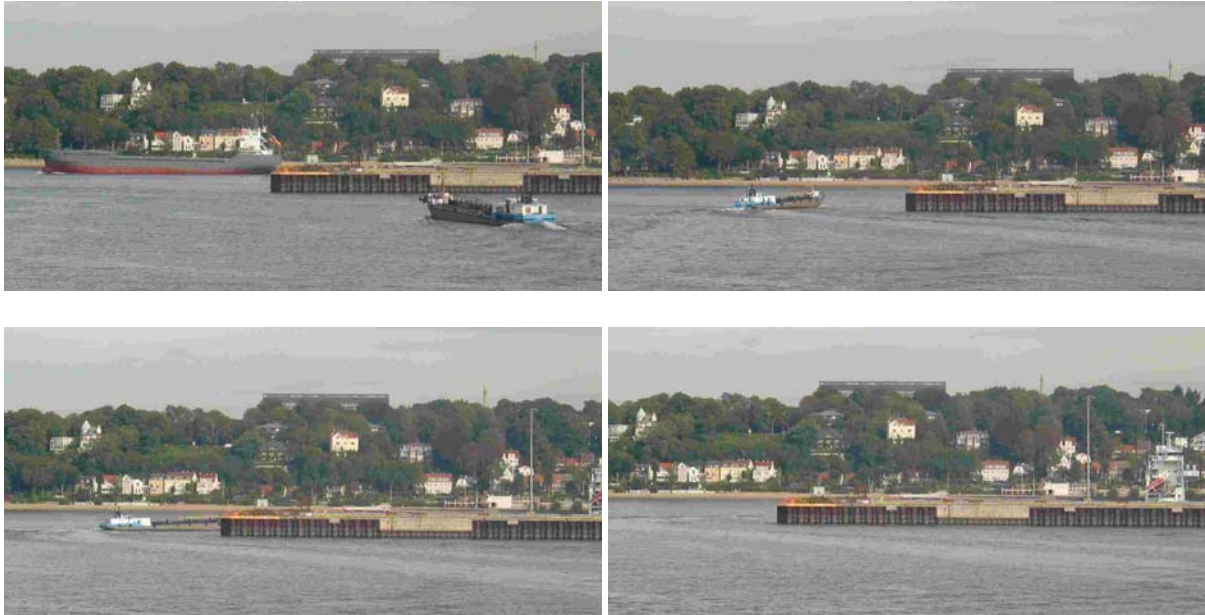
The picture series below (Figure 17) produced the next time PUDONG SENATOR ran through the port on 18 September 2004 and taken from the starboard wing, shows by way of example how a vessel of a size comparable with ENA 2 proceeding through Parkhafen in the direction of Norderelbe (upstream on the Elbe) "disappears" behind the Athabaskakai, even when no larger vessel has berthed there.

Abbildung 17: Athabaskakai wharf as optical barrier...
