Investigation Report 181/04

Very serious marine casualty

**Fatal accident of diver
on CMS CMA CGM VERLAINE
on 11 July 2004
in Marsaxlokk (Malta)**

1 June 2005

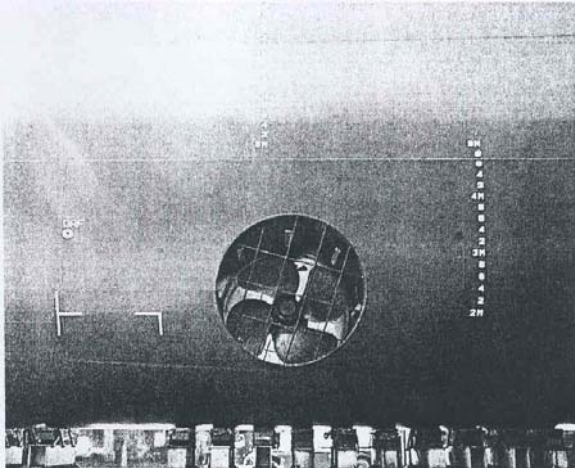
Figure 4: Bow thruster rudder tunnel

The bow thruster tunnel was originally secured by sea gratings that served primarily to protect the pitch propeller against flotsam. When the system was switched off, the propeller pitch could be adjusted by the vessel's own movement. The propeller had reportedly sustained damage due to the interfering / disturbing sea grating. That is why the sea grating on the port side facing the propeller had been removed. Photos of the original condition of the sea grating are available on board (see Figures 4, 5). According to the information supplied by the Master, a technical solution has been implemented in the meantime in that the hydraulic motor of the bow thruster switches on automatically when the propeller unintentionally builds up pitch due to the vessel's own movement in a pressure-free condition. This returns the pitch to "ZERO". The sea grating was not remounted.

- The Master was unable to provide an explanation for the lack of the sea grating at the bow thruster tunnel. The inspector justified this with material fractures and removal as a precautionary measure. It was not possible to determine when and where the sea grating had been removed.

The bow thruster tunnel was originally secured at the ends by sea gratings. The sea grating on the port side is missing. It was removed by way of precaution since damage to the bow thruster system was feared as a result of wear. This measure was not known to the Master, the Chief Engineer and the surveyor. No records of the removal of the sea grating have been submitted to the BSU. The sea grating might have been able to prevent possible winding of the diver's supply cables round the propeller of the bow thruster and have prevented the diver from coming into the propeller area. The actual purpose of the sea grating is to protect the bow thruster system against flotsam, however.

The owner must observe his obligation of reporting structural changes in the authorised structural condition of the vessel to the supervisory institutions.

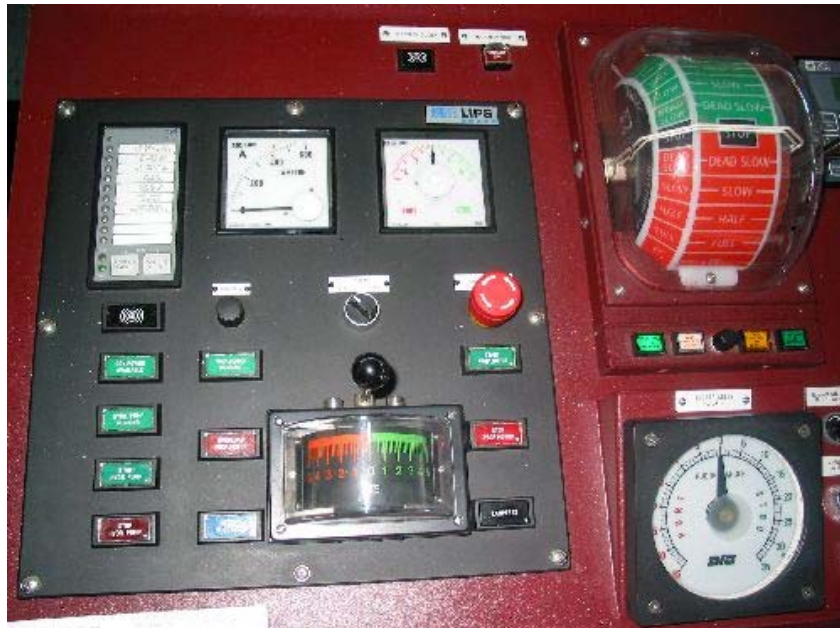
Figure 6: Control console bridge

Two auxiliary diesels are needed to switch on the bow thruster. In normal operation the system is then switched to the bridge for immediate starting (see Figure 6):

- Turn the rotary knob "System on/off" to "on". The system checks whether there is sufficient generator power available. If only one auxiliary diesel is running in the port mode (customary mode), the power management system automatically starts a second auxiliary diesel and switched this on in addition. The appropriate lamp on the operating panel only lights up when sufficient generator power is available.

- The hydraulic pump can now be started by push button. A further lamp indicates operation of the pump. In this condition the propeller pitch can already be changed via the hydraulic pump, but the propeller is not yet turning.

- If the bow thruster system is not turned off after operation, the propeller continues to rotate with zero pitch. This condition can be maintained in port operation too with just one auxiliary diesel running. If the pitch is now altered, the auxiliary diesel running picks up load and can continue to work up to a pitch of 50% without reaching the capacity limit. At a greater pitch, loads would then be cut off from the power system successively until a "blackout" occurs.

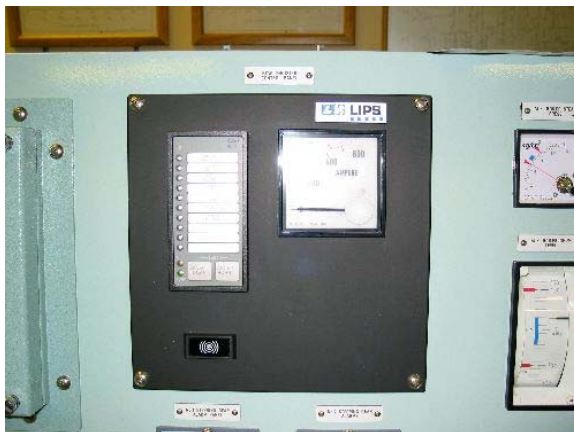
Figure 7: Control console engine control room

- The bow thruster can also be started from the engine room (see Figure 7). The bow thruster switch panel is located in front of the engine control room. Here it is necessary to turn the rotary switch "Local/Remote" to "Local". This switches operation from the bridge ("remote") to the engine room ("local"). Then the push button "Motor Start" on the bow thruster switch panel is actuated. The propeller now starts to rotate without pitch. It is not possible to change the pitch from the engine room. In port operation, with one auxiliary diesel running, the second auxiliary diesel necessary has to be started manually and switched in. In this case this is not done automatically. If the second auxiliary diesel is lacking, a blackout occurs (see figure. 8).

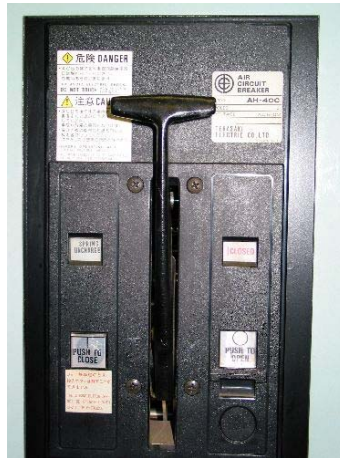
Figure 9: Main switch bow thruster

- The most important safety measure for the diver's assignment would be to interrupt the power supply to the bow thruster on the main switch panel in the engine control room by opening the main switch and mounting an appropriate warning on this main switch. When the main switch is open it is not possible to operate the bow thruster. To close the main switch it is necessary to apply tension to the spring that opens by push button actuation again (see Figure 9). For this it is necessary to actuate the hand lever several times. Only then is it possible to actuate the push button "close". The push buttons for both opening

and closing the main switch are provided with a synthetic cover against unintentional actuation.

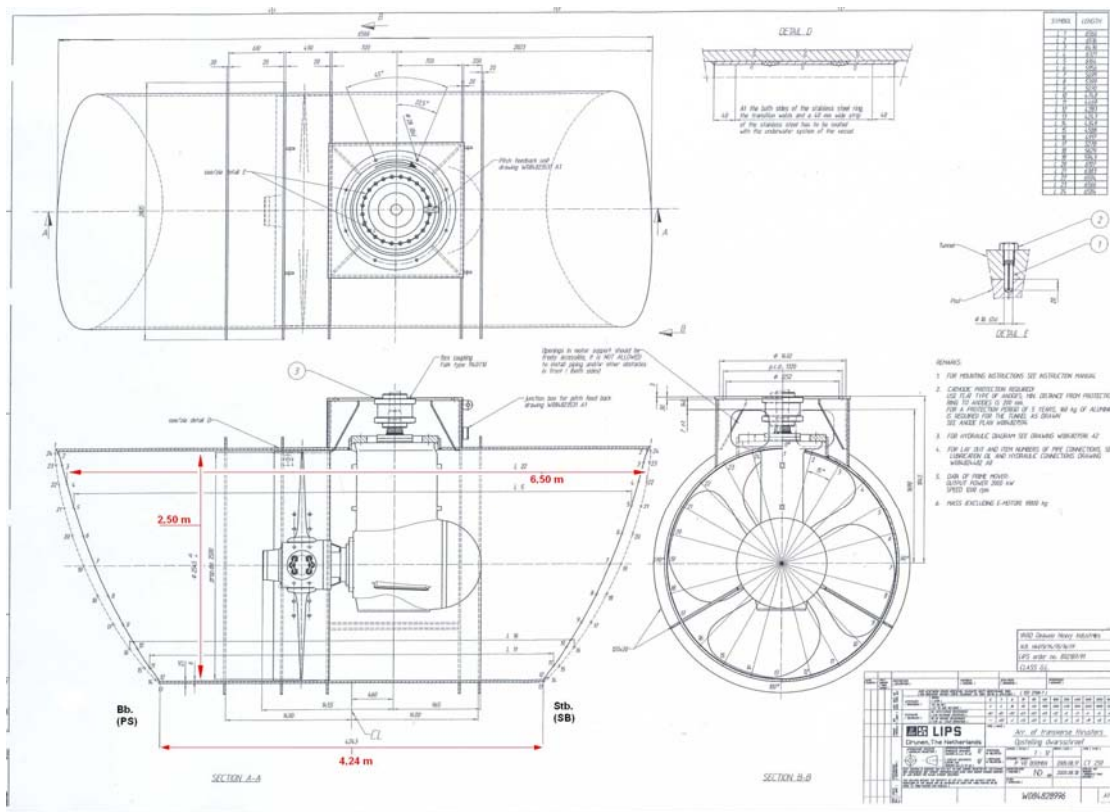
Figure 10: Plan of bow thruster system

The automatic monitoring of bow thruster system operation at the control console on the bridge (see Figure 6) and in the engine control room can be monitored via freely programmable alarms. These include voltage, hydraulic pressure, oil level in the tanks and motor temperature. The status of the system and operation of the aggregates is displayed by lamps. There are further switch panels in the bow thruster chamber and in the bridge wings.

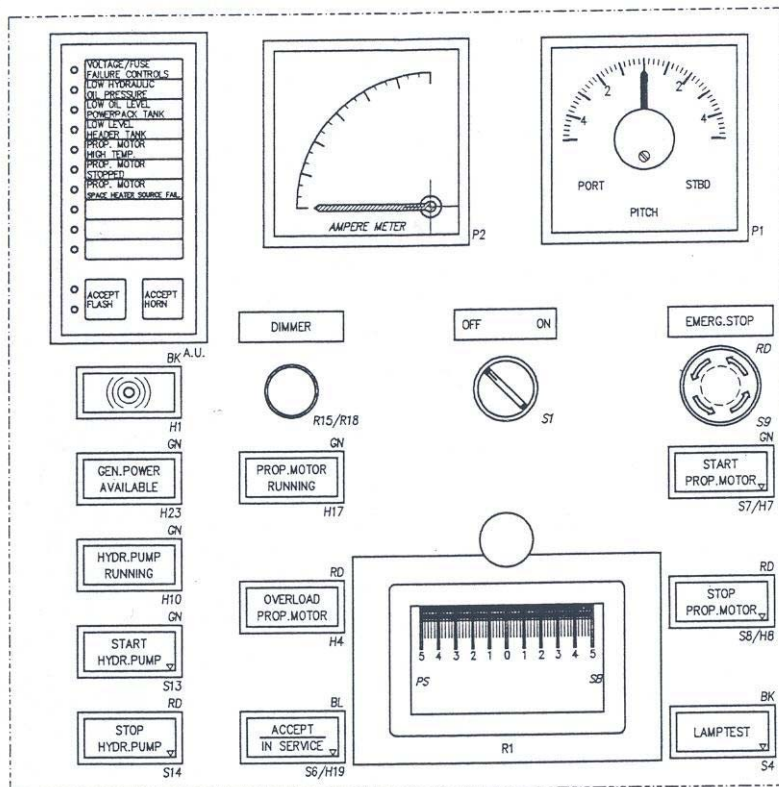
Figure 11: Control console bow thruster system Messrs. John Crane-Lips

Following actions have to be taken to give a start signal to the bow thruster starter box:

1. Switch S1 must manually be set to on.
2. Generator power must be available. Main switch board must close a contact to withdraw the interlock of the "GEN power available".
3. Power pack must be manually started to withdraw the interlock "hydraulic pressure available".
4. Pitch must be in the „zero area“. Will be automatically adjusted to zero when power pack is switched on.
5. Start button on wheelhouse or engine room panel has to be activated manually.

The manufacturers of bow thruster systems must ensure that the maintenance and operating instructions of the equipment they bring into circulation include the necessary detail and provide easily understandable information about starting up and switching off. This also includes clear indications of the automatic switching off, the fine adjustment and the unintentional and uncontrollable build-up of pitch of the variable propeller when idling and of special dangers and risks in the pressure-free condition and during maintenance work or underwater surveys of the system.
