Investigation Report 202/04

Serious Marine Casualty

Explosion on board FC HARMONIE on 2 August 2004 off Baltrum

1 March 2005

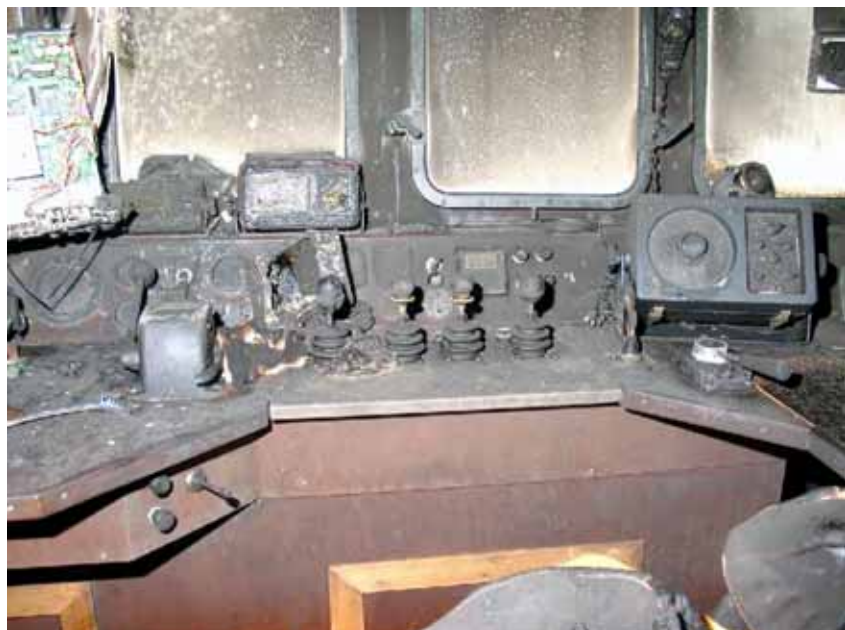
Figure 8: Wheelhouse looking forward

The bridge showed signs of fire damage over the ceilings, walls and fittings from a height of approx. 90 cm above floor level upwards. The bridge equipment (monitor, communications facilities, operating facilities) was largely charred and had started to melt. The ceiling installation made of plastic (lampshades and housing) was completely destroyed.

The artificial leather upholstery and the upholstery of the bridge seat were approx. 30 % burned. The equipment and furnishings below a height of 90 cm including the flooring were not affected. The bridge windows were covered in soot and had been rendered opaque.

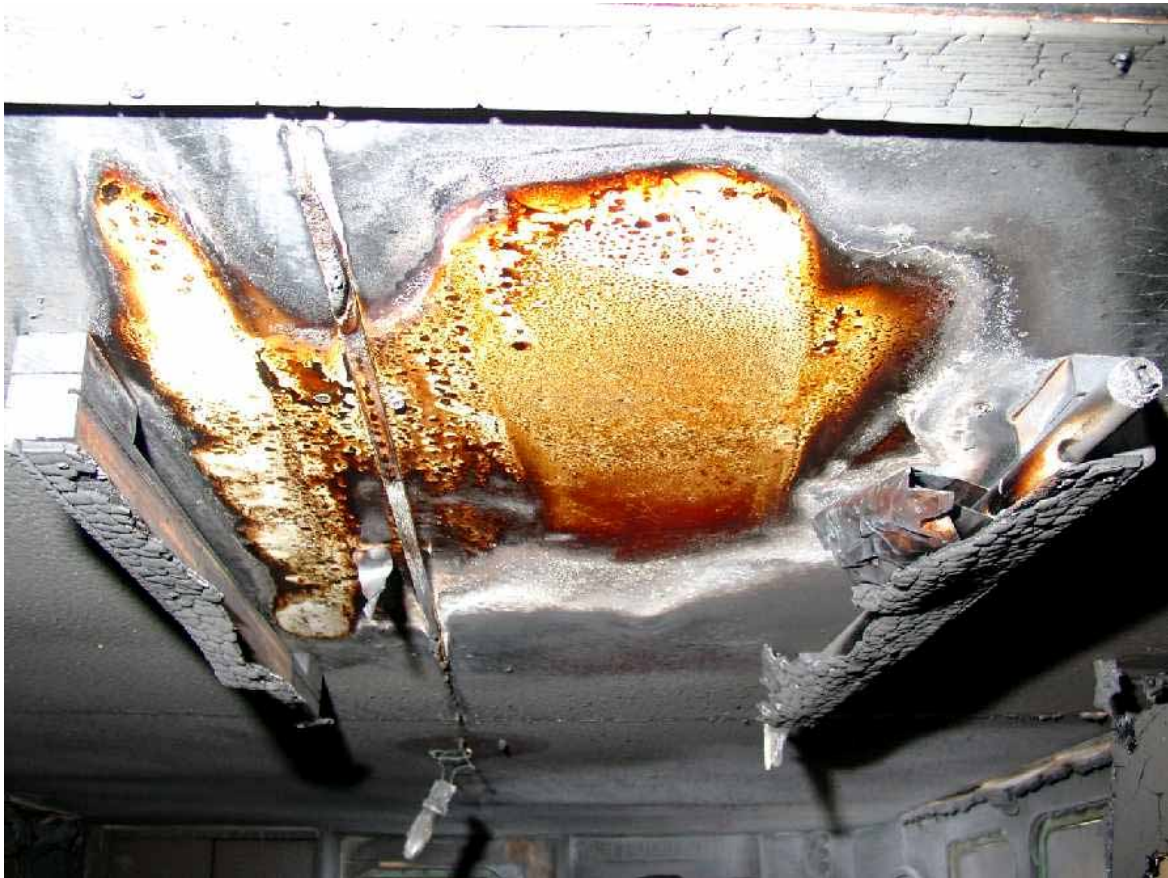
Figure 9: Chart compartment

The surfaces of the ceiling and wall covering, the furniture, the fittings and the PVC floor covering were completely destroyed by fire. The floor skirting boards had mostly melted and burned. The fibreboard panels on the floor remained intact. There were characteristic fire patterns on the wooden panelling, the wooden furniture, the wooden mouldings and the curtain rails. Stronger effects of the fire than in other areas were ascertained in the area of the engine room entrance. Plastic parts lying open had melted. The ceiling lamp had been destroyed completely and the bulb had melted. The chart compartment with the sea charts in it beneath the ceiling in the central aisle had been totally burned. The upholstery on the seats was almost completely burned. The aft windows were very opaque, covered with soot and had partly cracked.

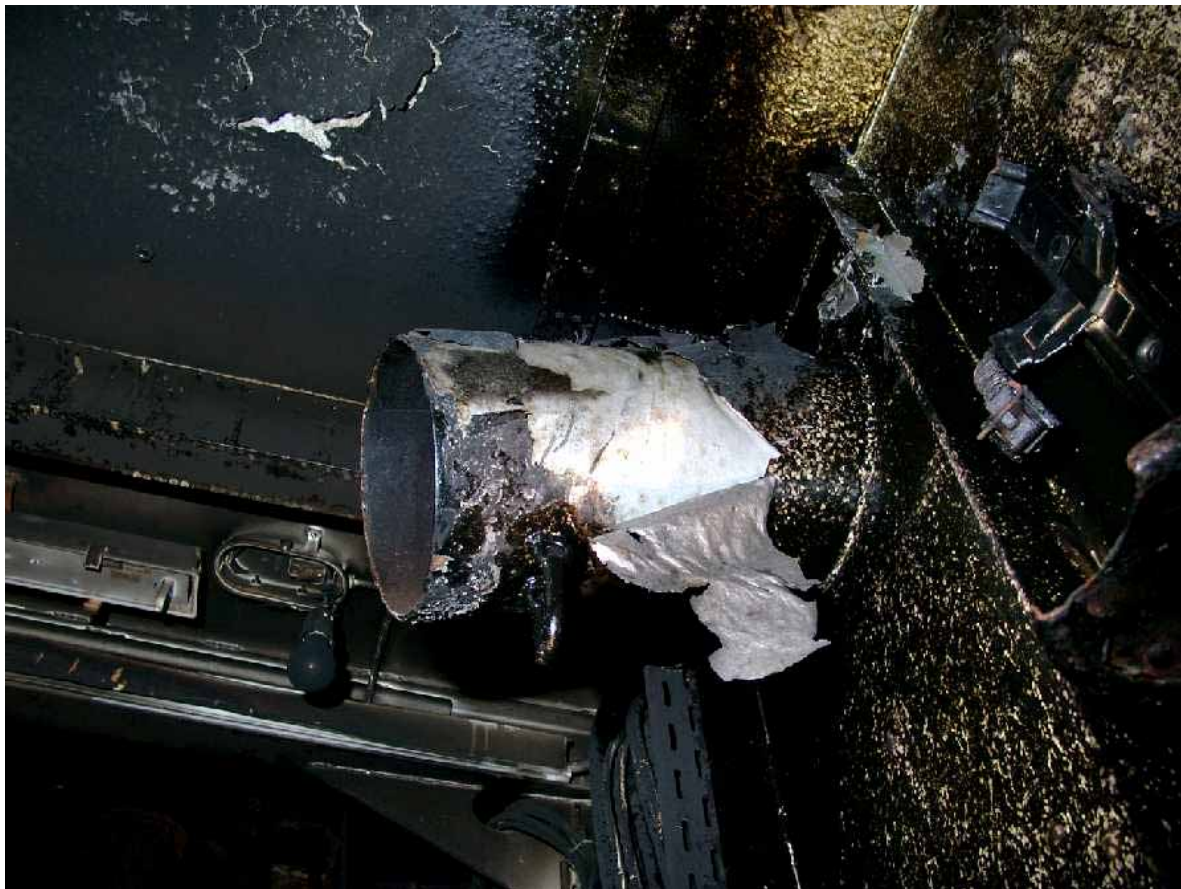
Figure 10: Ventilation pipe

Large areas of the starboard side with the companionway, the workbench, the ceiling and aft edge starboard of the ER were covered with oil. The ER deck showed damage on the starboard aft part, such as burned layers of paint, blistering and peeling. The area of the ER entrance was coated with soot, but the paintwork beneath this coating of oil/soot was largely intact. The housing of the water circulating pump at the aft edge of the ER companionway and the housing of a measuring sensor on the starboard forward edge of the main engine were charred. Various cables in the ceiling area starboard were partly charred. The covers of sundry lamps and a cable duct at the front edge of the ER had melted. The layer of paint on the ventilation pipe on the starboard side was burned and peeling off. The companionway was largely intact, only the upper part and parts of the right-hand handrail showed signs of fire. The fire extinguisher in the ER entrance was no longer in its bracket and was lying in secured condition in the starboard bilge. The remaining areas of the ER were covered with a slight layer of soot. The further systems and facilities in the ER such as diesel generator and net winches showed no notable signs of damage.

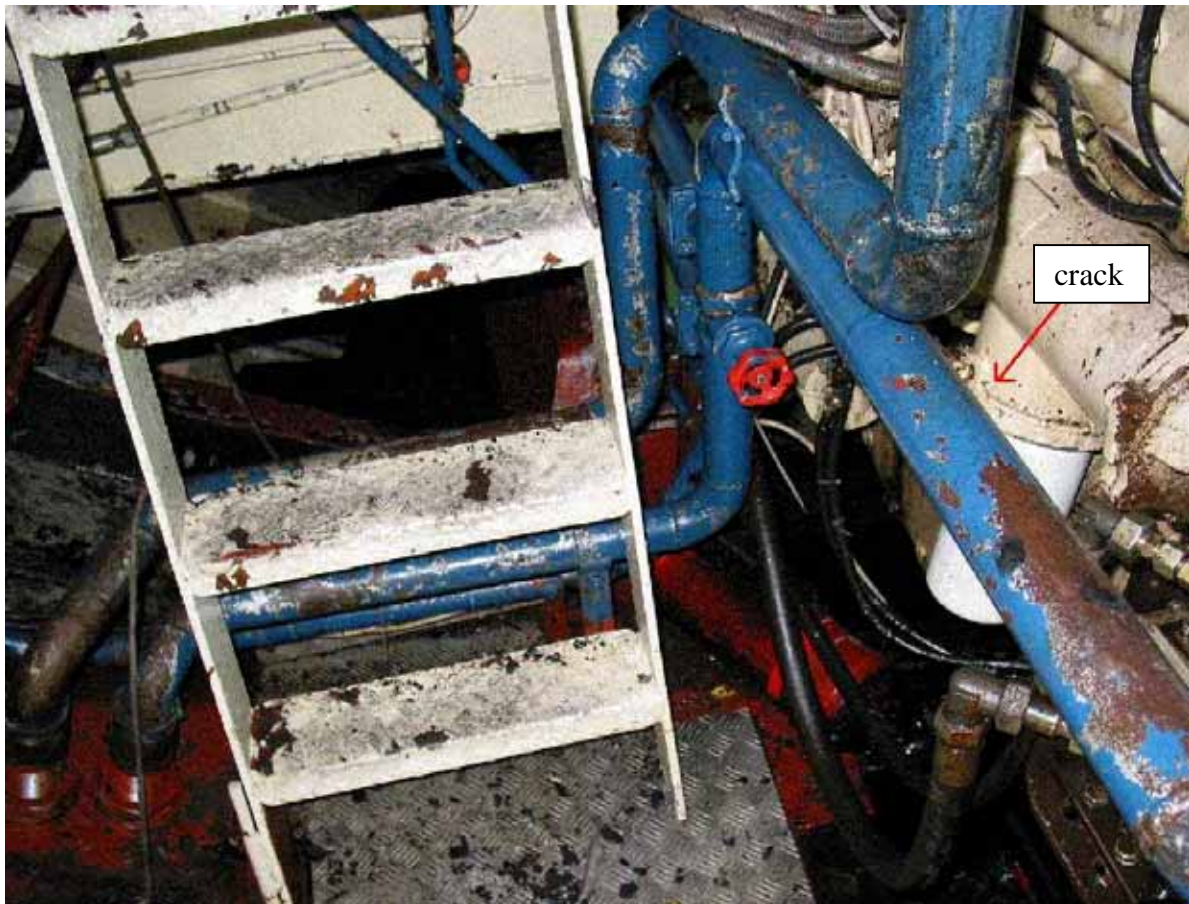
Figure 11: Companionway starboard side

The oil film on the walls and ceiling on the starboard side of the ER was identified as lubricating oil from the main engine (ME). The ME of type CUMMINS NTA 855 M was thereupon examined in detail. During a visual inspection of the ME and its systems no signs of leaks in the fuel system or cable defects or evidently loose screw fittings were ascertained. The sounding of the oil sump using a sounding stick showed a filling level of 3 mm below maximum level. The only leak in the lubricating oil system was ascertained in the angle screw fitting of the lubricating oil line to the exhaust gas turbocharger on the filter housing of the oil cooler. The screw-in thread of this line was torn off at the housing and bent slightly downwards.

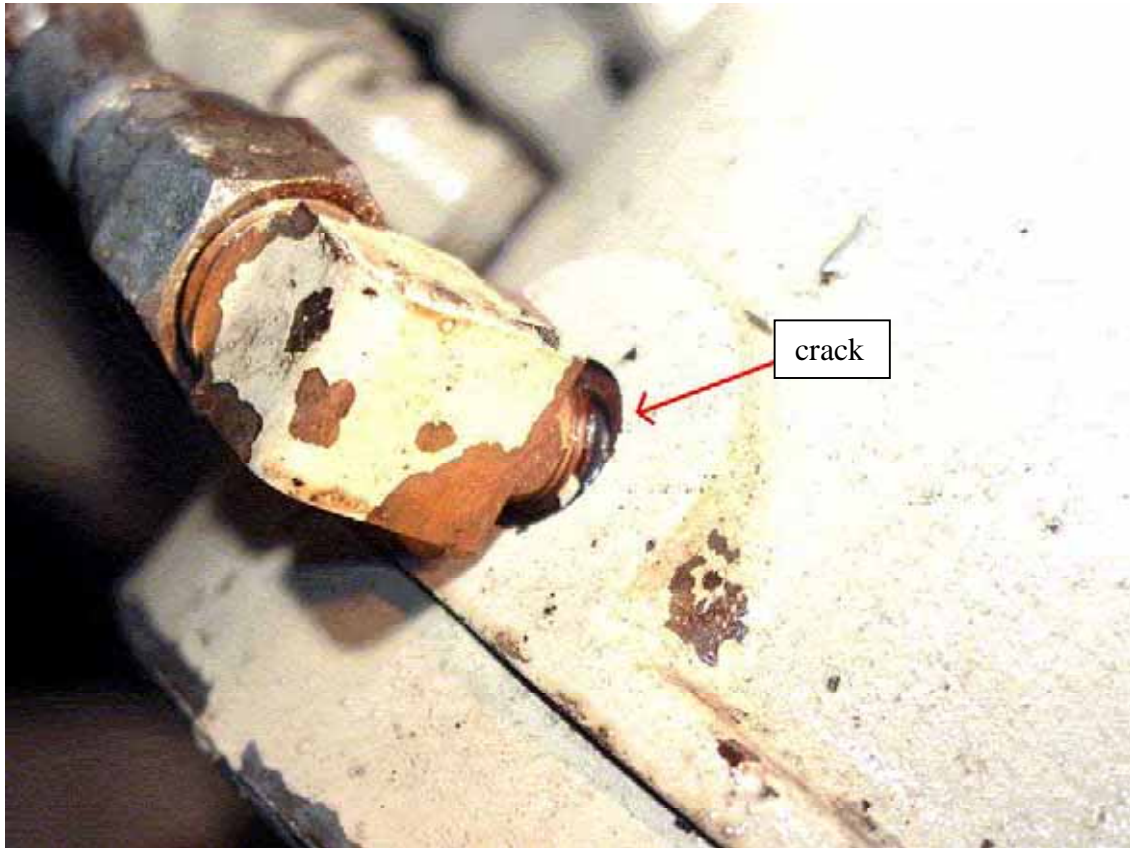
Figure 12: Screw fitting on oil cooler

The screw fitting of the lubricating oil line at the oil cooler showed signs of a leak. Lubricating oil escaped from this leak at a pressure of approx. 3 bar unimpeded in the form of spray mist. The size of the oily area and the fact that the volume of lubricating oil in the oil sump had evidently hardly been reduced indicate that no major quantities of lubricating oil can have escaped. The lubricating oil mist was spread over the starboard side of the ER, had wetted parts of the installation such as ceilings, walls, workbench etc., and formed an oily room atmosphere. At the same time the oil began to evaporate on the wetted, hot surface of the machine parts and formed ignitable mixtures. These products of evaporation and oil droplets gathered primarily in the starboard area beneath the ER ceiling.

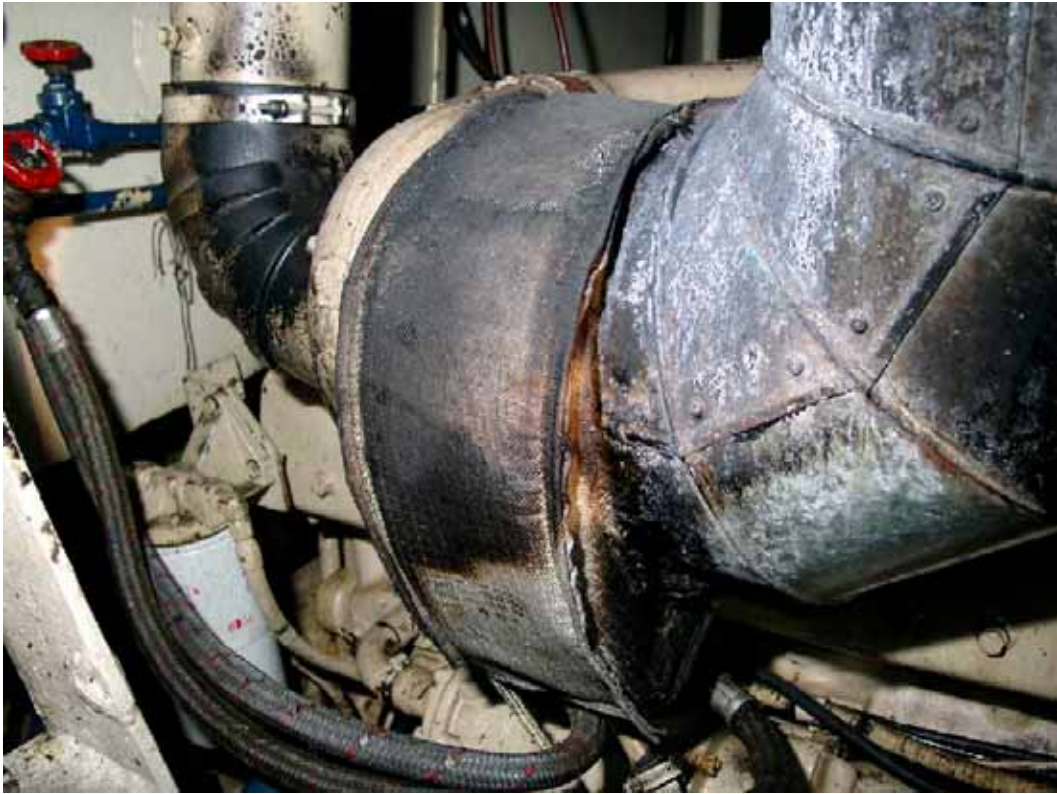
Figure 13: Exhaust gas turbocharger insulation

The further examination was concentrated on the source of ignition. The ME has an insulated, metal clad exhaust line on the starboard side. This line was also oily in the bottom area and showed clear traces of flames over its whole length. The exhaust gas turbocharger was insulated by a mat. No wiring was ascertained. This insulation and the housing of the exhaust gas turbocharger as well as the parts of the exhaust duct directly adjacent to it showed traces of fire, were covered with soot and contained residues of burned oil.

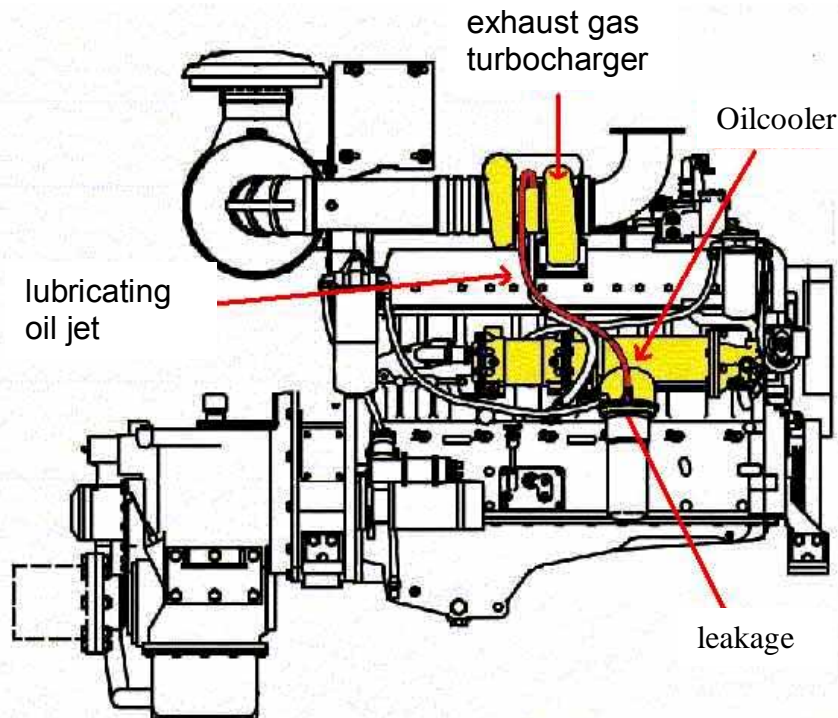
Figure 16: Leak and exhaust gas turbocharger at the ME

On the day of the accident the Master checked the engine operation and ascertained oil drops on the angle screw fitting between the oil cooler and the connection hose. He thereupon tried to tighten the nut on the connection hose using a spanner. In doing so he ripped off the angle screw fitting at the oil cooler. It can be assumed that the angle screw fitting was not ripped off completely, but instead that a fine crack first formed in the upper part through which oil was additionally atomised.

The exhaust gas turbocharger on this engine is located approx. 23 cm away horizontally and 38 cm away vertically from the position of the leak. As a result of the crack in the upper part of the angle screw fitting the exhaust system, especially the exhaust gas turbocharger, was necessarily in the direct area of the lubricating oil jet. The oil infiltrated beneath the insulation at the joint between the exhaust gas turbocharger and the exhaust gas line and was heated up to 600° C. As the damage configuration on the exhaust gas turbocharger and the insulation demonstrate, the lubricating oil ignited at this point.

The leak of the screw fitting on the oil cooler was not easily visible for the Master, since it was located behind a cooling pipeline. His attempt to eliminate the leak by tightening the cap nut without the help of any suitable fixing of the fitting body failed. This design in itself very quickly leads to excessive stress and unless the fitting is secured using a 17-mm spanner also to cracking of the fitting at the thread to the filter housing.

This Regulation must be observed during all work on pressurised systems by engine fitters and masters. During work on main or auxiliary engines these are to be stopped so that in particular the lubricating oil and fuel lines are not under pressure.

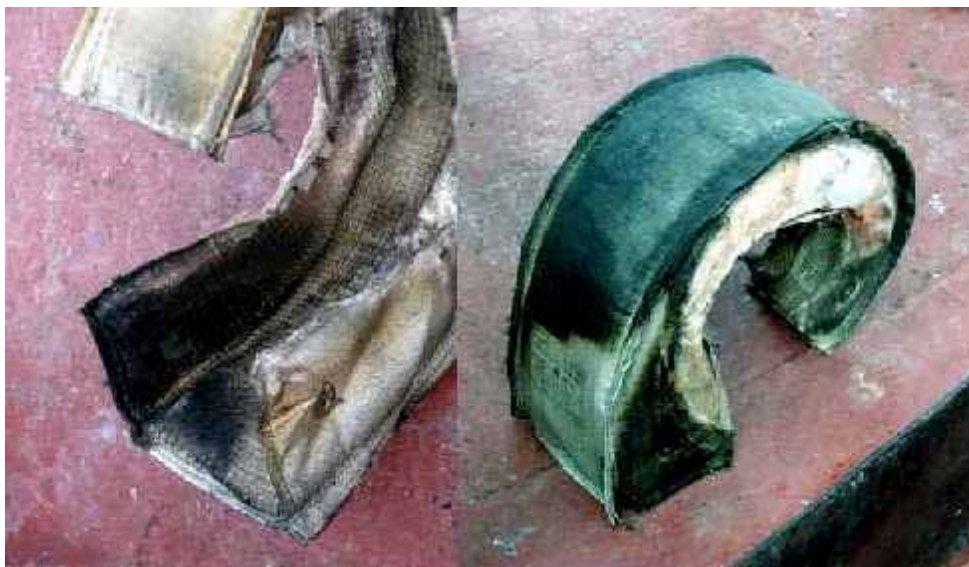
Figure 17: Insulation exhaust gas turbocharger

Open flames developed on the upper side of the oil-saturated insulation and the fire was initially restricted to this area alone. The traces of flames on the exhaust gas insulation indicate that the open fire on the insulation of the exhaust gas turbocharger must be seen as the source of the ignition. The fire then progressed as follows: During sea operation the entrance to the ER is only open for inspection and repair measures. At the time of the accident, however, this entrance cover had been opened for the inspection and was arrested in the device installed for this purpose. At the same time the port and aft door of the deckhouse were open. It can be assumed that as a result of this ventilation situation extra fresh air made its way into the ER and the oil mist-air mixture was at the same time able to spread out into the wheelhouse lying above it. The conditions now applying led to the oil mist-air mixture igniting right through, whereby with this sudden combustion a large quantity of heat was released within a very short space of time. This also involved an increase of temperature in the areas beneath the ER ceiling, the ER entrance and below the deckhouse of approx. 1100 °C and at the same time the hot gases expanded very quickly.

A fire test was conducted in the laboratory with a sample of the lubricating oil taken from the vessel. This experiment revealed that the experimental sample ignited automatically without the presence of an ignition flame at a temperature of 580 °C. It is to be assumed that at the time of the accident, due to the drag operation, the engine was running in a high load range. The exhaust gas temperature, approx. 1.0 m after the exhaust gas turbocharger, is usually 430 °C according to the information supplied by the manufacturer. Thus the exhaust temperature in front of the exhaust gas turbocharger at the time of the accident was about 580 °C to 600 °C. Consequently self ignition of the lubricating oil hitting the exhaust gas turbocharger appears certain.

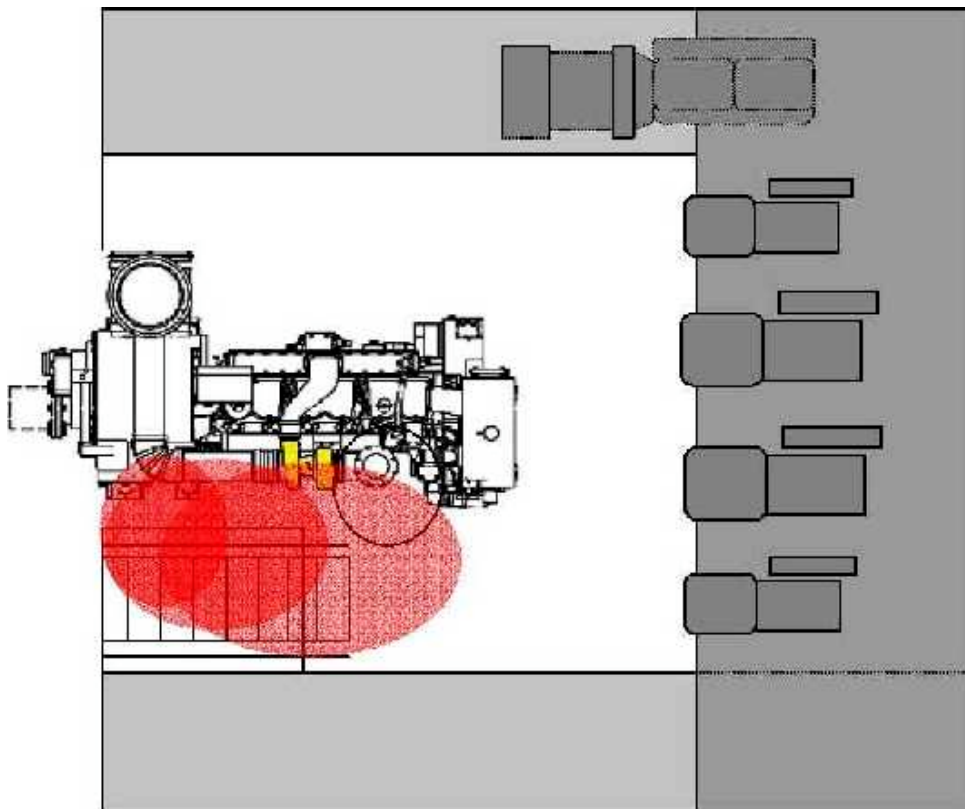
Figure 18: Fire propagation below deck in the ER

In the first phase of the now following fire propagation the oil mist-air mixture in the area of the ER ceiling burned off at the entrance and produced the damage configuration found here.

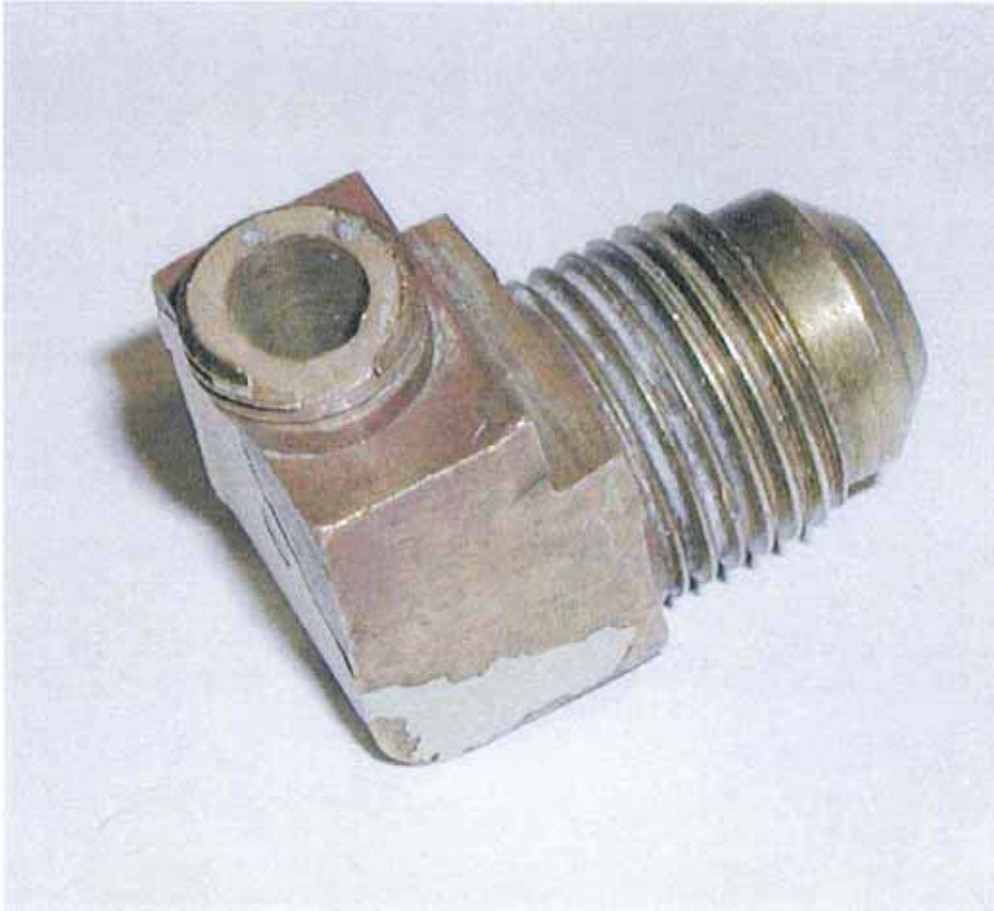
Figure 19: Angle screw fitting / 90° fitting

The angle piece is a so-called 90° fitting made of free cutting brass. These fittings are normally used in oil lines, but also in water lines. The angle screw fitting has two external threads with an external thread diameter of 16 mm and an almost square body 17 mm thick. Thanks to the form the fitting body is suitable for use with a spanner width of 17 mm. The 17 mm spanner can on the one hand be used to mount the fitting in the oil cooler housing, and on the other hand to hold it in place when tightening the cap nut of the connecting hose.

The hardness test resulting from three measurements produced an average hardness of 105 HBW (Brinell hardness value). This corresponds to a customary hardness for this material.

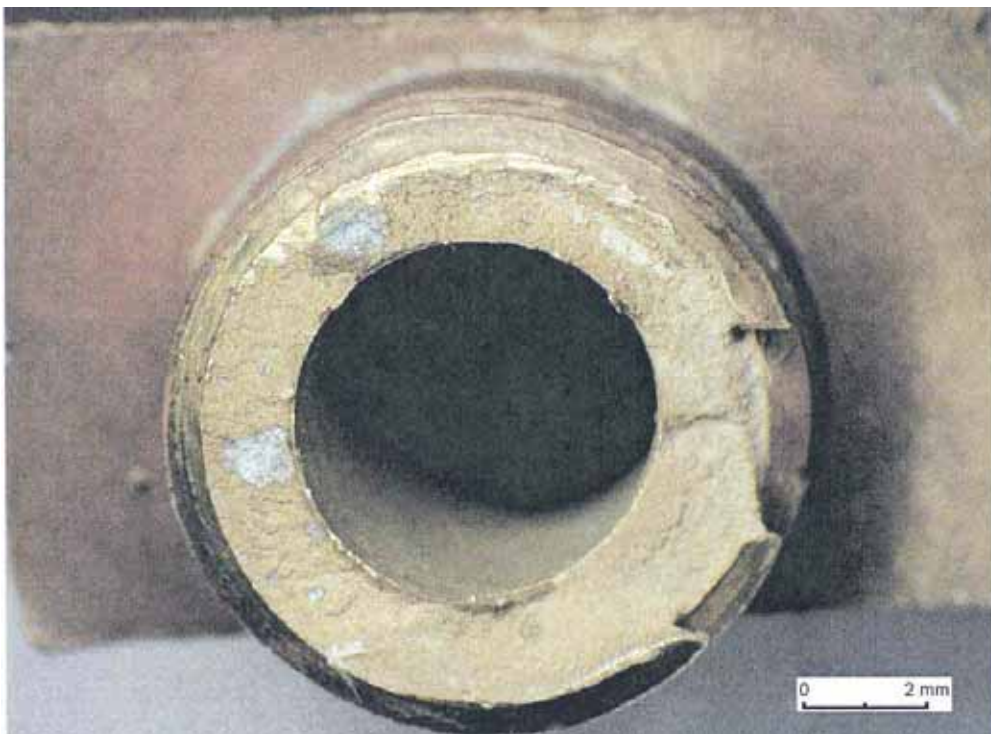
Figure 20: Fractured surface

The photo of the fractured face only shows that the crack occurred at the top in the installed condition and spread from the top to the bottom.
The fractured face was thereupon examined with a scanning electron microscope.

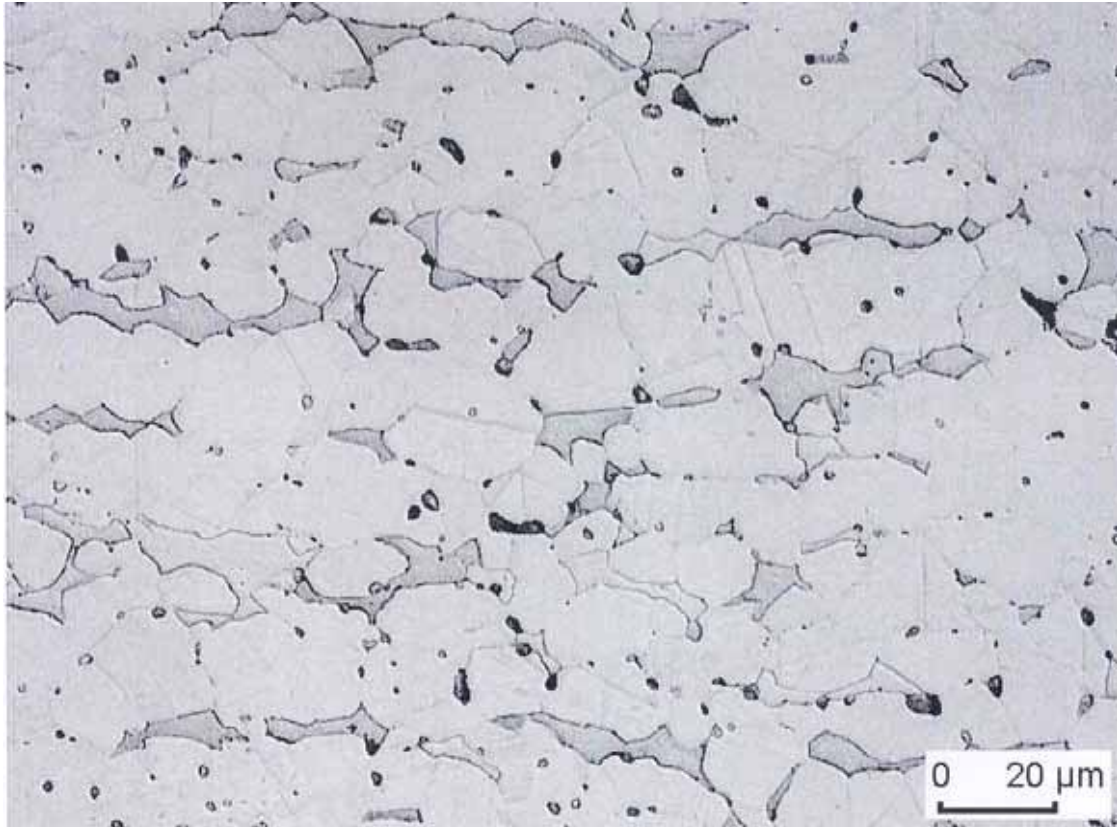
Figure 21: View under the scanning electron microscope

Viewed under the scanning electron microscope, a uniform picture was found almost all over the entire fractured face. This picture is characterised by a honeycomb structure as is shown in Figure 21. These structures indicate a forced fracture and are interrupted by lead eliminations and stains with corrosion products. The eliminations and corrosion evidently occurred subsequently when the area came into contact with firewater during extinguishing of the fire. In view of the microscopic fracture structure, prior damage of the fitting can be ruled out.

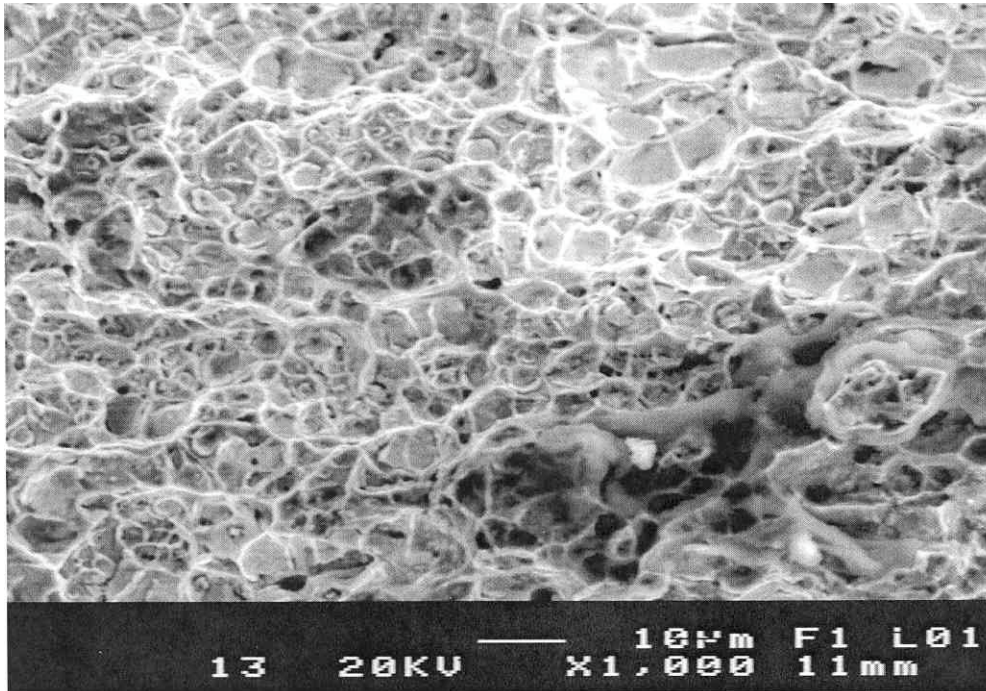
Figure 22: Photo of the structure

The micro-section (Figure 22) shows the structure of the material consisting of Alfa and Beta brass with finely distributed lead eliminations. The structure appears fine-grained and uniform. No abnormalities have been ascertained. The structure is typical for free-cutting brass.

No prior damage or material faults that could have promoted the damage were ascertained.
