**Investigation Report 240/04**

**Very serious marine casualty**

**Sinking of SY MADAME PELE  
and drowning of two sailors  
off Borkum on 26 August 2004**

1 May 2005

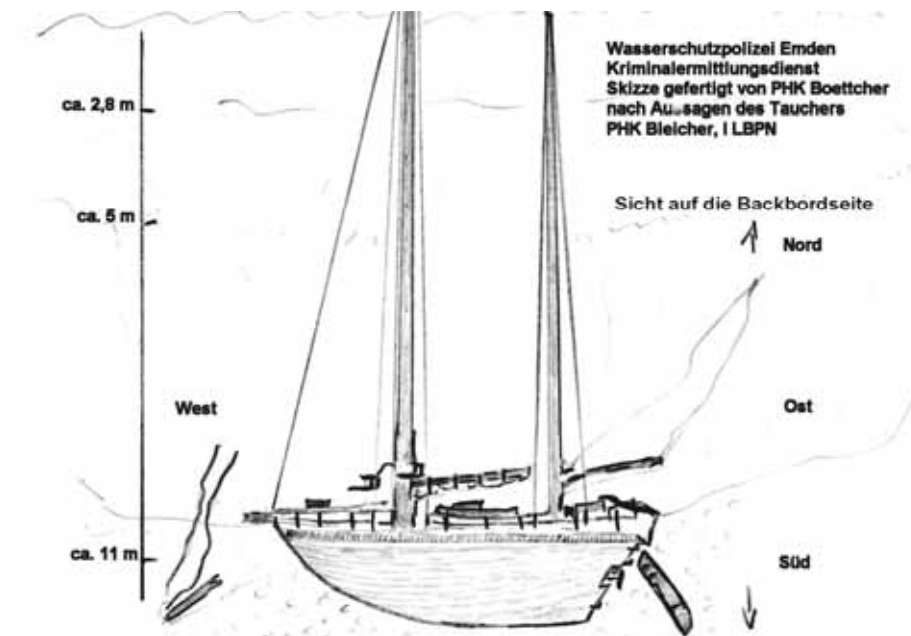
Figure 6: diver's sketch, side

The next diving operation was conducted by two police divers on 3 September 2004. The starboard side of the hull was buried in sand up to the deck and the vessel was now lying at a depth of 11 m with a list of approx. 45° at low water with the stem facing in a south-westerly direction. No damage to the planks on the port side could be felt on the actual hull. Both masts and the rig were undamaged. The main mast projected approx. 1.50 m out of the water at low water. The starboard side lights had been ripped out of the shrouds. The jib sail had been ripped out of the mast rail and was swaying over the vessel. The jib boom was broken off close to the stem and was still directly next to the vessel, being held by the bow stays.

The three-blade propeller was not bent and was plugged freely in the shaft. The mounted rudder was lying on the starboard side next to the yacht and was held close to the vessel by a lashing. An examination revealed that the pintles of the rudder blade had been pressed out of the rudder eyes. The pintles on the rudder blade were not cross-pegged, despite the bore holes there.

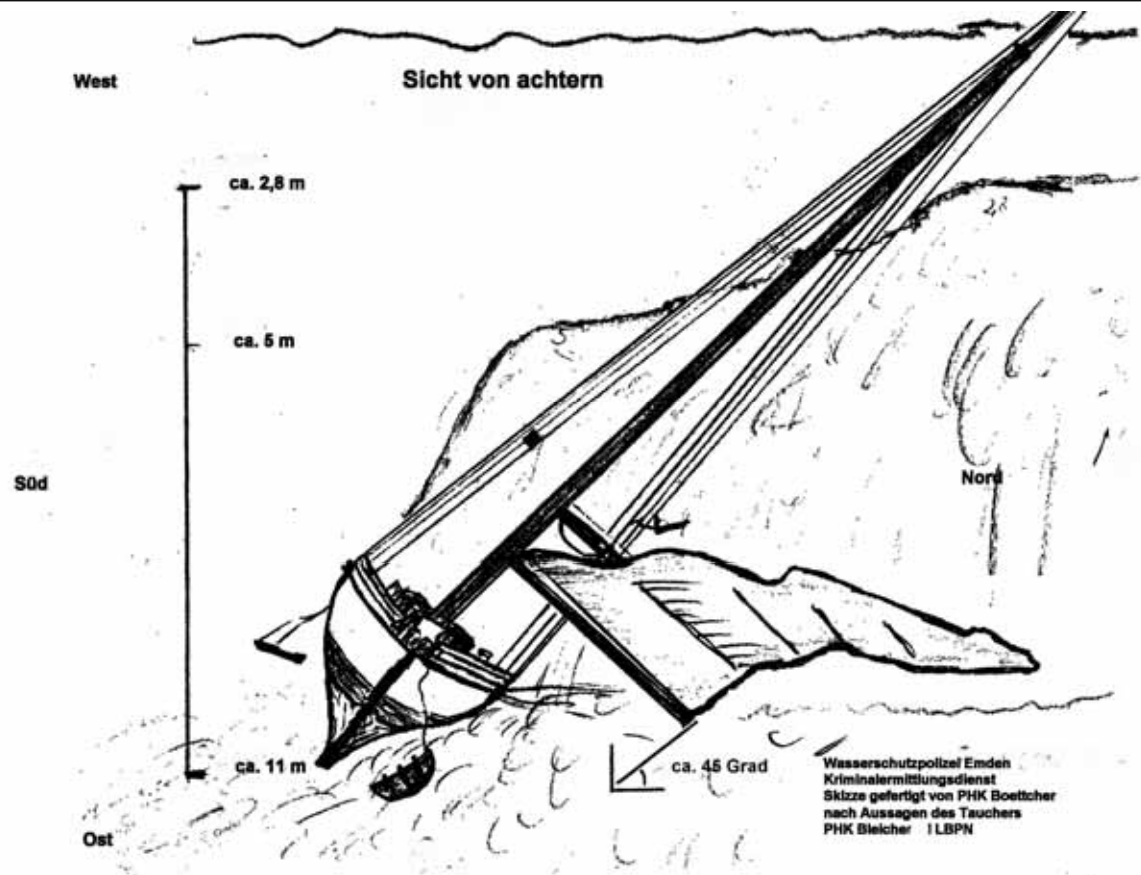
Figure 7: Diver's sketch from aft

The vessel was not closed. The companionway in the aft steering cockpit to the aft cabin was open. The sliding hatch from the companionway to midships in the guest cockpit was open. The companionway in front of the main mast to the fore ship bunks was closed and was broken open by the divers in order to look for the missing co-sailor. Altogether four lifejackets were found in the forward area.

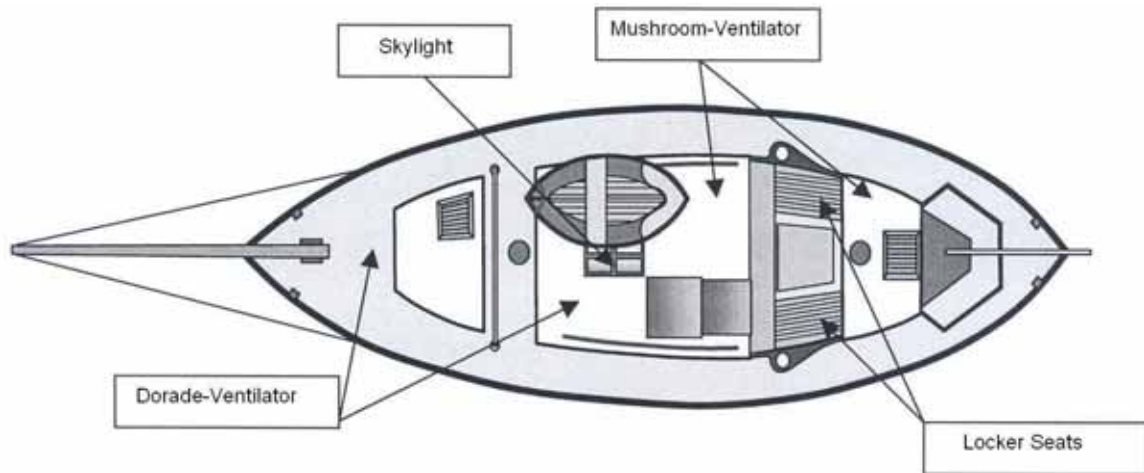
Figure 8: Deck drawing

The lids of the locker seats were provided with moss rubber seals in the central cockpit but were only held in place by their own weight. The locker seats could not be closed water-tight and in a heeling position water could enter into the superstructure.

The draining pipe of the cockpit was joint with the outlet from the WC. According to recommendations cockpit draining pipes are to be kept open at all times and may not be connected with bilge pump draining pipes.

It was not possible to produce a watertight condition in several places, e.g. for the ventilators and the cockpit seats.

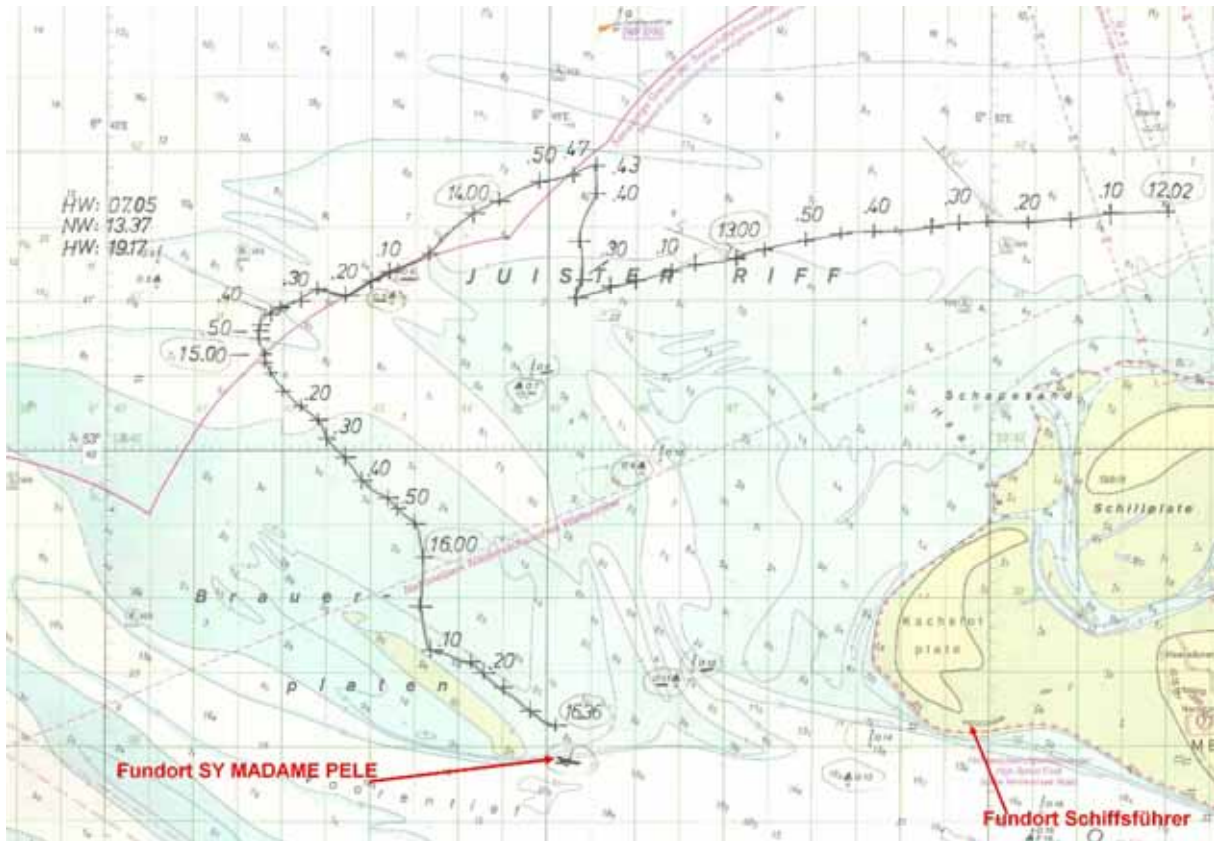
Figure 18: Course of voyage from 12:05 h to approx. 16:36 h

After the larger rain front had passed with wind speeds of approx. 8 Bft the echo of SY MADAME PELE was lost at 16:36 h.

The Osterems buoys O5 and O6 were passed at close quarters at approx. 14:10 h. If the ship's electronics and navigation equipment and the radio set had failed at this time, which appears to be probable due to the unfavourable arrangement of the load batteries, it would have been easily possible to find the position terrestrially with the good visibilities. According to this the owner ought to have known where the vessel was. If he deliberately wanted to run into the Osterems, he would now have had to make a change in course, falling by 110° to a course of approx. 130°. Instead he continued to run for 10 minutes on the old course of 240°. At 14:20 h the course was changed to 290° for about 5 minutes and then up to 14:40 h the vessel proceeded back on the course of approx. 240° on which it had been heading since 13:45 h.

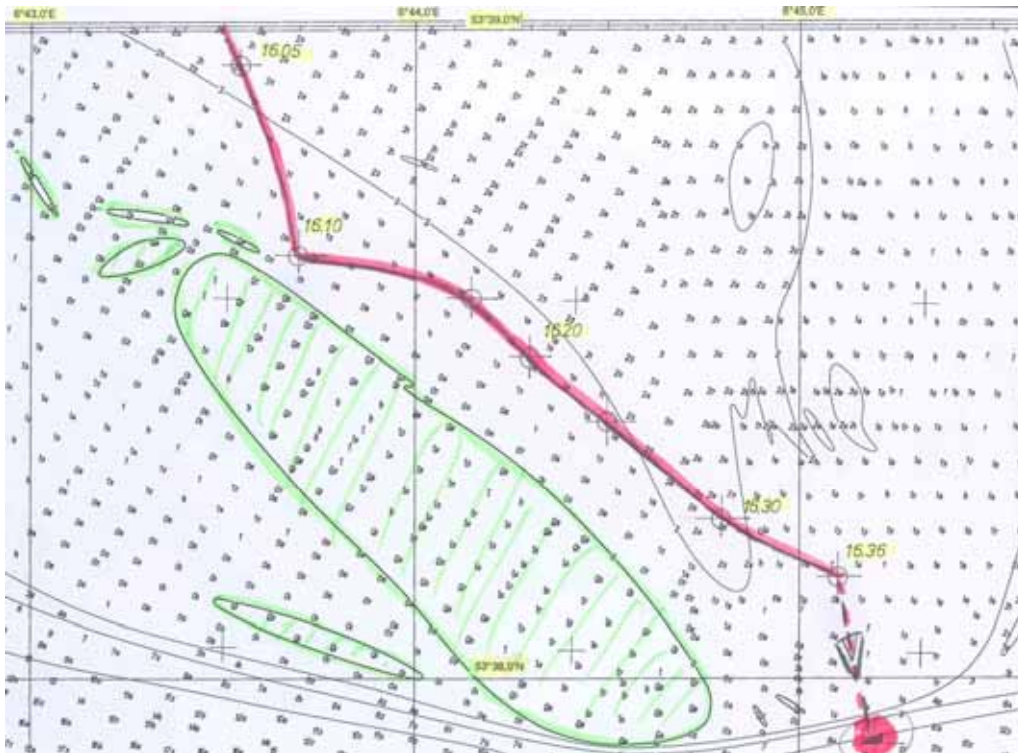
Figure 22: Course in the sounding plan

Time	Position	Sounding depths in m without wave	Sounding depths in m with a wave height of		
			1.50	2m	3m
1.)16:05 CEST	53°38'57'' N, 006°43'33'' E	4.20 m	3.45	3.10	2.70
2.)16:10 CEST	53°38'39'' N 006°43'42'' E	2.80 m	2.05	1.80	1.30
3.)16:36 CEST	53°38'09'' N 006°45'06'' E	3.00 m	2.25	2.00	1.50

The jib boom and the rudder appear to have been broken off after the first ground contact. The breakers breaking over the vessel evidently led to the aft cabin and the forward area below deck running full of water through the open insert hatches.
