Investigation Report 343/04

Very serious marine casualty:

**Collision between MV RITHI BHUM
and MV EASTERN CHALLENGER
with subsequent foundering of
MV EASTERN CHALLENGER
on 14 November 2004
in the South China Sea / Taiwan Strait**

15 July 2005

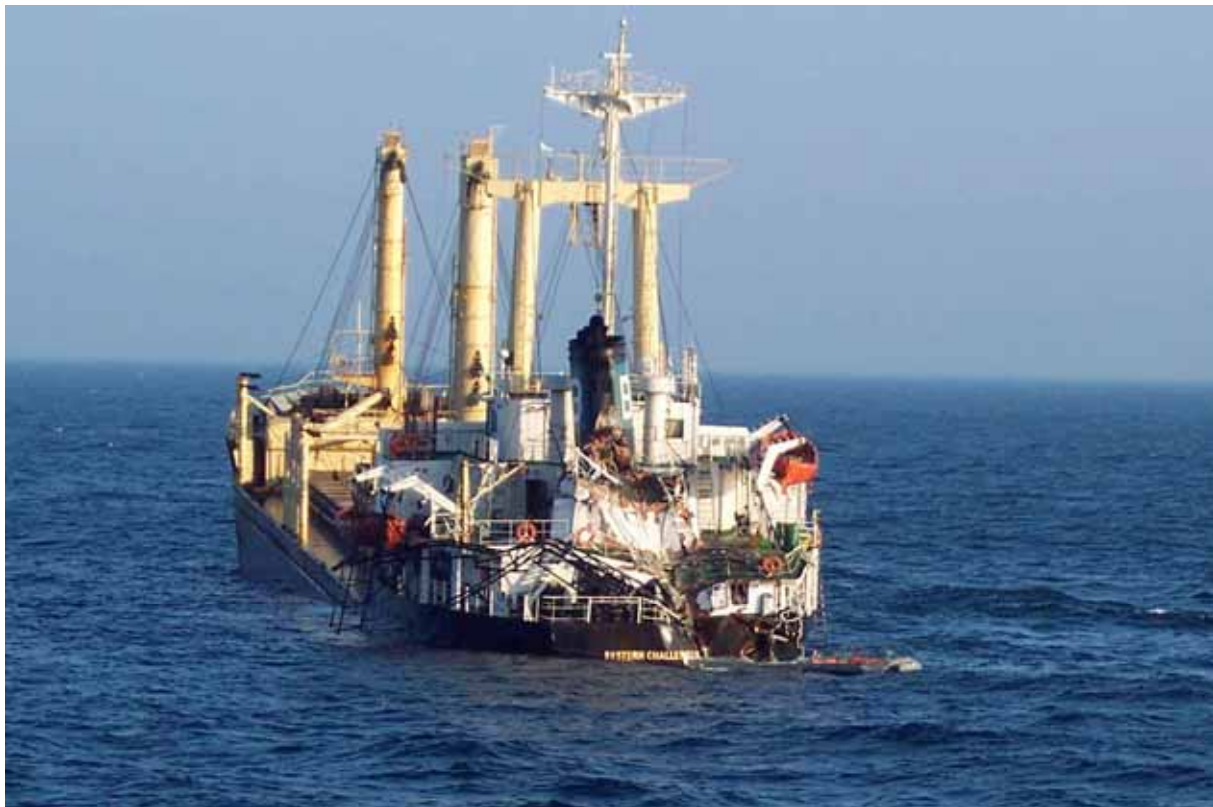
The entire starboard stern on EASTERN CHALLENGER was destroyed. The main engine and generators failed as a result of heavy flooding in the engine room and the vessel was down by its stern post. The two lifeboats could no longer be used. About 20 minutes after the collision the crew abandoned the vessel and entered one of the two liferafts that were launched.

Figure 4: EASTERN CHALLENGER the morning after the collision
(Photo: Daebo Shipping Co., Ltd., Seoul)

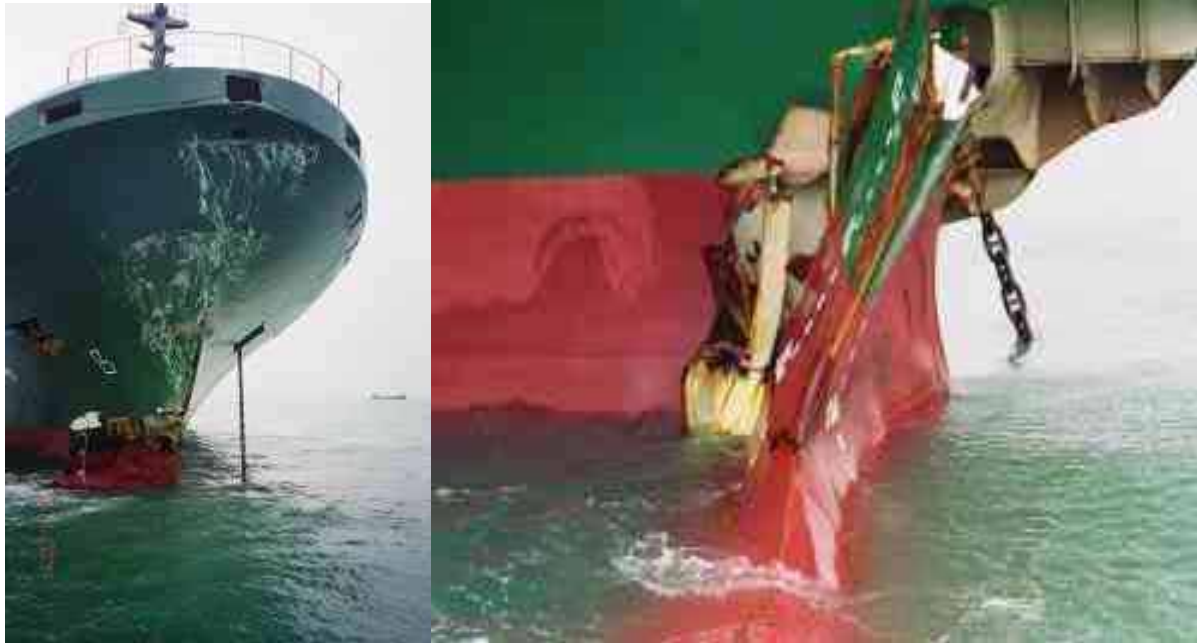
On RITHI BHUM the forecastle area was damaged. The bulbous bow had been bent about 120° to starboard, the fore peak tank was ripped open. In addition a hole with a diameter of about 80 cm and many cracks and dents had been sustained in the above-water area forward of the collision bulkhead. The ballast water tanks in the fore ship and on the starboard side were sounded and the fore peak deballasted. The water ingress was under control at about 03:30 h¹². Owing to the damage RITHI BHUM could only proceed at dead slow ahead and return to assist EASTERN CHALLENGER. At about 03:00 h a lifeboat was launched from RITHI BHUM and 20 minutes later all 17 crew members of EASTERN CHALLENGER were on board this lifeboat. At 03:35 h the lifeboat and raft were alongside RITHI BHUM. The Captain

Figure 5: RITHI BHUM after the collision
(Photos: Jacky Rickmers Schiffahrtsgesellschaft mbH & Cie.KG)

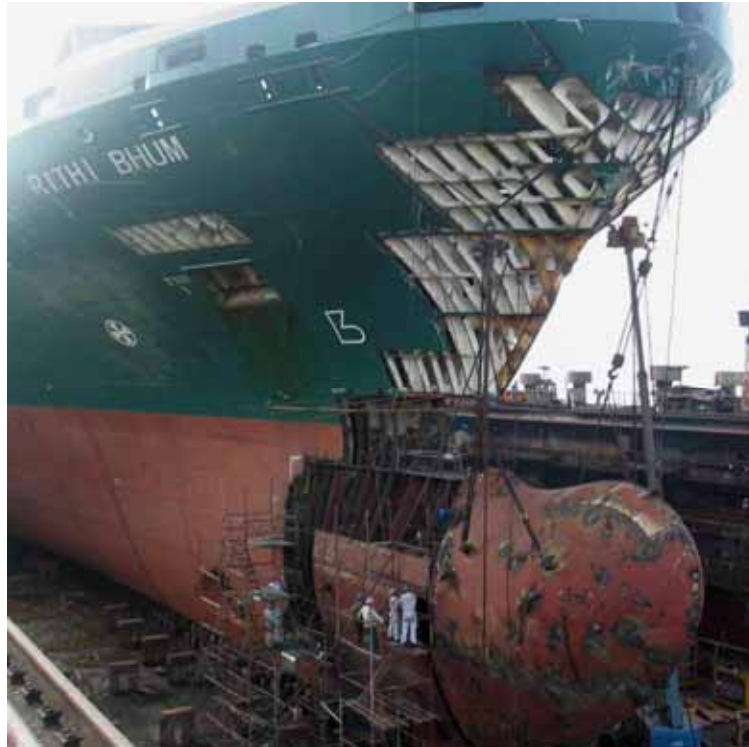
Figure 6: RITHI BHUM in the repair dock
(Photo: Federal Bureau of Maritime Casualty Investigation)

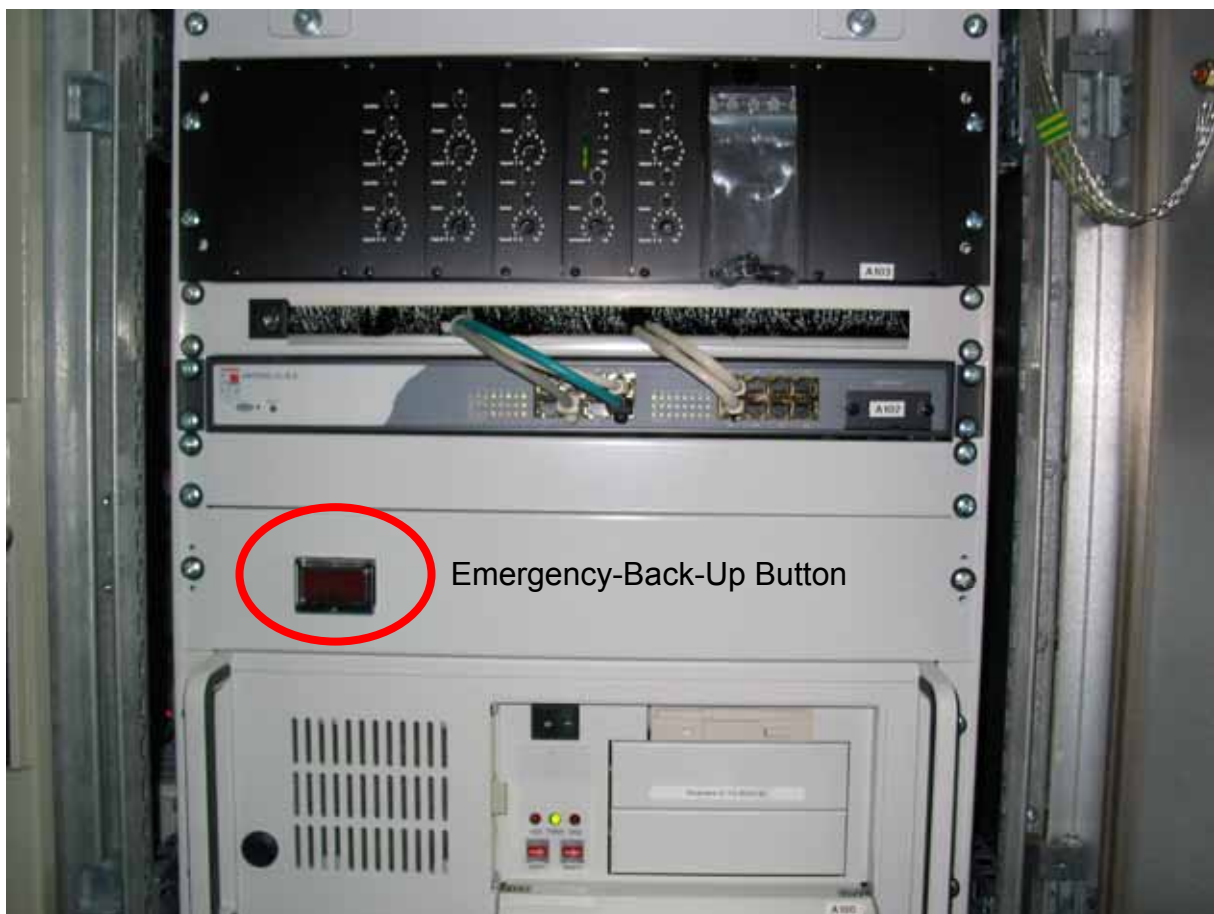
In accordance with Chapter V Rule 20 of SOLAS¹⁶, RITHI BHUM was equipped with a voyage data recorder. The vessel command was not given any type-specific familiarisation and instruction concerning the emergency back-up for storing data relevant to an accident period. It was only after making a telephone enquiry that the Captain was able to learn that the emergency back-up key was not integrated in the bridge console, but instead was mounted directly on the unit.

Figure 7: Emergency-Back-Up-Button on the VDR
(Photo: Federal Bureau of Maritime Casualty Investigation)

The data were saved at 10:50 h on 14 November 2004. The data concerning the time of the accident at 02:12 h were within the 12-hour period that should have been stored in this data saving operation¹⁷. The internal re-start, which is initiated routinely every seven days, began at 08:30 h. As a result of the routine re-start there was faulty overwriting inside the voyage data recorder. Vessel data up to 02:00 h and then again from 03:00 h are available. However, only the audio data of the bridge

The Federal Bureau of Maritime Casualty Investigation recommends the manufacturer of the voyage data recorder to evaluate the technical inadequacies of the device that occurred in close co-operation with the Federal Maritime and Hydrographic Agency responsible for type approvals for vessels sailing under German flag and to secure the complete functionality of the system and the required quality of the data to be recorded in accordance with the performance standard of the IMO and the European standard. Furthermore the possibility of a suitable notification to the vessel's command of inadequacies within the device should be reviewed, and if appropriate implemented into practice. This applies especially with regard to the lack of sensor data mandatory for recording.

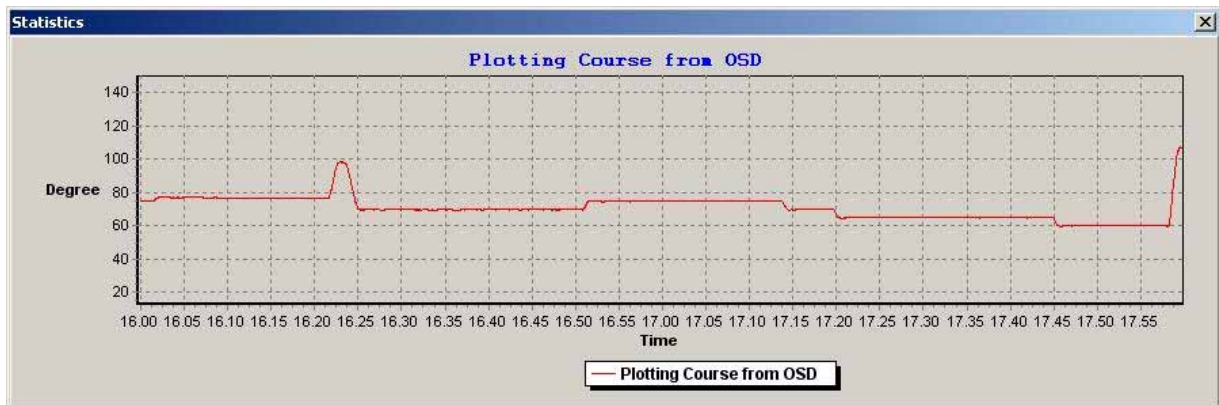
Figure 8: Changes of course of RITHI BHUM between midnight and 02:00 h on 14.11.2004 (Print from VDR RITHI BHUM, times UTC)

The last three course corrections between 01:00 h and 02:00 h were each made 5° to port. As a result the other party in the subsequent collision always remained approximately right ahead. After the last course correction at 01:45 h from 065° to 060° EASTERN CHALLENGER was again on a bearing right ahead and up to the start of the evasion manoeuvre shortly before 02:00 h had a slight bearing movement to starboard. This was only about 0.36° per minute, and at the same time the distance was reduced to about 2.3 nm.

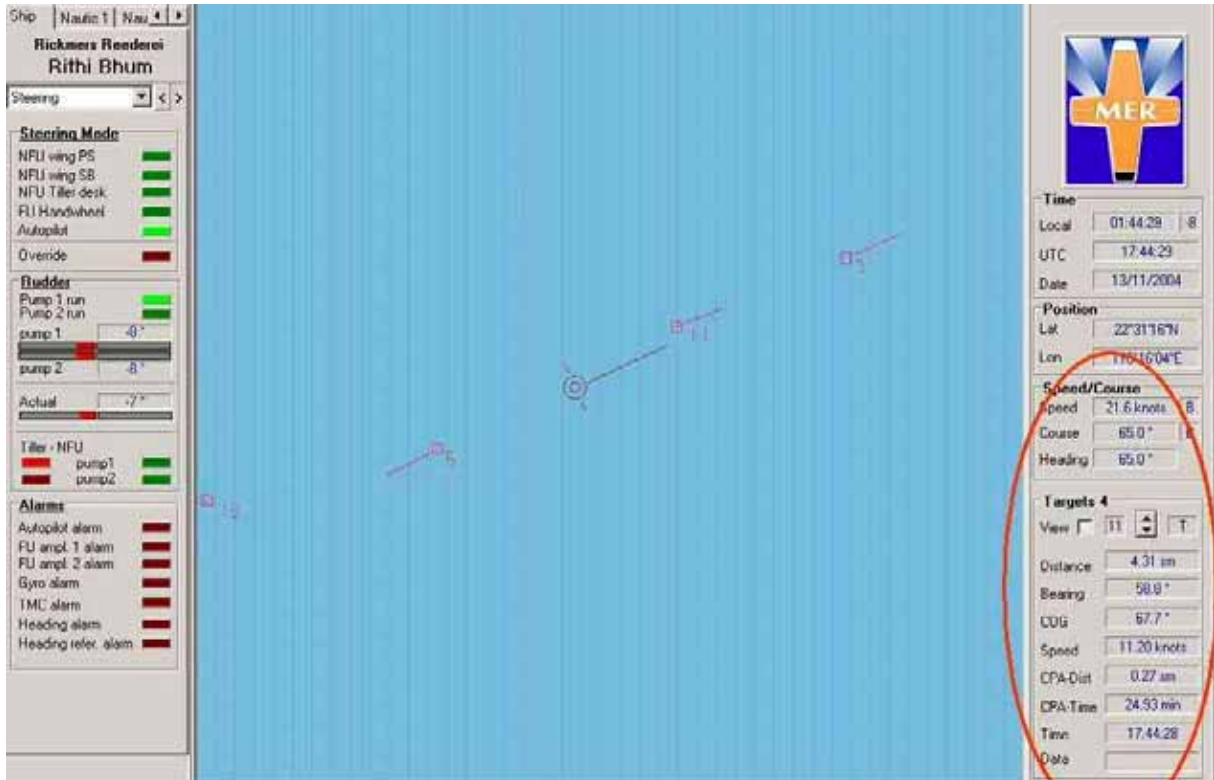
Figure 9: VDR data for EASTERN CHALLENGER on change of course at 01:45 h (print out from VDR RITHI BHUM)

Following the change of course at 01:45 h the second officer of the watch on RITHI BHUM could no longer assume that he would overtake EASTERN CHALLENGER on the port side of his vessel. With a vessel right ahead with a slight change of the compass bearing to starboard, he should instead have assumed at this time that he would pass at close quarters on starboard. At about the same time as the change of course at 01:45 h a further vessel had been recorded and tracked on the starboard side as an ARPA target. In the following minutes this vessel quickly became a close-quarters opponent on a crossing course from starboard due to changes in its course and speed. The second nautical officer of the watch on RITHI BHUM switched over to manual steering shortly before 02:00 h and initiated a hard to starboard evasion manoeuvre. The vessel was passed at a distance of about two cables. After this the second officer switched back to the automatic pilot mode and RITHI BHUM turned back to port. The last course ordered had been 057°.

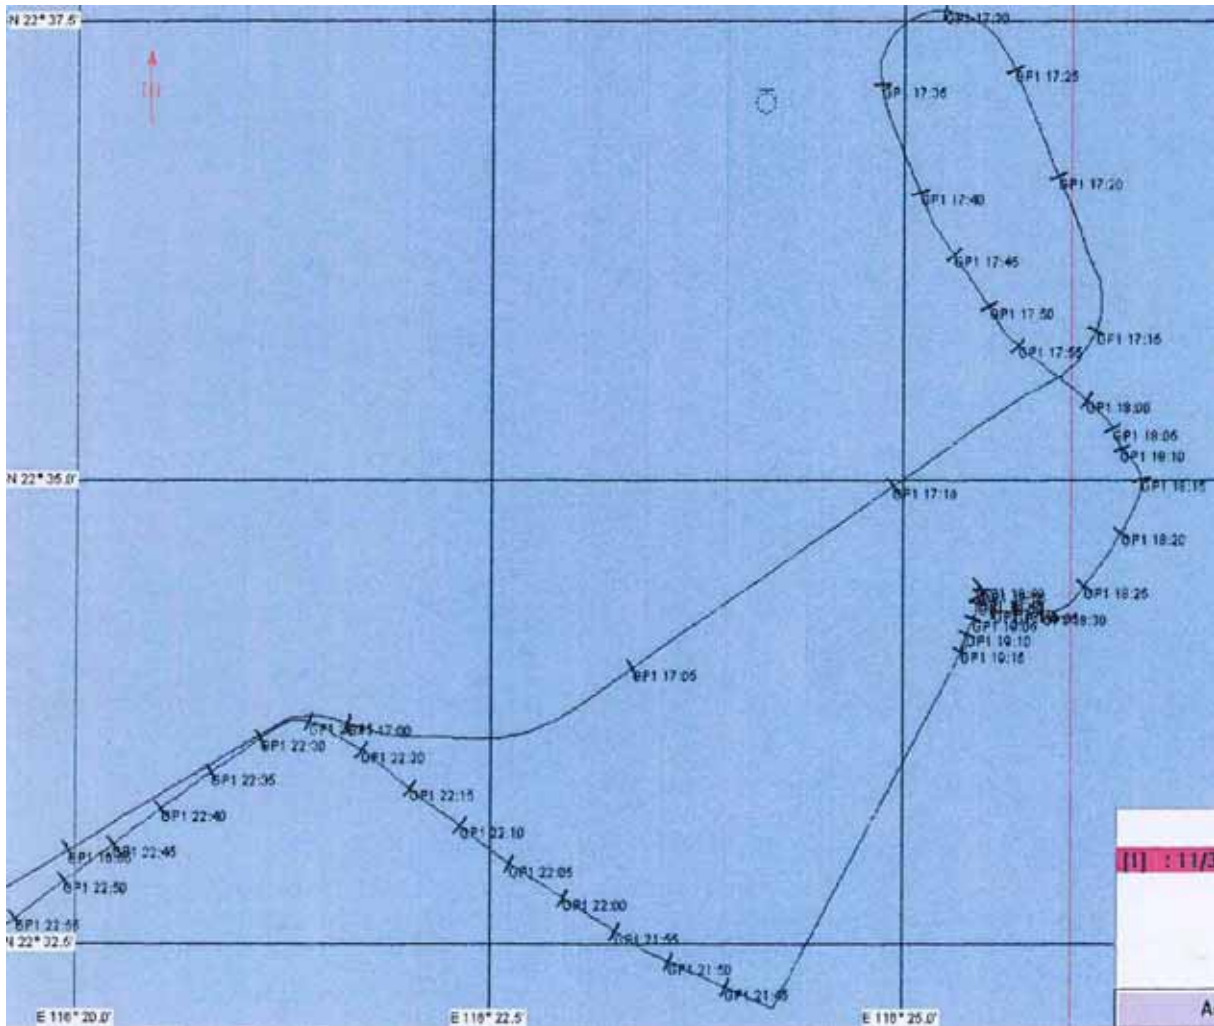
The situation with regard to EASTERN CHALLENGER changed again with the evasion manoeuvre to starboard for the new vessel detected in the radar shortly before 02:00 h. The other vessel in the subsequent collision was again on a port bearing at a distance of now only 2 nm. On subsequently turning back to port to then 057° the distance had become even further reduced and EASTERN CHALLENGER was now on a bearing approximately right ahead. The second officer on RITHI BHUM should now have assumed the possibility of the risk of a collision. Up to the collision she continued on a constant course, no last minute manoeuvre was initiated.

Figure 14: Course of RITHI BHUM
(ECS recording, all times UTC – 1h)

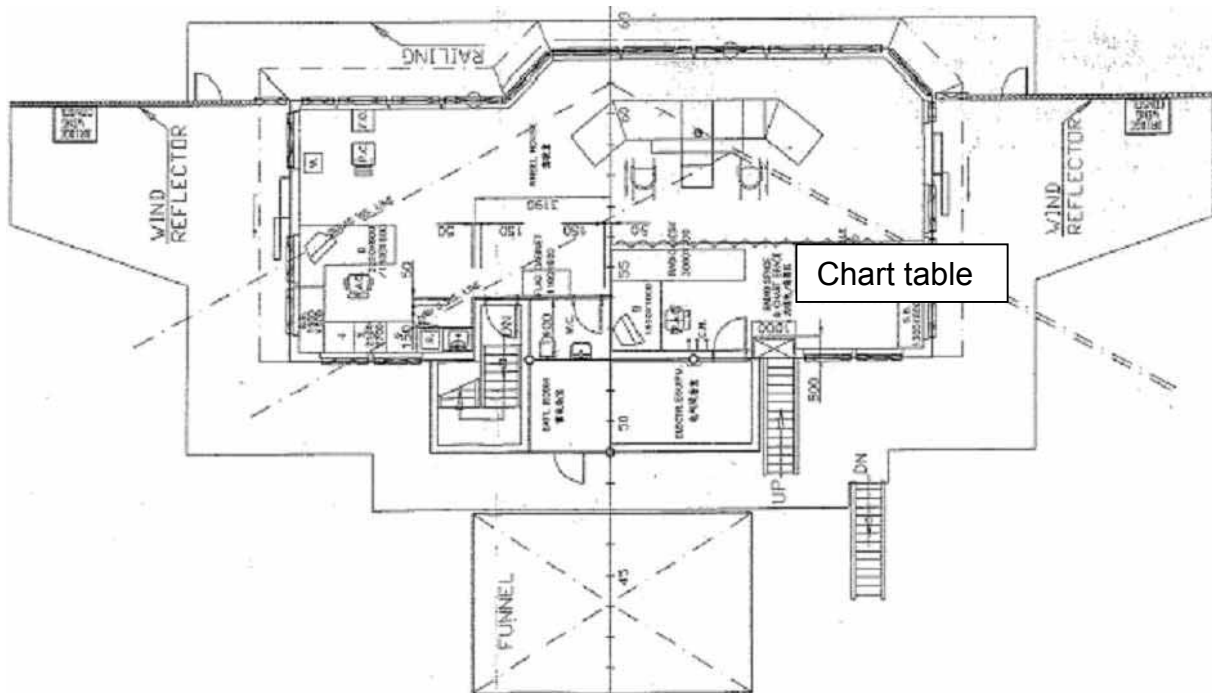
After ending the evasion manoeuvre the second officer then fixed and recorded the current position with GPS and for this had stayed at the chart table. The chart table on RITHI BHUM was in the aft area of the bridge on the starboard side. The 02:00 h position was entered on the paper chart, the longitude and latitude of the position were entered in the ship's log. In addition course and weather data for 02:00 h were noted in the log. About 10 minutes after reaching the ordered course upon completion of the preceding evasion manoeuvre RITHI BHUM collided with EASTERN CHALLENGER.

Figure 15: Bridge Arrangement Plan RITHI BHUM
