Bundesstelle für Seeunfalluntersuchung
Federal Bureau of Maritime Casualty Investigation
Bundesoberbehörde im Geschäftsbereich des Bundesministeriums
für Verkehr, Bau- und Wohnungswesen

Investigation Report 371/04

Very serious marine casualty

**Collision of MV MSC ILONA
with MV HYUNDAI ADVANCE
on 7 December 2004
off Hong Kong / China**

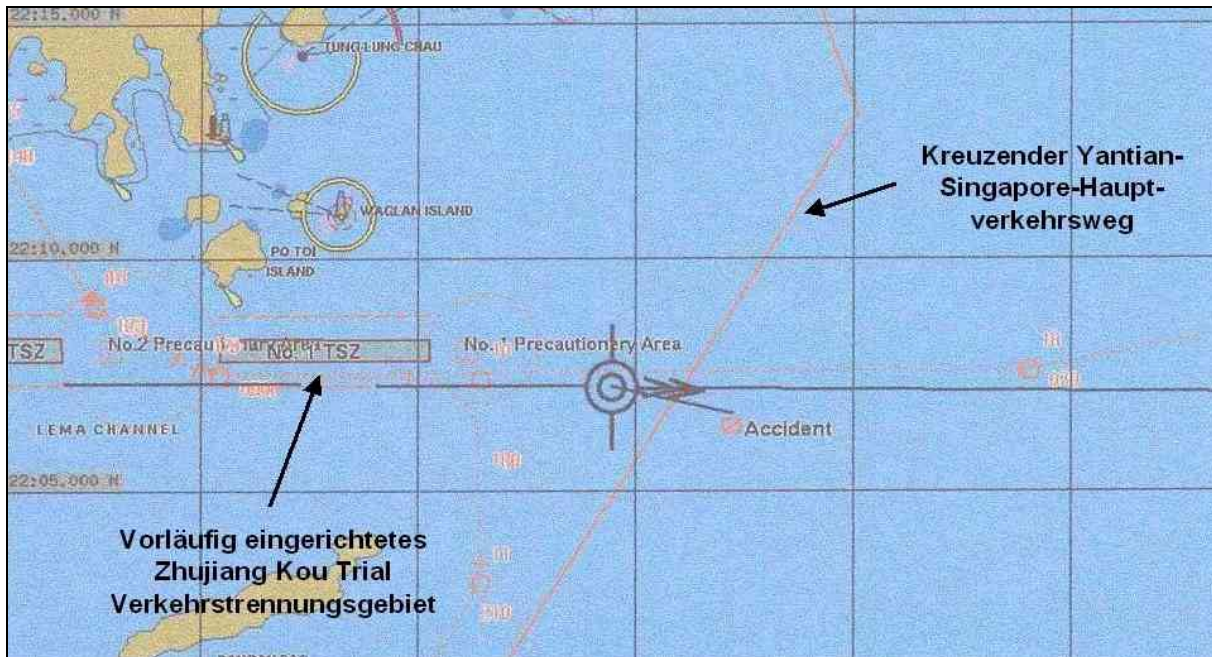
Figure 4: Display of the electronic chart of MSC ILONA with manual supplements by the vessel's command

The electronic chart system on board MSC ILONA was being used in the ECS mode. Consequently it was being used not as a primary navigational aid, but simply as a supporting measure. The vessel's track crossing the Yantian-Singapore main traffic route, known to the Master, was noted on the ECS. The ECS was overlaid on the starboard radar, so that the additional information of the electronic chart was available to the Nautical Officers. No additional warning was entered on the paper chart, nor in the Sail Plan Notes "Chiwang to Shanghai". The Nautical Officer of the watch primarily used the port radar and the paper chart. Consequently the additional information on the ECS was not directly before her. This information might have been able to give the Nautical Officer of the watch supplementary information about the crossing traffic to be expected in this sea area.

The BSU recommends that the operator of MSC ILONA specify in its voyage planning procedure how the available information important for safe passage of the vessel are to be entered clearly in all appropriate charts and that it should be constantly available for the Nautical Officer of the watch.

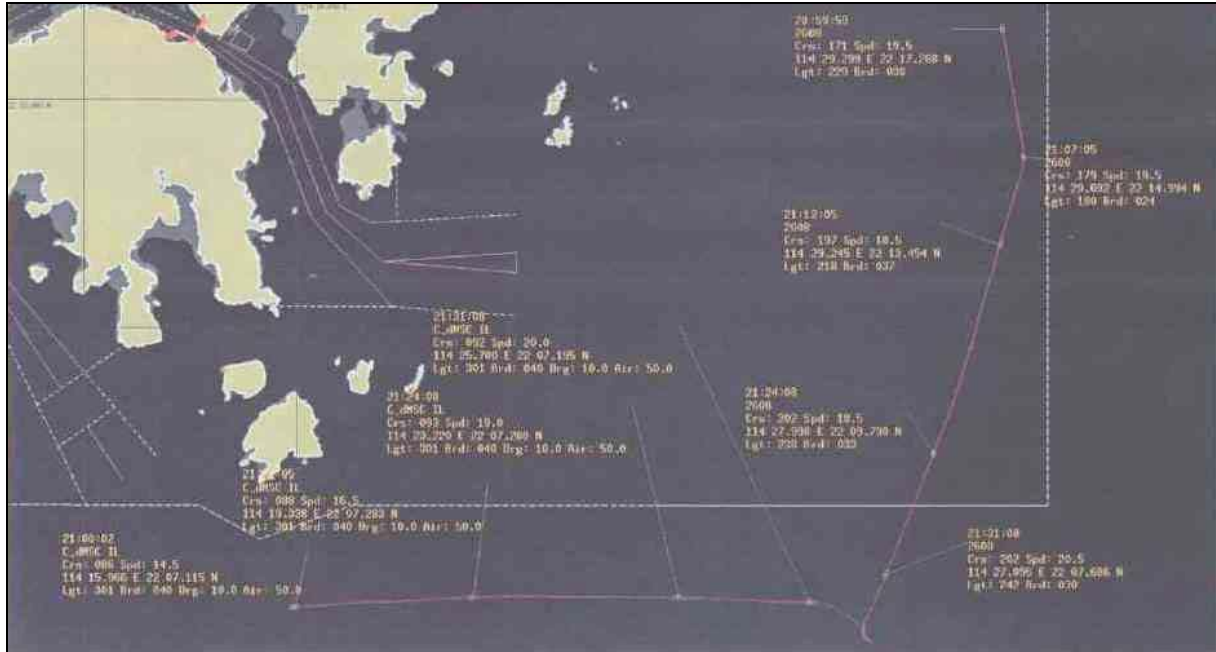
Figure 6: Radar plot of Radar Station Hong Kong at 21:00 h
 [at the lower image edge MSC ILONA on an easterly course, on the right HYUNDAI ADVANCE on a south/south-westerly course]
 (Source: Marine Department Hong Kong)

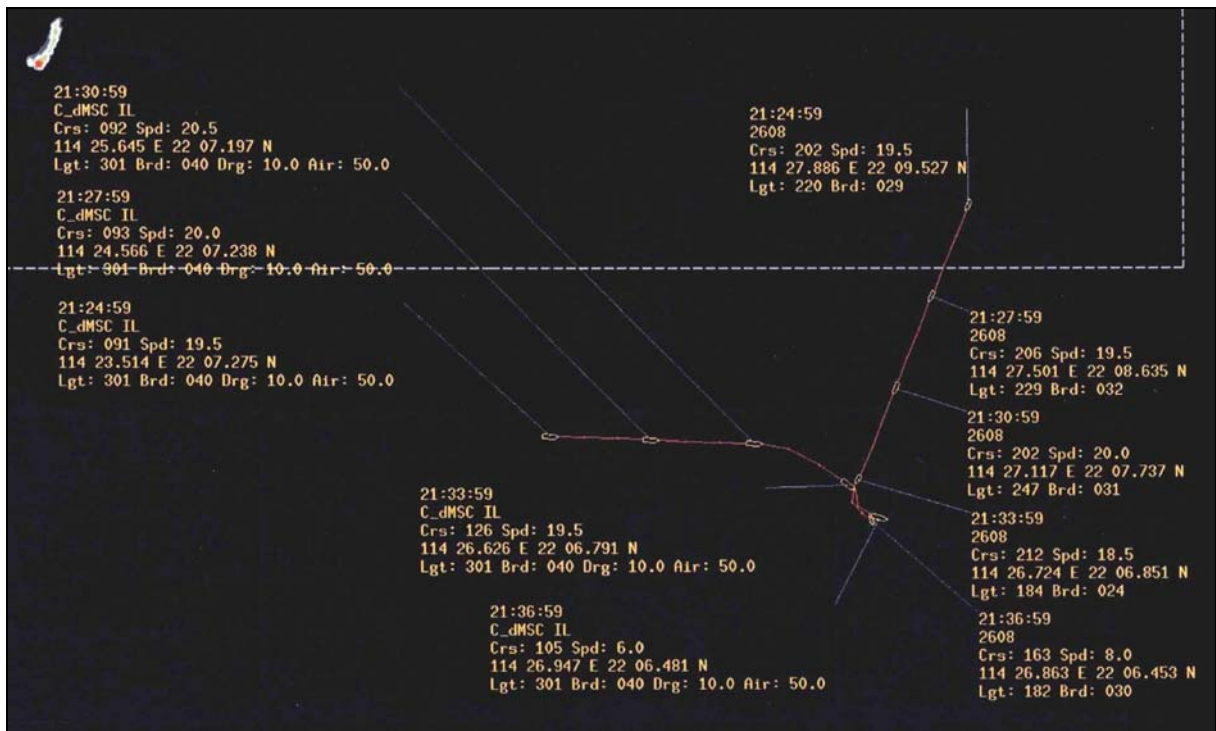
Figure 7: Radar plot of Radar Station Hong Kong at 21:25 h
 (source: Marine Department Hong Kong)

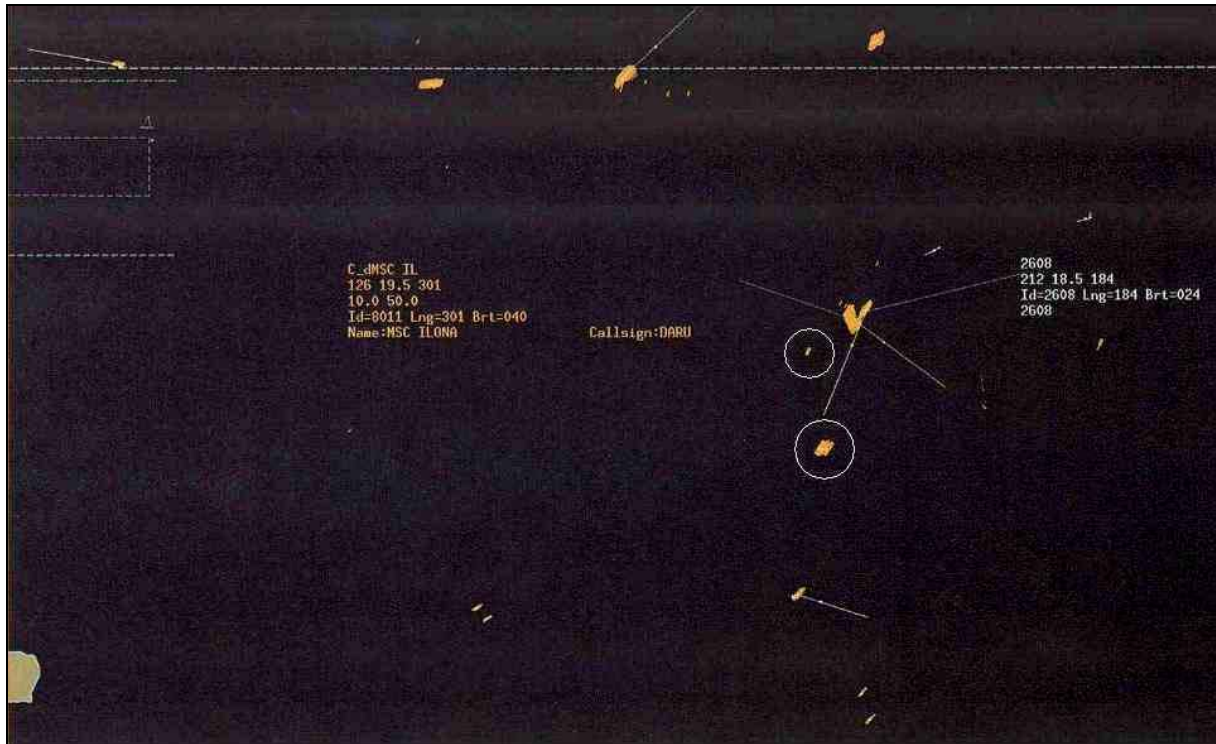
According to the records of Radar Station Hong Kong the collision between MSC ILONA and HYUNDAI ADVANCE occurred a few seconds after 21:34 h. At the time of the collision the radar showed a relatively small contact in the direct vicinity south of the collision location and a somewhat larger radar contact a little further away.

Figure 8: Further radar contacts south of the collision location
(Source: Marine Department Hong Kong)

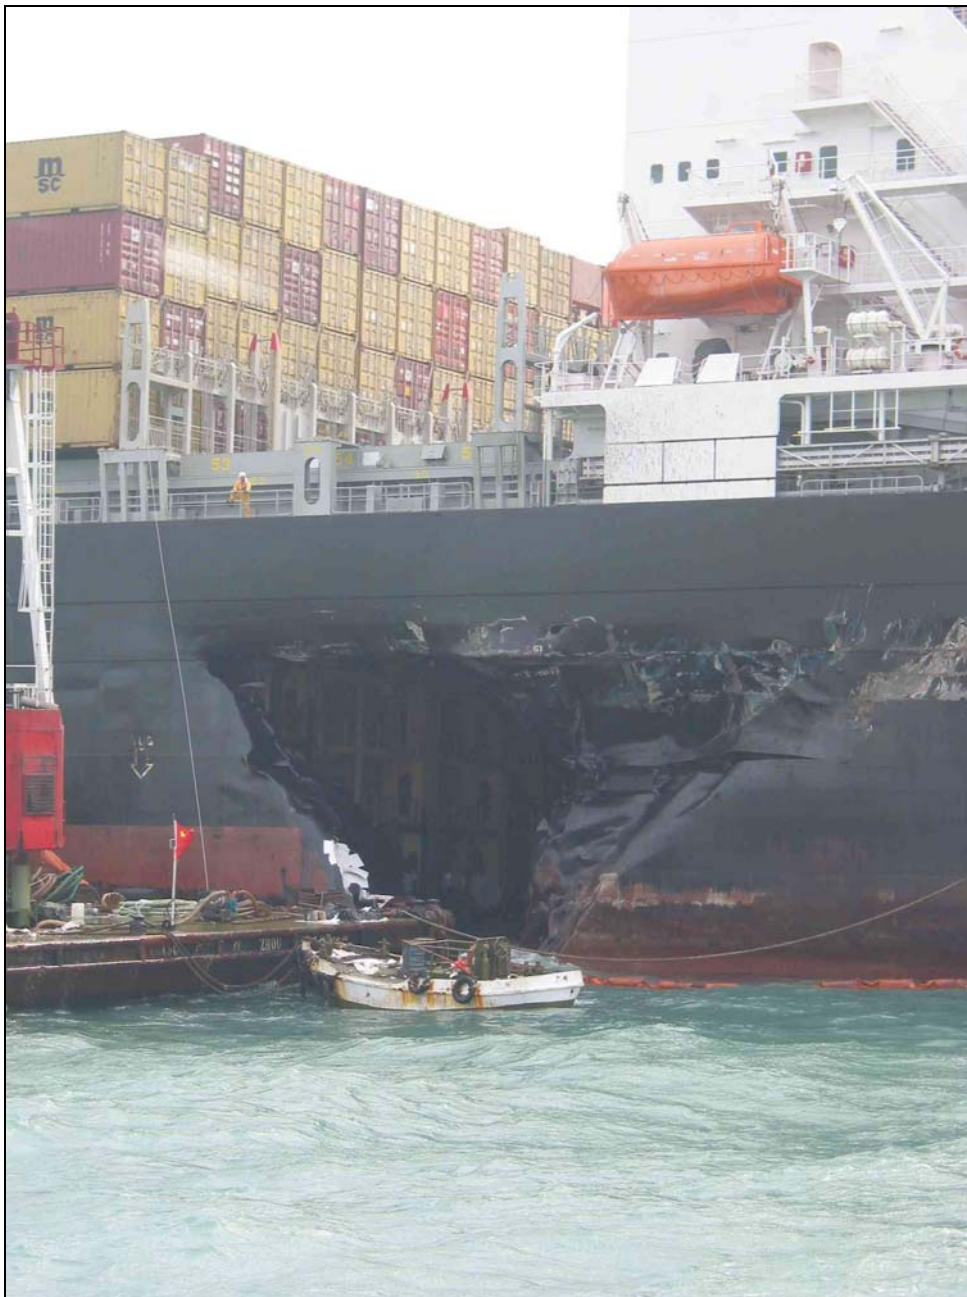
Figure 10: Damage to MSC ILONA
(Photo: BSU)

On MSC ILONA the port side was ripped open on a level with the forward edge of the superstructures. The heavy oil tank 7 port, the bunker tank port and the settling tank port were heavily damaged. Furthermore 62 twenty-foot and 22 forty-foot containers in hold 7 on the port side were damaged by the collision.

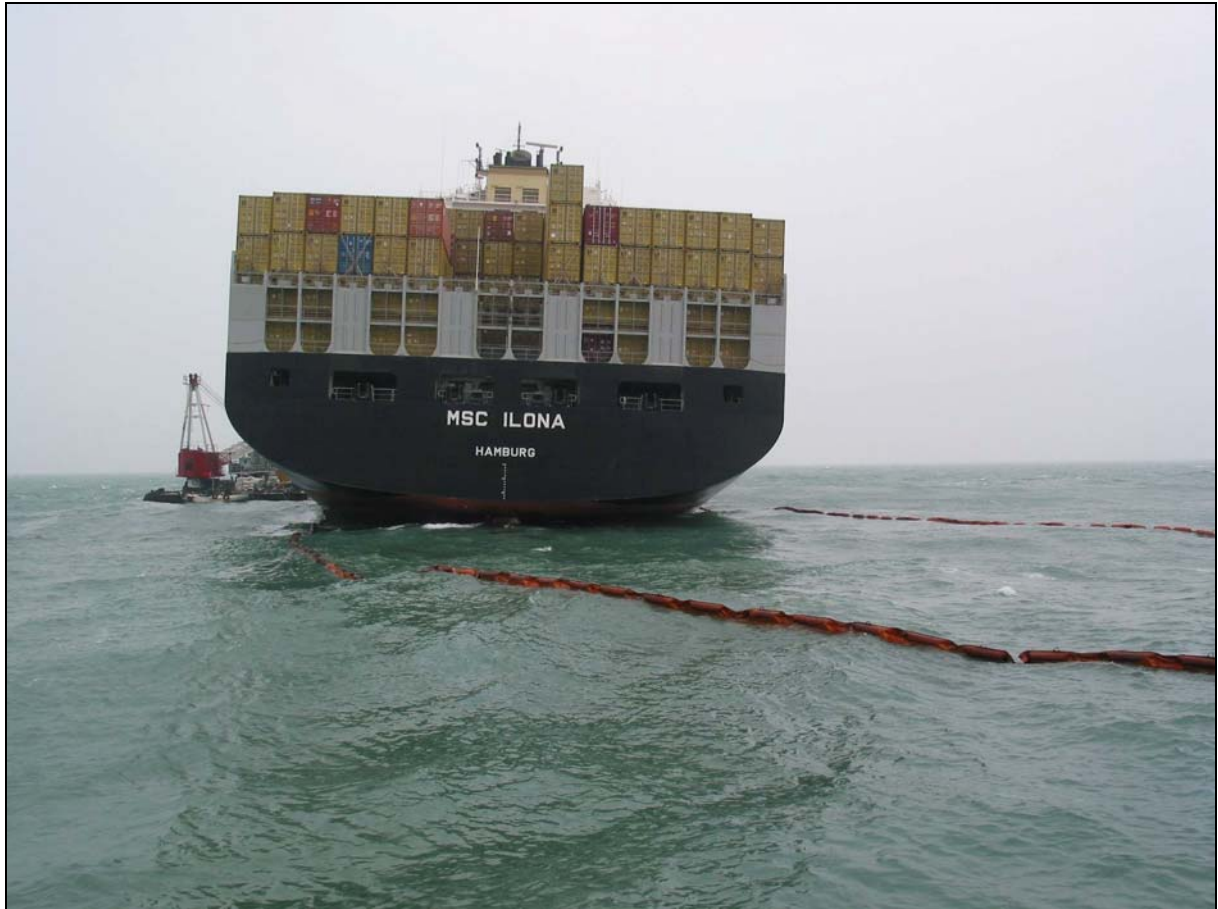
Figure 11: Oil boom around MSC ILONA
(Photo: BSU)

1283 tonnes of heavy oil flowed into the open sea from the destroyed wing tanks of MSC ILONA. This largest case of environmental pollution in Chinese waters occasioned the competent authorities to work extremely conscientiously and cautiously. It was only several weeks after the collision and after execution of extensive cleaning and emergency repair measures that therefore MSC ILONA was allowed to leave her allocated anchor position and steer for a yard in Singapore. Nothing is known about environmental damage caused by pollutants spilling out from HYUNDAI ADVANCE.
