Investigation Report 381/04

Very serious marine casualty

**Capsizing and foundering of the
Tug JULIUS with one fatality
off Brunsbüttel on 16 December 2004**

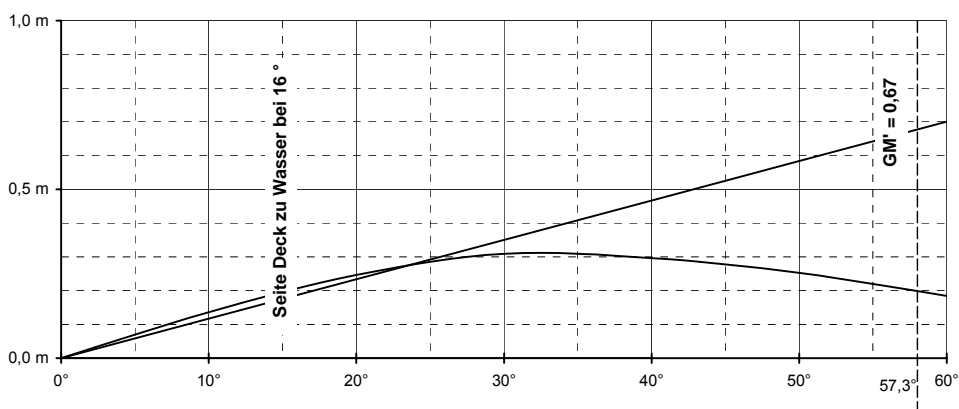
Righting arm curve

The following stability case from the documents of 1977 with an empty weight of 47.24 t and approx. 50% stocks roughly corresponds to the condition of the tug on capsizing.

required	available
Area* 0,0° bis 30,0°	≥ 0,055 m rad	0,095 m rad
Area* 0,0° bis 40,0°	≥ 0,09 m rad	0,149 m rad
Area* 30,0° bis 40,0°	≥ 0,03 m rad	0,054 m rad
Lever arm at 30 °		0,31m
Angle at maximum of curve		32,2°
Initial MG	0,15 m	0,67m
Stability scope (≥) 60°

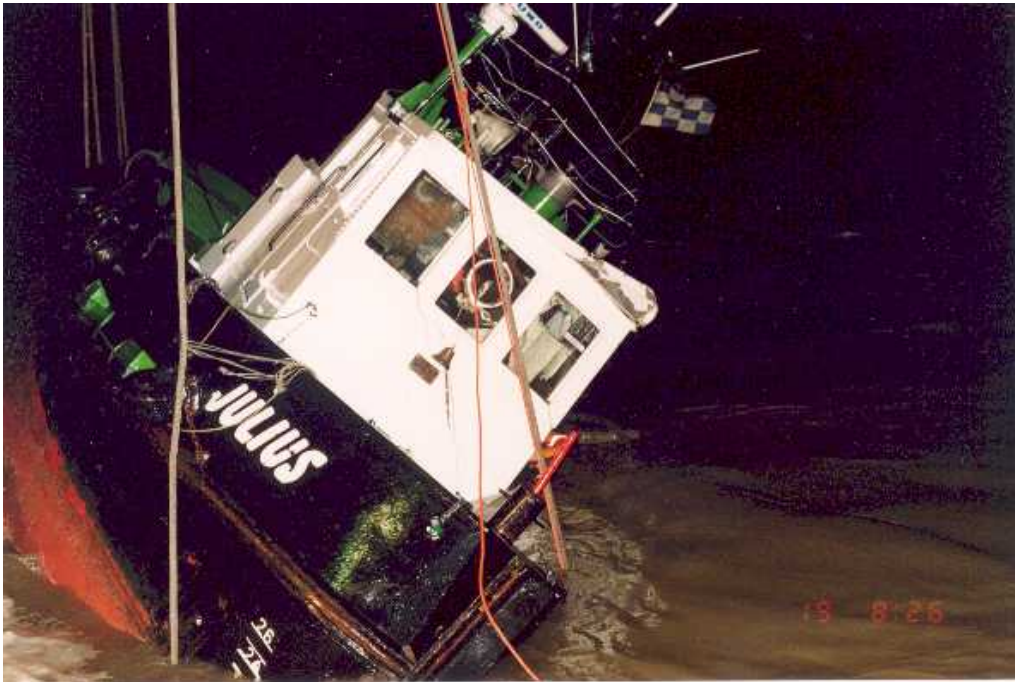
Figure 5: Forward view of the salvage

The wheelhouse roof was bent upwards on the port side. There was no line on the post bollard. The starboard wheelhouse door was closed, but not latched. The port side wheelhouse door was no longer in the door hinges and was lying crossways in the wheelhouse.

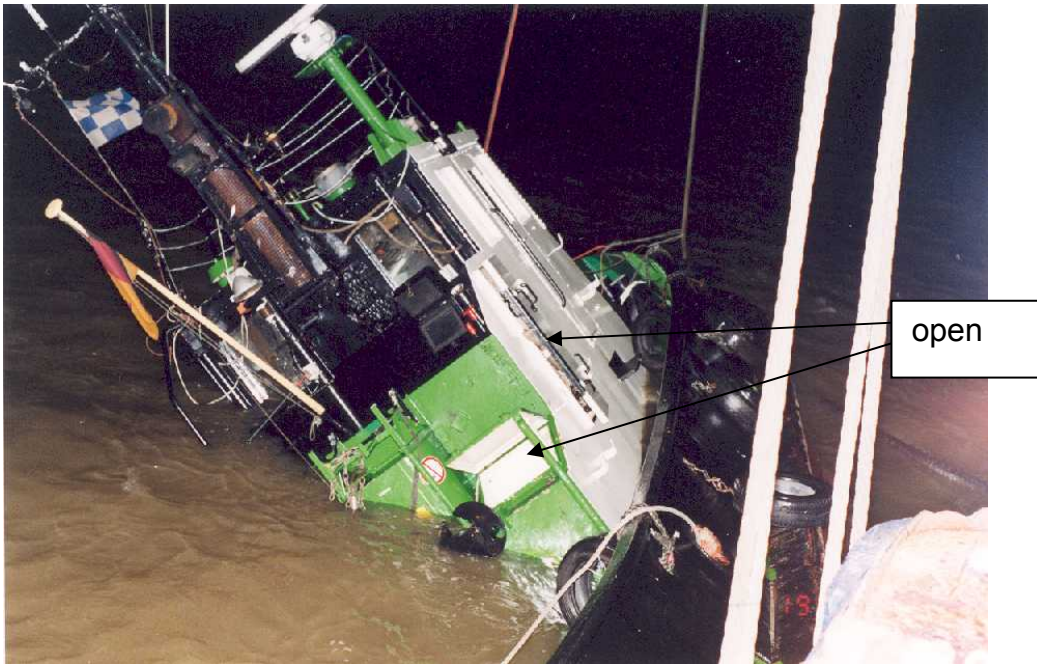
Figure 6: View from stern, starboard

The access door to the engine room was unlatched and open. The starboard side engine room ventilation flap was opened and fixed in an approx. 50° position.

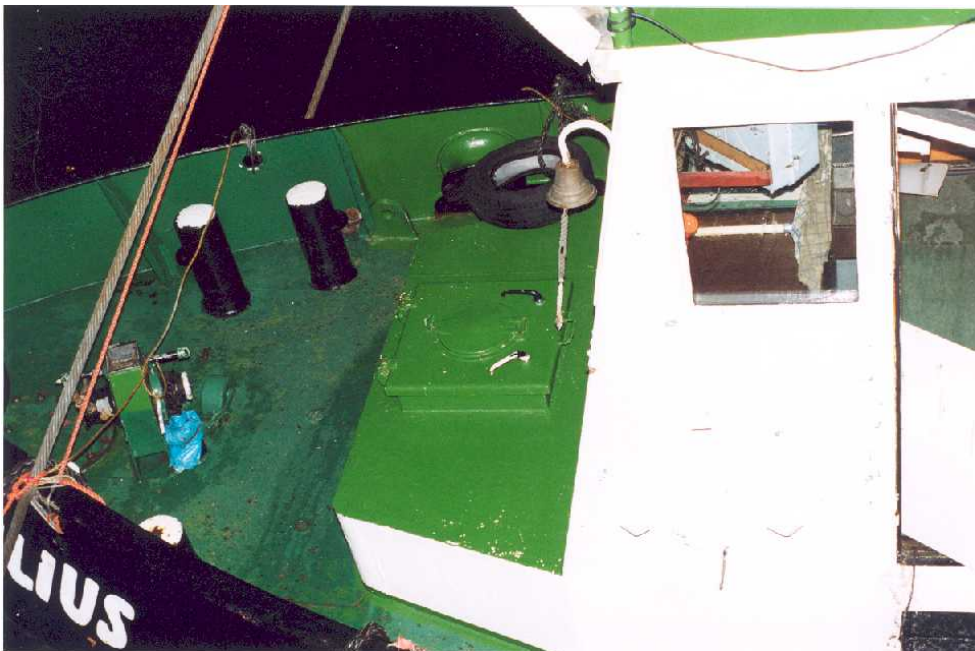
Figure 7: Fore ship

There was no mooring line on the post bollard and on the bollards on port and starboard.

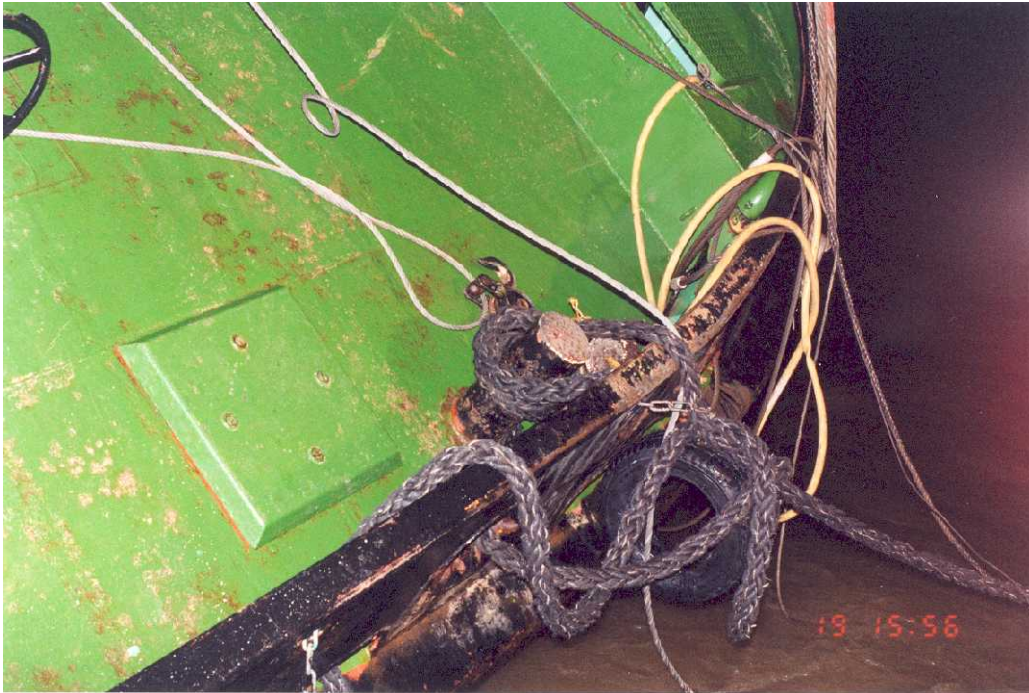
Figure 8: Aft ship port side

The double bollard on the port side aft had an 80 mm polypropylene line that was ruptured. The aft bollard tube of the double bollard had been ripped half out of the deck and was bent forwards. A ruptured 22 mm mooring line coming from the hand winch arranged midships via a guide pulley shackled on to the aft ship was lying on deck.

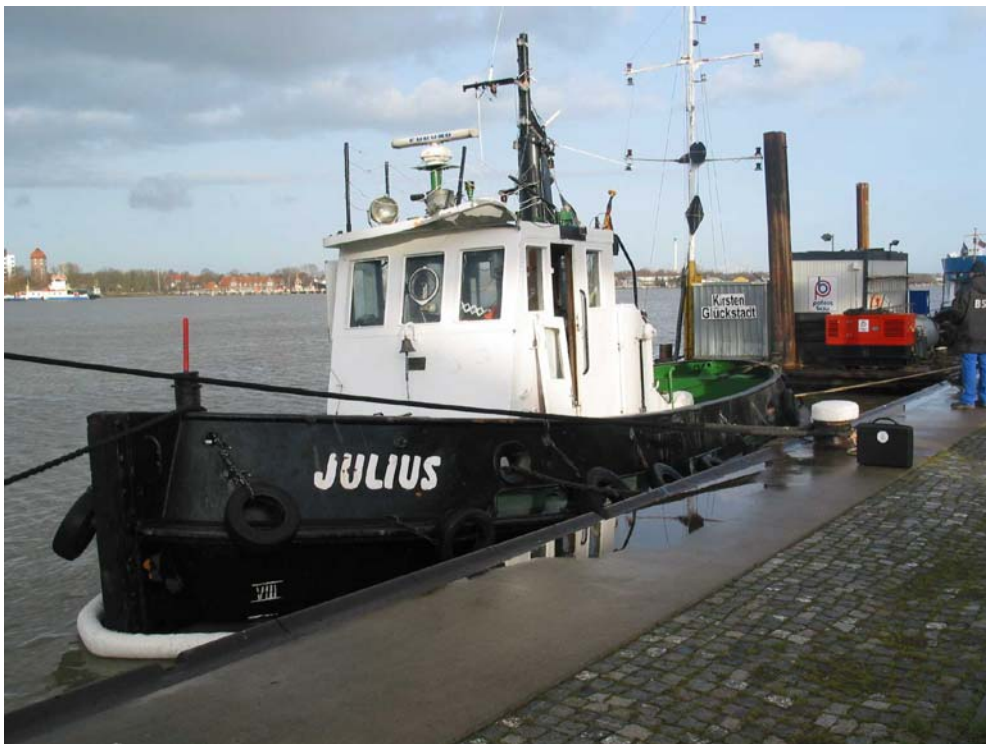
Figure 9: Wheelhouse damage

1. The faceplate and the projecting part of the upper deck on the port side were bent upwards and ripped. The railing stanchions on the port side on the upper deck were bent and ripped out.

2. There were traces of scratching on the forward edge of the wheelhouse on the port side and residues of a black polypropylene line were hanging here and on the torn areas on the upper deck.

3. The wheelhouse door was lying in the wheelhouse. The top hinge had been ripped off and the bottom hinge bent downwards. The wheelhouse window was cracked and the inside door latch had been ripped off.

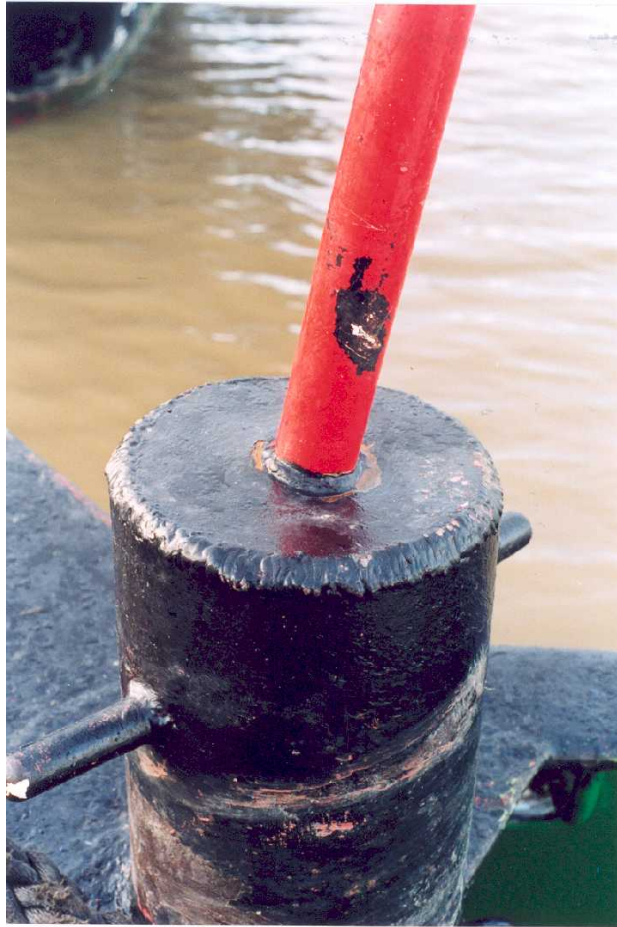
Figure 10: Bent bow flag pole

4. The bow flag pole on the post bollard was bent to starboard.
5. The rearmost of the double bollard port side aft was ripped off and the deck had been welded tight with a steel plate after salvage. Paint had chipped off the forward hawse in the aft ship and the hawse was slightly deformed in the front part.

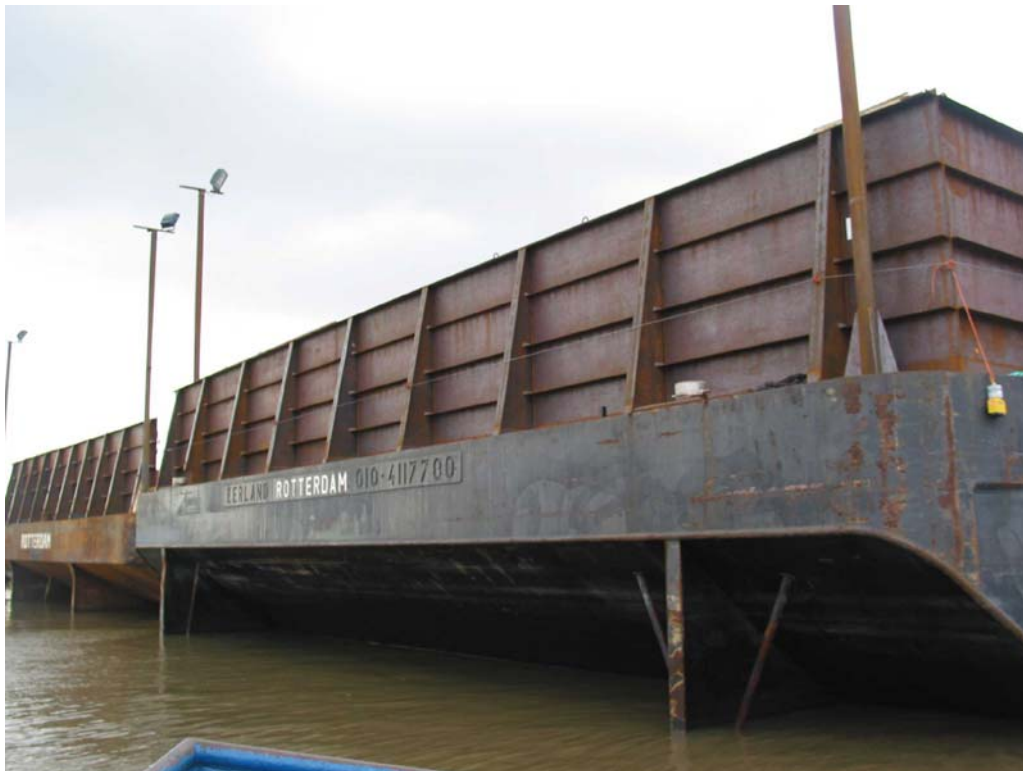
Figure 12: Rear edge of pontoon

1. No damage indicating a collision with the tug was discovered.
2. The pontoon had only one bollard on each side, port and starboard, at the rear edge of the stern, diameter approx. 400 mm. The bollards were approx. 16 m apart. At the time of the accident a flat iron had been welded to the port bollard so that it was not possible to place a loop over this. There were no other fastening possibilities using bollard, fairlead, or eyes/rings. There was thus no possibility of fastening a line in the middle at the stern of the pontoon. There was one bollard in the middle at the bow of the pontoon. The Pontoon E 3505 lying next to Pontoon E 3504 had a bollard on the port and starboard side and at the middle of the pontoon are the rear.

There was no possibility of fastening the tug midships on the pontoon. For safe fastening it is absolutely necessary to secure the post safely on the pontoon. The 20 cm wide rubber padding at the post is not sufficient for a pusher tug. Two pusher shoulders at a spacing of two thirds of the ship's width are necessary for safe handling for use as a pushing tug or a steering tug.

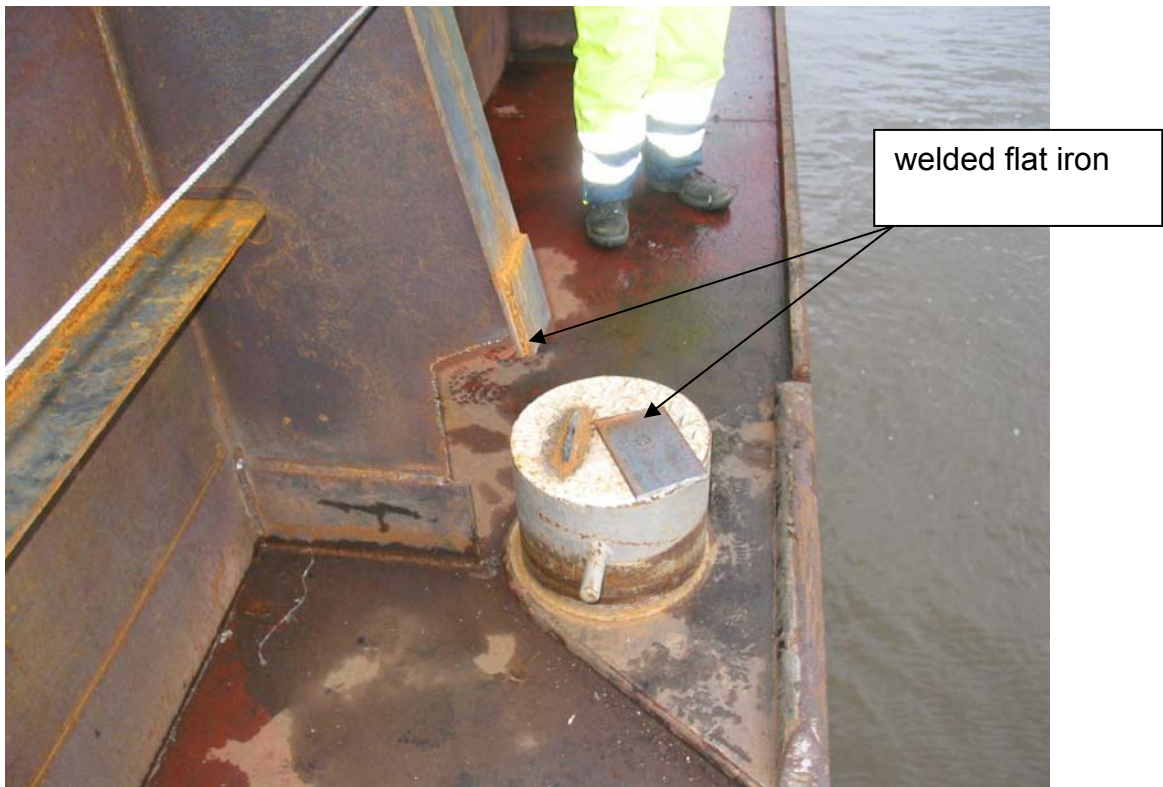
Figure 13: Port bollard

Around the rear port bollard there was an approx. 4 m long and approx. 80 mm thick ruptured polypropylene line. The eye of a 2 m long and 22 mm thick ruptured line (wire line) was about the starboard bollard. There were no further lines aft on board the pontoon.

The port bollard on the pontoon was only conditionally suitable for use due to the flat iron welded on, and it was difficult to use. Within the scope of the 60-day hearing period in accordance with § 15 SUG Para. 1, the vessel operator explained in a letter to the BSU that all involved were aware of the circumstance that this flat iron was welded onto the bollard and that therefore a double bow was intended as a forward line from the start. This statement was not confirmed by the participants. The arrangement of the flat iron does not make any sense for reasons of strength and it was therefore evidently removed after this casualty. After the assembly of the welded structure the suitability of the pontoon for this shifting operation had not been checked by the vessel operator of the SBG or by a classification society.

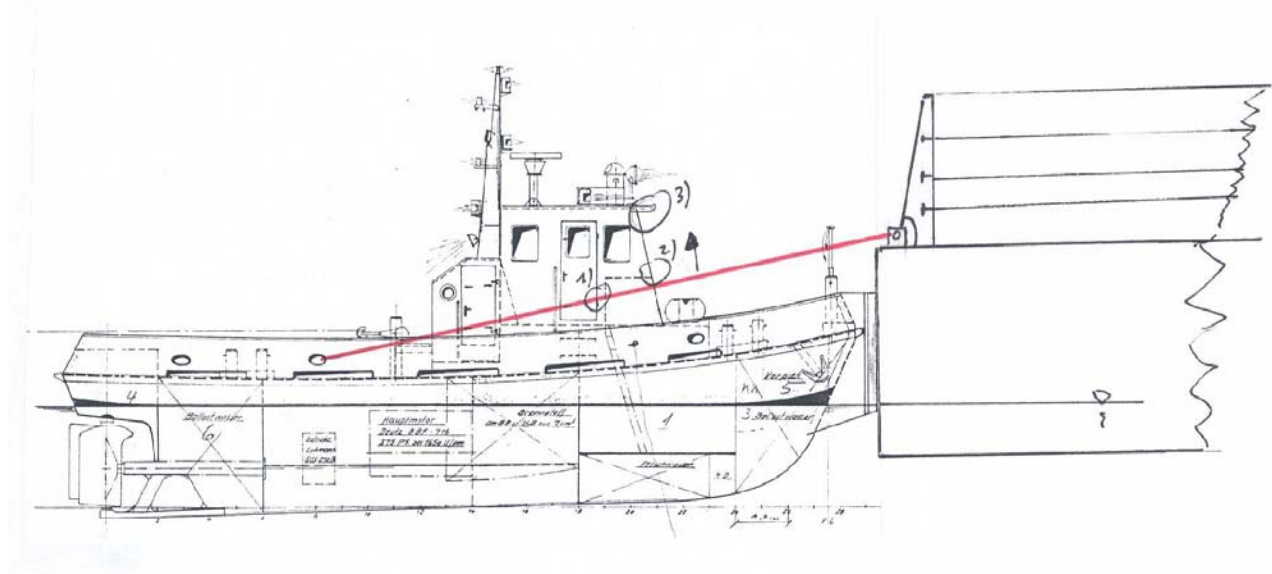
Figure 15: Figure 16: Longitudinal section

The above drawing shows the starboard side. The scraping marks mentioned below of the aft polypropylene line are on the port side:

- 1) wheelhouse,
- 2) edge of wheelhouse and
- 3) faceplate of the wheelhouse roof

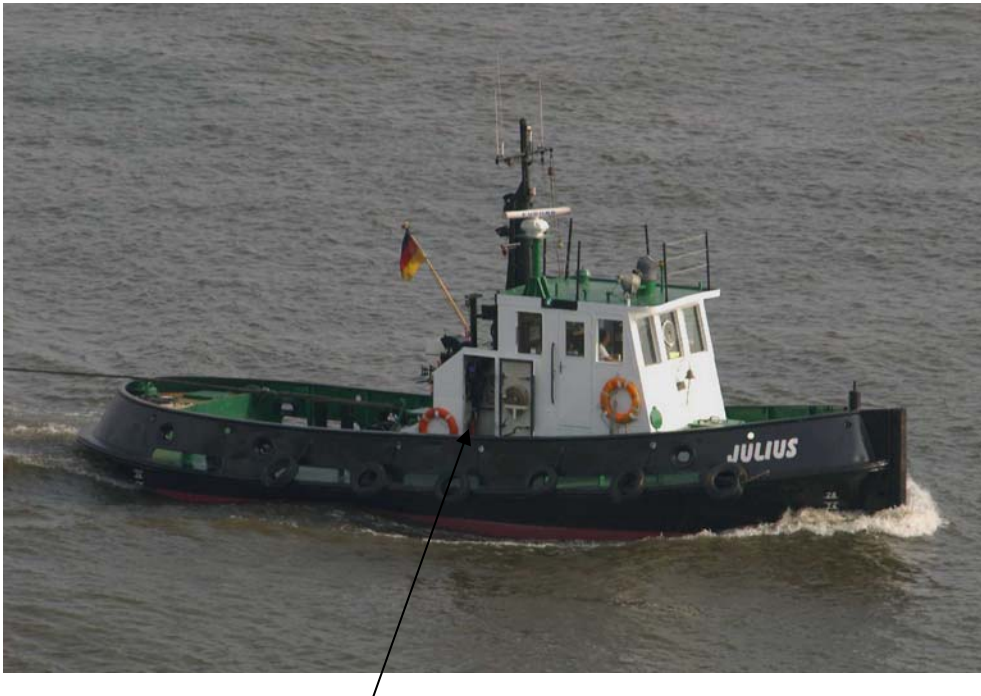
Figure 17: Open ER door during towing voyage

When the tug was salvaged the access door to the engine room was open. This door is equipped with four sliding bolts and must be firmly closed for coastal voyages. The previous owner was notified of this by the See-BG Report No. 25 in 1995, "*the engine room bulkhead (starboard side) must always be kept close during coastal travel*". This door was evidently frequently kept open during towing voyages as the photo below shows.

In addition to the open door, the fan light on the starboard side was open at an approx. 50° position and had been locked in this position. This fan light has a clear opening of 60 x 40 cm.

These two openings, that come to water with a heeling angle of approx. 43°, contributed to the tug sinking so quickly.

The non-closed opening to the engine room had a negative influence on the floating condition as of an inclination of 43°.
