Investigation Report 146/05

**Very serious marine casualty**

**Fatal work accident on board  
MV WERDER BREMEN  
on 27 April 2005  
in Santa Cruz de Tenerife**

15 February 2006

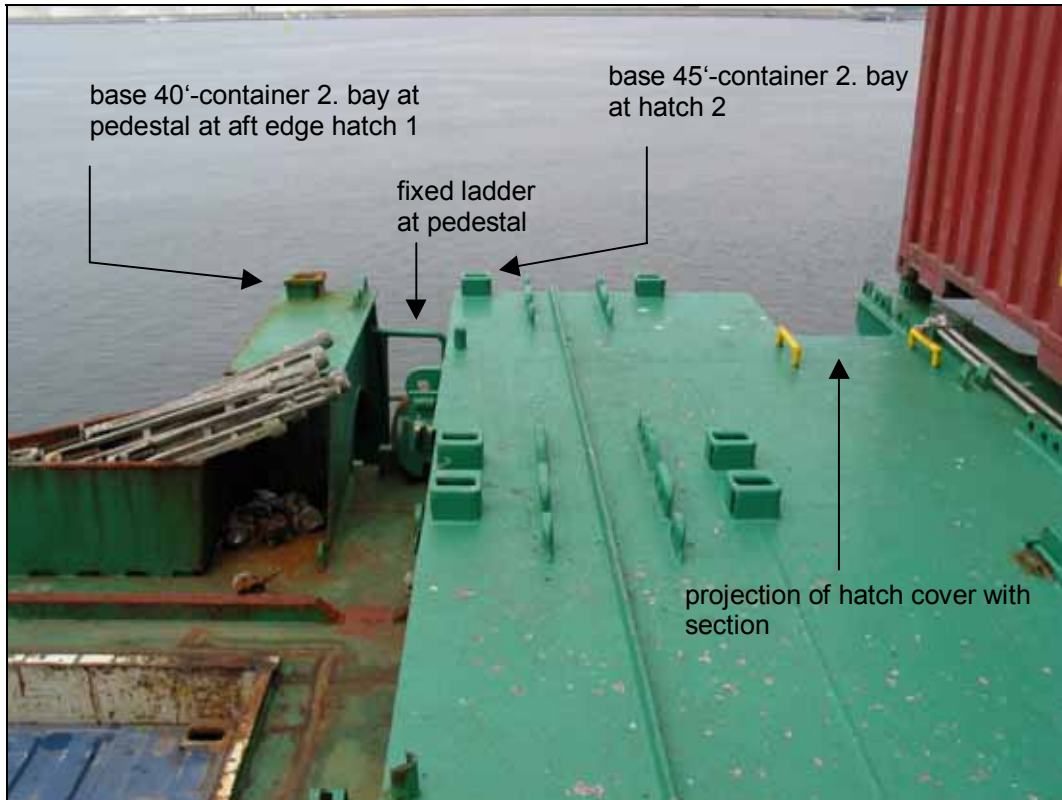
When 45' containers are stowed on hatch 1 the cargo situation is that the aft edge of the containers of the 2<sup>nd</sup> bay extend up to the cover of hatch 2 (Figure 3).

Figure 3: Front edge of the hatch cover on the starboard side of hatch 2 on WERDER BREMEN

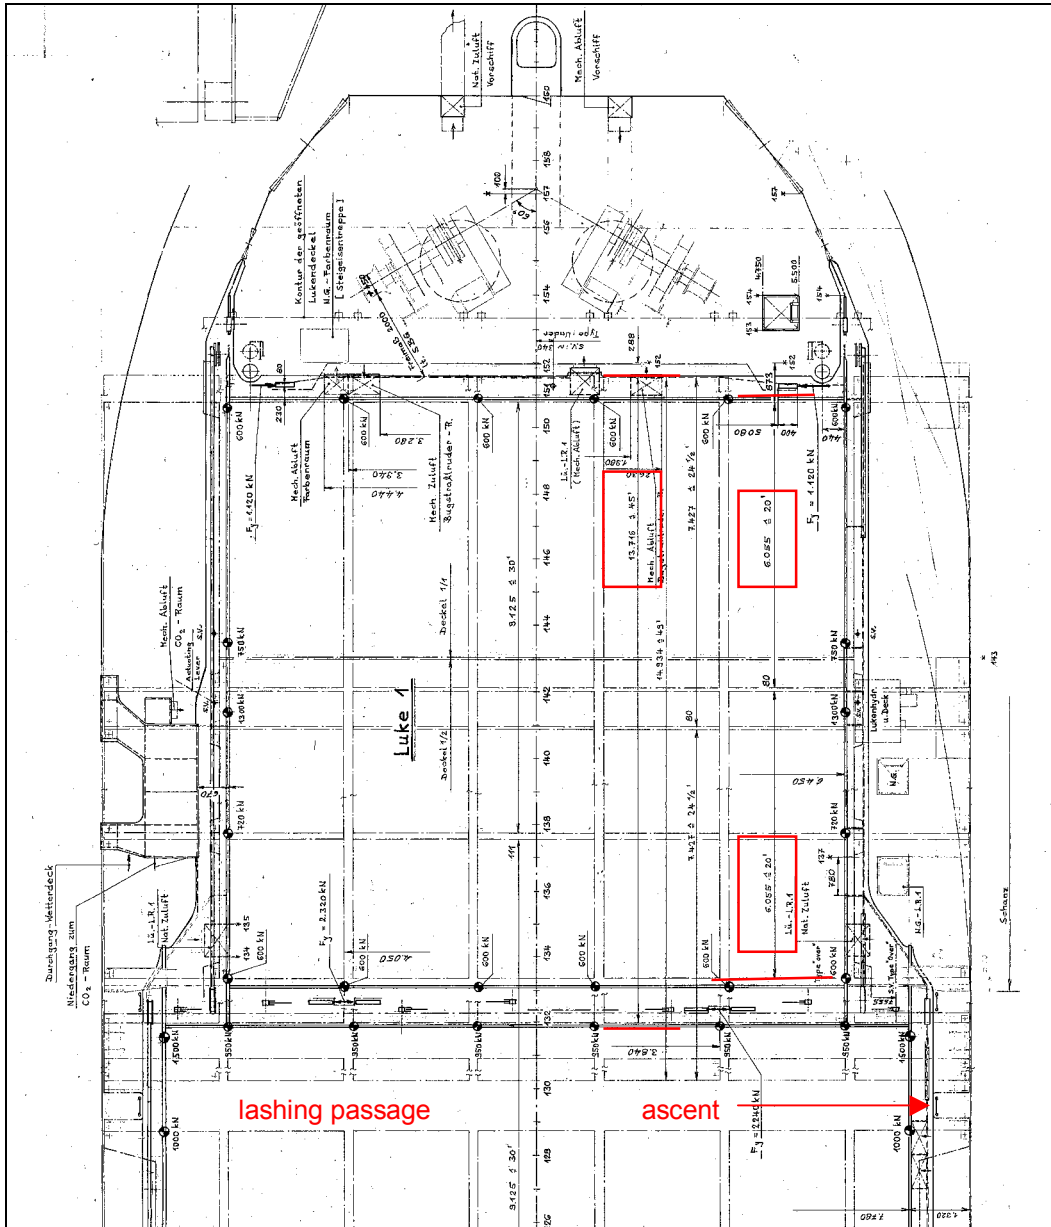
Figure 4: Top view of hatch 1 and front edge of hatch 2

The drawings inspected at the See-BG<sup>7</sup> and the yard show a ladder at this point, as does the drawing in Figure 4. The yard was unable to make any statement on this circumstance. At the time of construction installations on board the vessel were discussed directly on the spot, and there was no subsequent documentation. The yard has altered this procedure in the meantime.

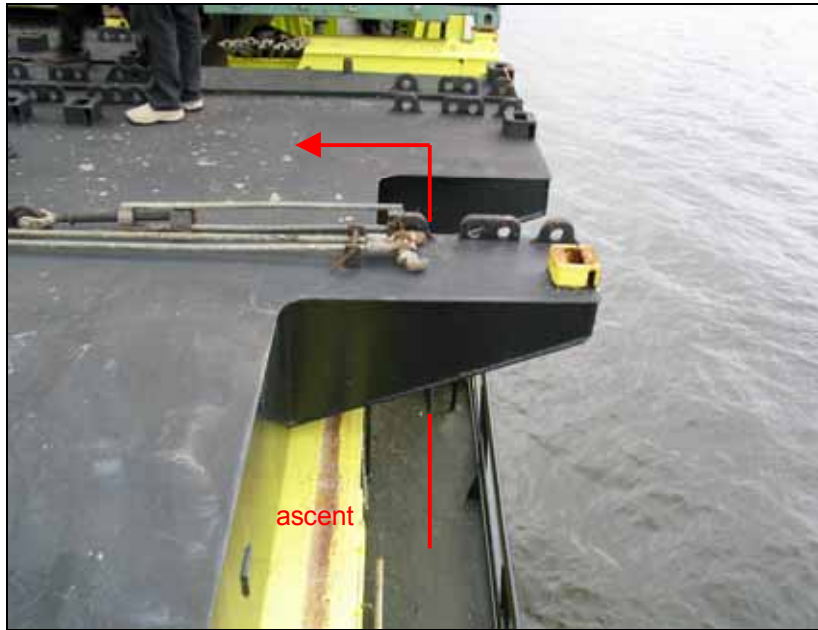
The projections of the hatch cover have a cut-out. Consequently if the vessel is loaded with 45' containers on hatch 1 and containers in bay 5 it is possible to access the hatch / lashing passage there (Figure 5). At the time of the accident there was no ladder here. That was why the crew had to climb over the hatch coaming, a height of at least 2.40 m, or use a mobile ladder (see Figure 6).

Figure 5: Projection of hatch cover (black) with section to the ascent

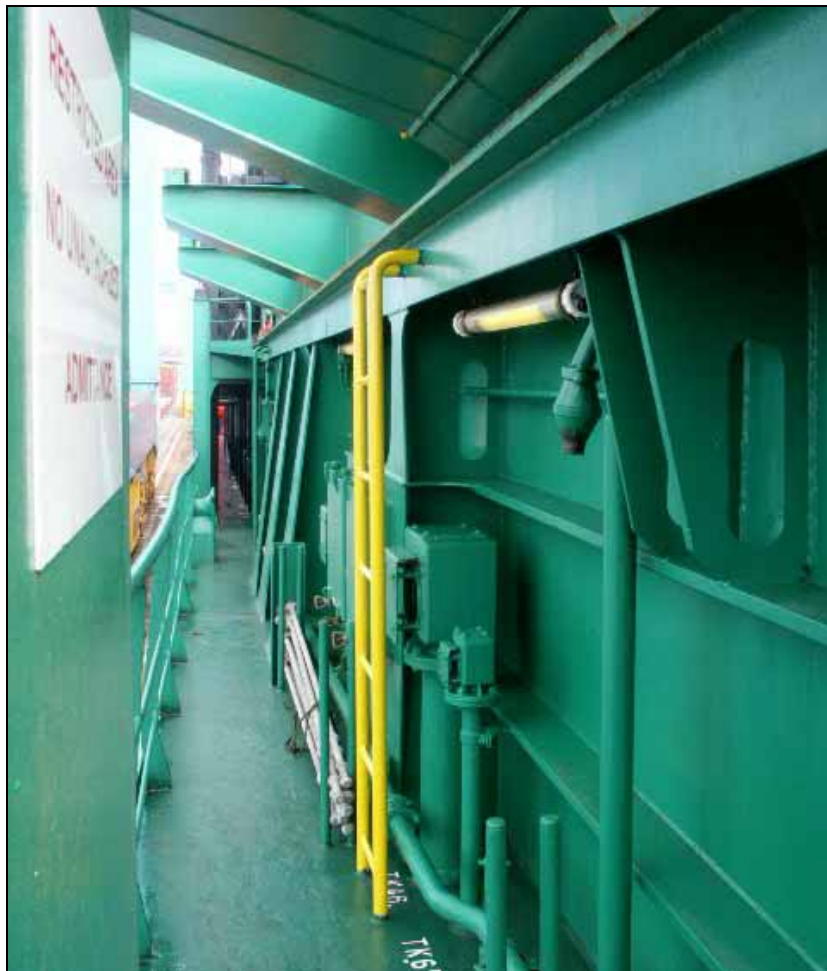
Figure 6: Ascent facility to hatch 2 (without ladder at the time of the accident)

It was ascertained during the investigation that no ladders were installed in the area of the lashing passage between bays 3 and 5 of any of the vessels of this building series inspected. Reference has already been made to the discrepancy between some of the building drawings with regard to this fact (see Figure 4). So far the crews of the sister vessels had only partly noticed this lack due to the differing ranges of trade and the associated different cargoes carried.

A vertical ladder was mounted on the starboard side between bays 3 and 5 for reaching the lashing passage. Appropriate holding devices were installed at the dismounting position and marked in colour.

It is recommended that the operators of the vessels of building series 160 from Sietas Werft equip their vessels with permanently installed ladders at both sides of the lashing passage between bays 3 and 5. This will prevent dangerous climbing onto and descending from the hatch coaming and incorrect use of mobile ladders for leaning.

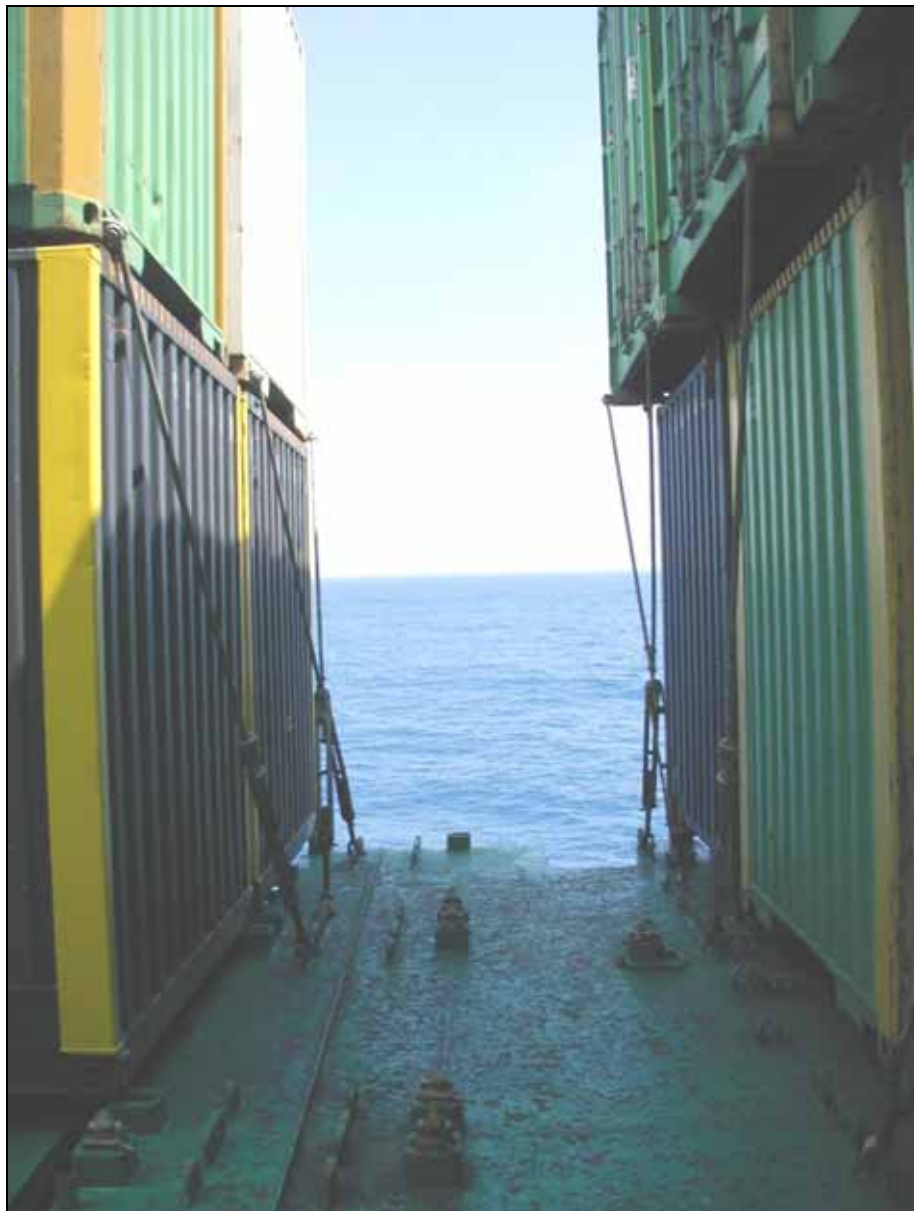
The lashing passage between bays 3 and 5 is approx. 2.2 m wide when 45' containers are carried. It does not represent a level surface, as lashing points and receiving points for container feet are welded on (see Figure 7). It was not possible to clarify finally to what extent lashing materials were lying in the lashing passage or had already been put in place there at the time of the accident. The paint coating on the hatch cover corresponded to the customary standard. No structural fall protection facilities could be placed at the edge of the hatch cover. They had not been planned by the yard and had not been installed subsequently either.

Figure 7: Loading situation after the accident in the lashing passage on hatch 2

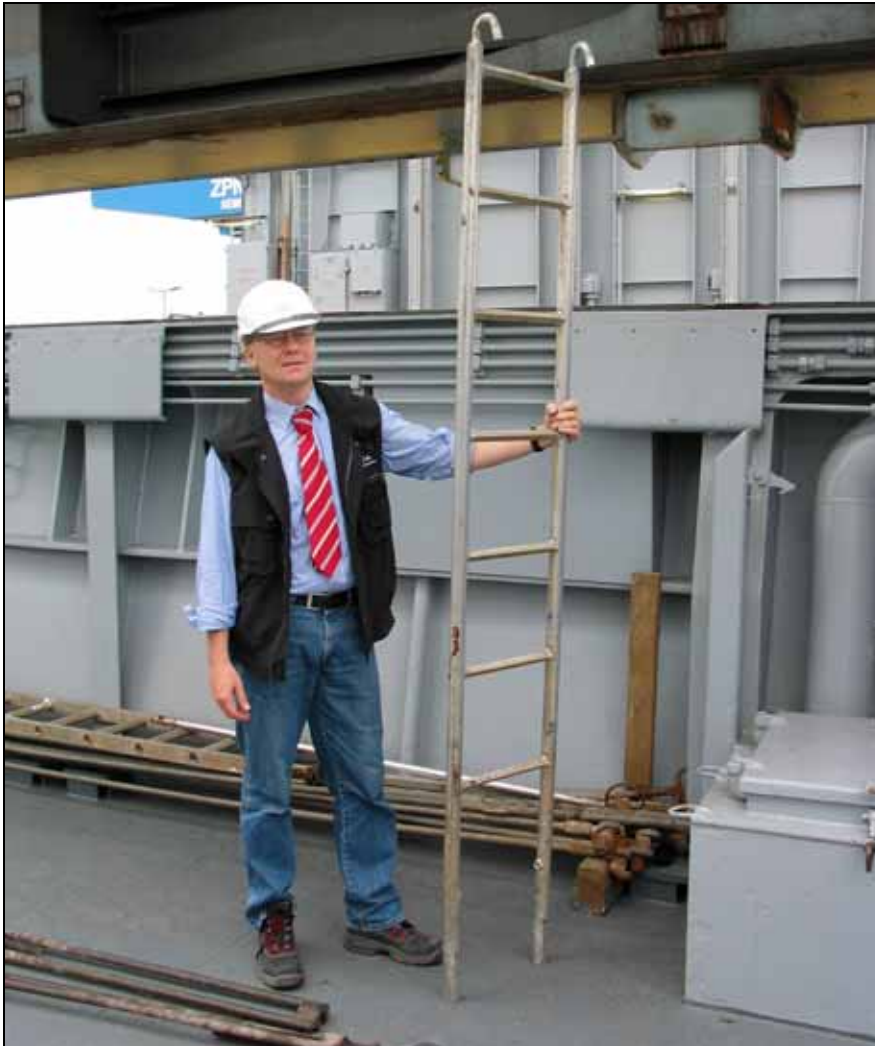
During the inspection the BSU team ascertained that there were several ladders of a certain type on board WERDER BREMEN. These were aluminium ladders of which the sides were made of hollow round material and the rungs of a rectangular, solid material welded on upright. The ladders were provided with hooks at the top. The bottom ends were not equipped with rubber feet (see Figure 8). The statements on use made by the crew of WERDER BREMEN were not uniform. Some said they had only been used to latch the Twistlocks in the first layer of containers, while others said that they had also been used to climb onto containers in order to fit the bridge fittings there. The ladder had always been held by a second man. However, placing of the Twistlocks and bridge fittings as well as the associated climbing onto the containers had generally been carried out by staff of the stevedore companies. The ladders had also been used to reach the hatches. In order to prevent them from slipping, the ladders had been placed against the outer plate marking the edge of the gangboard.

Figure 8: Mobile ladders (sister vessel)

The attention of the crew members should be drawn to the special purpose of the ladders supplied by Sietas Werft.

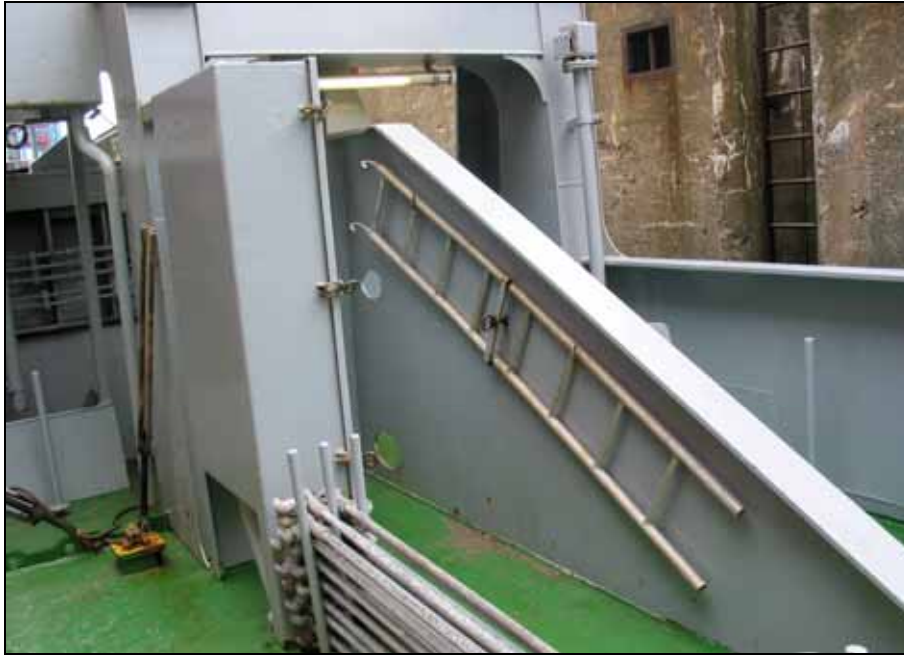
During the survey of the sister vessels, small numbers of this type of ladder were found repeatedly. Through contact with Sietas Werft it was ascertained that the building yard also supplied these ladders. The ladders were only intended for use at certain points specially planned for this purpose. The yard had attached a strap at these points. The upper end of the ladder was to be hooked into these straps in order to ensure stability. That is why the ladders were not provided with rubber feet. The yard had not intended these ladders to be used in other places. Generally, two ladders were supplied with the vessel. These were stored in special brackets (see Figure 9).

Figure 9: Example of a stored ladder (sister vessel)

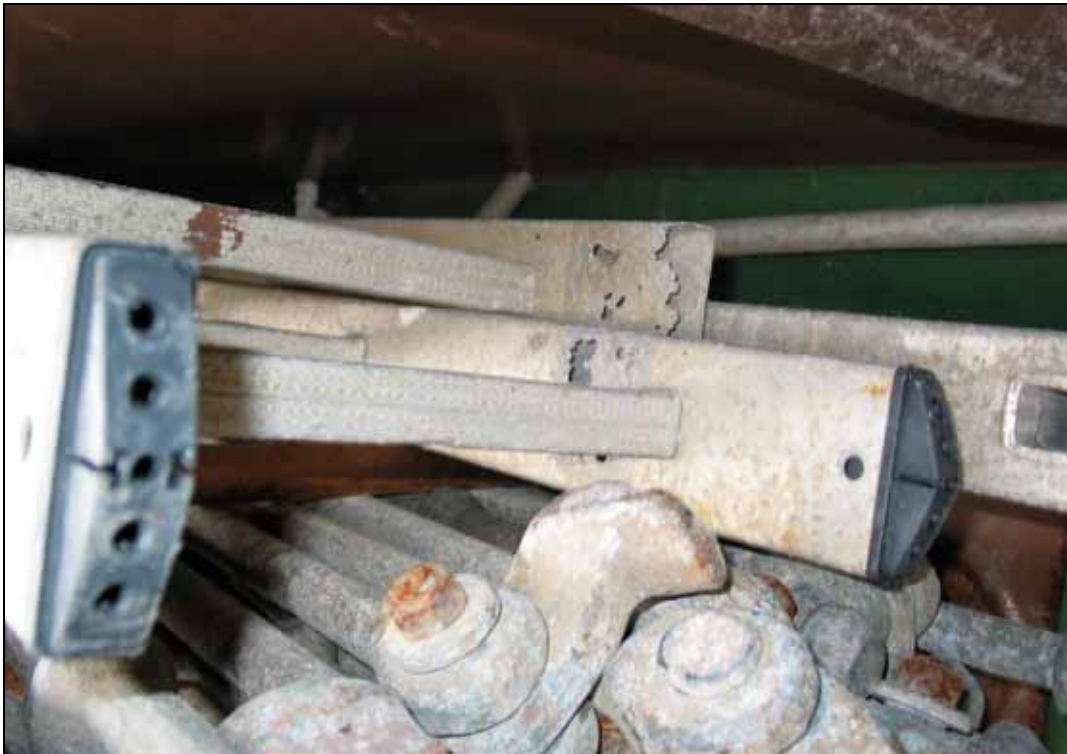
Alongside this the BSU team found a large number of other types of ladders on the sister vessels inspected. Some of these were in a very poor condition. Some of them showed strong signs of corrosion, had no rubber feet, loose rungs, or were badly bent (see Figures 10 to 15). The steps on the wooden ladders were nailed on (see Figures 14 and 16). According to the information provided by the crews these ladders were used at all points on the vessel. However, their use during loading and discharge operations varied and depended on the range of trade, especially the distribution of lashing works between the stevedore companies and the crew.

Figure 11: Corroded ladder ends

The See-Berufsgenossenschaft, vessel commands and safety officers of the vessels are called upon to pay greater attention to the technical condition of the mobile ladders on board during their checks. Missing parts should be replaced expertly, heavily corroded ladders should be removed.

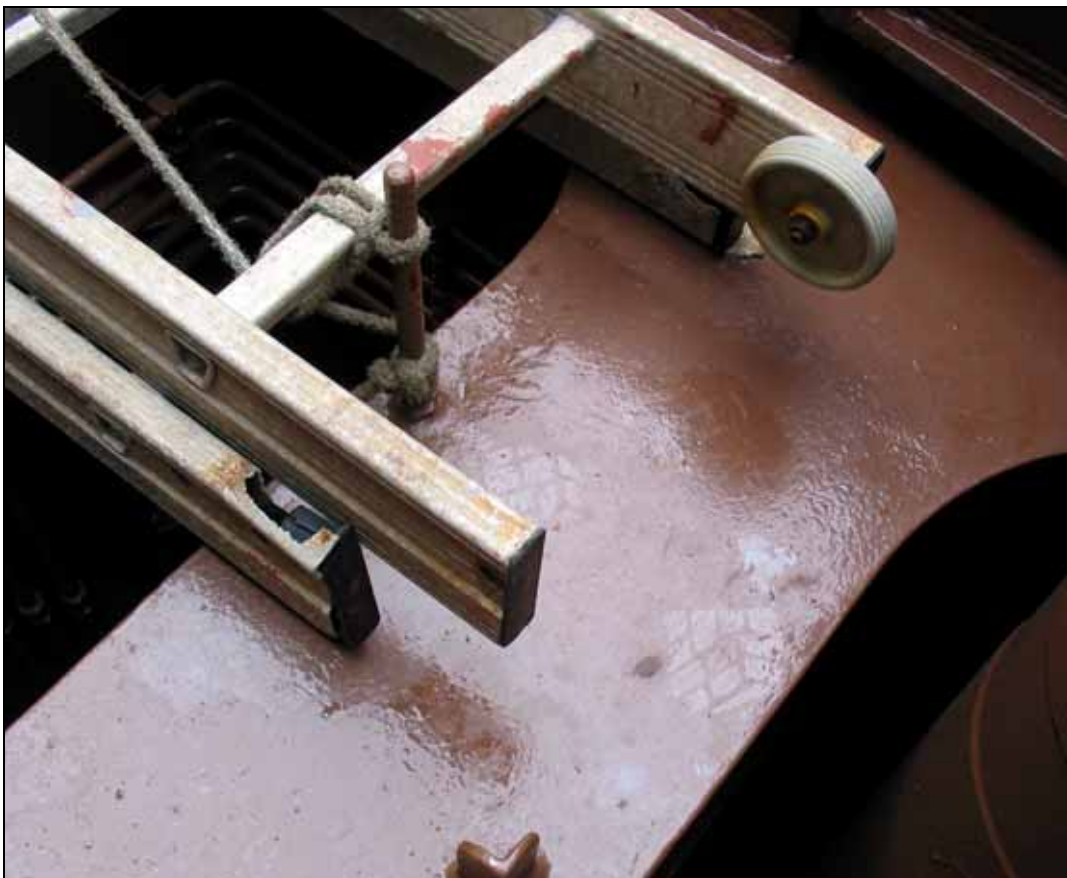
Figure 12: Corrosion and missing roller

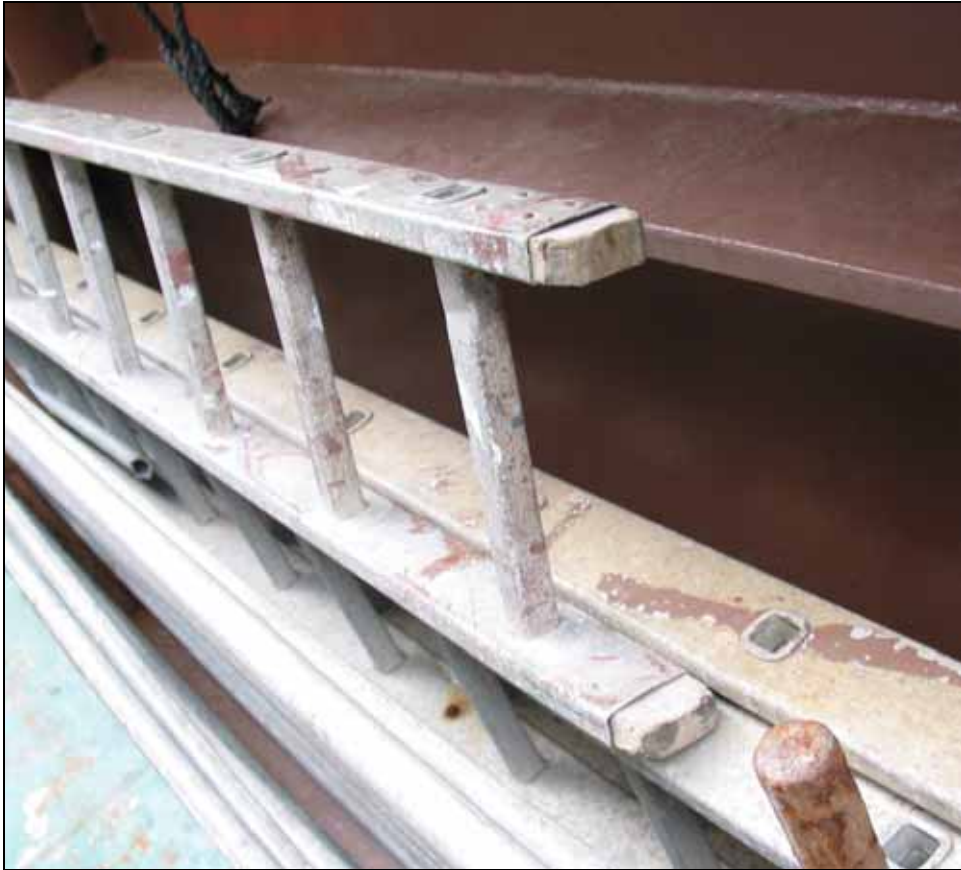
Figure 13: No rubber feet

As regards the other defects ascertained, the following provisions under the law of employment protection from § 73 Para 1 UVV-See provide information on the correct procedure: *"Ladders for leaning may only be used if they are set up safely and secured against sliding and tilting."* This is specified in more detail in the leaflet under II. 3: *"In the case of equipment with ladders for leaning, it should be ensured depending on the purpose of use that these are largely secured against slipping. Safeguards preventing the foot of the ladder from slipping are suitable design of the feet, such as e.g. steel tips for use on wooden floorings, or rubber feet for use on steel decks."*

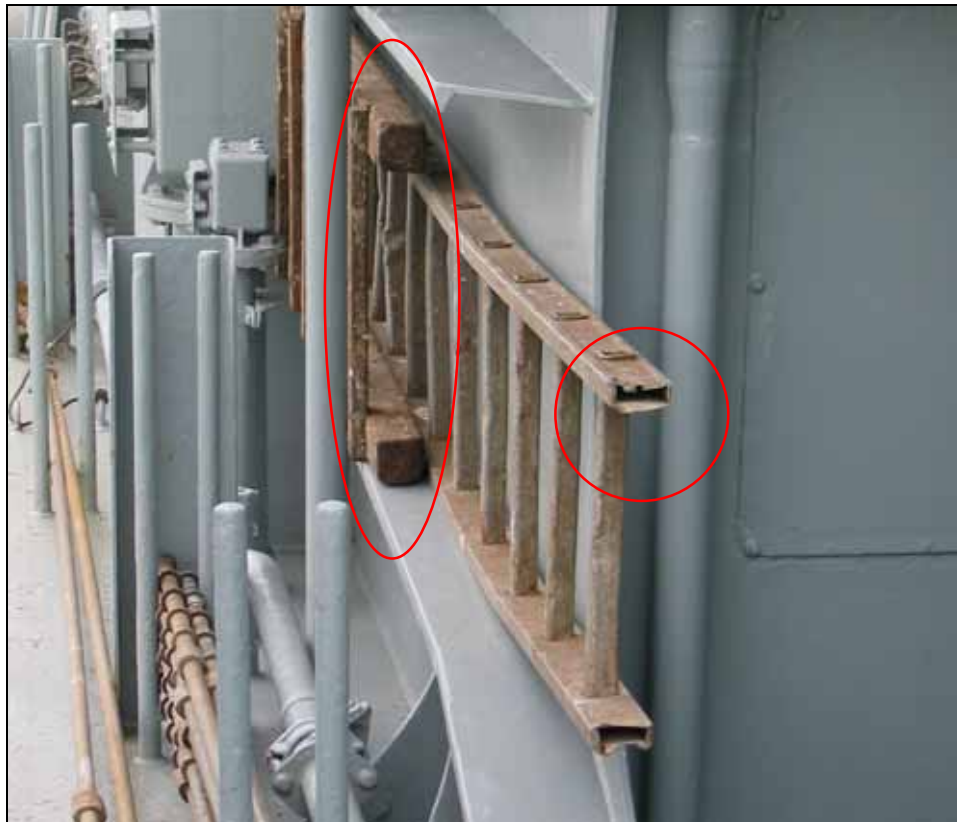
Figure 14: Damaged aluminium ladder, wooden ladder with rungs nailed on

*Fastenings of wooden parts using nails or woodscrews are not considered to be permanent fastenings ..."*

A statement about damaged ladders is made under I. 5.: *"Damaged ladders must be removed from use. They may only be used again after proper repair that restores their original strength and ensures safe use.*

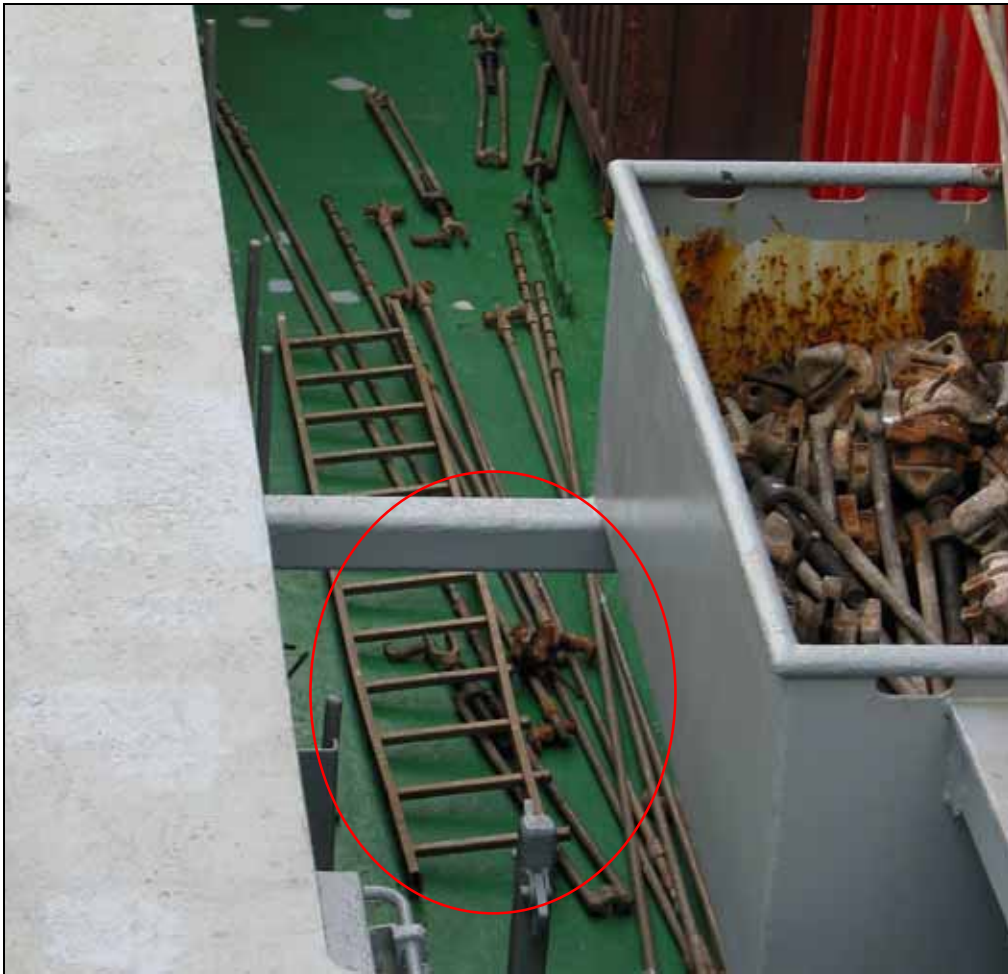
Figure 15: Loose rungs

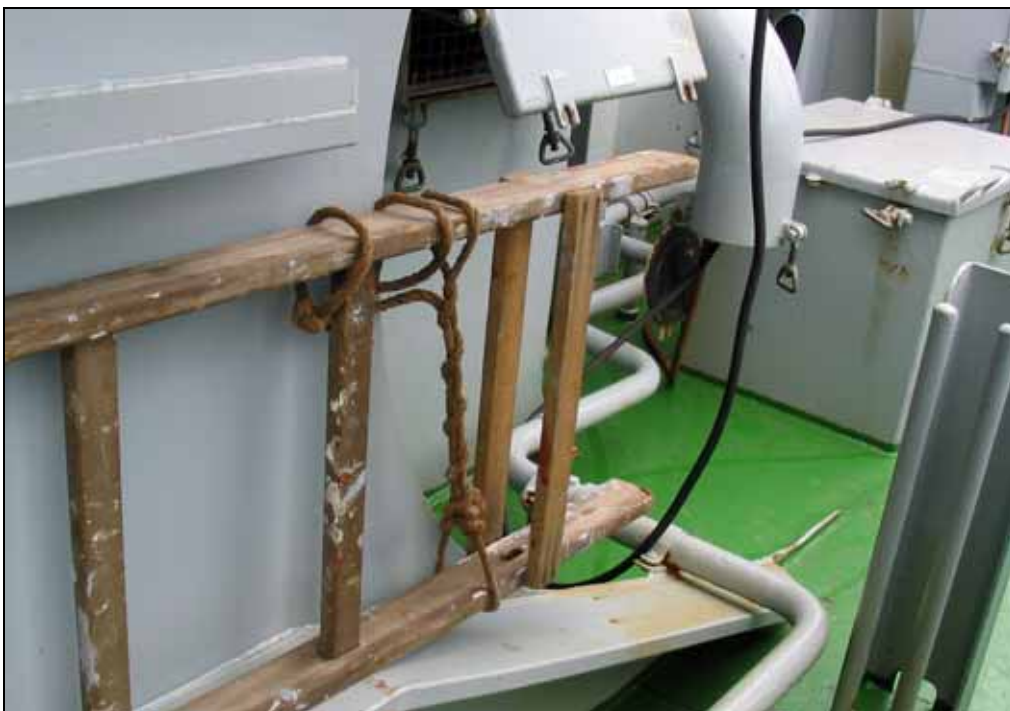
Figure 16: Improper repairs

*Ladders no longer suitable for repair should be destroyed immediately if possible. Experience has shown that this is the most effective way of withdrawing them from use. Inexpert repair comprises, for example, the use of bandages round broken ladder struts. When rungs are replaced, care should be taken to ensure that damaged or missing rungs are replaced by sound rungs of the same type. The strength of the struts may not be impaired by the use of rung holders for fastening replacement struts."*
