Bundesstelle für Seeunfalluntersuchung
Federal Bureau of Maritime Casualty Investigation
Bundesoberbehörde im Geschäftsbereich des Bundesministeriums
für Verkehr, Bau und Stadtentwicklung

Investigation Report 187/05

**Explosion and Fire
on board CMV PUNJAB SENATOR
in Hold No. 6
on 30 May 2005
on the way to Sri Lanka**

15 December 2006

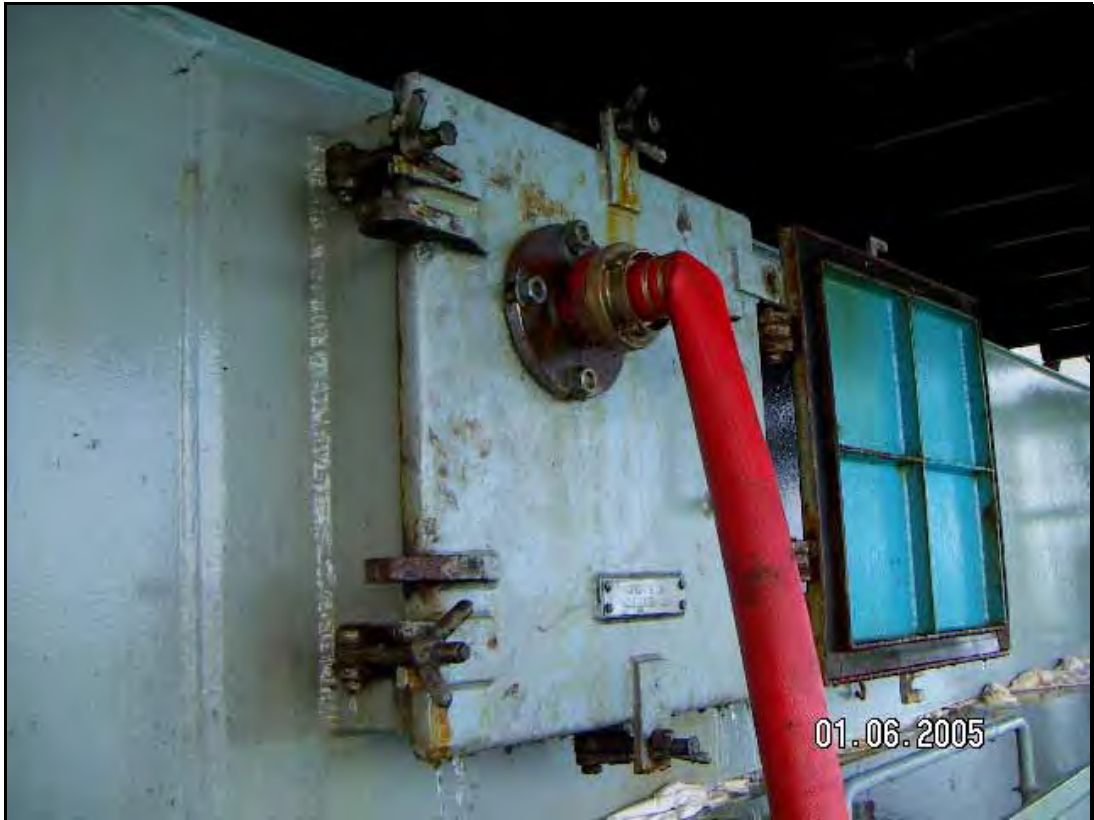
In the meantime the crew had cut a hole in a ventilator damper to which a fire hose coupling was welded.

At about 10:40 h exchanging of this special ventilator damper had been ordered so that firewater could then be pumped directly into the hold without allowing oxygen to enter through the hatch (**see also Figures 3 and 4**). The bilge pump had at all times been well able to pump the gathering water out of the hold again. About one hour later the temperatures measured had dropped distinctly.

Figure 3: Ventilator damper converted for cooling

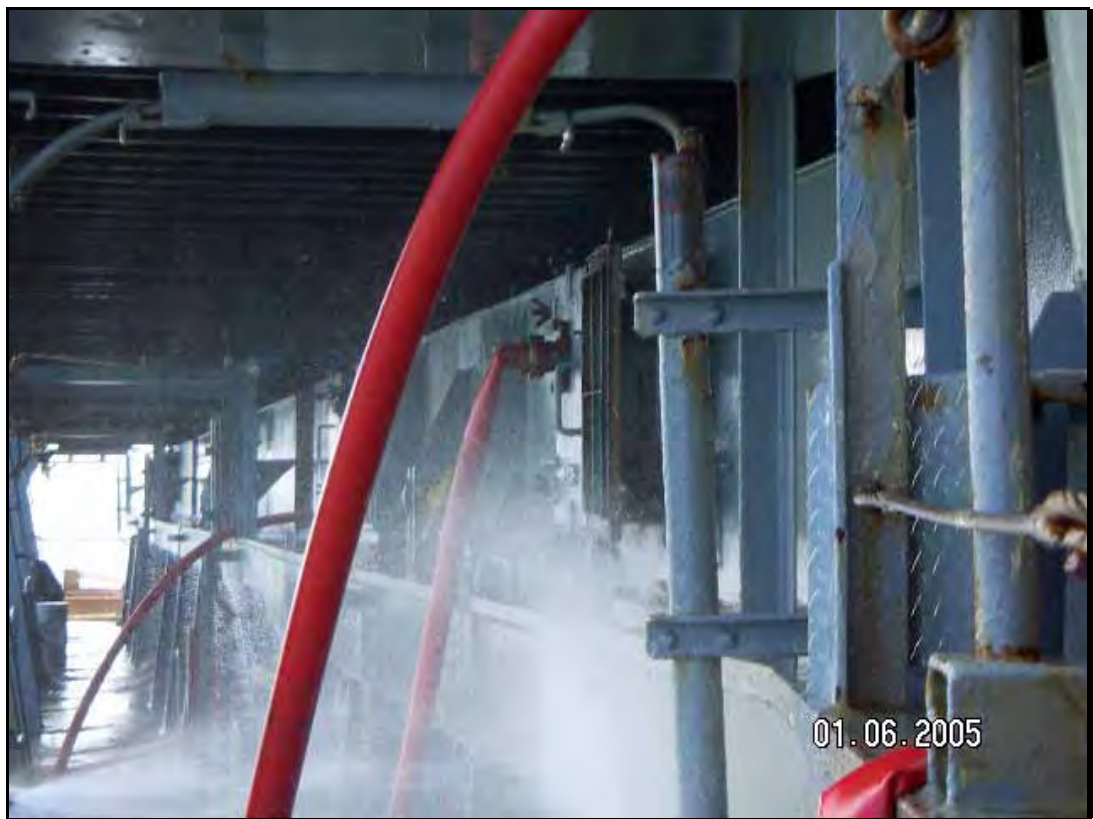
Figure 4: Cooling of the hatch

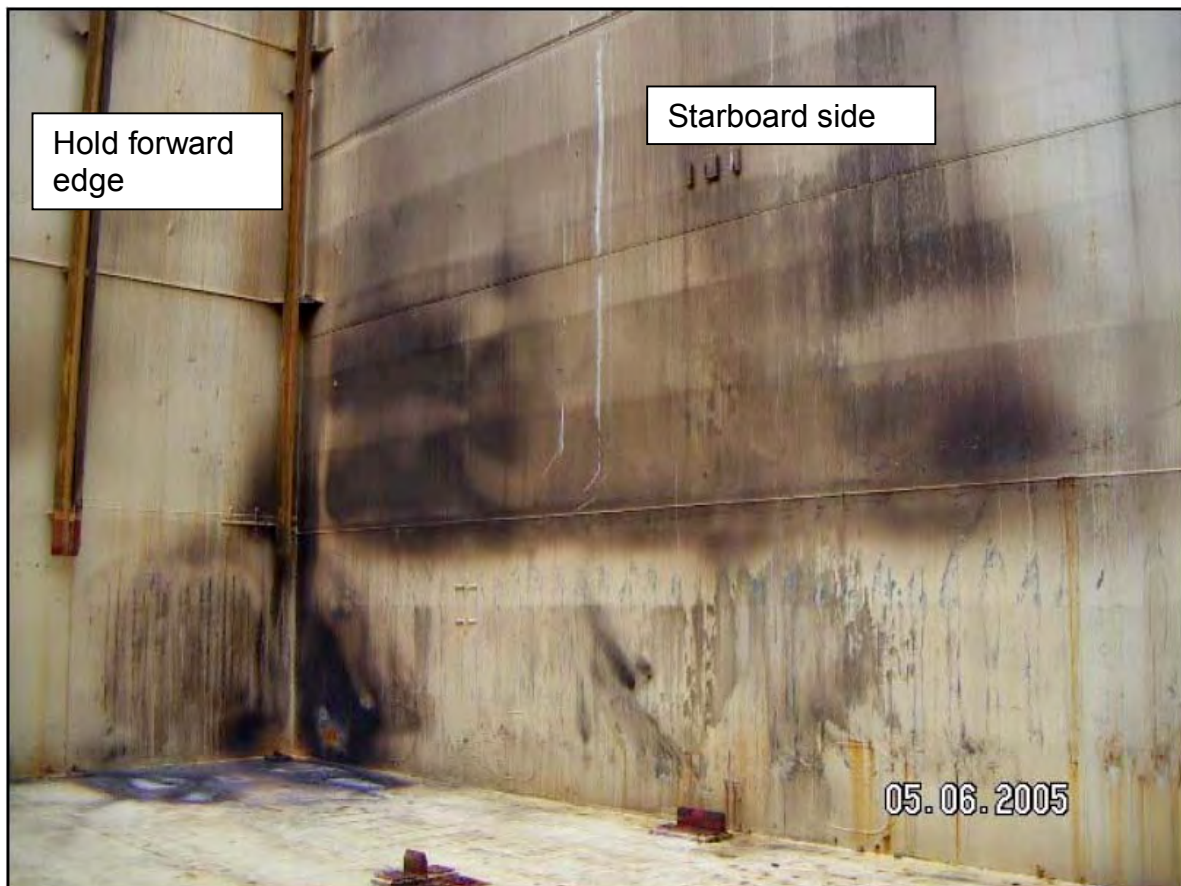
Hold 6 on the starboard side shows traces of fire and damage in the place where containers 1 and 2⁵ were stored. In the area of the corner (hold floor / forward edge / outer side) the paint coating on the wall sections is discoloured and partly burnt. In the area of the position of container 1 the paint coating is intact apart from the corner area. In the area of the lower hold corner there are clear traces of major heat influence that can be seen (see also Figure 4: Hold 6 – storage place of container 1). In the outer wall area the paint coating is burnt over an area of approx. 1 m. In the floor area there is discolouring, blister formation and peeling in the area of the outer edges of the container over a length of approx. 2 m. The paint coating on the outer wall is discoloured in the entire area of container 2 (see also Figure 3: Hold 6 – starboard forward edge). However it can be ascertained that the temperature in the forward edge area must have been higher.

Figure 5: Hold 6 - forward edge stbd.

The fire probably started at the forward edge of container 1. The discolouring over large areas of the hold floor and the burnt coats of paint in the hold wall are an indication of the occurrence of high temperatures in this area. Moreover, the container was closed in this area after the fire too, indicating that the fire damage to the hold wall resulted from radiant heat from the container and not from direct flame action. The presence of this source of fire is confirmed by the coinciding traces of fire on the outer wall of the container. After evaluating the data available it can be assumed that the fire developed as a smouldering fire in the bottom container. It can also be assumed that this smouldering fire broke out before the explosion and could not be detected due to the lock and the spatial geometry. As a result of the smouldering fire, the cargo consisting of NiMH rechargeable batteries size AA, corrugated cardboard, plastic sheeting and paperboard in various thicknesses was further conditioned thermally. According to the information supplied by the manufacturer, it can be assumed that NiMH rechargeable batteries in particular give off the hydrogen resulting at higher temperatures and during the internal chemical reactions taking place at these temperatures, e.g. discharging operations, via the safety valve on the plus pole. The experiments conducted show that plastic film sheeting begins to melt already at approx. 60°C, and that in addition combustible gases occur when the paperboard is heated to temperatures above 140°C. Furthermore, the moisture present is given off by the outer packaging and condenses on the cooler rechargeable batteries and plastic sheeting. This leads to the possibility

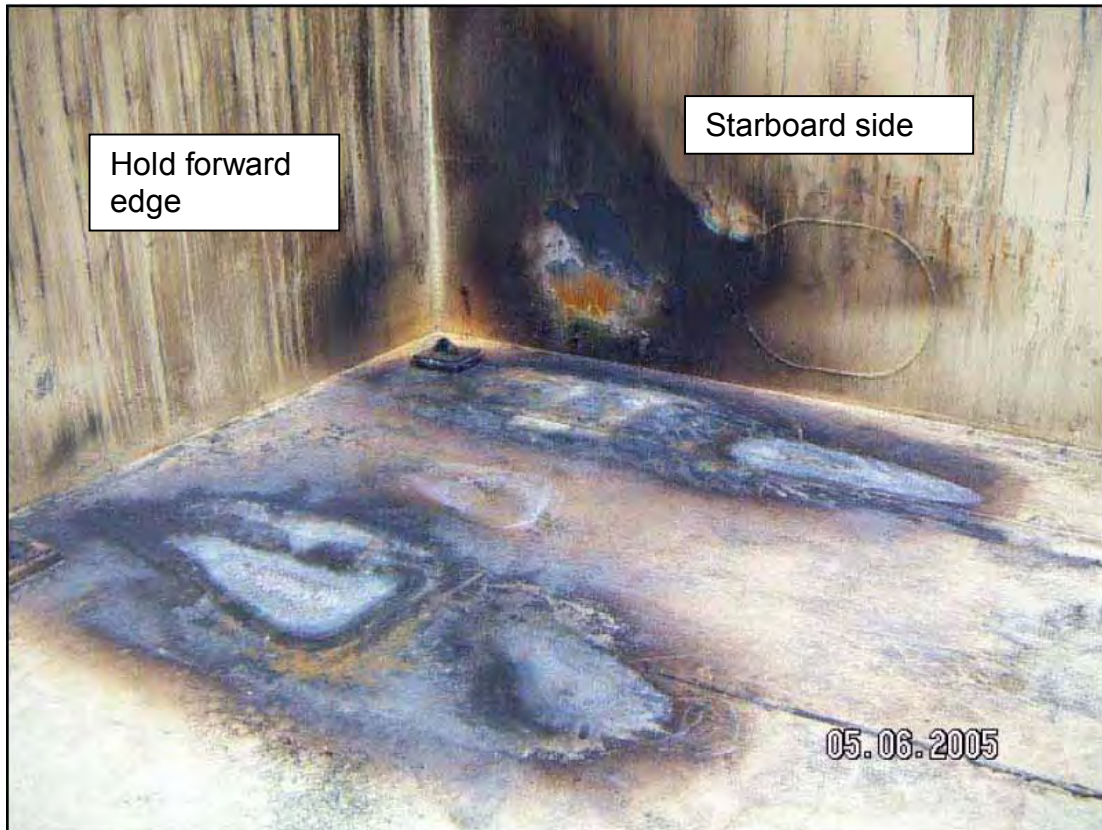
Figure 6: Hold 6 - Storage space of Container 1

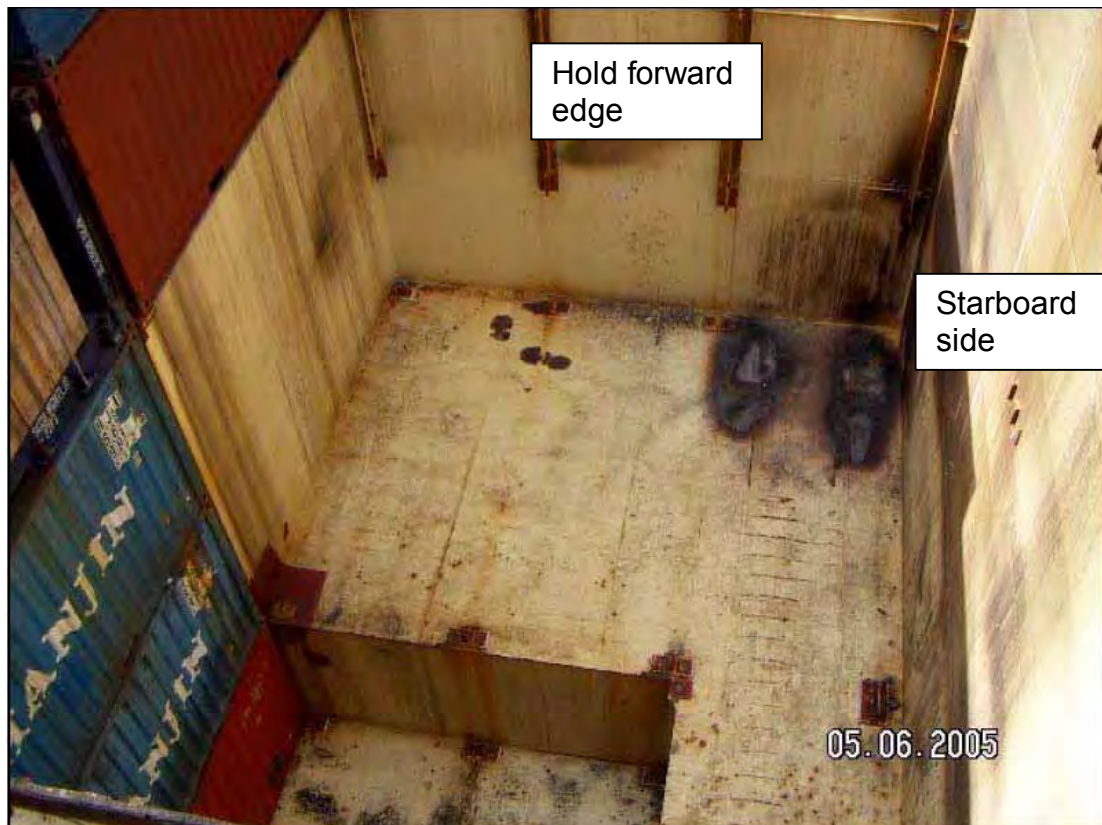
Figure 7: Hold 6 Stbd. - view from above

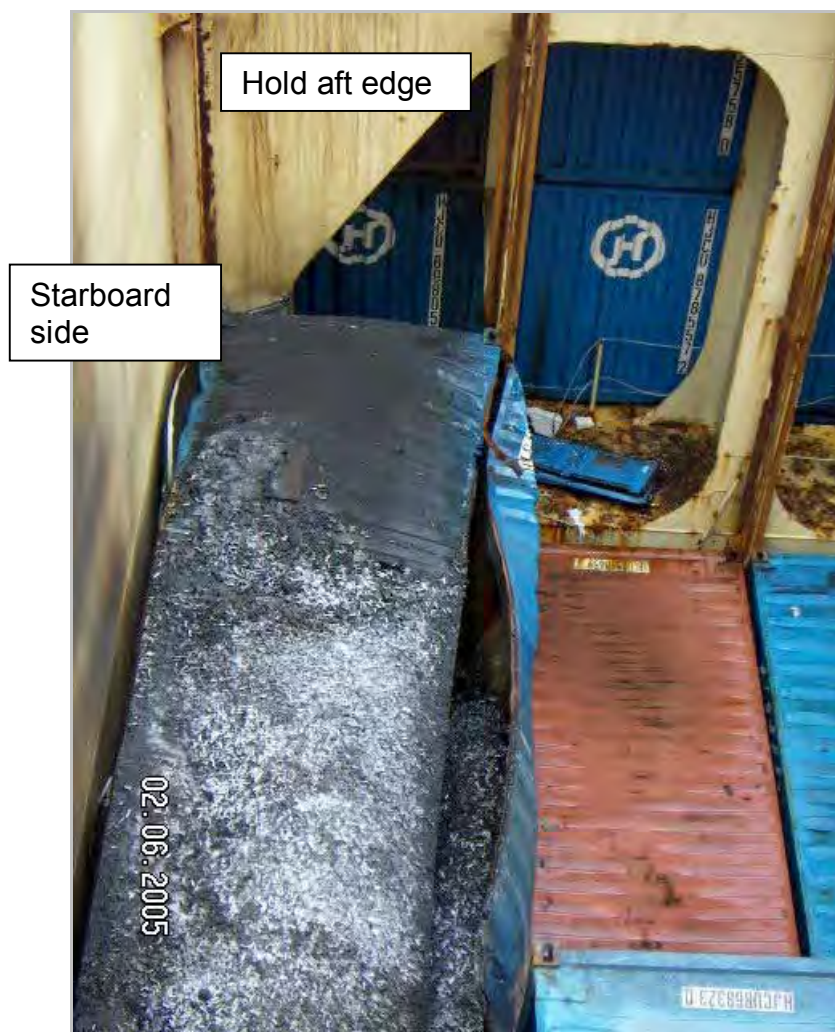
The evidently exploded container No. 1 in the bottom layer shows substantial signs of fire and damage. In addition it shows signs of mechanical damage over a large area. The container ceiling is closed and the whole area shows discolouring of the paint layer resulting from the influence of heat (see also Figure 8: Container 1 – plan view). The port sidewall is separated from the container ceiling at the top over the entire length and bulges outwards. The starboard sidewall is severed in the aft area. The mechanical destruction of container 1 can be explained by a fast and steep increase of pressure inside the container that could have only been caused by detonation or explosion, judging by the extent of the damage (see also Figure 9: Container door of Container 1 wrapped round the frame). The inside of the container shows no signs of fire in the aft area (see also Figure 10: Container 1, partial view of interior). The sidewall shows clear signs of fire and damage. In the forward area there are large areas of discolouring and burnt coatings of paint. There are further burnt coatings of paint and discolouring in parts of the bottom area of the container. The aft area is intact (see also Figure 11: Container 1 side view).

Figure 8: Container 1 – plan view

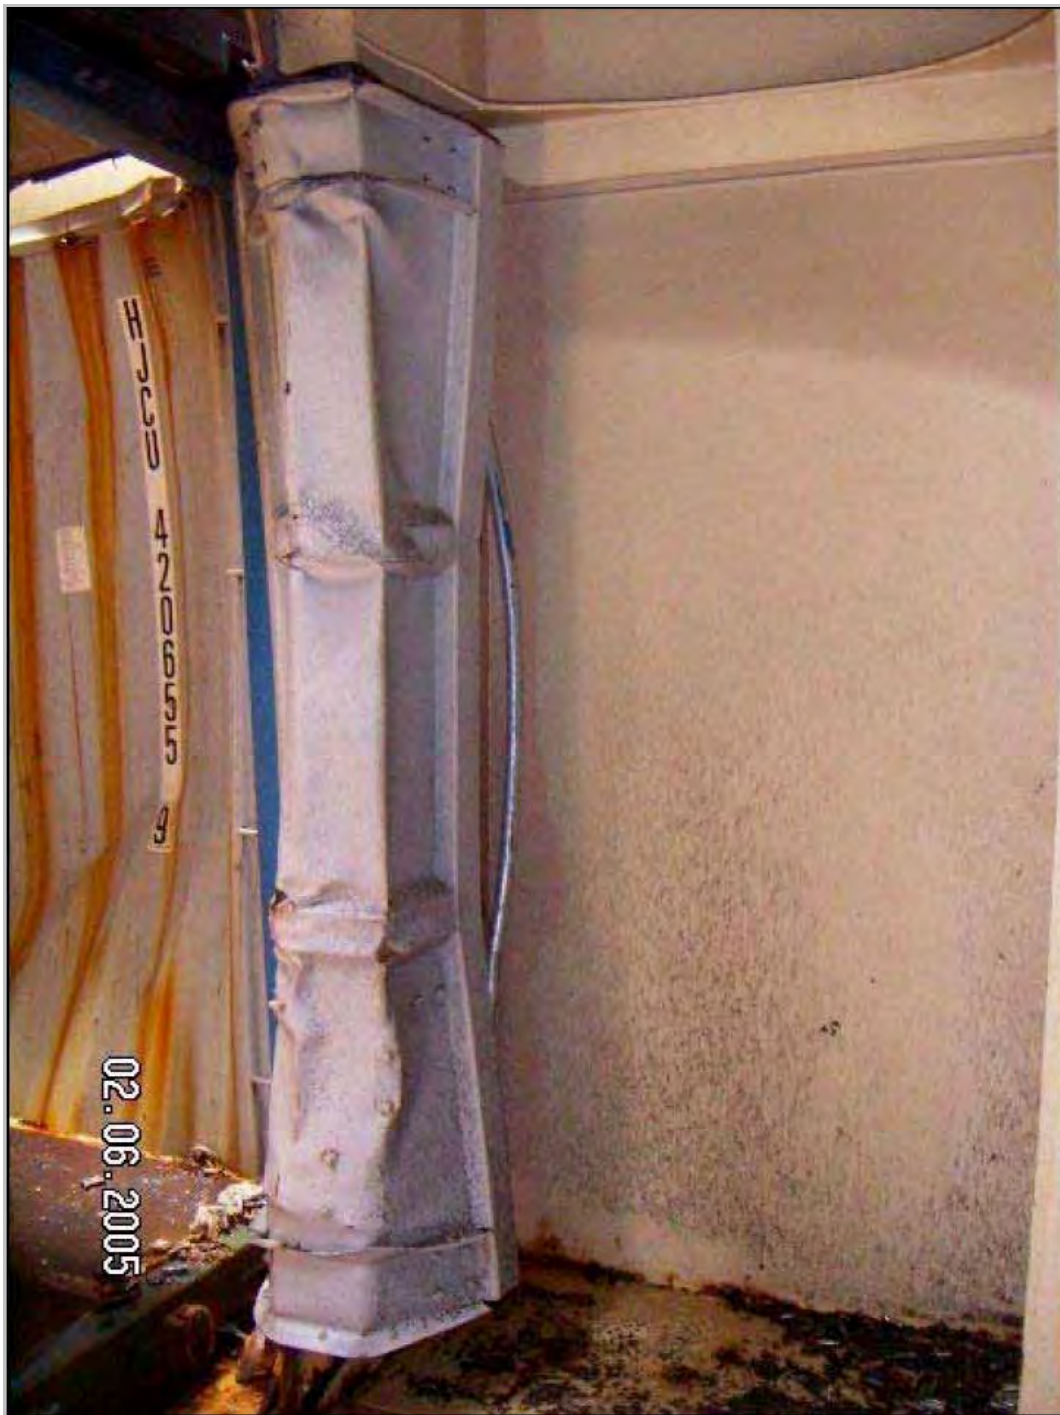
Figure 9: Container door of Container 1 wrapped round the frame

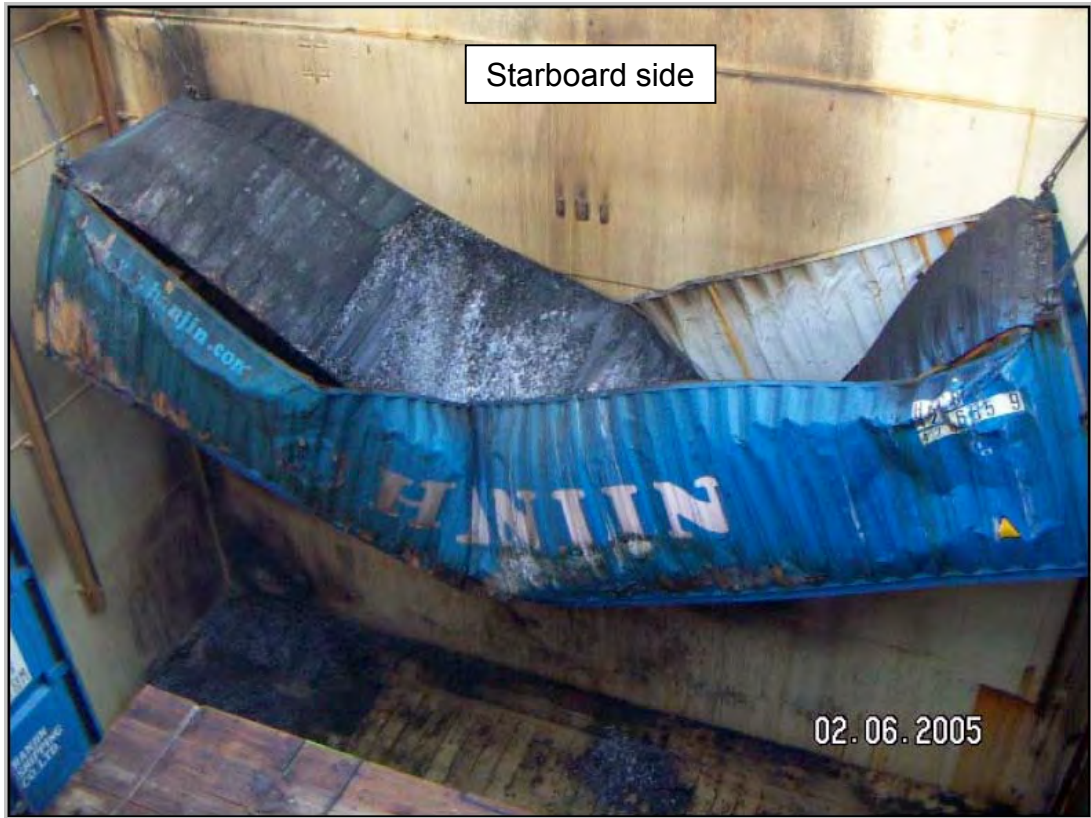
Figure 10: Container 1 partial view of interior

In container 1 naked flames only occurred in the forward edge area where the fire originated. The inside paint in container 1 shows hardly any traces of fire (**see also Figure 10, Partial view of interior**).

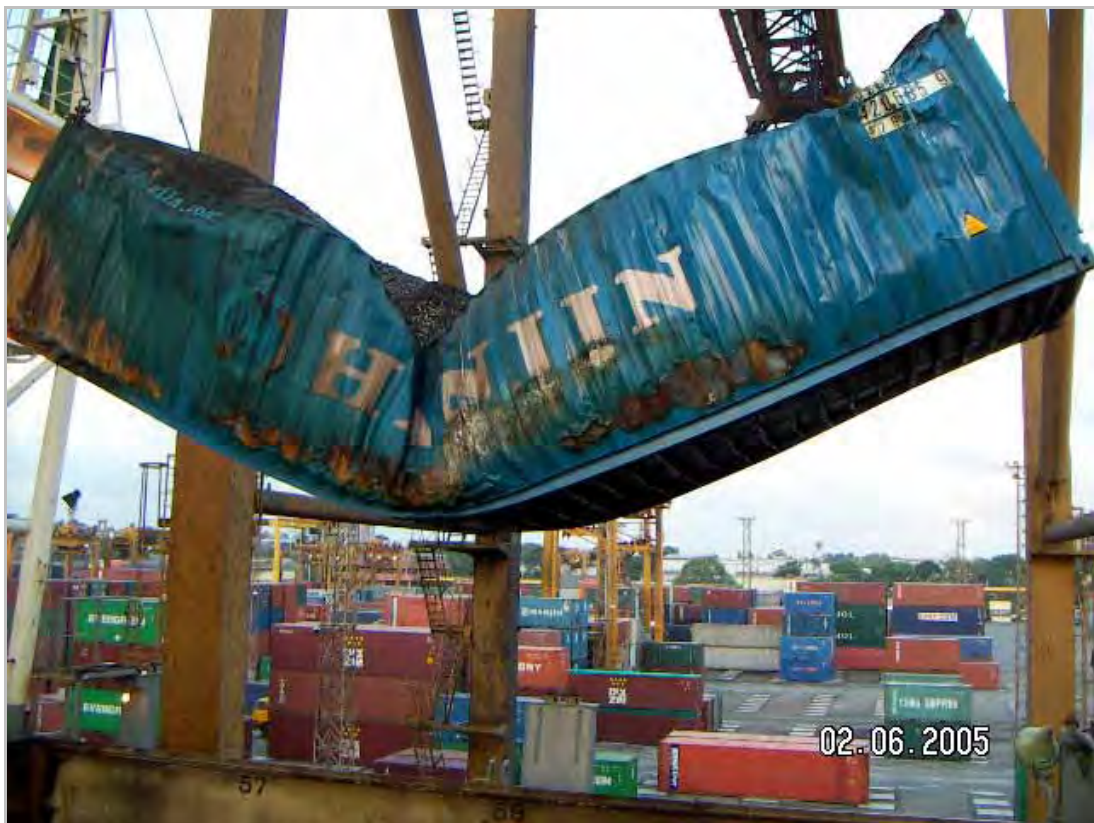
Figure 11: Container 1 side view

The processes that took place in container 1 have the following impacts on container 2 standing above it: heat is transferred by radiation and conduction so that the container and the cargo become thermally conditioned. As a consequence the floor and the cargo ignite. The damage constellation confirms this process, whereby the fires in container 1 and container 2 can have run in a similar manner but offset in time up to the explosion. Evidently explosive mixtures did not occur and ignite in container 2. After flooding with CO₂, the naked flame fires in container 1 opened by the explosion were extinguished and smouldering fires developed in the outer packaging on the container floor (**see also Figure 11: Container 1 side view**).

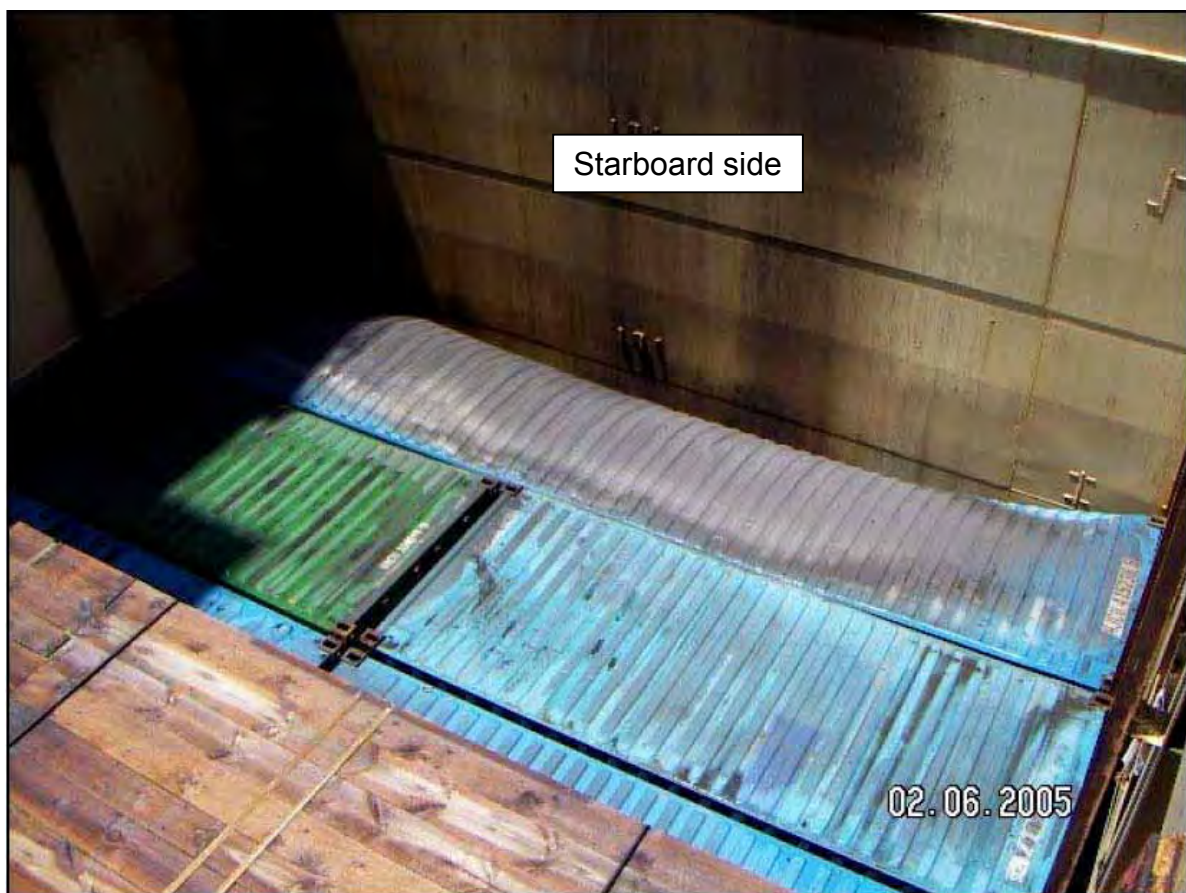
The evidently burnt out container No. 2 in the second layer shows substantial traces of fire and resulting damage. No major mechanical damage was noted. The container ceiling is closed and bulges up slightly, and the whole area shows signs of discolouring of the paint layer due to the effect of heat. The aft edge and forward edge of the container are less strongly affected (see also **Figure 12: Container 2 plan view in the hold**). The sidewall also bulges out. The starboard side was subjected to slight thermal stress, the paint coating is intact. In the front area burnt paint coatings and discolouring can be seen over approx. 1-2 m (see also **Figure 13: Container 2 side view**).

Figure 12: Container 2 plan view in the hold

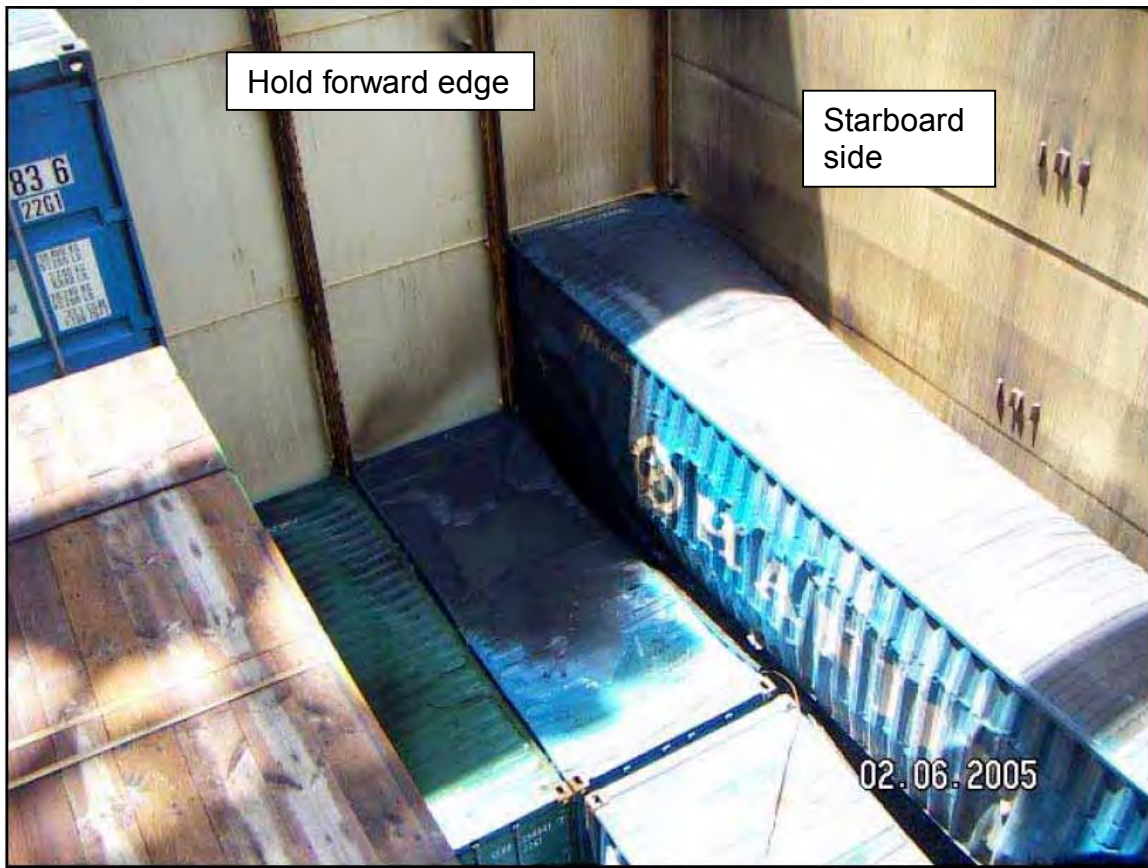
Figure 13: Container 2 side view

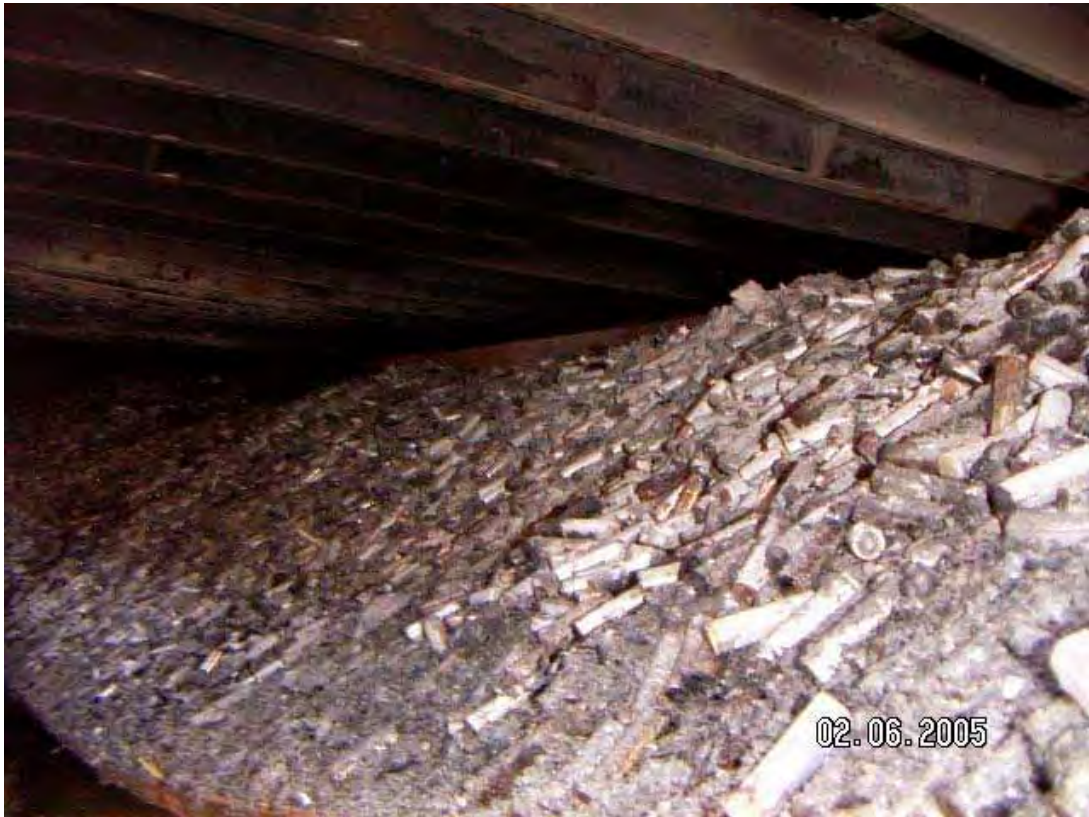
According to an analysis of the photos, nearly all the rechargeable batteries or rechargeable battery housings still exist after the fire. It is possible to ascertain that the outer packaging consisting of corrugated cardboard (cartons) and plastic film sheeting was largely burnt. The rechargeable batteries show clear differences in the degree of thermal stress. Some batches are only coated with soot, whereas the casing of others is burnt, and still others evidently burnt out. The almost complete lack of residues of the outer packaging is an indication of active embers over a relatively long period. Figure 14 shows the view from aft on both containers at the time of the lifting of the top container. The top of container 1 is visible and the rechargeable batteries from container 2, whose bottom was burnt away, lying on it. Apparently the bigger part of the cargo of container 2 lies on the top of container 1. Accordingly only few rechargeable batteries got in container 1.

Figure 14: NiMH rechargeable batteries after the fire

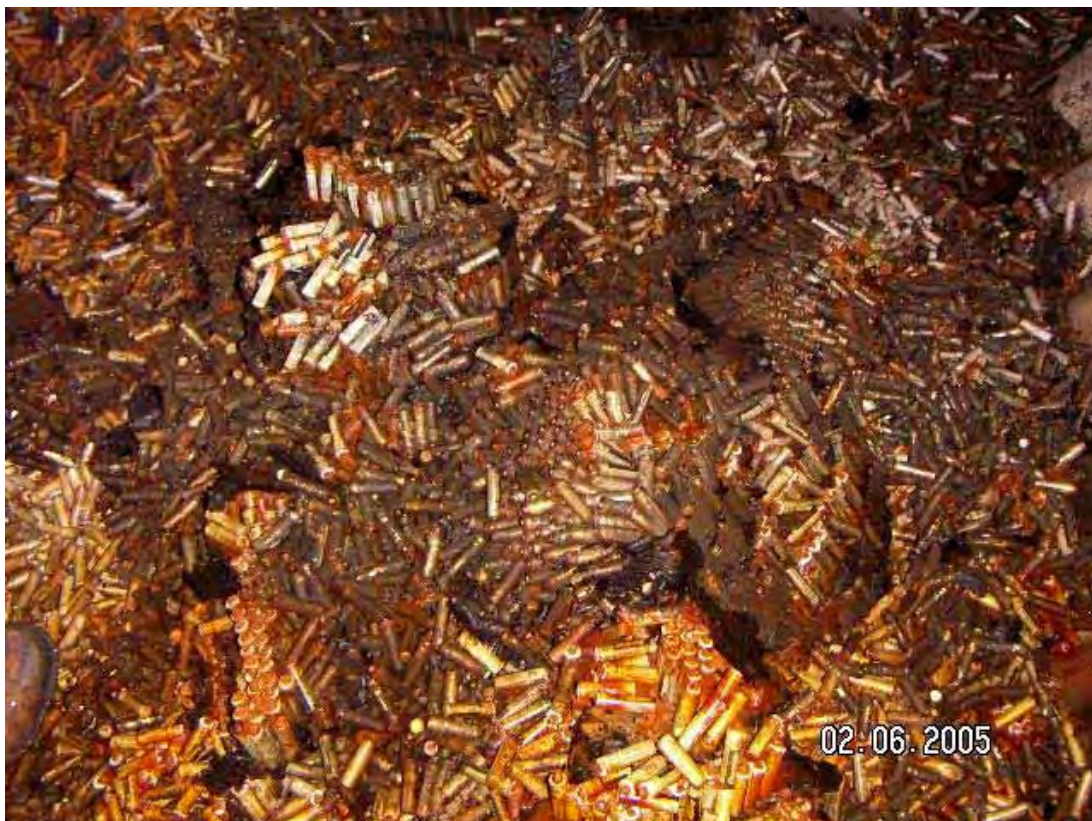
Figure 15: NiMH rechargeable batteries after the fire

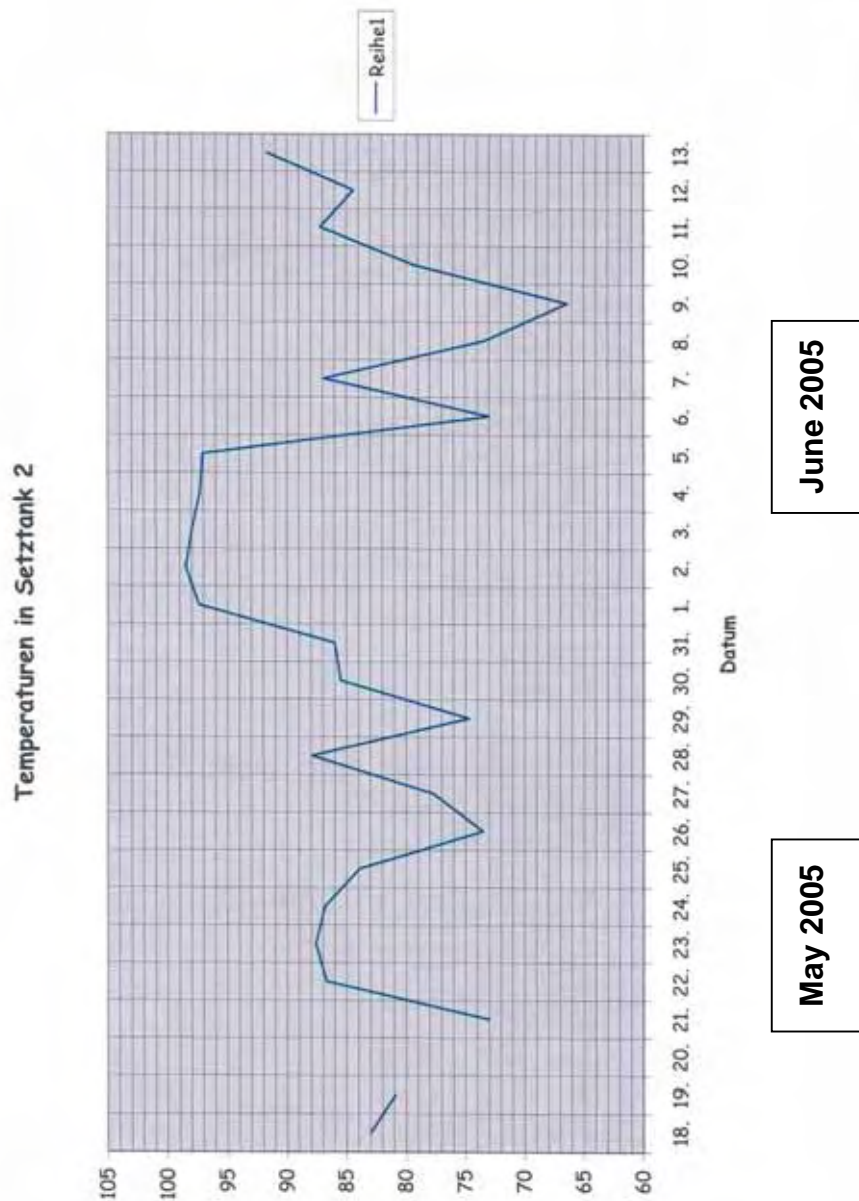
14 Annex: Graph of the temperatures measured in settling tank No. 2 on board

The cause of the fire on board PUNJAB SENATOR was the fact that the NiMH rechargeable batteries were stored close to the vessel's own source of heat, settling tank No. 2. A contributory cause was the lack of any exchange of information about or ignorance of

The computer technology on board automatically records the internal temperature of settling tank No. 2 once a day. It was possible to read out these data and use them for the investigation. The measurements taken by GL for purposes of comparison confirmed that the recording system was free of errors.

- 5) The Federal Bureau of Maritime Casualty Investigation (BSU) recommends that classification societies should review adapting their shipbuilding regulations in order to insulate cargo from sources of heat due to vessel operations.
