**Bundesstelle für Seeunfalluntersuchung**  
**Federal Bureau of Maritime Casualty Investigation**  
Bundesoberbehörde im Geschäftsbereich des Bundesministeriums  
für Verkehr, Bau und Stadtentwicklung

Investigation Report 203/04

**Very serious marine casualty**

**Foundering of SY ALLMIN and  
drowning of two sailors  
on 29 June 2004  
east of Rügen**

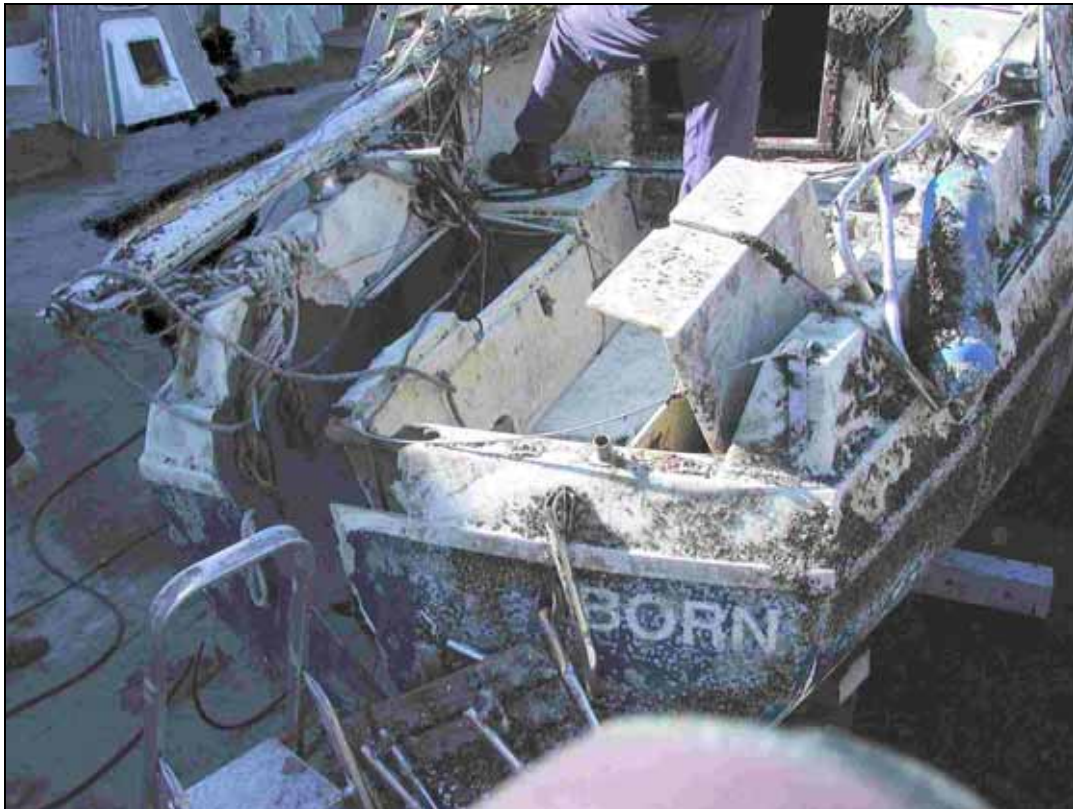
The yacht had sustained most damage in the stern area. There was a gap corresponding in width to the diameter of the rudder head from the opening for the rudder head in the bottom up to the transom. Here the gap widened to become a triangular hole in the stern. A large piece of material of the stern, the aft coaming and the port side of cockpit were missing.

The broken edges at the transom stern were sharp and not pressed inwards. The lower edge of the stern showed no other signs of damage (Figures 5, 6, 7, 8).

Figure 5: View from the stern

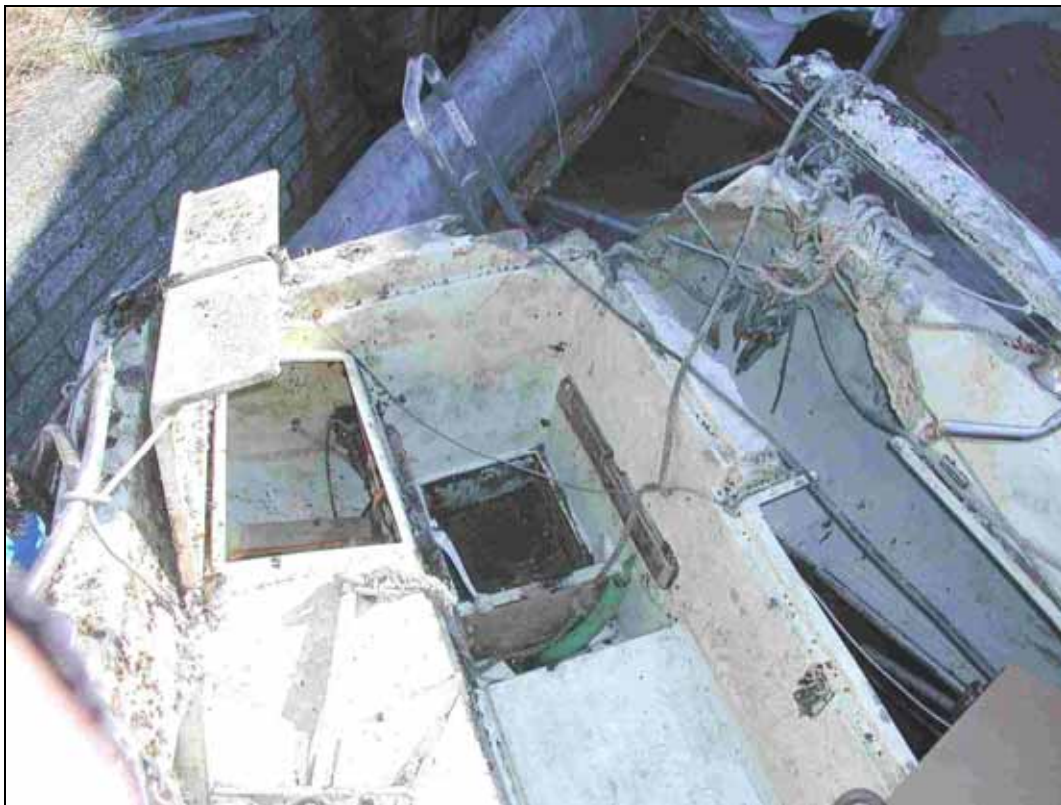
Figure 6: Plan view of stern

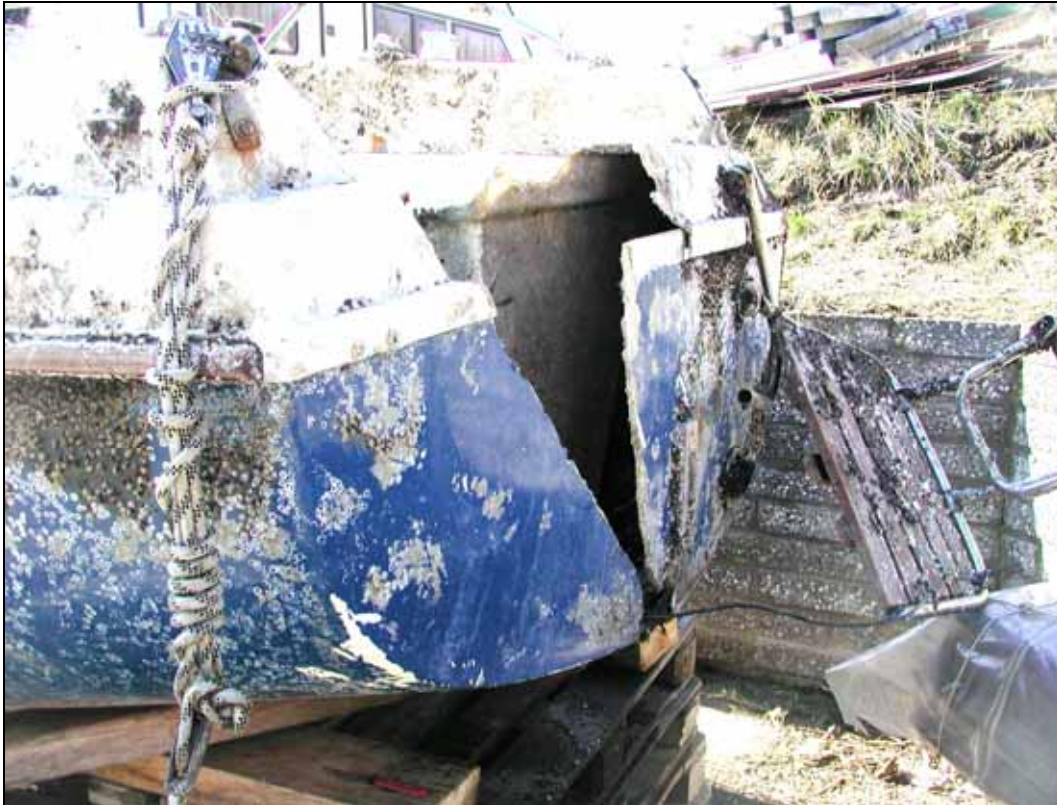
- The fractured edges did not point inwards and were smooth and not roughened.
- The swimming ladder had been pushed away to the side and not into the hull. The reason for this could be the straight stern of the fishing cutter or the collision with the bottom of the sea.
- No traces of paint from another vessel could be ascertained.
- The bottom edge of the stern transom, in other words the transition to the bottom, showed only one area of damage. This damage consisted of drawing the rudder head through the deck and showed a clear damage constellation.
- The crew of the fishing cutter CRAMPAS saw only one crack in the stern.

The cause of the large area of damage is considered to be the tangling of the rudder blade in the net of the fishing cutter. This resulted in forces that exerted excessive stress on the stern section, thus first leading to a crack and then pulling the entire rudder out of the vessel. The fishers recovered the rudder. It was no longer on the yacht when it sank again.

Figure 7: Straight cut edges at stern

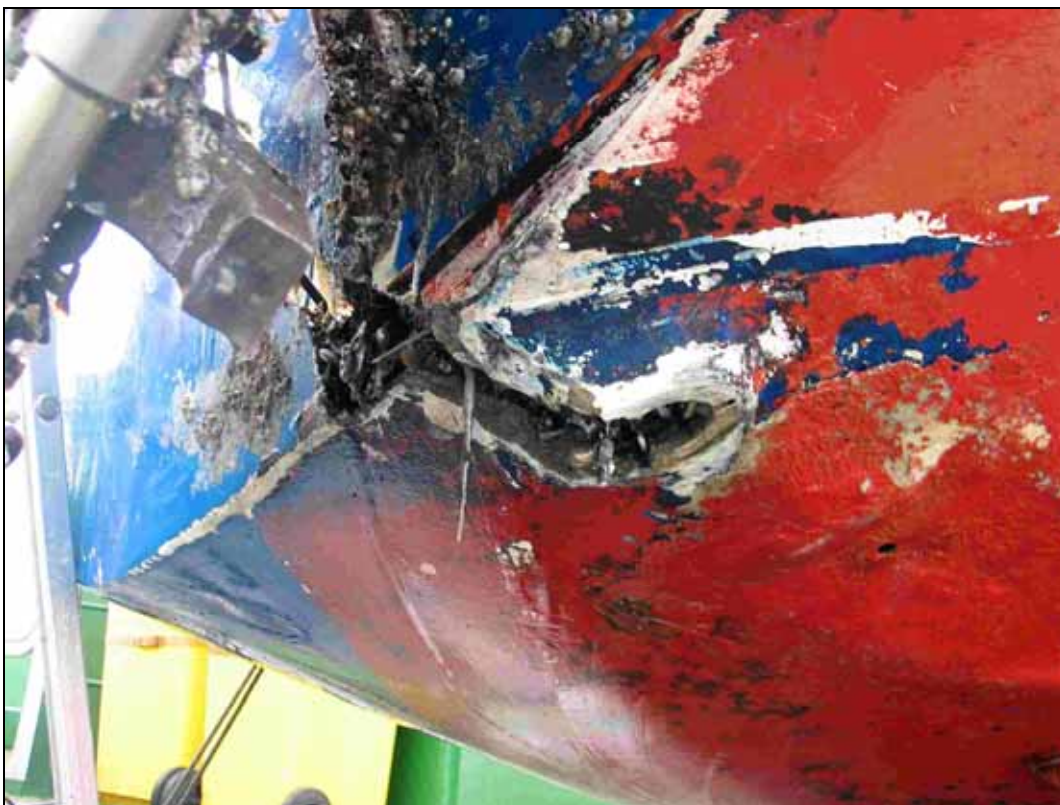
Figure 8: Crack in the bottom

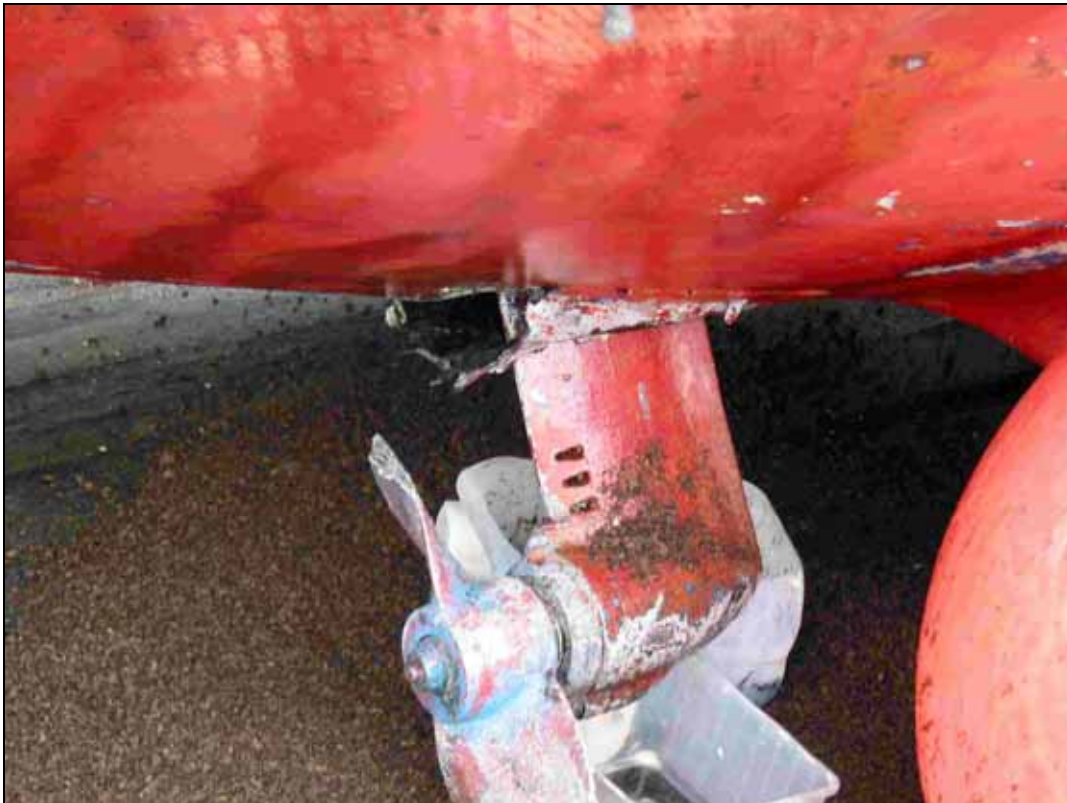
During the inspection of the yacht by the BSU it was also ascertained that the shaft of the drive had made contact hard on the forward edge of the hull cut-out of the Saildrive. As a result the forward edge showed clear signs of damage (see Figure 10). The shaft of the Saildrive had visibly tipped forward, and as a result the silent blocks were cracked. The two-bladed, left-handed propeller turning anticlockwise was bent forwards at both flukes at the rear (Figure 9).

Figure 9: Saildrive shaft pushed forward and damaged propeller

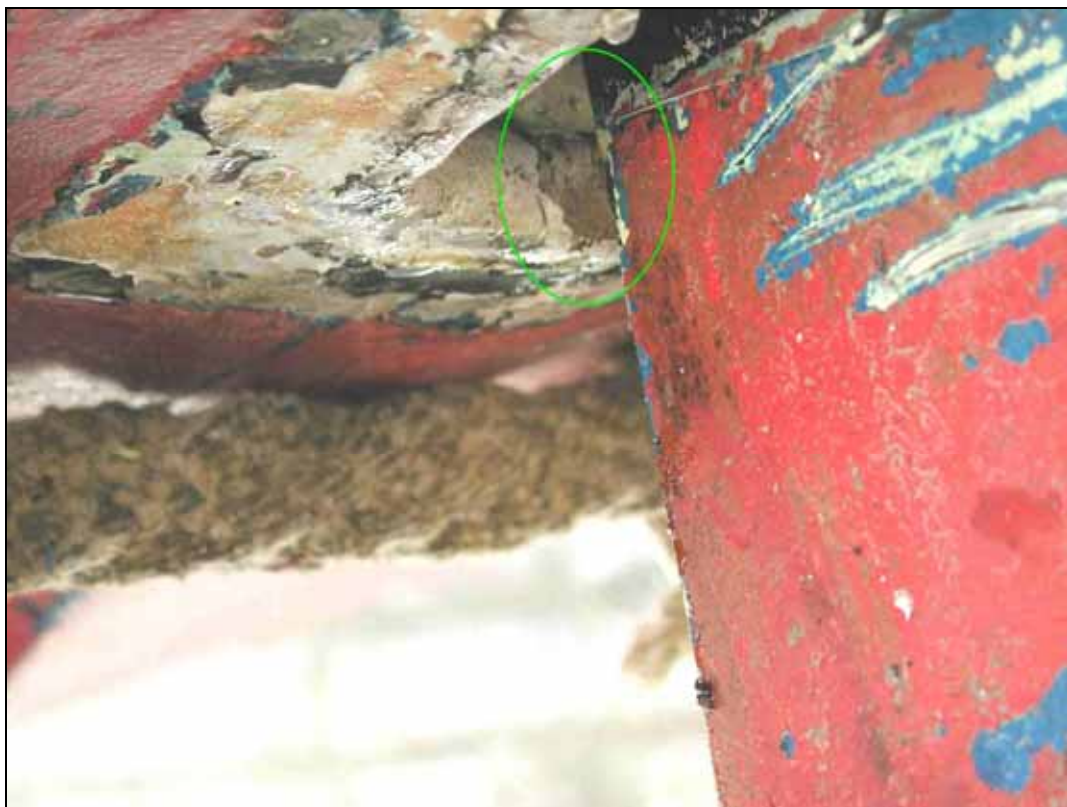
Figure 10: Damage to the trunk of the Saildrive

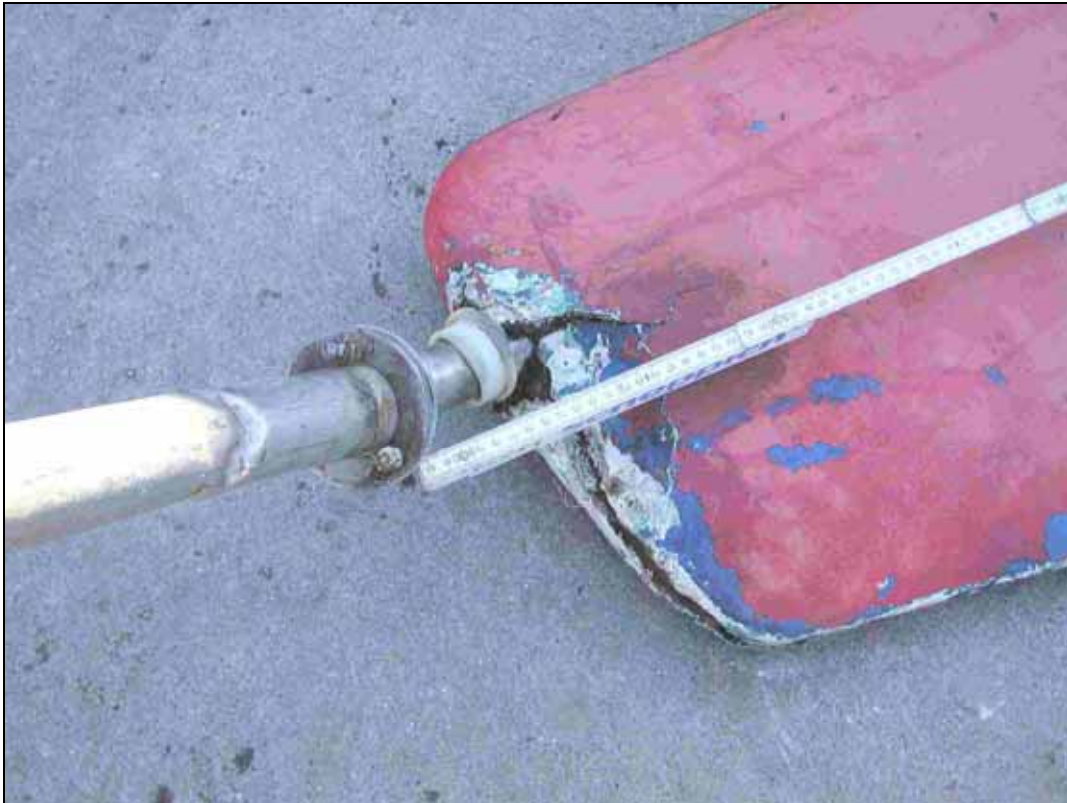
Figure 11: Upper part of the rudder blade with buckling

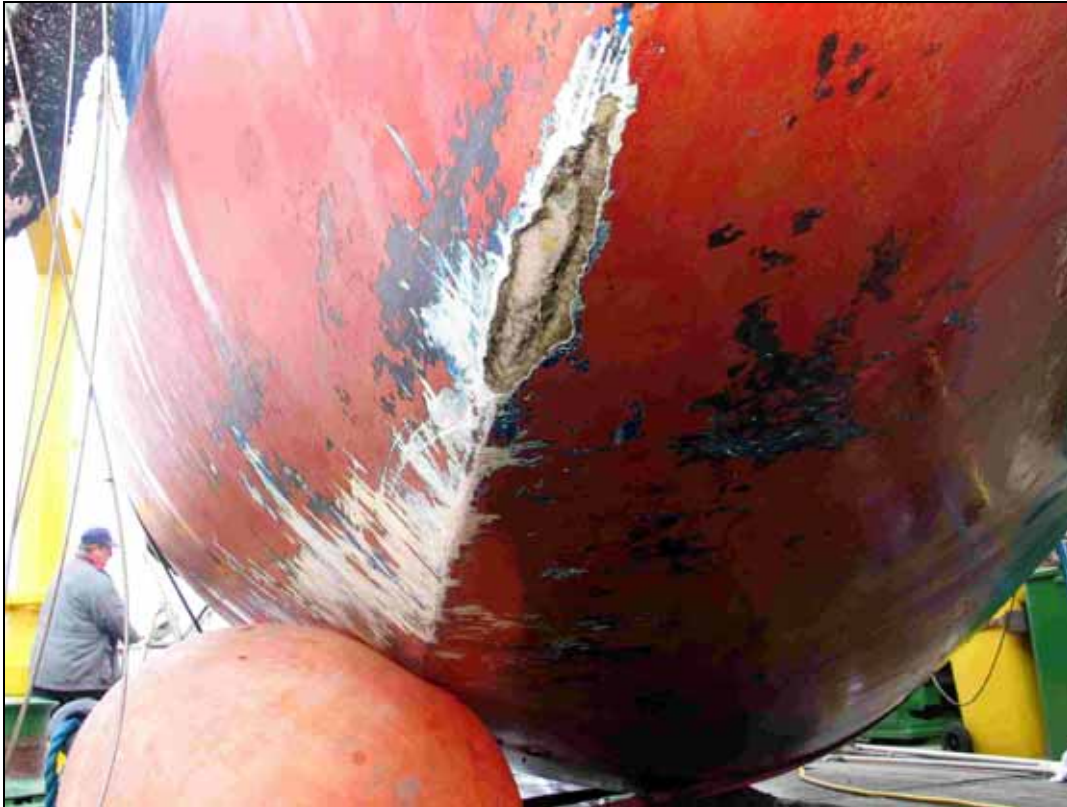
Further damage to the hull was found in the bow area in the transition to the keel, approx. 26 cm below the water line. Here the gelcoat and the laminate were affected massively over an area of approx. 20 cm (Figure 13). The gelcoat was no longer present, the laminate appeared to be buckled. When the vessel was salvaged water emerged from this point.

During the survey two areas of damage that were crucial for maintaining the floatability were ascertained. The first damage was in the fore ship area. It very probably occurred as a result of the yacht running onto the shallow at Südperd. The fact that the crew were unable to tow the yacht from the stones onto which it had run with the aid of a motorised inflatable boat provides some information about the force of the stranding.

The BSU considers the damage to the bow to be the cause of the yacht foundering.

Figure 13: Damage to the bow

- the weather conditions
  - and the sea behaviour of the boat.
- to skippers, after grounding, that they carefully examine the vessel for damage and if appropriate run into the next port in order to be able to examine the damage better.

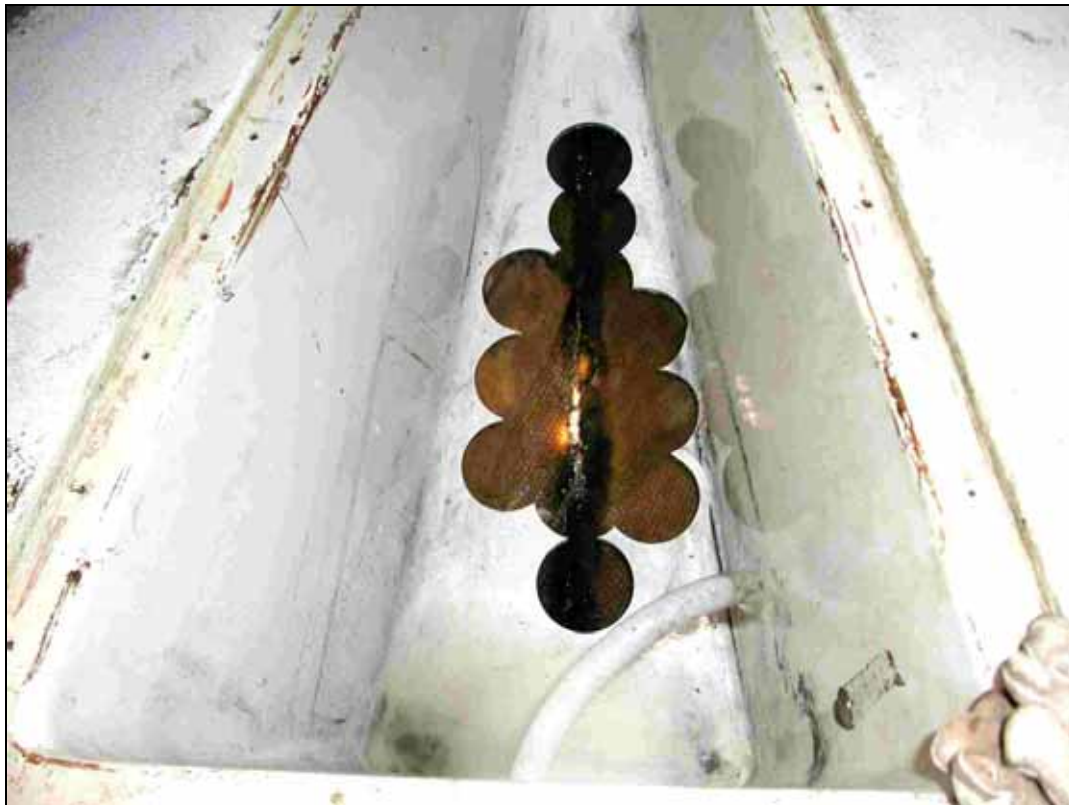
Due to the shell laminated in place in the fore ship, it was not possible to inspect the damage in the bow area directly. First of all the wooden cases were dismantled and then the shell was cut open in the area of the recess. From here it was possible to see the deep damage (Figures 14, 15, 16). After removal of the wooden chests it was ascertained that the cavity formed on both sides through the inner shells was through-going from the fore ship to aft.

Figure 15: Inner shell cut open in the fore ship

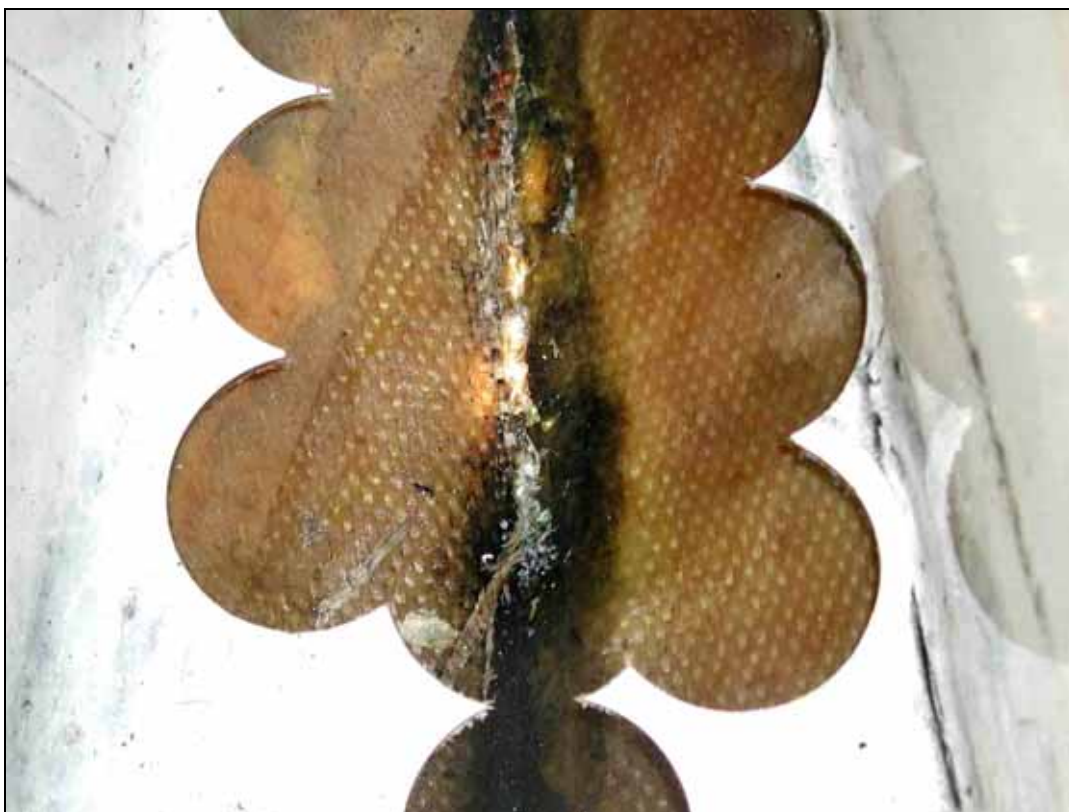
Figure 16: Damage in the bow area
