Investigation Report 203/04

Very serious marine casualty

**Foundering of SY ALLMIN and
drowning of two sailors
on 29 June 2004
east of Rügen**

1 October 2005

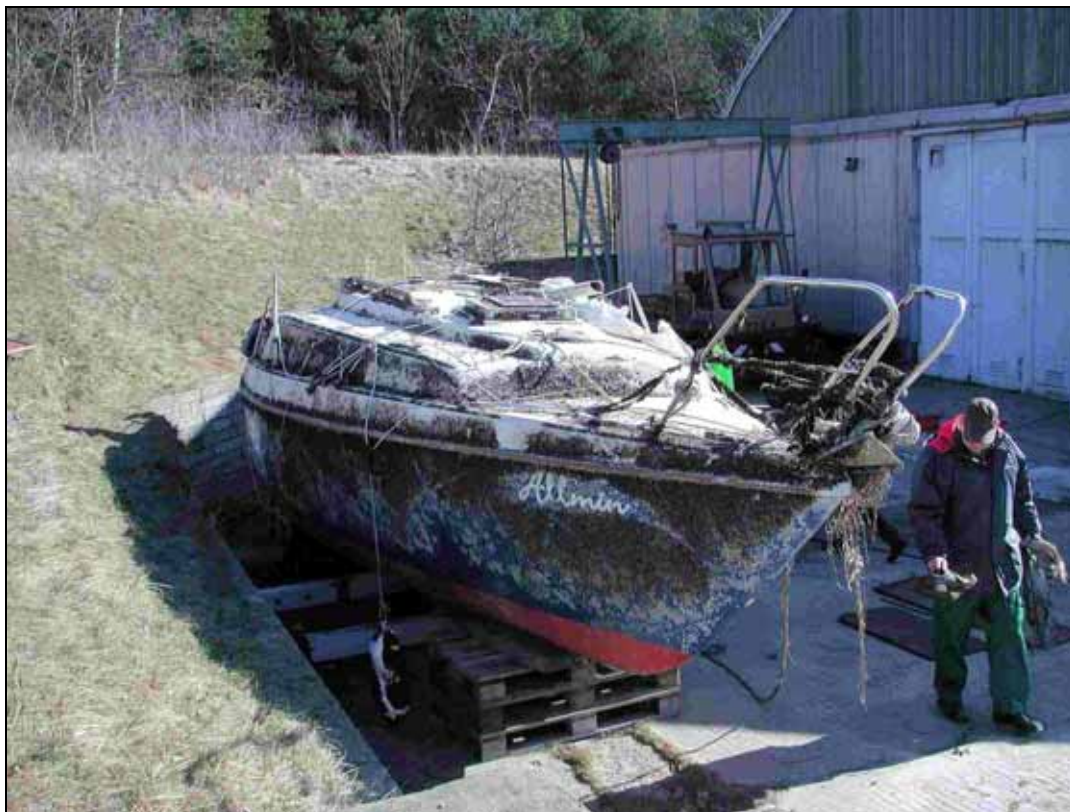
Figure 4: View from the bow

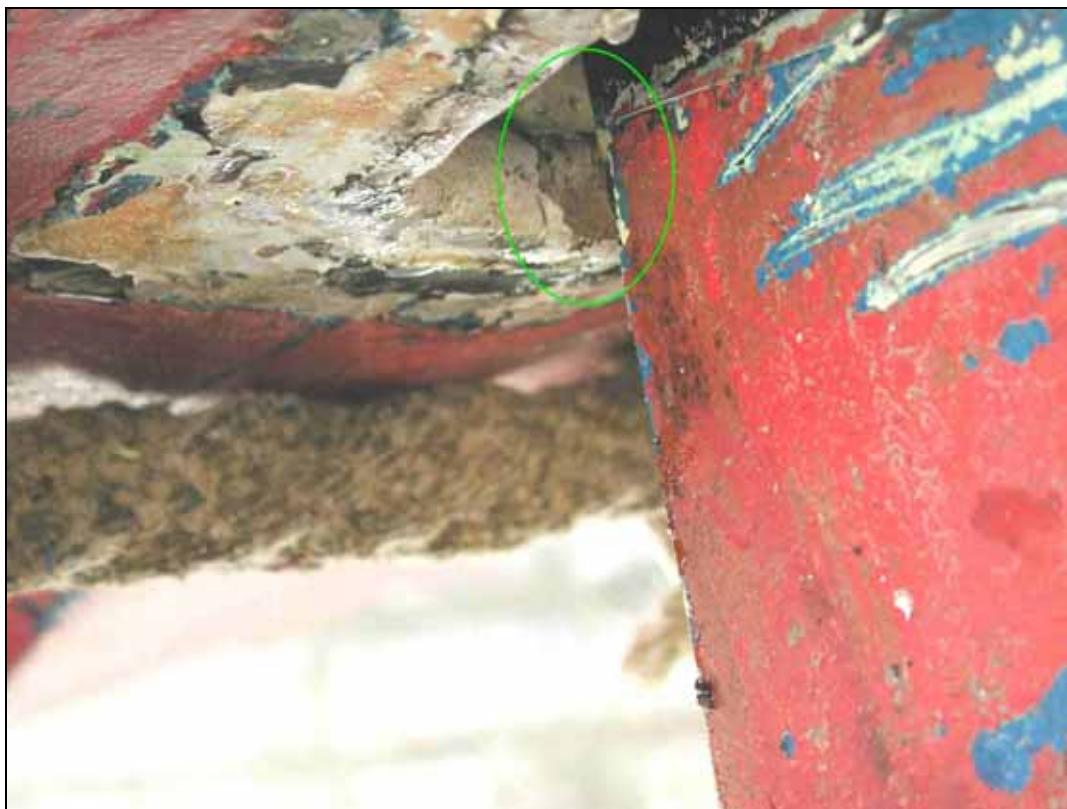
During the inspection of the yacht by the BSU it was also ascertained that the shaft of the drive had made contact hard on the forward edge of the hull cut-out of the Saildrive. As a result the forward edge showed clear signs of damage (see Figure 10). The shaft of the Saildrive had visibly tipped forward, and as a result the silent blocks were cracked. The two-bladed, left-handed propeller turning anticlockwise was bent forwards at both flukes at the rear (Figure 9).

Figure 10: Damage to the trunk of the Saildrive

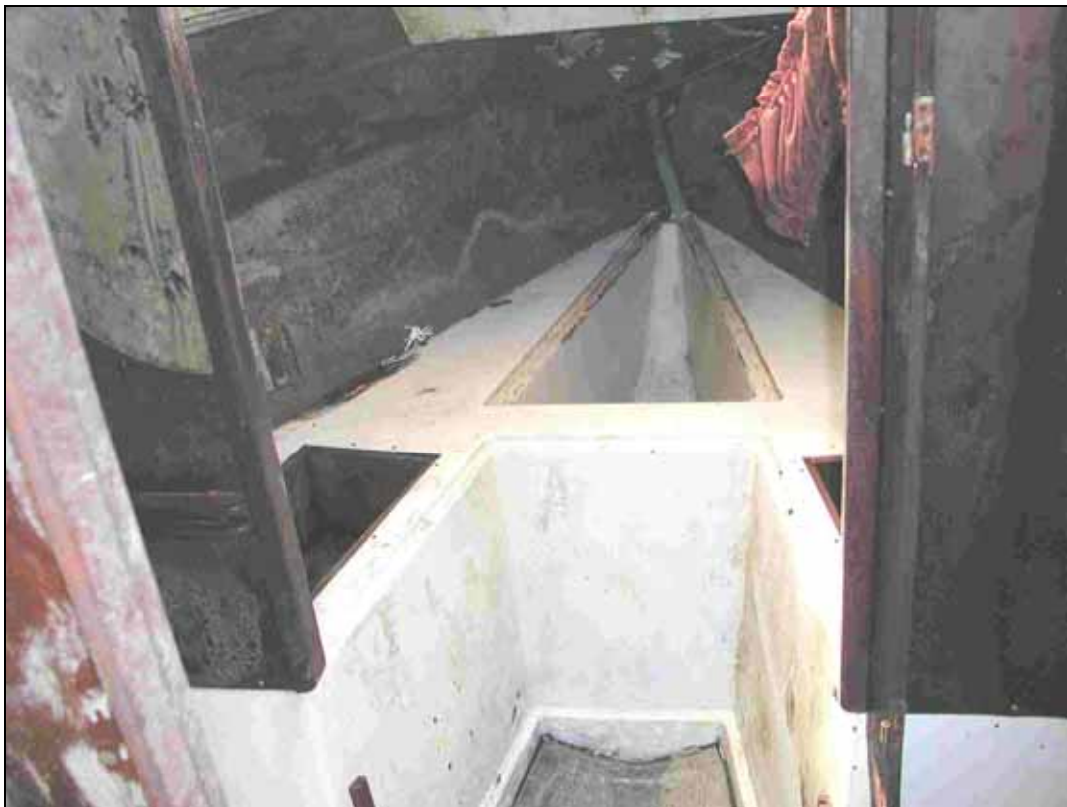
Figure 14: View into the fore ship
