Bundesstelle für Seeunfalluntersuchung
Federal Bureau of Maritime Casualty Investigation
Bundesoberbehörde im Geschäftsbereich des Bundesministeriums
für Verkehr, Bau und Stadtentwicklung

Investigation Report 39/05

**Collision of MT STOLT FULMAR
with the ferry link span
in Hamburg on 29 January 2005**

1 May 2006

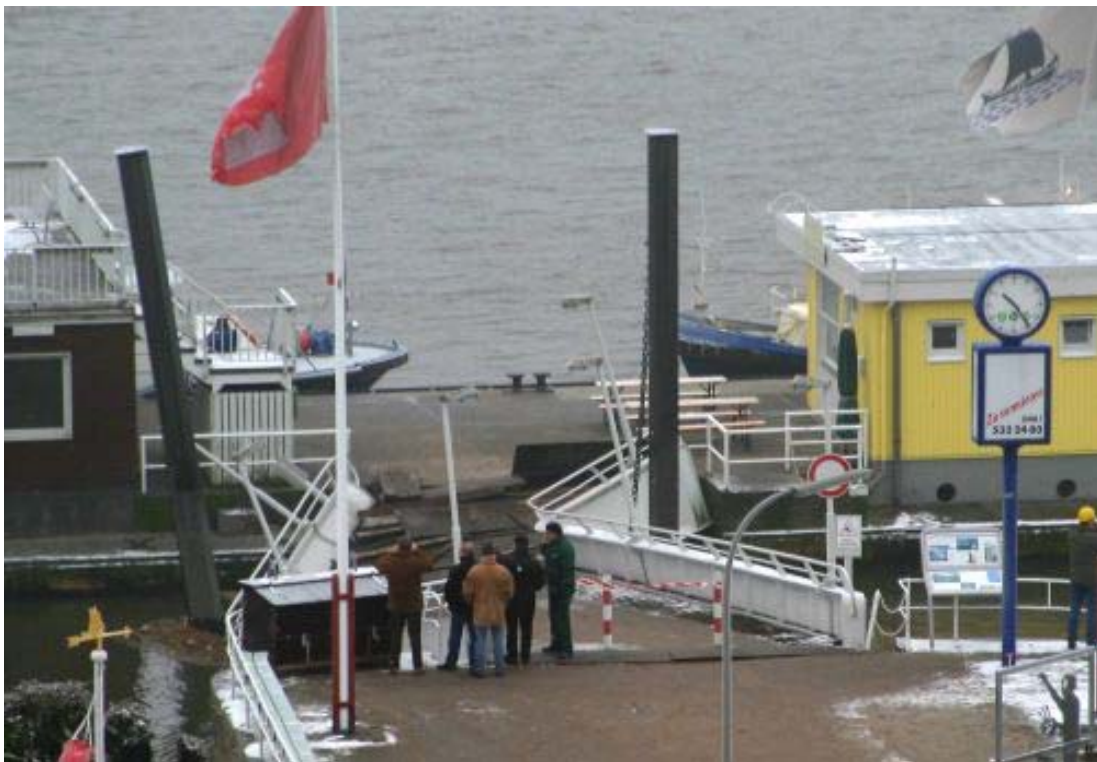
Figure 3: Link span Blankenese

The ferry link span was heavily damaged by the collision (see Fig. 3) and the property damage was estimated at euro 2 million. SCHLEPPKO 7 was damaged aft on the port side and was taking in water. Slight quantities of fuels and lubricants spilled out. By way of precaution the fire brigade laid out an oil barrier and used drainage pumps. STOLT FULMAR was slightly deformed at the bulbous bow and had sustained an approx. 20 cm long crack in the outer plating on the port side of the bulbous bow on a level with the water line, as well as paint abrasion damage. No fuel or lubricants or sulphuric acid spilled out.

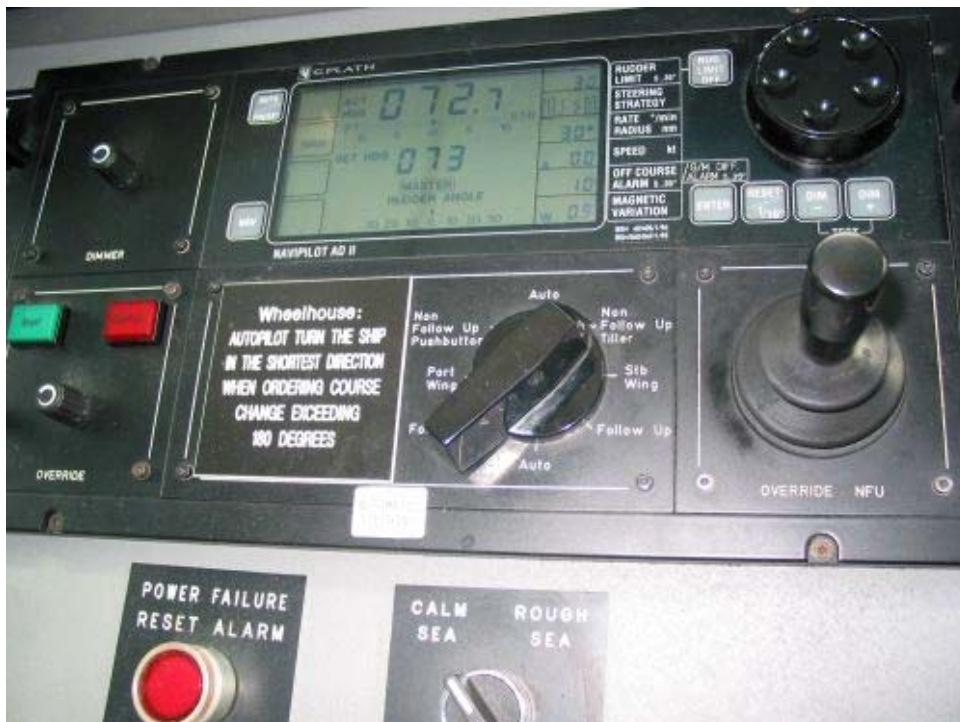
Figure 4: Steering mode selector switch with automatic pilot

The steering mode selector switch (see Fig. 4) has 8 switch positions. The automatic pilot Navipilot AD II can be switched on via the positions "Auto" at the top and bottom. At the top on the right side is the position "Non Follow Up Tiller". This is used to switch over to the "Override-Tiller" directly next to the conning position. In the middle on the right and left it is possible to switch to the controls "Stb. Wing" and "Port Wing" in the bridge wings. The steering modes NFU and FU are not marked here. In the bottom half right and bottom half left "Follow Up" positions it is possible to switch the hand wheel at the steering stand (see Fig. 5). The turning angle of the hand wheel is approx. 90° to port and starboard. On the half left side at the top is the position "Non Follow Up Pushbutton" for push-button control at the steering stand (see Fig. 5). In front of the steering stand is a rudder position indicator (see Fig. 6) mounted on the bridge deck that can be read off by the helmsman from starboard and port. At the conning position there is a rudder position indicator on the console at eye level in front of the seat and on the multifunction screen. There are further rudder position indicators at the other steering stands. According to the information supplied by the crew, the rate of turn indicators received their signal from the gyro compass. By contrast with the autonomous turn indicator, this signal comes with a time lag.

When switching over the steering mode, constellations arise in which unintentional turning manoeuvres of the vessel can be started:

- Rudder at the steering stand is not in midships position
⇒ Rudder angle pre-selection is implemented directly
- Rudder at the wing positions port and starboard is not in midships position
⇒ Rudder angle pre-selection is implemented directly
- Override tiller at the conning position
⇒ Rudder is set immediately after moving the tiller

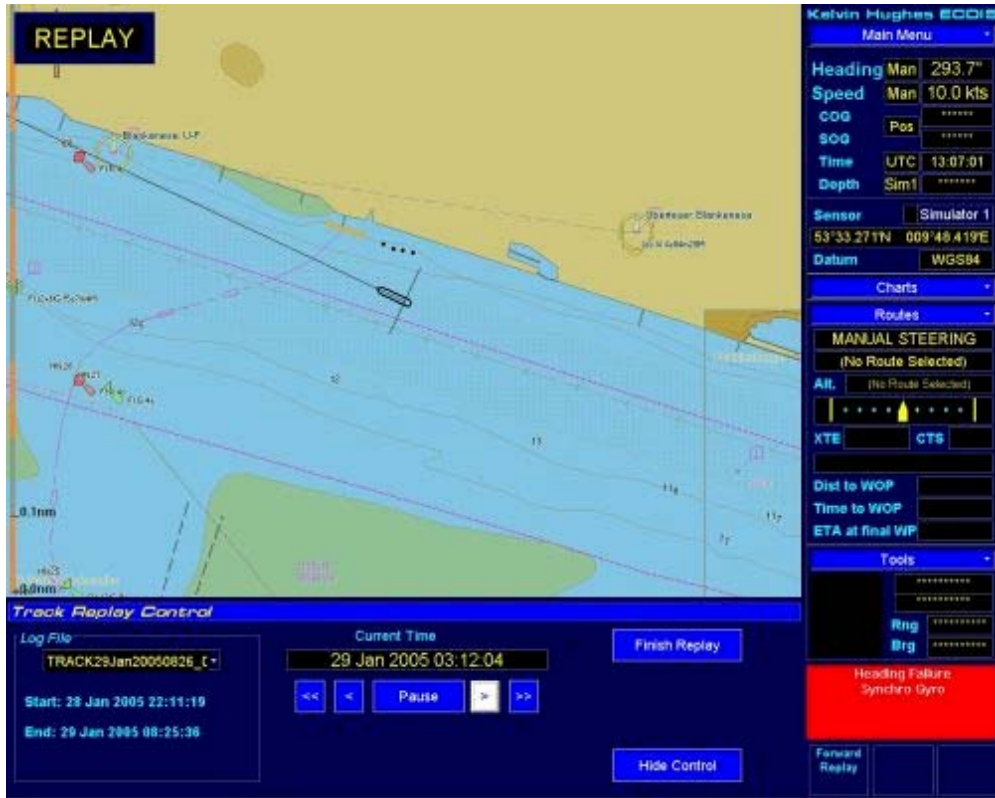
Figure 8: Electronic chart, turning to starboard

The evaluation of the electronic chart by the Kelvin Hughes' replay system revealed that at 04.12.04 h CET⁵ STOLT FULMAR turned to starboard abeam with the dolphins off the Blankenese link span (see Fig. 8) and collided with the link span at 04.12.53 h (see Fig. 9). Before this the parallel distance to the ferry link span was approx. 1 cable. The speed and rudder angle recordings of STOLT FULMAR as sensor information were not available to the BSU. The speed was specified manually in the system. A synchronisation error occurred in the gyro compass course information. The courses displayed were plausible, however.

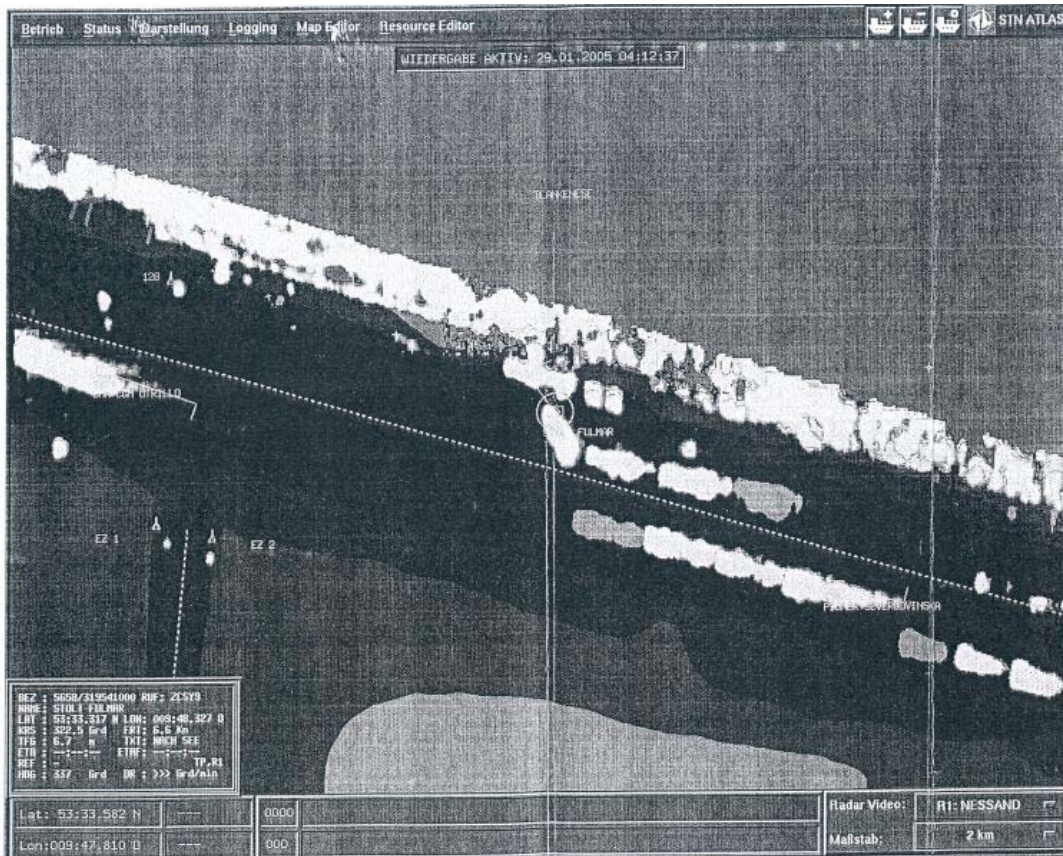
Figure 10: Radar recording by Vessel Traffic Services (VTS) Hamburg

According to the radar records of the Vessel Traffic Services (VTS) Hamburg, directly after the vessel "ran out of rudder" before the ferry link span speed over ground was 6.6 kn, in other words approx. 3.4 m/s (see Fig. 10). The speed measurements coincide with the statements by the crew.
