Investigation Report 465/05

**Serious marine casualty**

**Grounding of MV ILKA  
on 14 November 2005  
over a Submarine Pipeline  
on the River Tay off Perth (UK)**

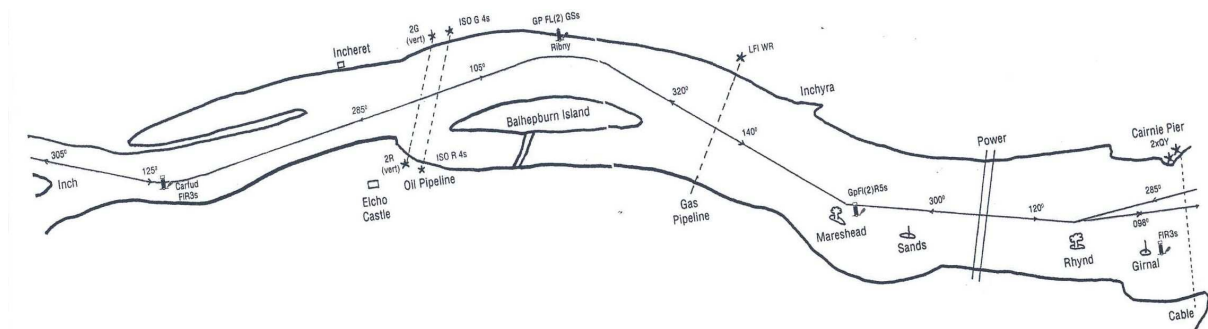
Figure 4: Excerpt Perth Harbour Passage Plan

The Perth & Kinross Council has published a sailing plan with recommended courses and manoeuvring aids for the passage Dundee to Perth that should be observed in the estuary (see Figure 4). The estuary is described as difficult and risky. No depth data were provided in the plan. The tidal current in the area of the accident is given as +/- 0.5 to 0.6 kn. There is a reference to a shallow patch by the submarine pipeline that is not sketched in (see 4.4.1 and Figure 4).

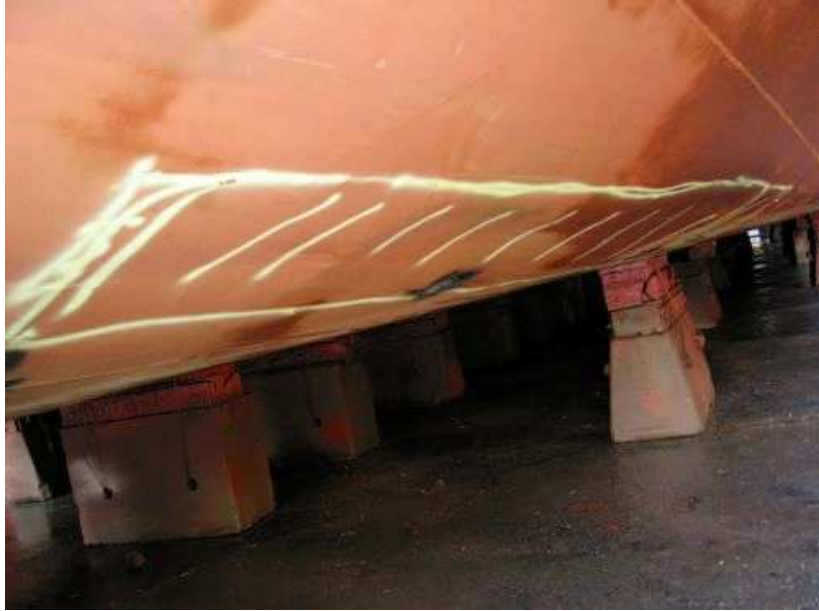
Figure 6: Bottom damage ILKA

In the course of the inspection of the hull, BSU ascertained denting at the forward port side behind the bow thruster canal that was already marked with chalk (see Figure 6). Approx. 3m<sup>2</sup> plating is to be replaced here. Slight denting and bending was visible aft at the propeller and rudder (see Figure 7). The blades of the variable pitch

propeller could be moved slightly by hand. A piece of fishing net was lying on the ground – it had become caught in the propeller. The damage aft is probably not attributable to the accident. In the estimation of the vessel operator the total costs can be quantified at approx. € 120,000.--. This reportedly includes tug costs of GBP 40,000.

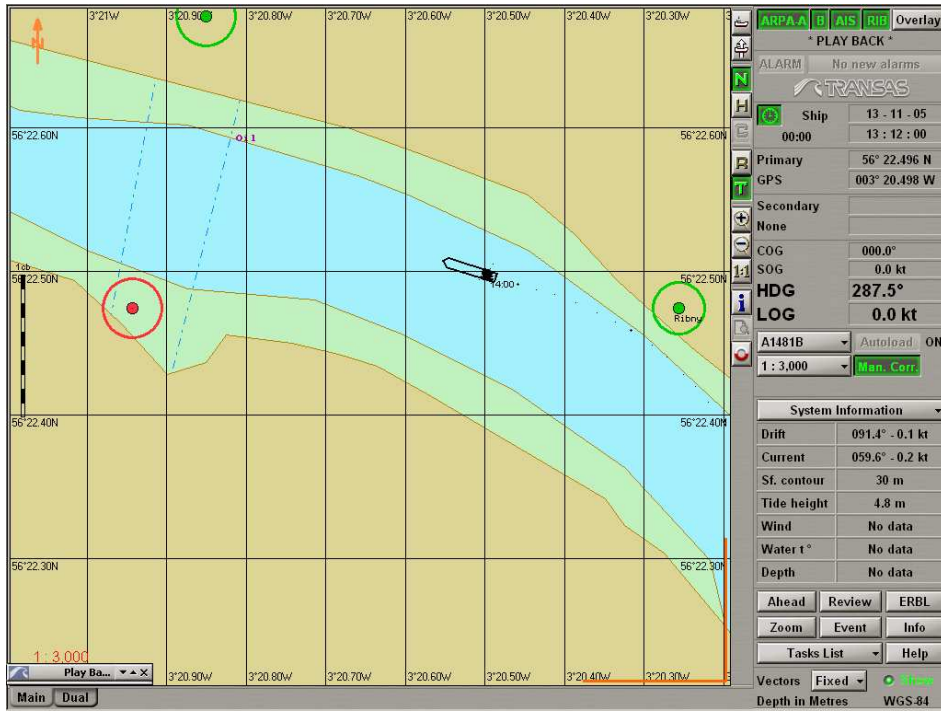
Figure 8: Grounding on 13 November 2005

The data of the electronic chart of type ECS Transas Navisailor 2400 provide a very generalised picture of the topography by comparison with the Perth Harbour Inward and Outward Passage Plan and chart BSH No. 228. According to this, the track followed by ILKA was in line with the recommendations of the Perth & Kinross Council in the Inward and Outward Passage Plan. The data stored by the ECS are visualised in Figures 8 and 9 and document the double grounding of ILKA.

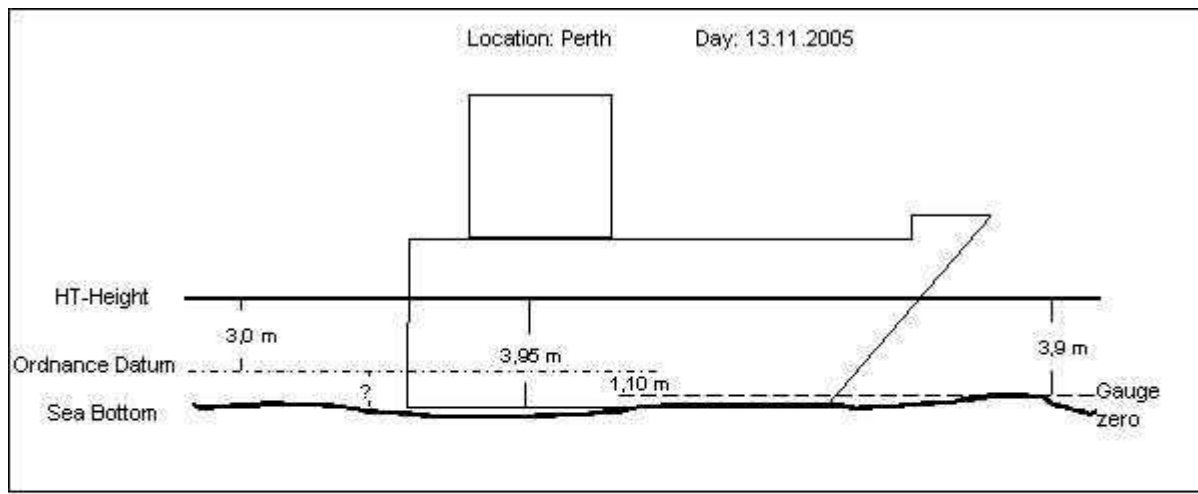
This means that 1.10 m must be deducted from the values in Table 2 in order to obtain the height above chart datum.

**ODN (Ordnance Datum Newlyn) = Chart Datum**  
**Gauge zero = 1.10 m below ODN** in the River Tay

Water level conditions on 13.11.2005 according to Table 1 and Table 2.
