Investigation Report 09/06

Collision
between MV TOR DANIA
and the tug and tow EMS TUG
on the river Elbe
at 00:12 a.m. CET
on January 10th, 2006

1 July 2007

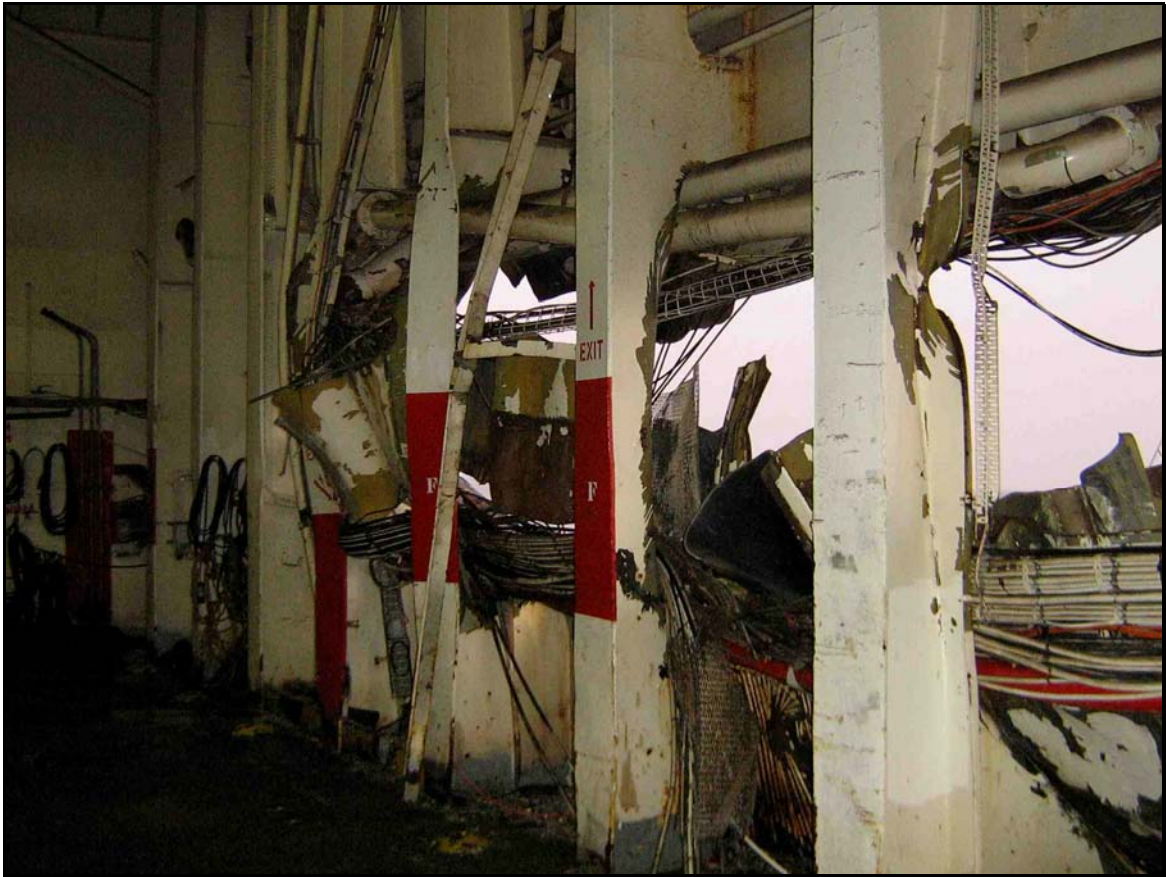
Fig. 6: TOR DANIA – damage photo 1

Colliding with the tow, TOR DANIA suffered a vertical tear about 12 m long with a height of up to 3 m in the aft area of her port side about 2 to 3 m above the waterline. Various pipes and cable ducts were destroyed and torn off. Fuel pipes were not affected, and no leakage of hazardous materials was stated. No persons were injured. The vessel remained afloat and could continue her voyage to Cuxhaven.

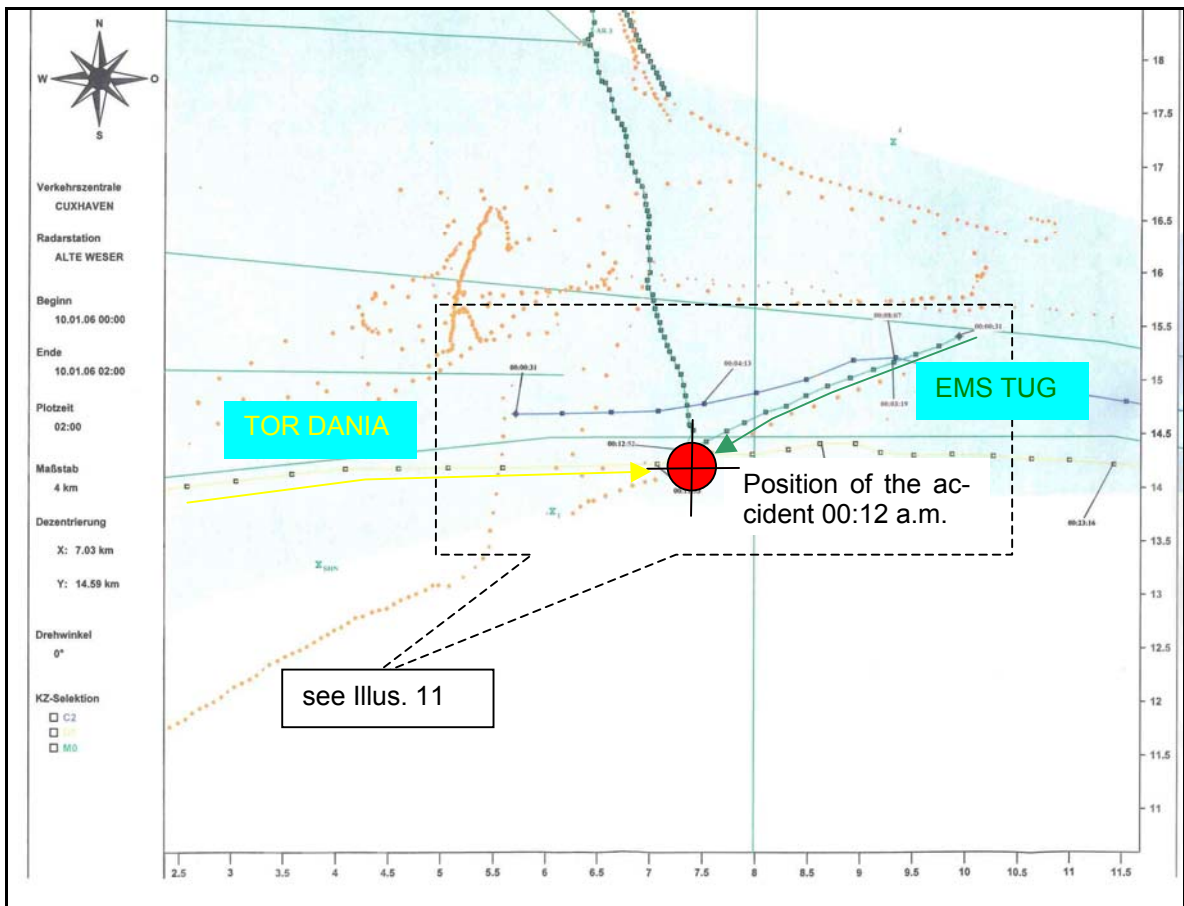
Fig. 11: Radar plot by the Traffic Centre

The radar data recorded by the Cuxhaven Traffic Centre show the course of the voyages of both ships. TOR DANIA is shown by a yellow line, EMS TUG by means of a green line. The blue line running north of them is the course of voyage of P&O NEDLLOYD PALLISER, which sailed upstream the Elbe and does not play any role in the course of the accident.
